# Failure Investigation of Under Construction Prestressed Concrete Bridge in Chitwan, Nepal

**Abstract:** On 6 April 2021, a 200 m-long under-construction prestressed concrete bridge failed in the Chitwan District in central Nepal. Two of the four bridge spans collapsed without any notable evidence of dynamic force application. Under-construction bridge failures are sometimes reported and can have a significant impact on the future construction adjustments. Thus, a detailed study of failure mechanisms will be insightful for the structural engineering community. Aiming to document the failure modes and exemplify lessons for improvement, this paper reports the detailed component level failure mechanisms of the bridge using visual inspection, site measurements, finite element modeling, and some forms of non-destructive testing. The chronological failure mechanisms are presented based on the field evidence and juxtaposed with the results of analytical modeling. The sum of findings highlights that the dead load failure, triggered by the settlement of falseworks, is the most critically governing factor that initiated and aggravated the damage scenario.

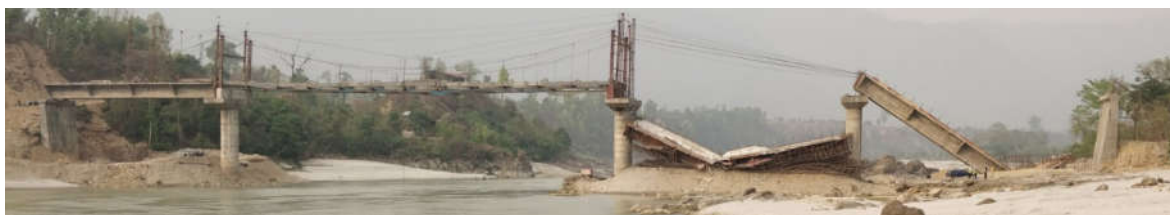
The first and fourth spans were structurally completed, and the second and third spans were under construction, when the partial collapse event occurred (Figure 2). The two spans located towards Thimura (left bank) collapsed in the early morning (4:30 am local time) of 6 April 2021. The collapse would have led to a loss of human life or injury had it occurred during working hours.

**Figure 2.** Thimura prestressed bridge with two collapsed spans.

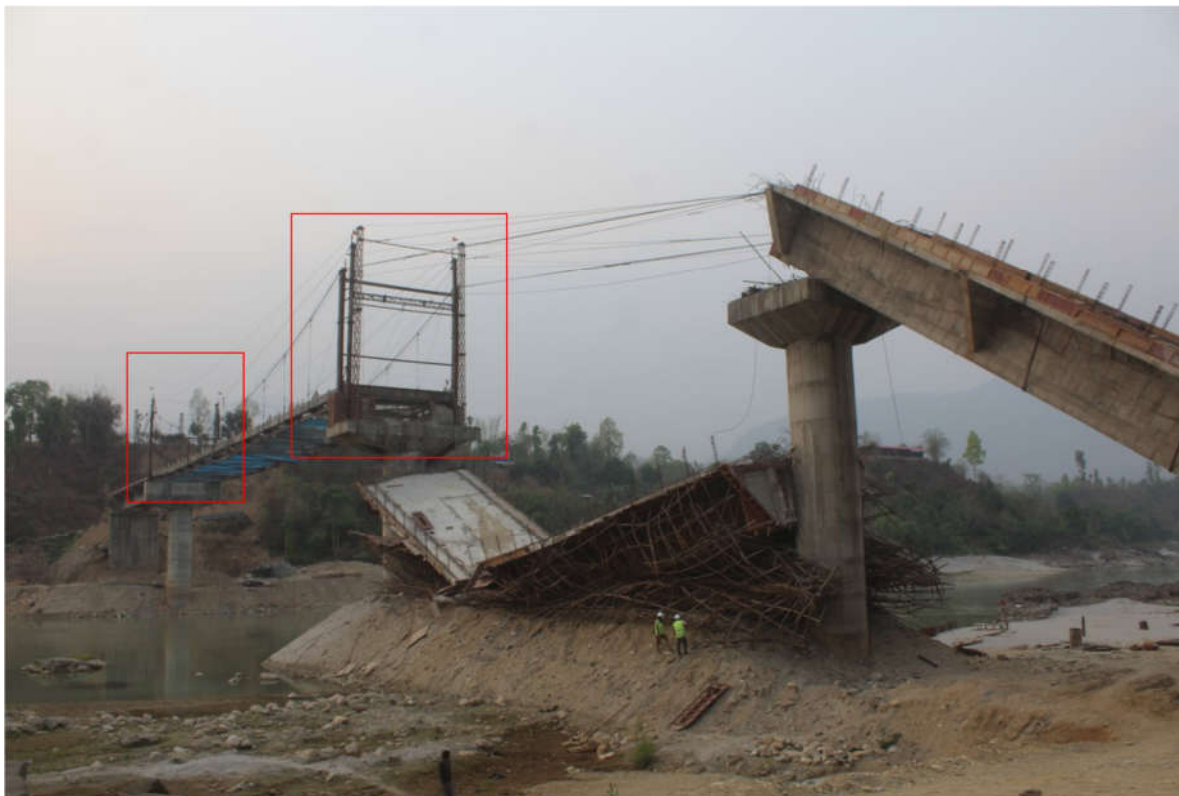
**Figure 3.** Steel towers constructed on pedestal.

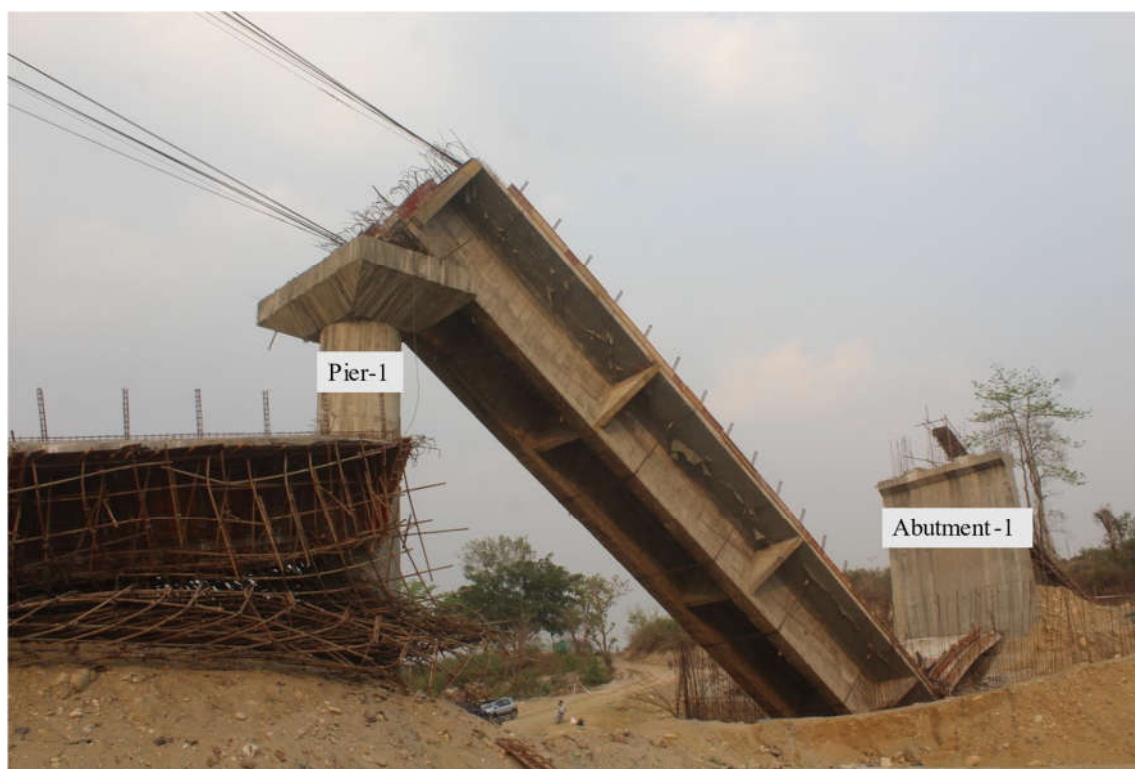
The first and second concrete spans fell off the piers and were destroyed (Figure 4). The first span fell off the abutment, meanwhile the slab still stood leaning on the first pier, with a total cantilevered portion of ~1 m (Figure 4). The second span fell off both piers with a fracture nearby the mid-span (Figure 5). Damage to individual components is presented in the following section.

**Figure 4.** Collapsed first span of the bridge.

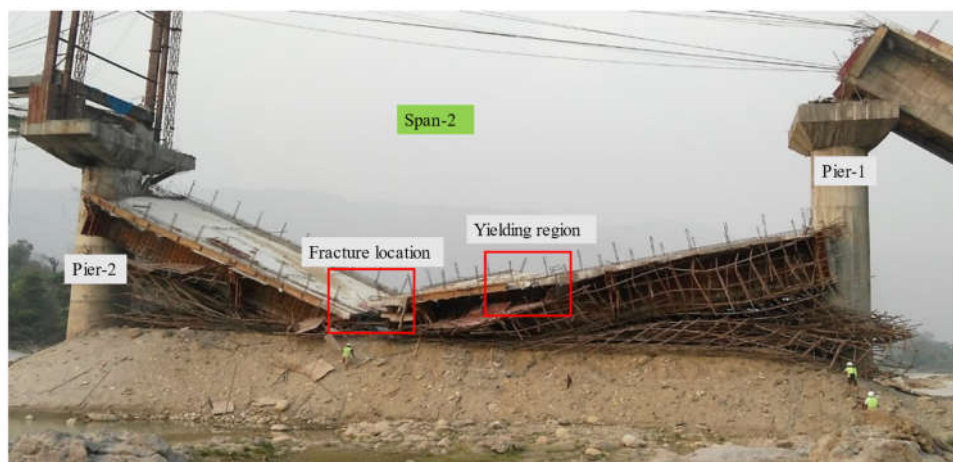
**Figure 5.** Destroyed second span of the bridge. The damaged props can be observed rested above loose sand and gravel.

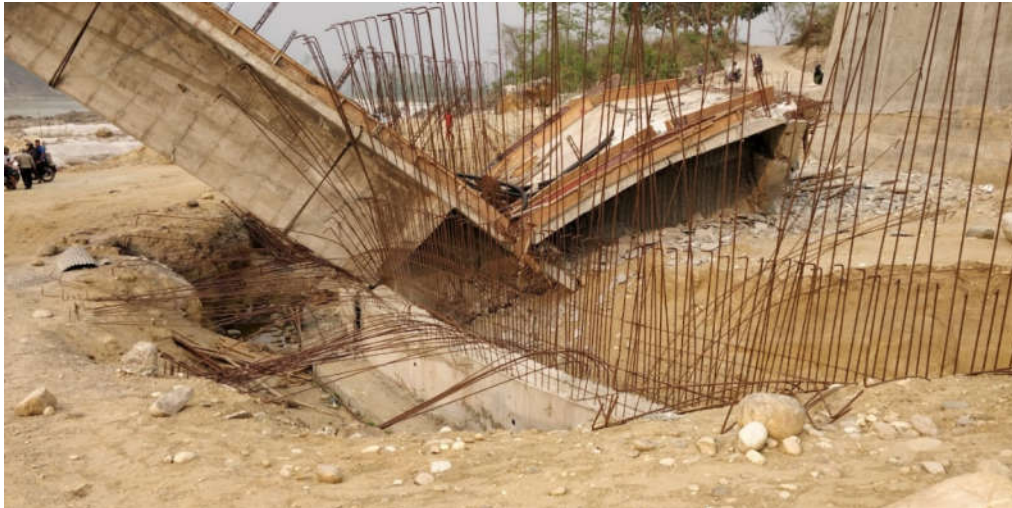
The first span fell off the first abutment that was governed by the settlement of the foundation soil. Thereafter, the beam hit the ground causing intense damage to approximately 25% of the length of the beam/slab in the first span. The remaining portion of the span only had some cracks, without reinforcement exposure. Horizontal shear failure of the beam concrete was observed in Span-1, as shown in Figure 6, which should have been initiated after the impact on the ground due to the occurrence of large shear stress. Interestingly, the shearing location exactly matched with the construction joint (interface of first day and second day concreting), as shown in Figure 7. Distinct flexure crack and yielding were identified in the beams of Span-2. The prestressing cables were exposed due

**Figure 6.** Collapsed Span-1 of the bridge.

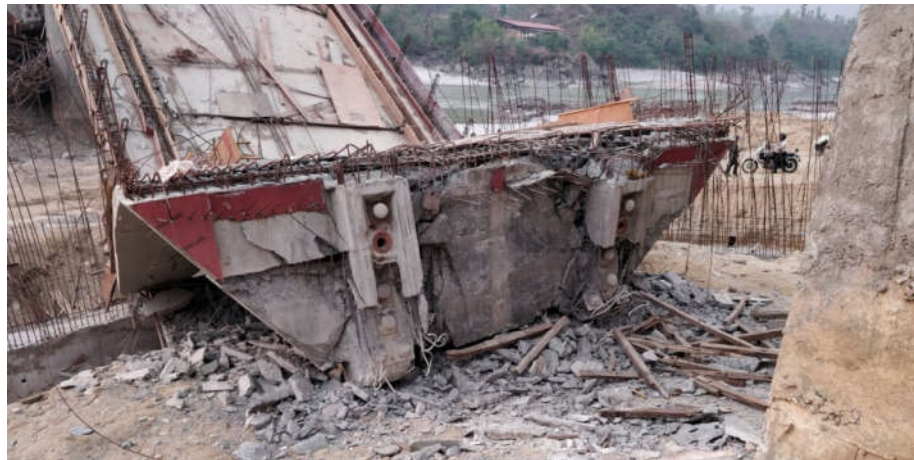
**Figure 7.** Horizontal shear failure at construction-joint level as the lower part of the beam that included four prestressing ducts slid inwards.

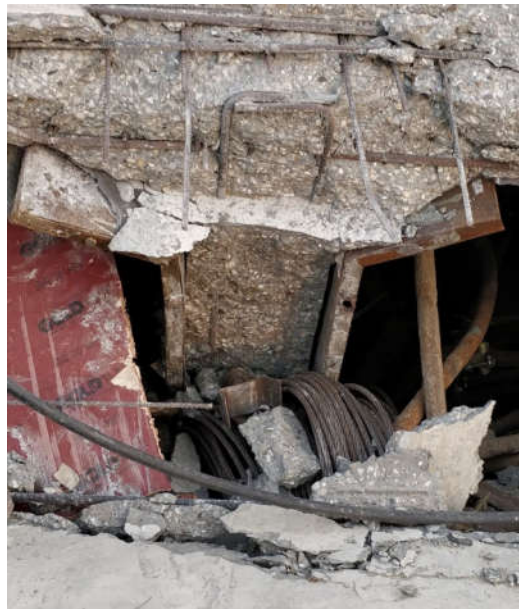
to flexure cracking, and the falling of the span caused breakage. Figure 8 shows a typical damaged section of the beam of Span-2. The end cross beams of Span-2 slid on the pier surfaces, thus sustaining heavy damage. As the bridge span fell down, the span was not housed within the available space between the piers. Therefore, it slid over the pier surface, the central portion of beam being the lowest point that got fractured.

**Figure 8.** L-bar of fractured beam, anchorage failure of some slab rebar, bearing failure of formwork around bolting holes, and prestressing cables pulled out to significant length and bent.

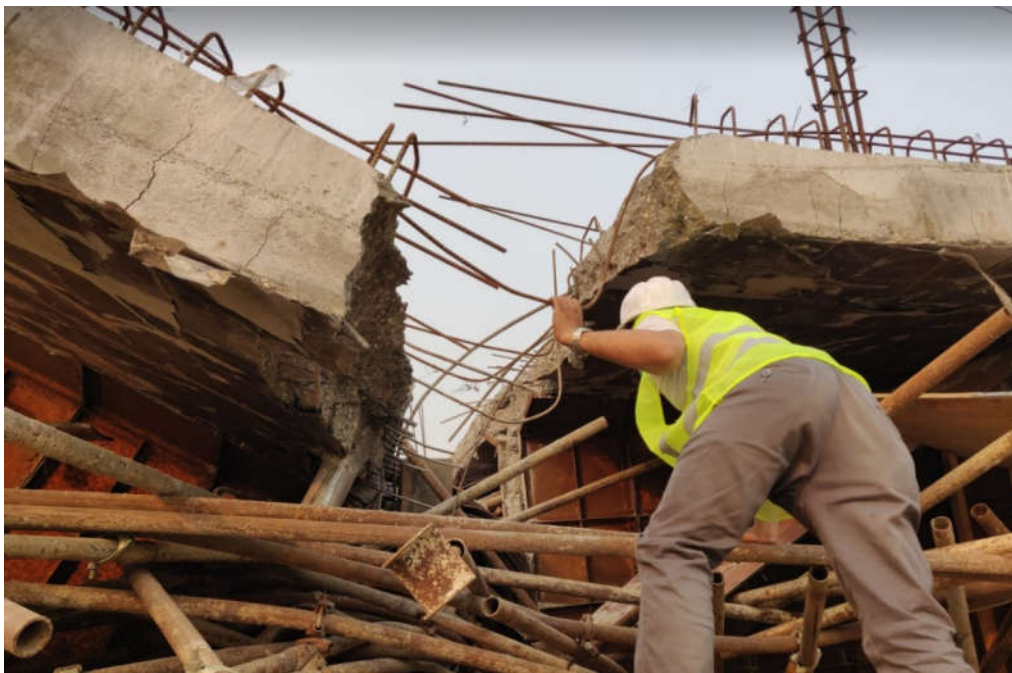
**Figure 9.** Fracture observed in slab of Span-2, including several flexural cracks near both sides of the main fracture region.

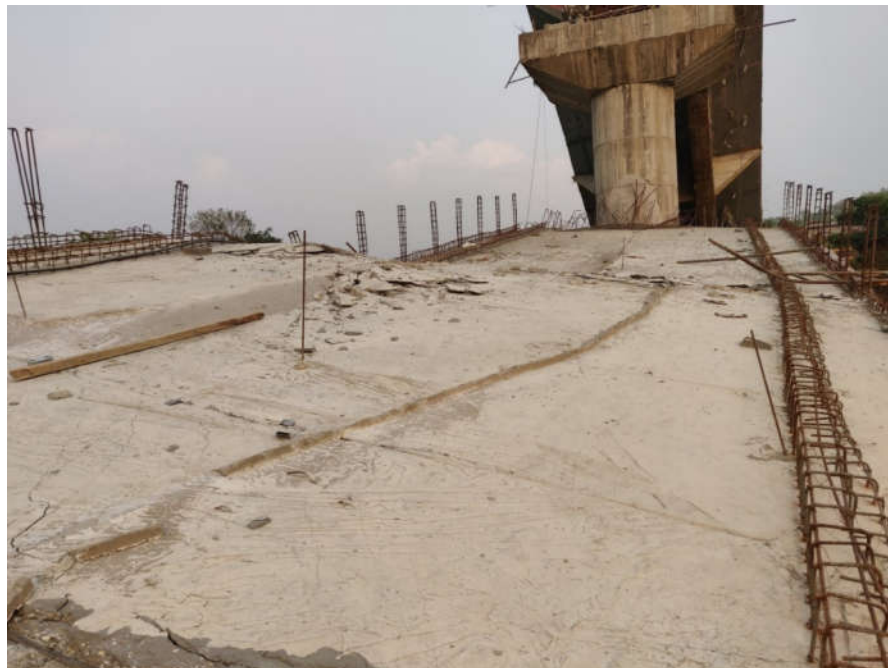
**Figure 10.** Cracks observed along the slab surface of Span-2.

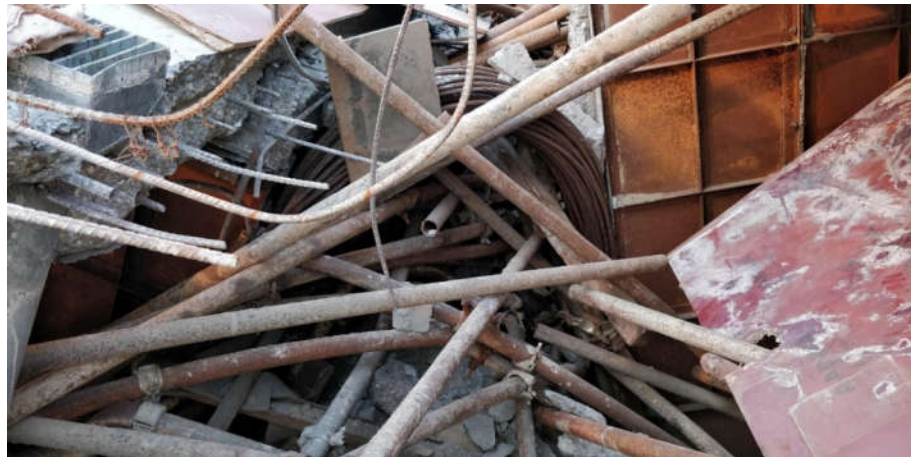
**Figure 11.** Several bars in the slab of Span-2 can be observed being pulled out and show up in pairs, indicating the significant lapping region of the slab; the prestressing cables were also pulled out to significant length during collapse.

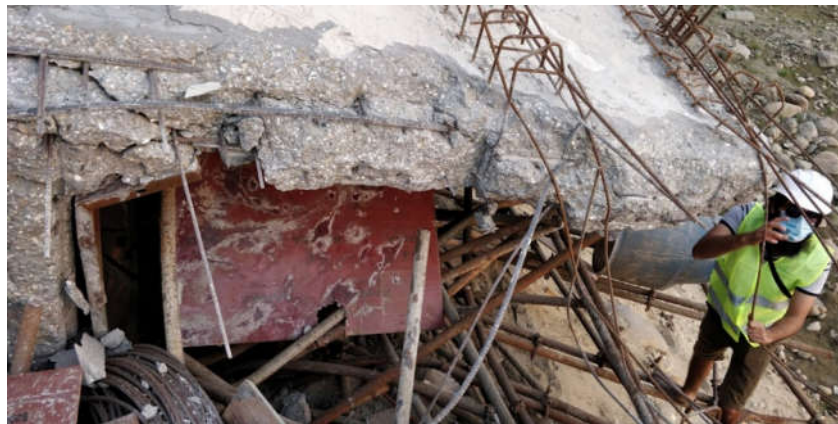
**Figure 12.** Pulled-out holes in slab in the fractured location.

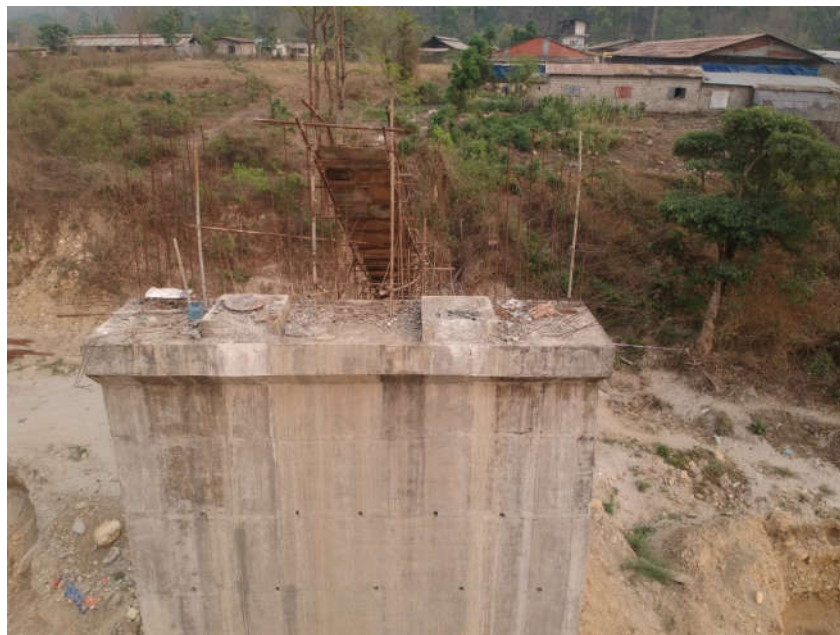
**Figure 14.** Bearing damage in Abutment-1 due to slippage of the slab before falling.

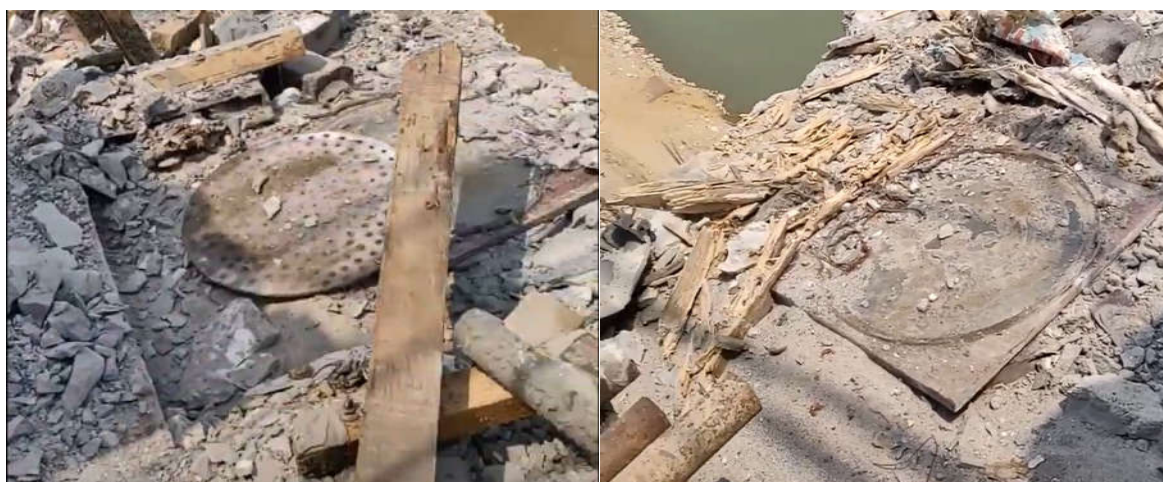
**Figure 15.** Damaged bearing above Pier-1, span-2 side (downstream and upstream side).

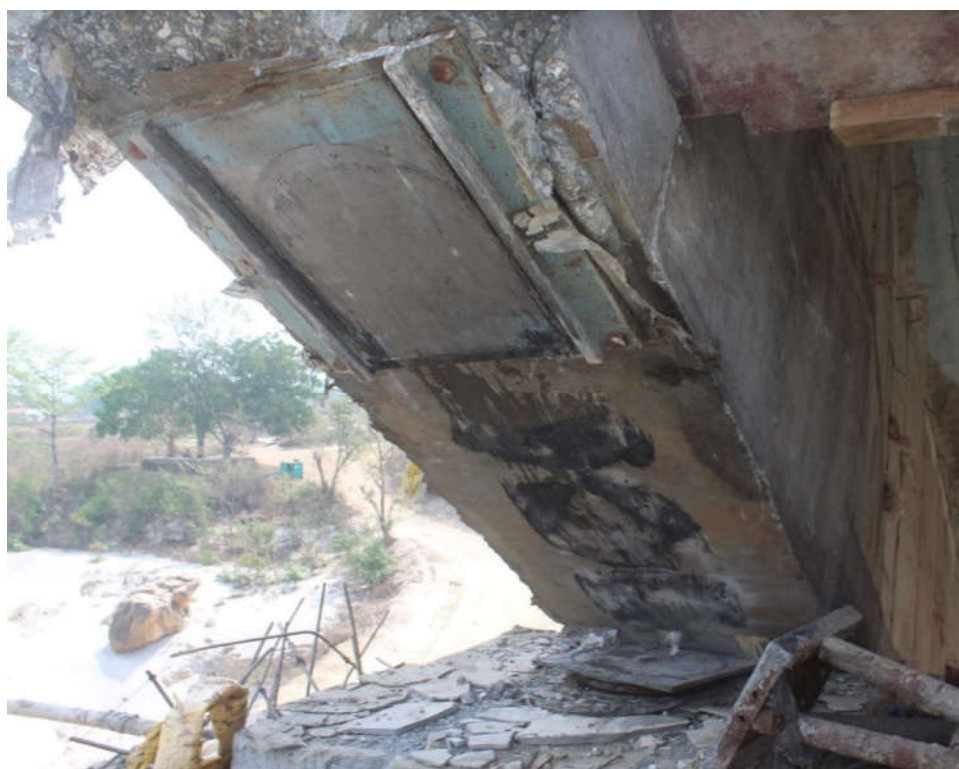
**Figure 16.** Span-1 deck (over Pier-1) that slid about 1 m towards Pier-1 indicating drag of deck (shown by bearing mark under the beam surface) and damage of bearing.

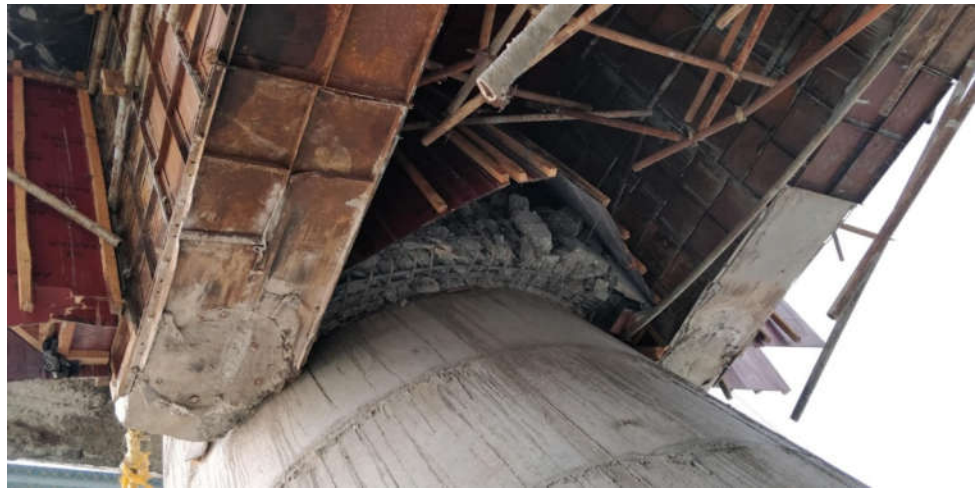
**Figure 17.** Bearing indentation in the beam with sheared bolts lodged (Pier-2).

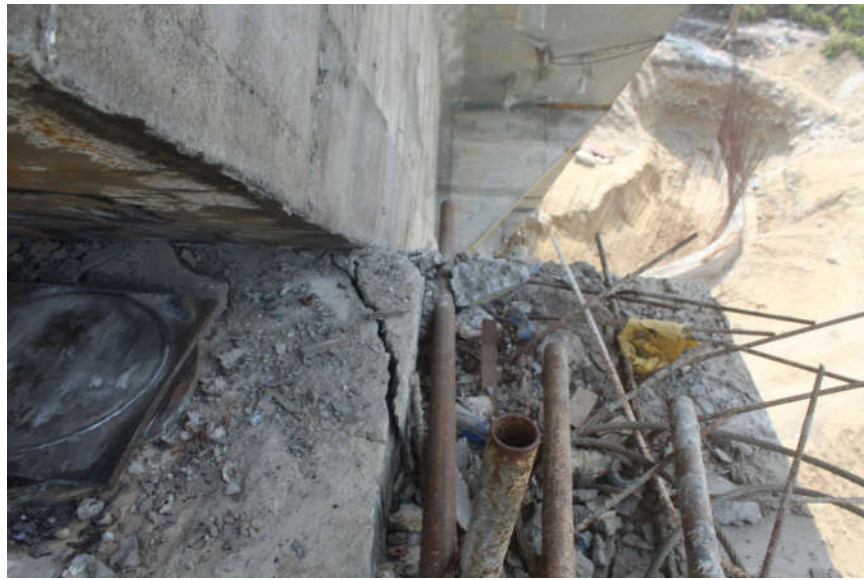
**Figure 19.** Damage to pier cap of Pier-1 due to Span-1 collapse.

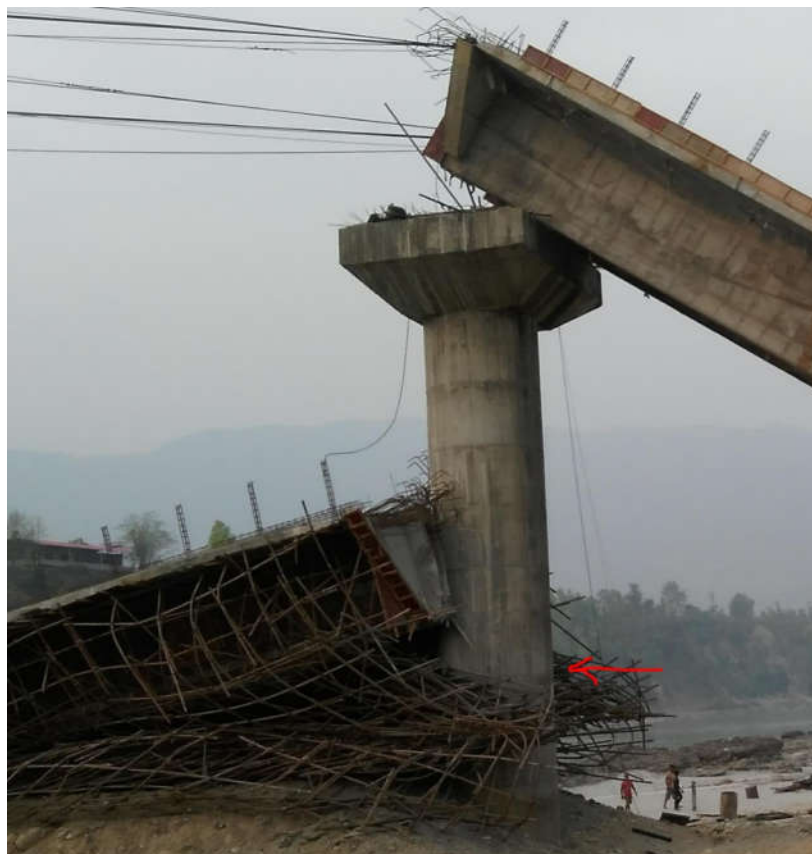
**Figure 20.** Pier-1 being pushed by Span-1 from the top and Span-2 from the middle in opposite directions. Horizontal crack is marked with an arrow.

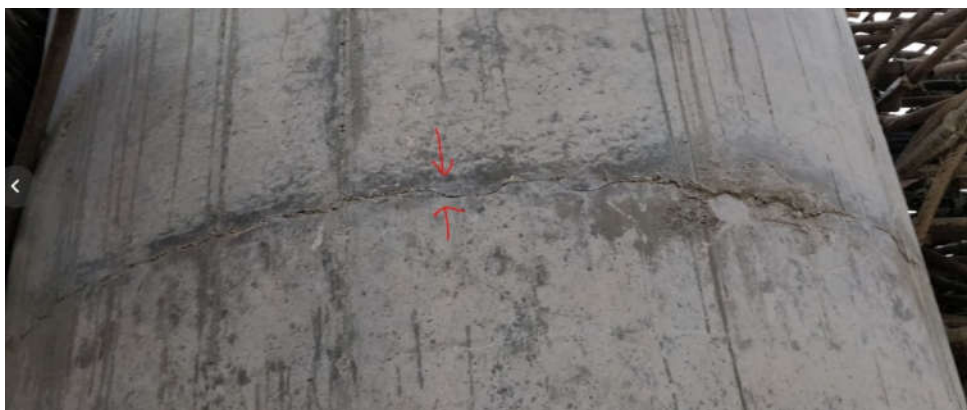
**Figure 21.** Horizontal crack towards the Span-1 side of Pier-1, at 2.5 m height from the ground level.

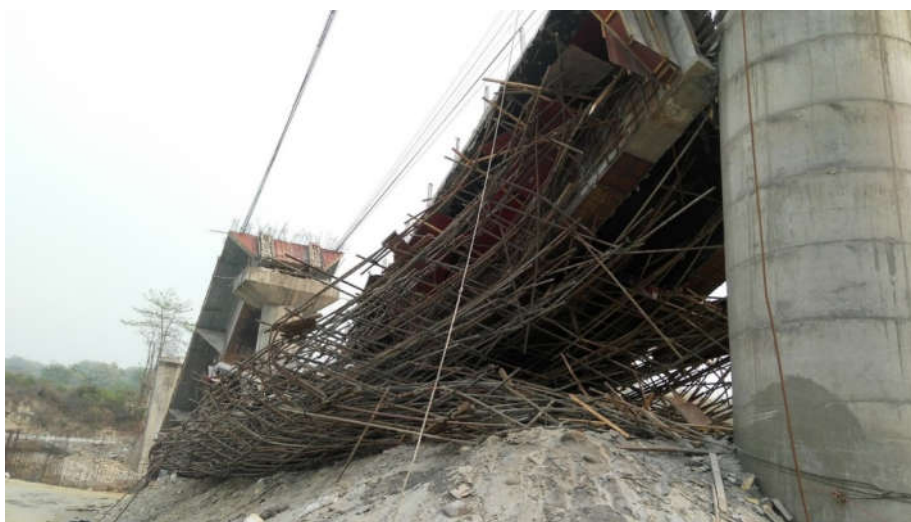
All the falseworks (props) under Span-2 were collapsed. The props were buckled outwards across the span (Figure 22), with inclination mostly towards the left bank (Chitwan side). Most of the steel formworks were intact, even after the collapse of the beam (Figure 23). However, near the fracture zone of the deck, the formworks were distorted due to bearing failure at bolted locations.

**Figure 22.** Falsework damage in Span-2; buckling was mostly towards upstream side, indicating damage initiation by settlement of downstream side first.

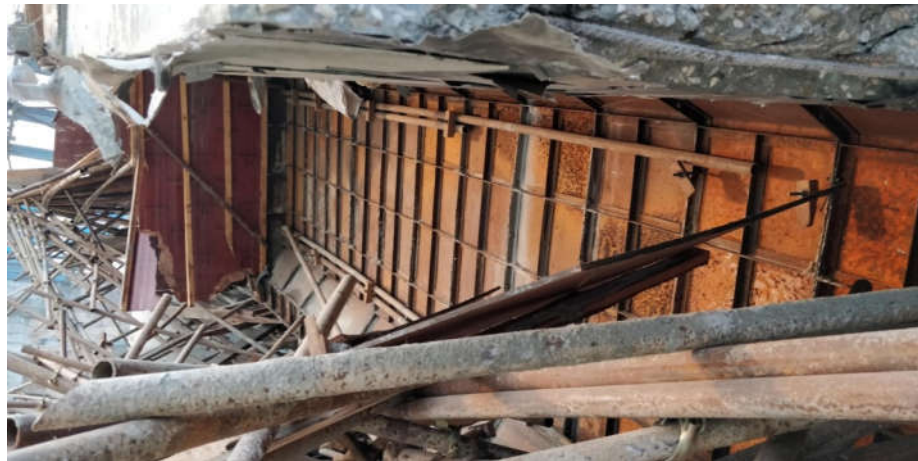
**Figure 23.** Intact formwork on other part of Span-2 (except the beam fracture location), indicating failure mechanism consists only one failure location.

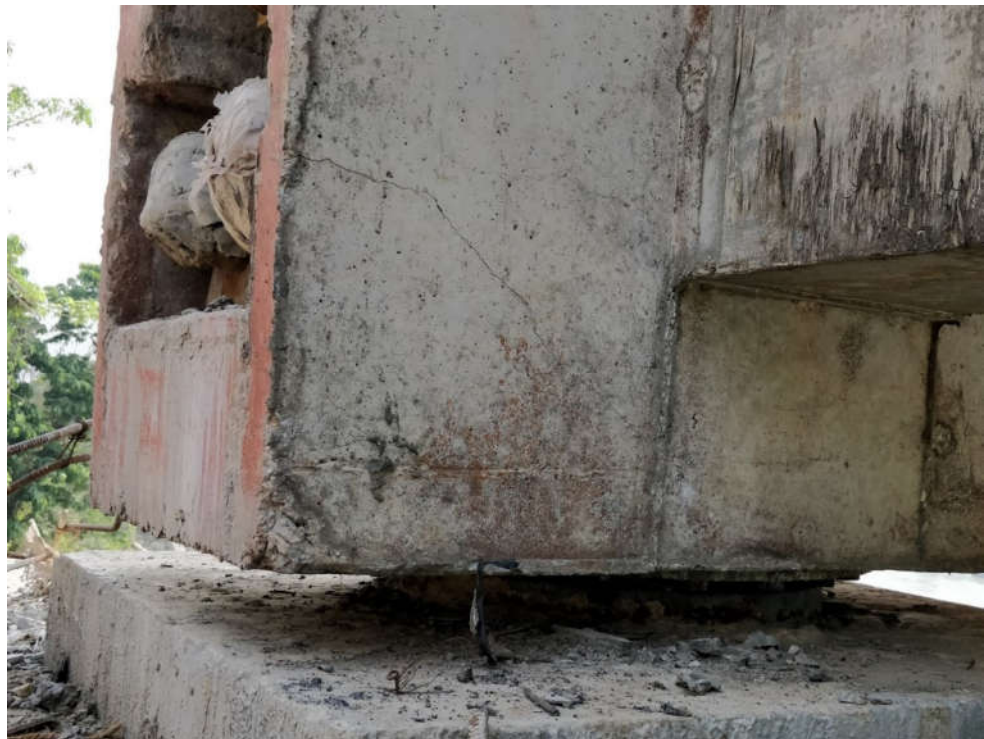
Some other damage mechanisms were observed at the ends of the fourth span above Abutment-2 (Figure 24). The edge around the prestressing cable anchorage was found to be cracked (Figure 25). The pier caps were also damaged in Pier-2 and Pier-3 due to the exertion of tensile force by the steel towers. Furthermore, the RC pedestal over the pier cap of Pier-3 was heavily damaged, as shown in Figure 26. Similarly, damage to the RC pedestal over the pier cap of Pier-2 is shown in Figure 27.

**Figure 24.** Some cracks around the end of Span-4 lower prestressing cable anchor zone, on Abutment-2 side.

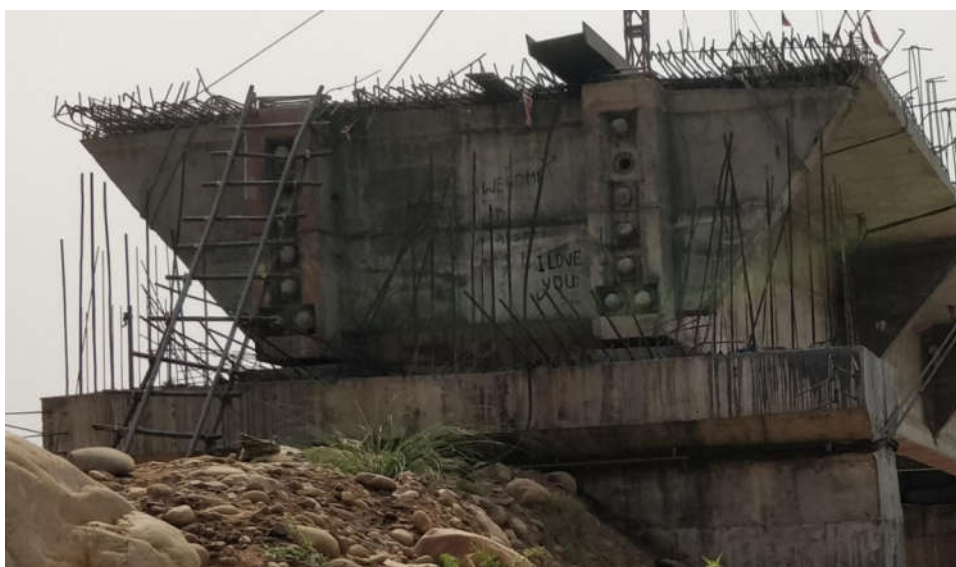
**Figure 25.** End of Span-4 over Abutment-2. Some temporary suspension cables were anchored at abutment and others were anchored near the end of Span-4 deck.

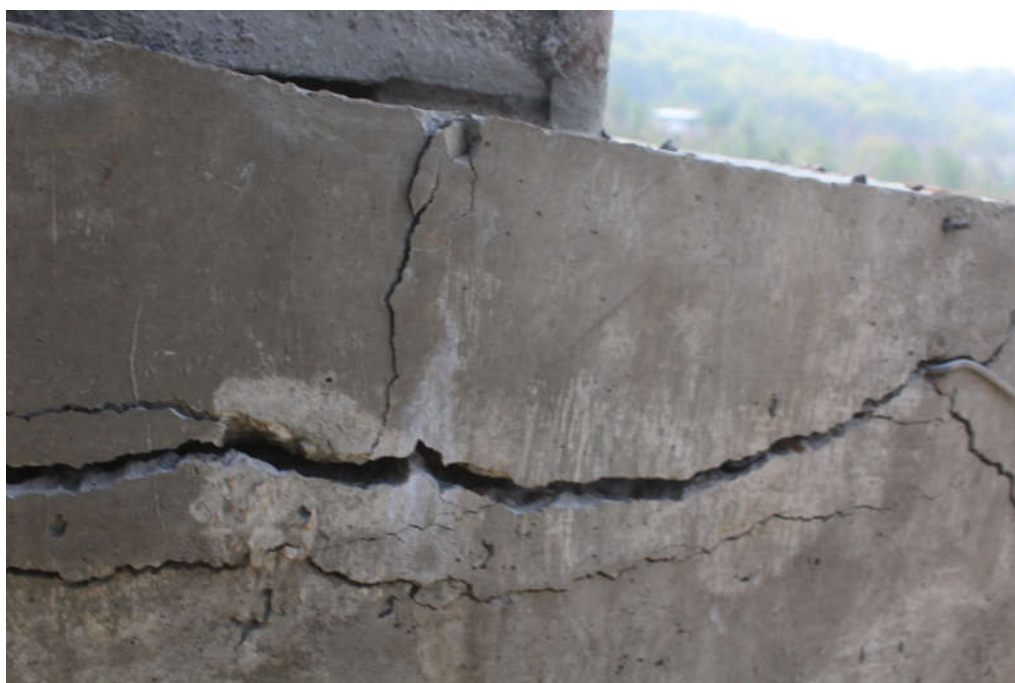
**Figure 26.** Heavily damaged pier cap above Pier-2 due to the tensile action exerted by the temporary suspension cables on the steel towers.

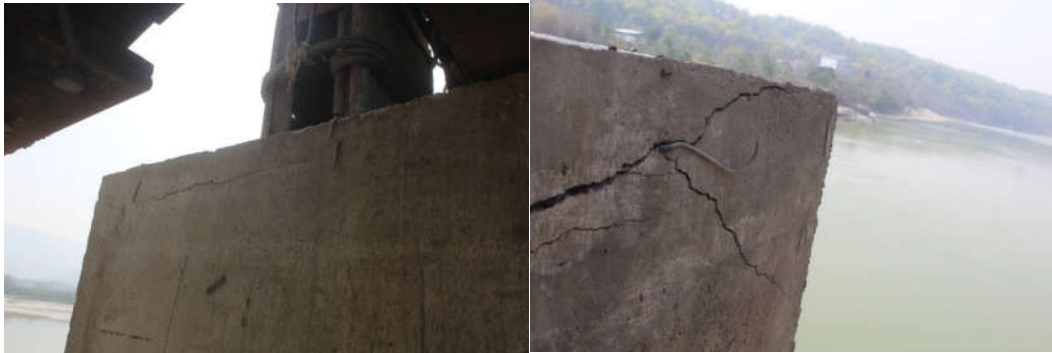
**Figure 27.** Damage to the RCC pedestal over pier-cap of Pier-2; steel tower was erected over it as a temporary structure for prestressing.

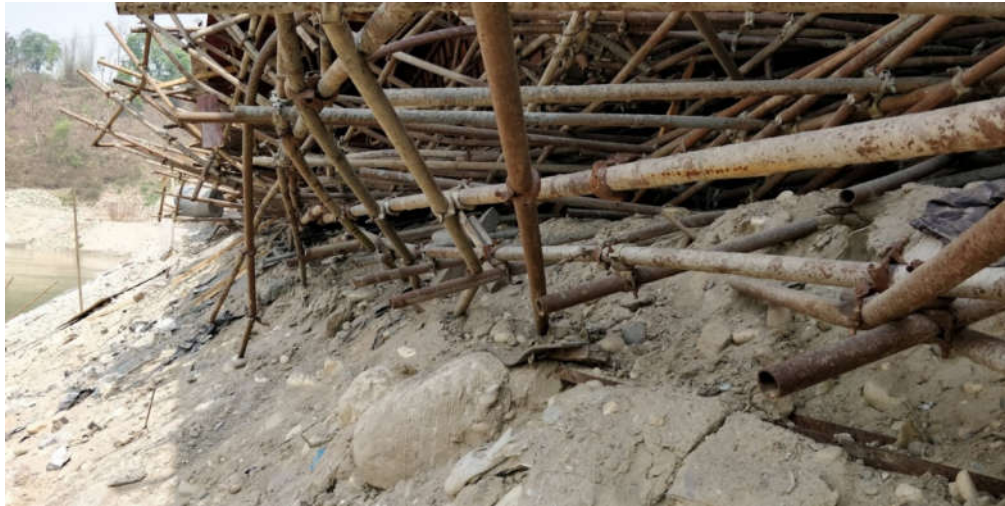
- a. There was a gradual settlement of falsework supporting the steel league of Span-2 on the downstream side (Figure 28). The settlement was caused by a gradual displacement of loose sand that was piled up to downscale the height of the falsework. The main hypothesis was that the collapse occurred as the rate of settlement had increased once curing was stopped five days prior to the collapse. This may be due to the fact that the water content was lost from the loose soil. In addition, small triggers, such as the vibration from the generator operating beside the embankment used by the steel erection team, as well as human movements, may have caused a significant displacement of loose sand;

**Figure 28.** Settlement of downstream-most steel-section league-supporting falseworks.

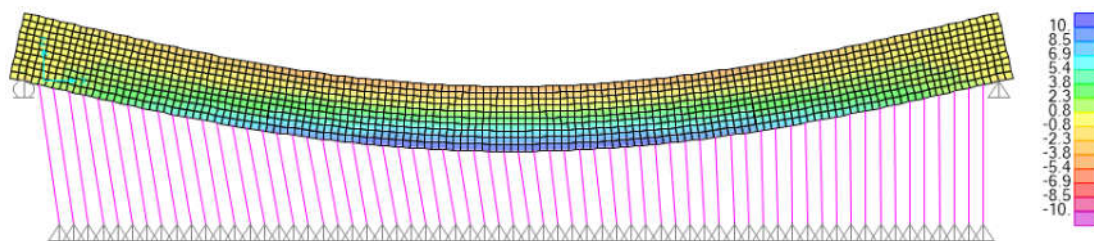
of 11.49 MPa at the bottom of the beam. However, this stage was never achieved due to the early tensile rupture of the beam. The flexural crack must have initiated at about 15 to 20 mm of central deflection, after which the moment of resistance of the section dropped to near zero and the collapse of the span occurred. It is observed that Span-2 would fail in tension even at 50 mm prop displacement, which is fairly lower than the displacement observed in the field (250 mm). Figure 30 and Figure 31, respectively, represent the distributions of tensile stresses for 50 mm and 10 mm settlement scenarios. The tensile capacity for M45 grade concrete is expected to be much lower than the tensile stresses that can occur in the failure regions. The finite element models effectively captured the main failure locations observed in the field, as shown in Figures 30 and 31.

Figure 30. Tensile stress distribution in Span-2 for 50 mm-settlement scenario.

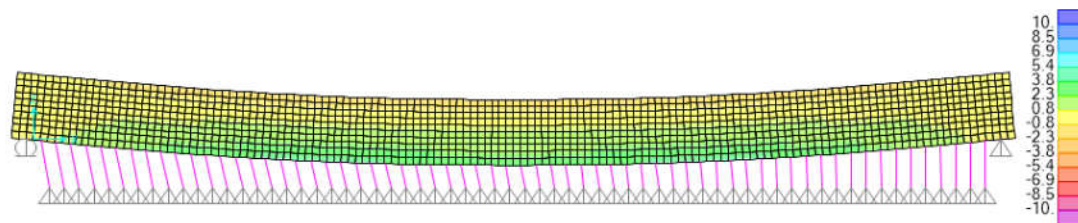
Figure 31. Tensile stress distribution for 10 mm-settlement scenario.
