Failure Investigation of under Construction Prestressed Concrete Bridge in Chitwan, Nepal

Abstract: On 6 April 2021, a 200 m-long under-construction prestressed concrete bridge failed in the Chitwan District in central Nepal. Two of the four bridge spans collapsed without any notable evidence of dynamic force application. Under-construction bridge failures are sometimes reported and can have a significant impact on the future construction adjustments. Thus, a detailed study of failure mechanisms will be insightful for the structural engineering community. Aiming to document the failure modes and exemplify lessons for improvement, this paper reports the detailed component level failure mechanisms of the bridge using visual inspection, site measurements, finite element modeling, and some forms of non-destructive testing. The chronological failure mechanisms are presented based on the field evidence and juxtaposed with the results of analytical modeling. The sum of findings highlights that the dead load failure, triggered by the settlement of falseworks, is the most critically governing factor that initiated and aggravated the damage scenario.

Keywords: prestressed concrete bridge;

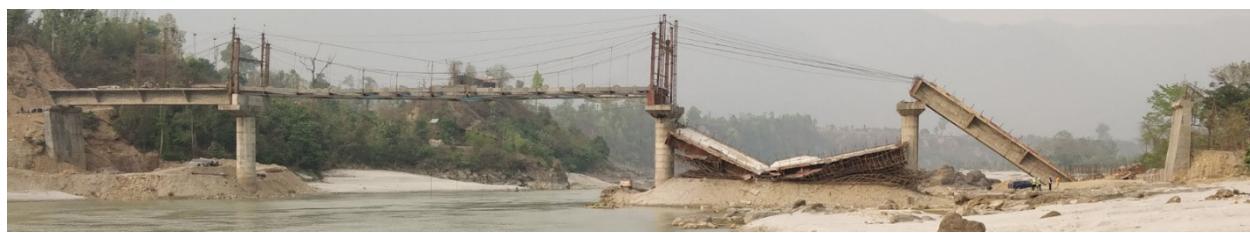
The first and fourth spans were structurally completed, and the second and third spans were under construction, when the partial collapse event occurred (Figure 2). The two spans located towards Thimura (left bank) collapsed in the early morning (4:30 am local time) of 6 April 2021. The collapse would have led to a loss of human life or injury had it occurred during working hours.

Figure 2. Thimura prestressed bridge with two collapsed spans.

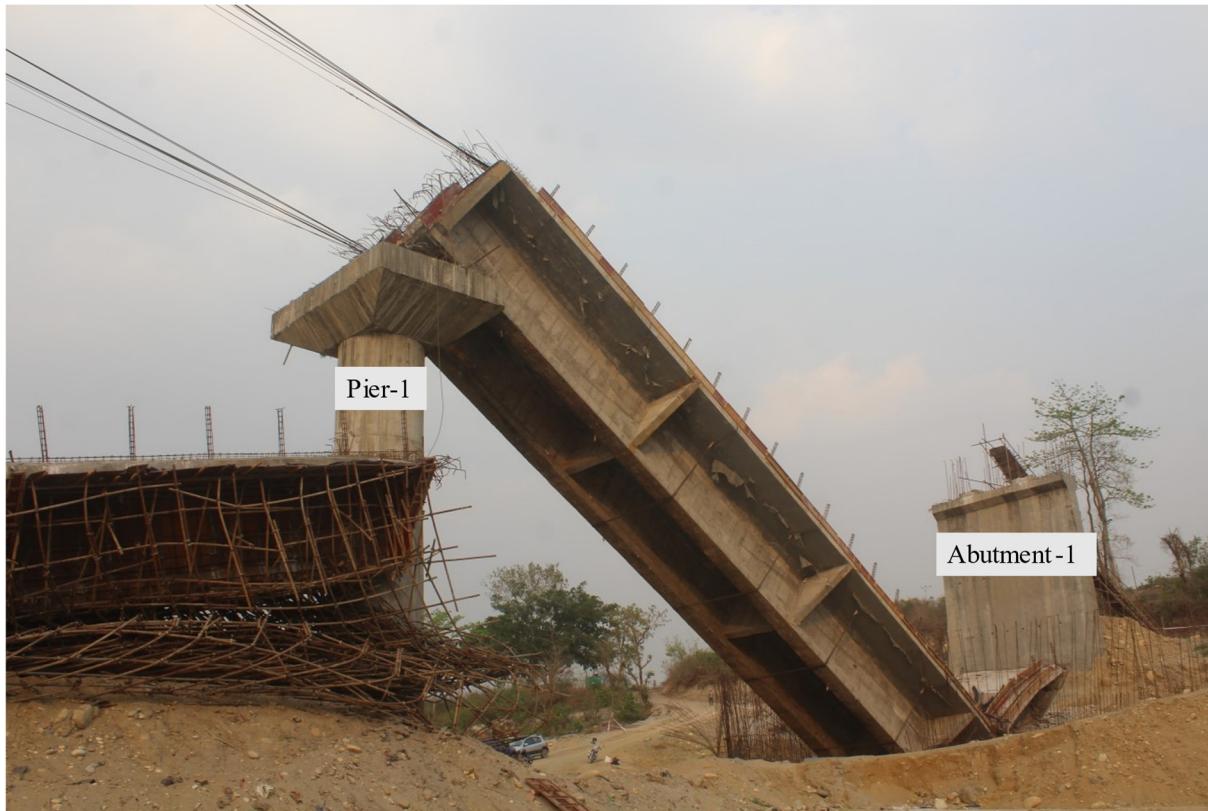
The first and second concrete spans fell off the piers and were destroyed (Figure 4). The first span fell off the abutment, meanwhile the slab still stood leaning on the first pier, with a total cantilevered portion of ~1 m (Figure 4). The second span fell off both piers with a fracture nearby the mid-span (Figure 5). Damage to individual components is presented in the following section.

Figure 4. Collapsed first span of the bridge.

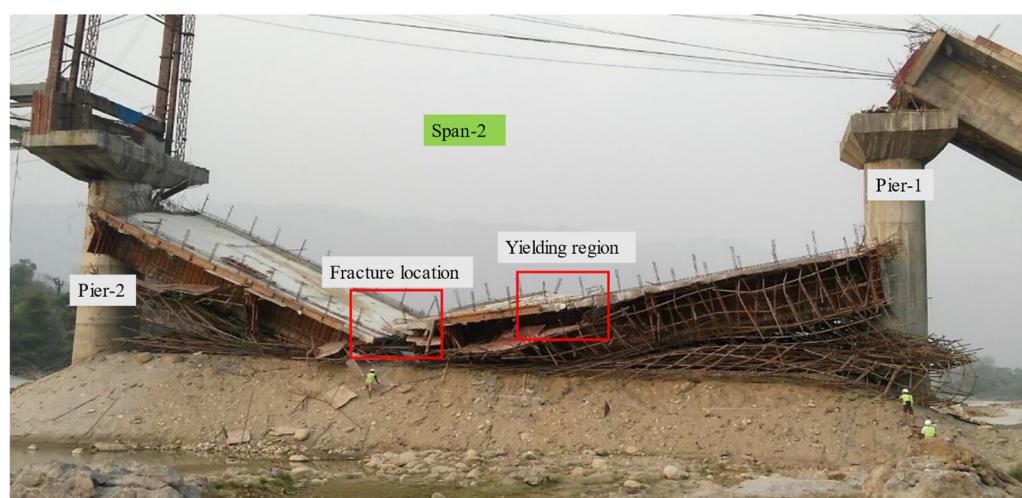
Figure 5. Destroyed second span of the bridge. The damaged props can be observed rested above loose sand and gravel.

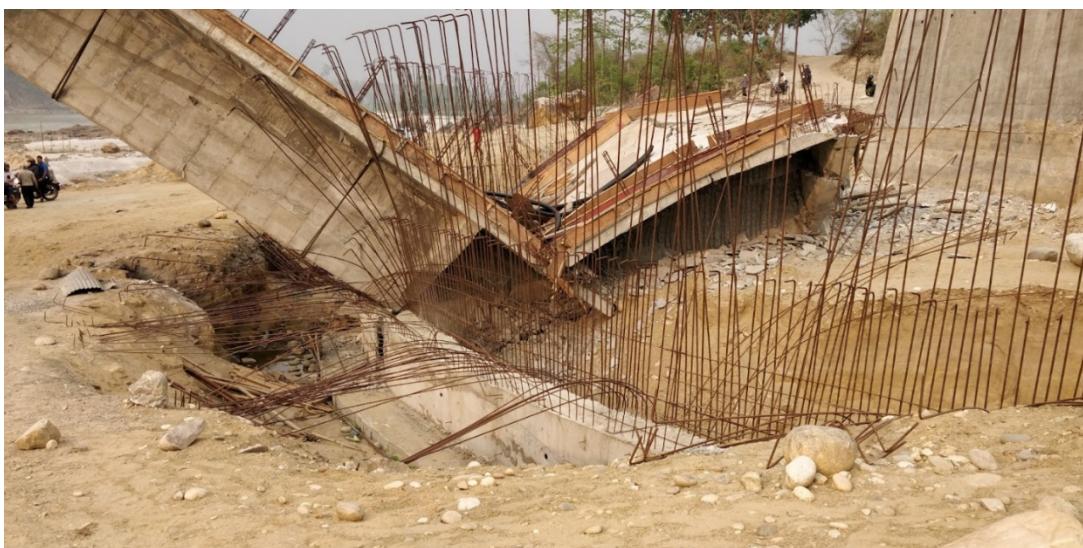
The first span fell off the first abutment that was governed by the settlement of the foundation soil. Thereafter, the beam hit the ground causing intense damage to approximately 25% of the length of the beam/slab in the first span. The remaining portion of the span only had some cracks, without reinforcement exposure. Horizontal shear failure of the beam concrete was observed in Span-1, as shown in Figure 6, which should have been initiated after the impact on the ground due to the occurrence of large shear stress. Interestingly, the shearing location exactly matched with the construction joint (interface of first day and second day concreting), as shown in Figure 7. Distinct flexure crack and

Figure 6. Collapsed Span-1 of the bridge.

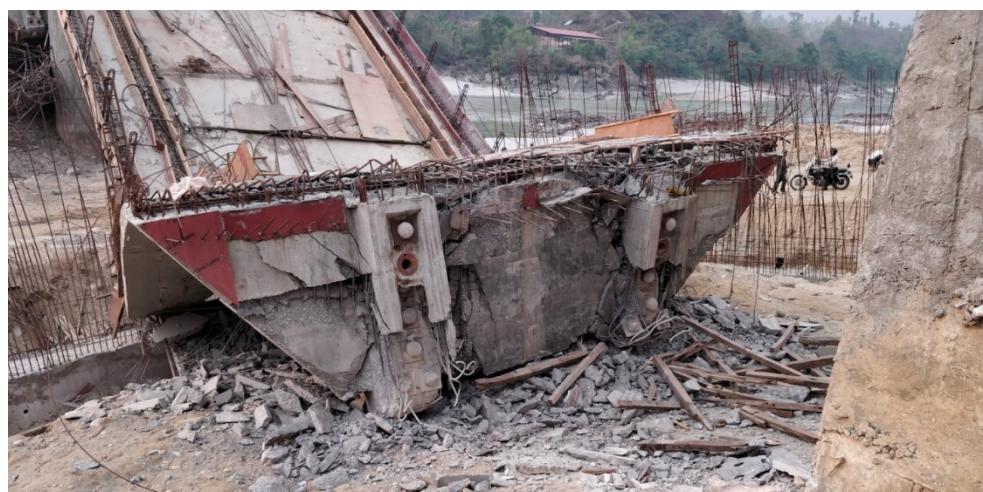
Figure 7. Horizontal shear failure at construction-joint level as the lower part of the beam that included four prestressing ducts slid inwards.

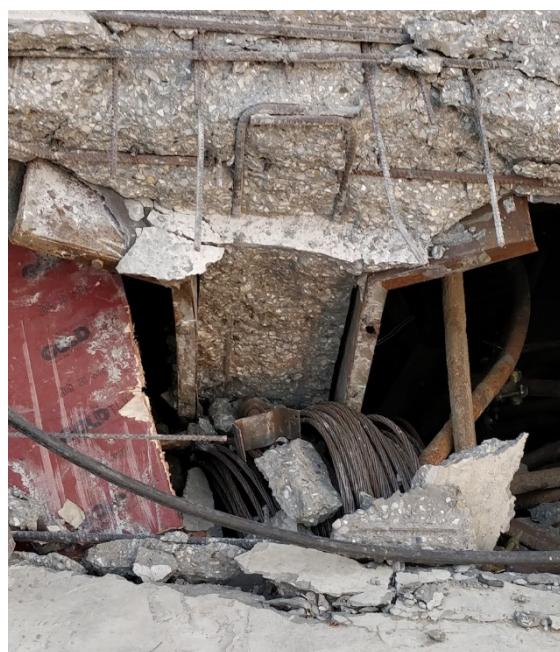
yielding were identified in the beams of Span-2. The prestressing cables were exposed due to flexure cracking, and the falling of the span caused breakage. Figure 8 shows a typical damaged section of the beam of Span-2. The end cross beams of Span-2 slid on the pier surfaces, thus sustaining heavy damage. As the bridge span fell down, the span was not housed within the available space between the piers. Therefore, it slid over the pier surface, the central portion of beam being the lowest point that got fractured.

Figure 8. L-bar of fractured beam, anchorage failure of some slab rebar, bearing failure of formwork around bolting holes, and prestressing cables pulled out to significant length and bent.

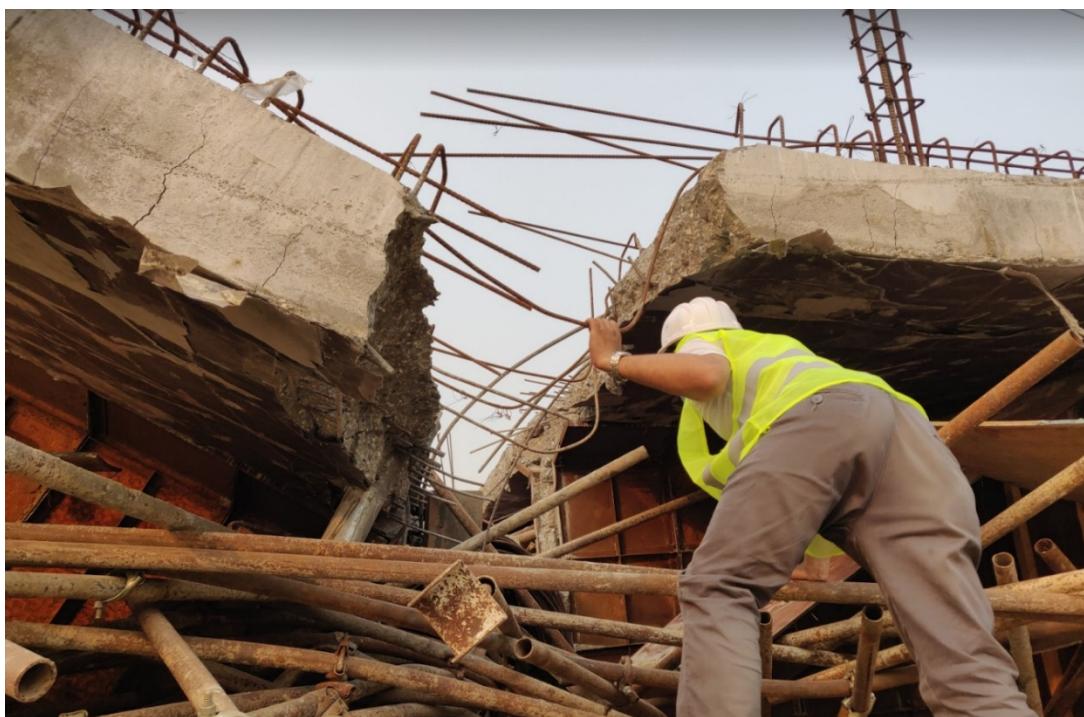
Figure 9. Fracture observed in slab of Span-2, including several flexural cracks near both sides of the main fracture region.

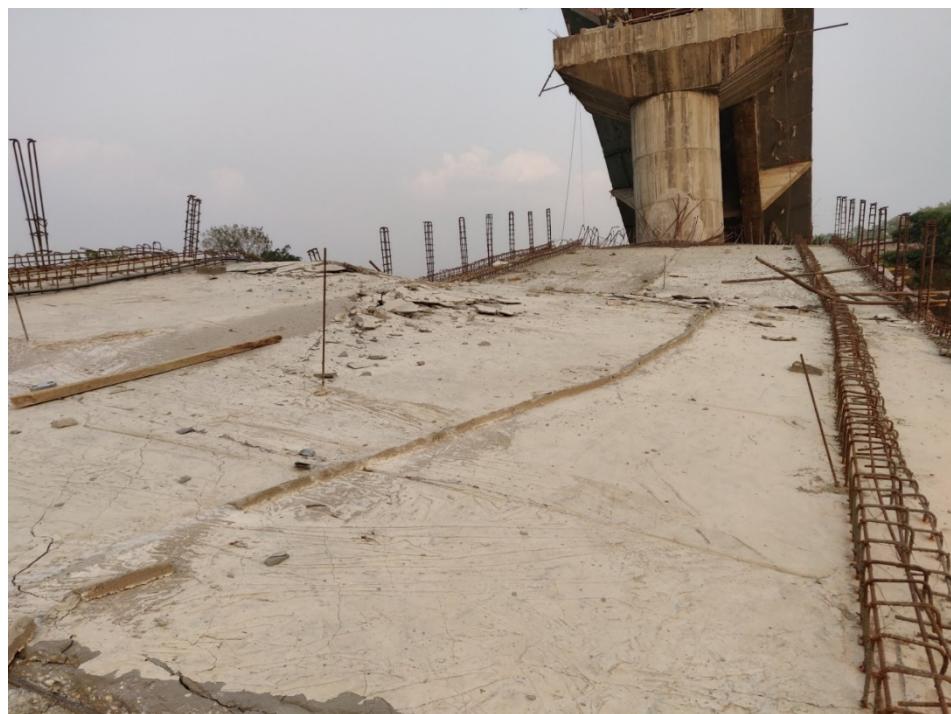
Figure 10. Cracks observed along the slab surface of Span-2.

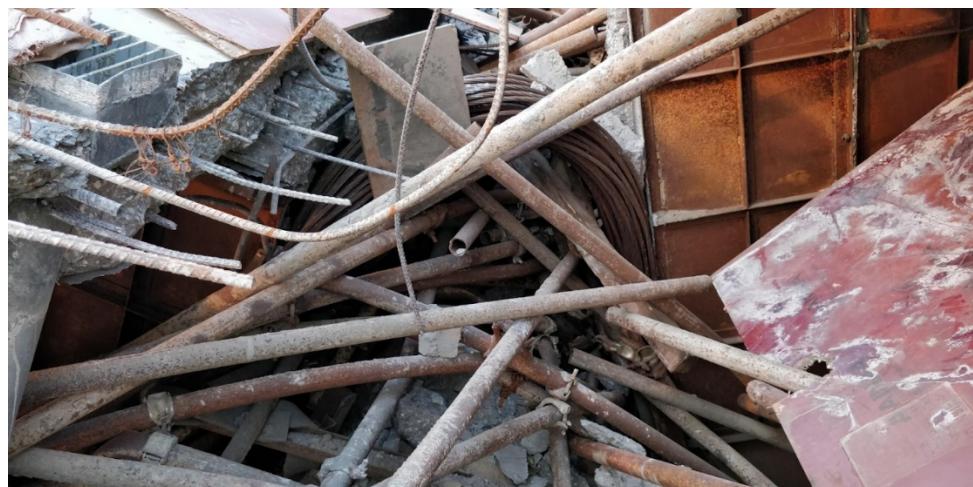
Span-1 and Span-2 separated from the piers/abutment and fell down. The slab was completely fractured together with the beam in both spans. In Span-1, there was some overlap of the slab (Figure 9) after fracture. The Span-1 deck was used to hold the temporary suspension cables from Span-3 for its erection. The deck was slightly shifted towards Span-3 and fell off from the Abutment-1 side only, while the Pier-1 side stayed above the pier. Apart from the complete fracture of the slab in Span-2 (Figure 9), there were several notable cracks on various parts of the slab (Figure 10), most likely due to the impact after falling. Importantly, several flexural cracks were observed on the slab on both sides of the slab separation in Span-2. While many bars of slab were found to be broken due to necking, many others were found at its end, indicating that the fractured section was the lap zone for quite a lot of bars (Figures 11 and 12).

Figure 11. Several bars in the slab of Span-2 can be observed being pulled out and show up in pairs, indicating the significant lapping region of the slab; the prestressing cables were also pulled out to significant length during collapse.

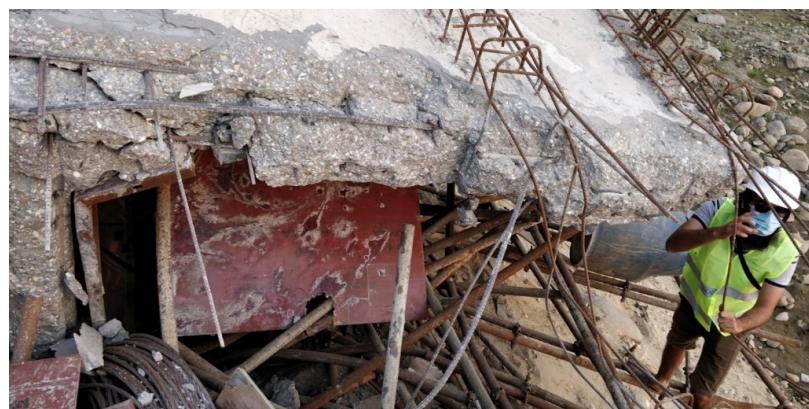
Figure 12. Pulled-out holes in slab in the fractured location.

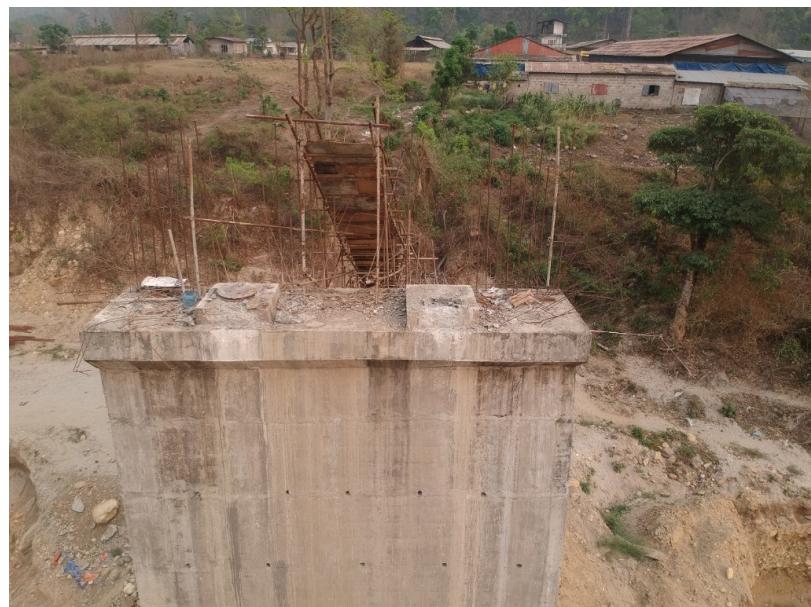
Bearing damage was attributed mostly to the horizontal movement of girders. A pot bearing system was used in the bridge, as shown in Figure 13. Bearing damage was observed in Abutment-1, Pier-1, and Pier-2, as shown in Figure 14, Figure 15, Figure 16, and Figure 17, respectively.

Figure 14. Bearing damage in Abutment-1 due to slippage of the slab before falling.

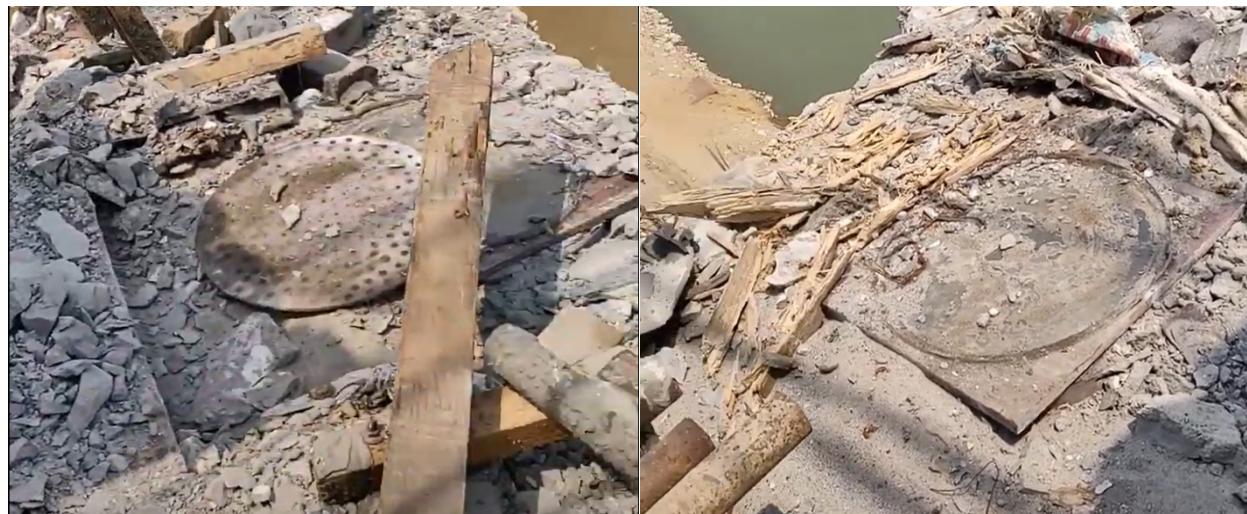
Figure 15. Damaged bearing above Pier-1, span-2 side (downstream and upstream side).

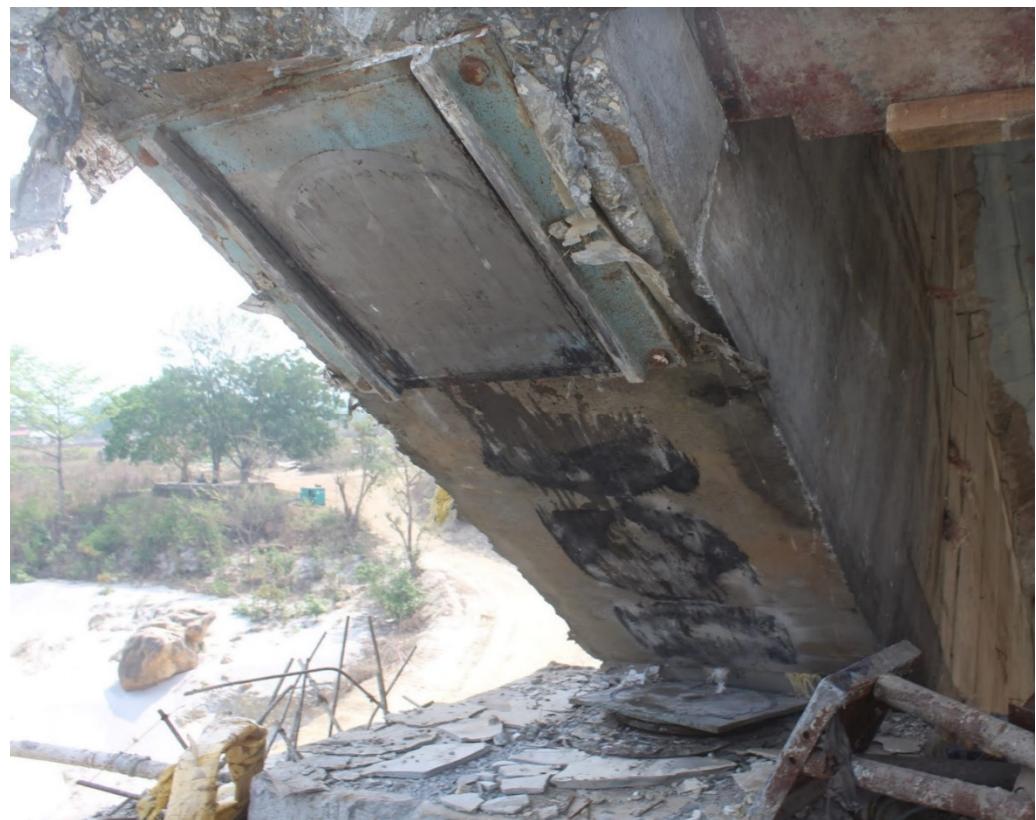
Figure 16. Span-1 deck (over Pier-1) that slid about 1 m towards Pier-1 indicating drag of deck (shown by bearing mark under the beam surface) and damage of bearing.

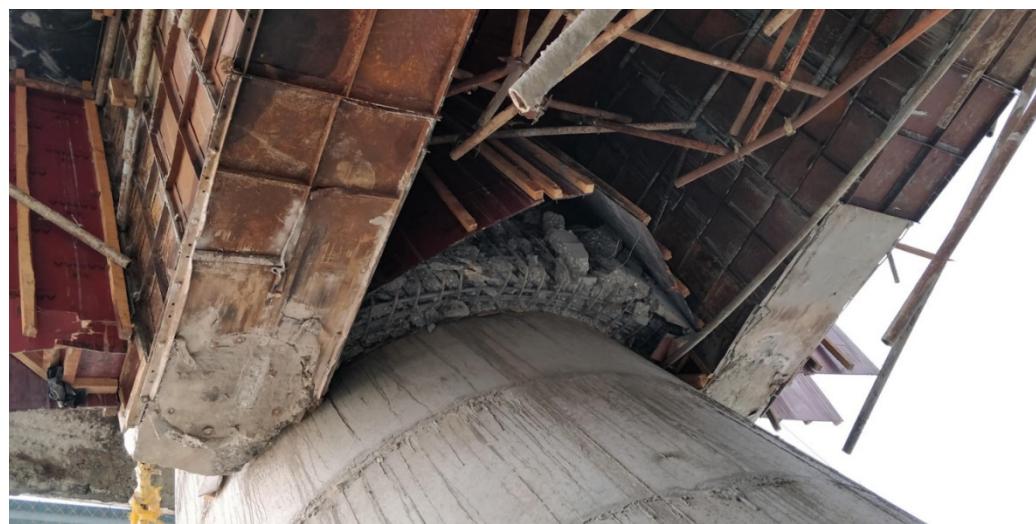
Figure 17. Bearing indentation in the beam with sheared bolts lodged (Pier-2).

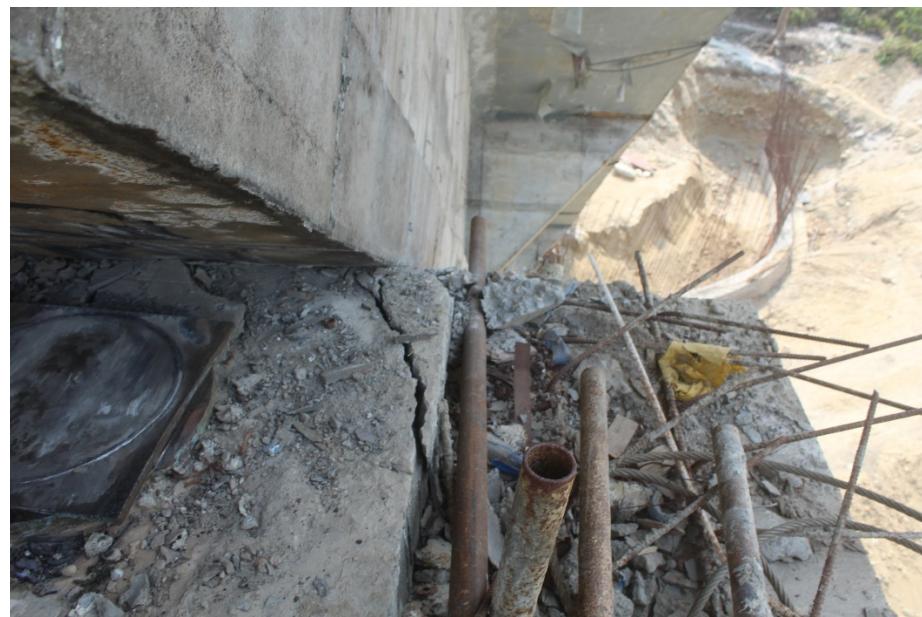
Figure 19. Damage to pier cap of Pier-1 due to Span-1 collapse.

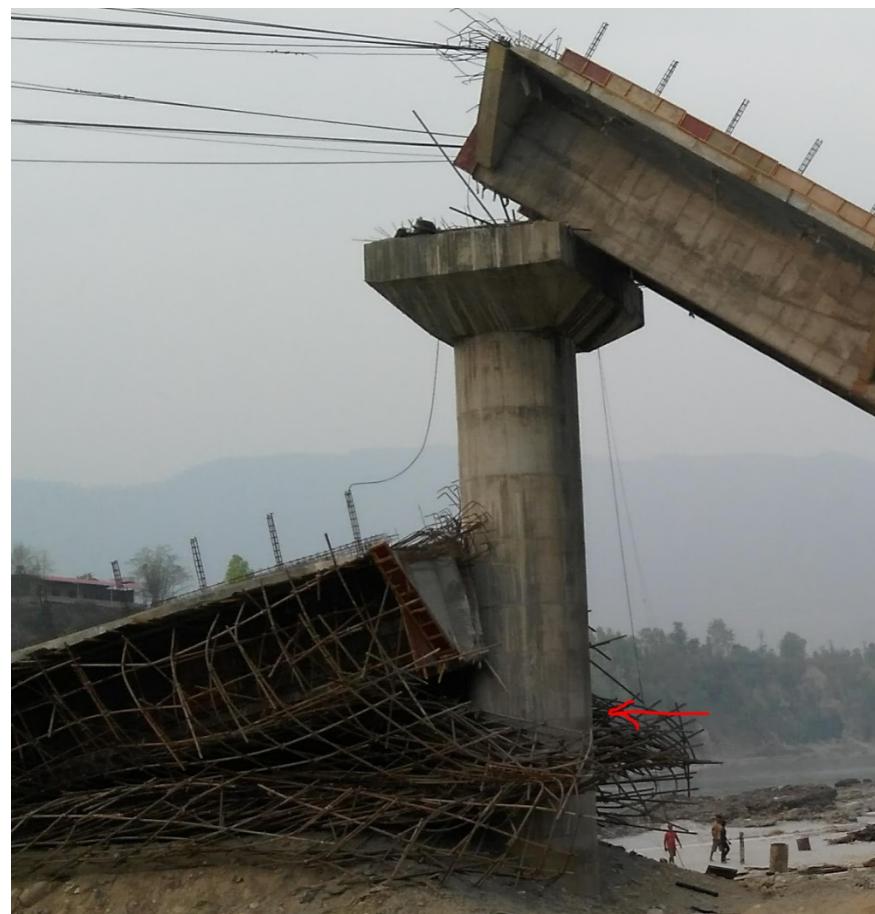
Figure 20. Pier-1 being pushed by Span-1 from the top and Span-2 from the middle in opposite directions. Horizontal crack is marked with an arrow.

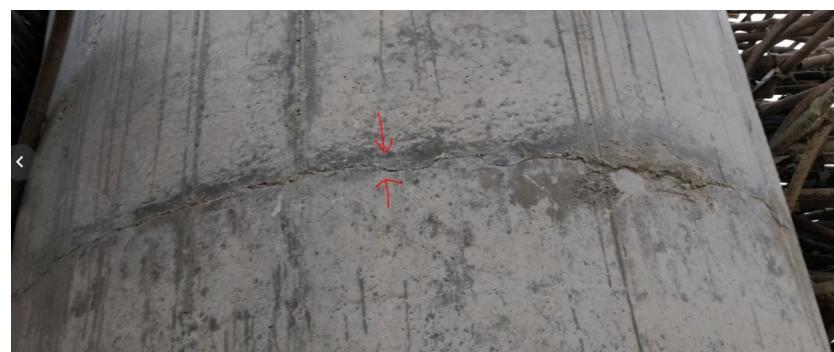
Figure 21. Horizontal crack towards the Span-1 side of Pier-1, at 2.5 m height from the ground level.

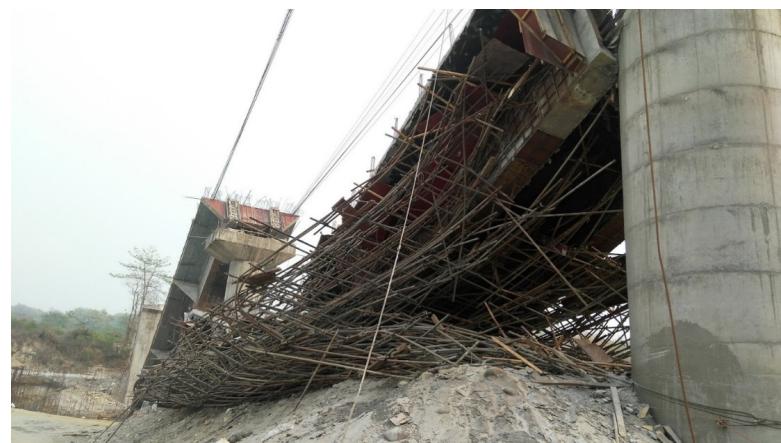
All the falseworks (props) under Span-2 were collapsed. The props were buckled outwards across the span (Figure 22), with inclination mostly towards the left bank (Chitwan side). Most of the steel formworks were intact, even after the collapse of the beam (Figure 23). However, near the fracture zone of the deck, the formworks were distorted due to bearing failure at bolted locations.

Figure 22. Falsework damage in Span-2; buckling was mostly towards upstream side, indicating damage initiation by settlement of downstream side first.

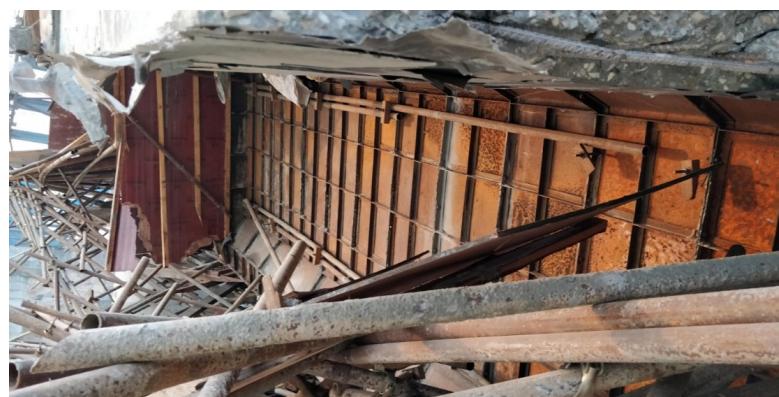
Figure 23. Intact formwork on other part of Span-2 (except the beam fracture location), indicating failure mechanism consists only one failure location.

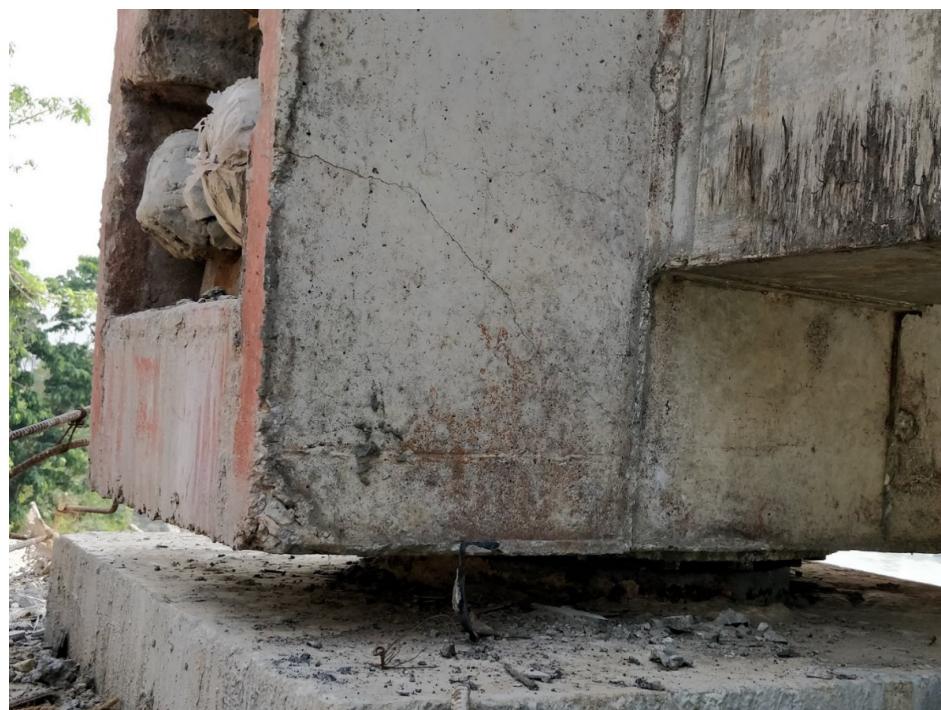
Some other damage mechanisms were observed at the ends of the fourth span above Abutment-2 (Figure 24). The edge around the prestressing cable anchorage was found to

Figure 24. Some cracks around the end of Span-4 lower prestressing cable anchor zone, on Abutment-2 side.

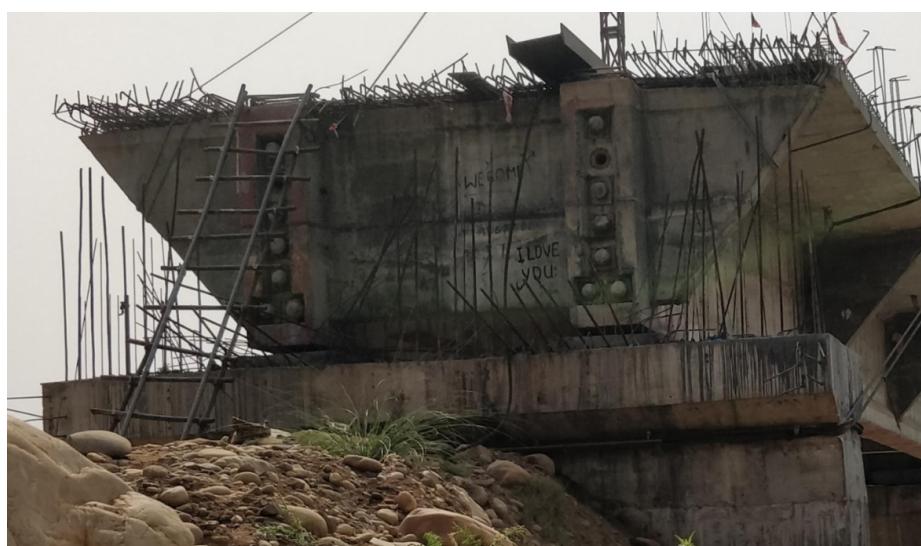
be cracked (Figure 25). The pier caps were also damaged in Pier-2 and Pier-3 due to the exertion of tensile force by the steel towers. Furthermore, the RC pedestal over the pier cap of Pier-3 was heavily damaged, as shown in Figure 26. Similarly, damage to the RC pedestal over the pier cap of Pier-2 is shown in Figure 27.

Figure 25. End of Span-4 over Abutment-2. Some temporary suspension cables were anchored at abutment and others were anchored near the end of Span-4 deck.

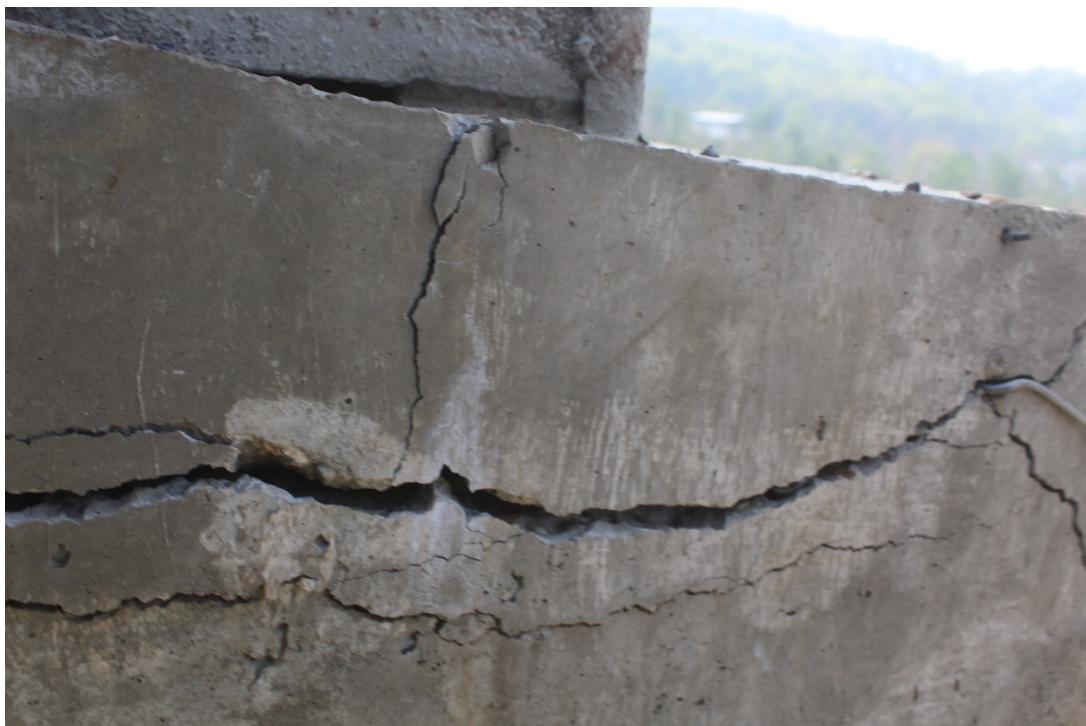
Figure 26. Heavily damaged pier cap above Pier-2 due to the tensile action exerted by the temporary suspension cables on the steel towers.

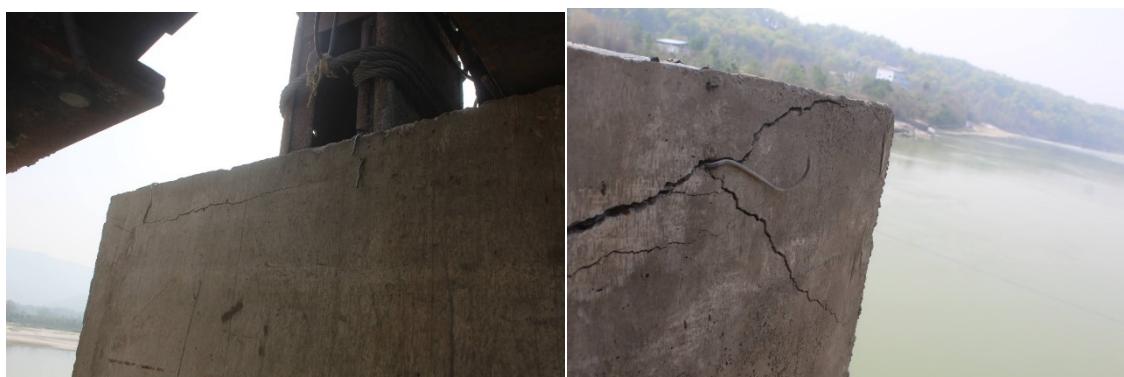
Figure 27. Damage to the RCC pedestal over pier-cap of Pier-2; steel tower was erected over it as a temporary structure for prestressing.

- h. During the collapse of Span-1, the tensions developed against the pull by Span-1 caused significant damage to RC pedestals over the pier caps of Pier-1 and Pier-2 that were used to support temporary steel towers.

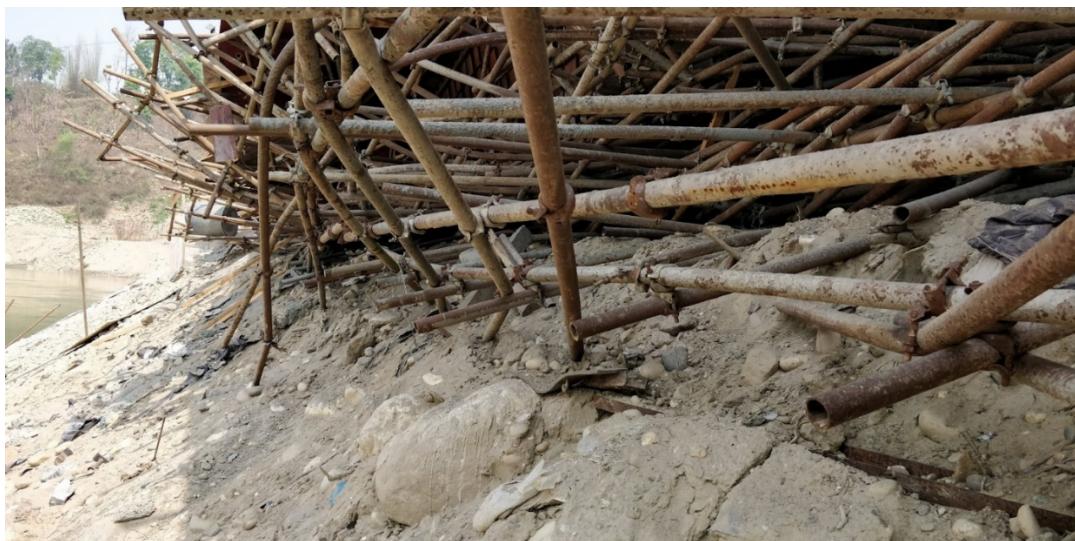
- a. There was a gradual settlement of falsework supporting the steel league of Span-2 on the downstream side (Figure 28). The settlement was caused by a gradual displacement of loose sand that was piled up to downscale the height of the falsework. The main hypothesis was that the collapse occurred as the rate of settlement had increased once curing was stopped five days prior to the collapse. This may be due to the fact that the water content was lost from the loose soil. In addition, small triggers, such as the vibration from the generator operating beside the embankment used by the steel erection team, as well as human movements, may have caused a significant displacement of loose sand;

Figure 28. Settlement of downstream-most steel-section league-supporting falseworks.

For the failure of the Thimura bridge, there could have been several factors that aggravated the effects, simultaneously leading to the collapse of Span-1 and Span-2. The embankment established to support the falseworks (props) consisted of local riverbank material. The riverbank material was poorly graded cohesionless sand with little gravel. Precisely, the sand consists of a common typology of riverbank material that is commonly found in Nepal, with a varied granulometric distribution of grains from fine silts to gravel. When not supported from the sides, such dry materials reflect very poor bearing capacity, especially near the edge of embankments. Thus, the falsework would easily settle down due to the displacement of loose sand. For loose and dry embankment materials used at the site to support the falsework, vibrations may induce significant reductions of the shear resistance, causing the sliding of material, especially where loosely piled up materials exist, as in the case of Thimura bridge site. The continuous use of the generator for site works could have contributed in the gradual weakening of the embankment, which gradually settled under the load of the deck right below the formwork. The earthquake-induced vibration that occurred a few days earlier could have also aggravated the settlement.

the soil embankment without proper confinement, which is not a recommended practice. Furthermore, no surface stabilization, such as plain cement concreting (PCC), was found over the surface, except a very thin layer of cement grout at some locations that caused moisture variation and marred the stability of the embankment material. No longitudinal stoppers were observed in the design that would resist the excessive displacement of the bridge deck under unforeseen loads. Furthermore, no design was found for the temporary suspension cable and its anchorage, indicating that proper design was not carried out. The designed reinforcement on the beam was found to be too low to contribute any significant strength to the girder. If there would have been some more reinforcement to resist some portions of the load through reinforced concrete beam action, the failure could have been less severe. For the erection method used—using steel towers and cables to temporarily hang the steel sections of steel span—the continuous movement of the live load and wind caused a continuous vibration on the partially connected steel deck, causing cyclic loads on the cables. The cables then induced cyclic loading to the deck, especially in Span-1. This eventually caused the weakening of the hinge bearing over Abutment-1, resulting in the sliding of Span-1. The concrete compressive strength test results were reported to be within the permissible ranges. However, a rebound hammer test on the concrete showed results lower than the expected values. This could have also aggravated the damage scenario, even at less settlement or unfavorable conditions.

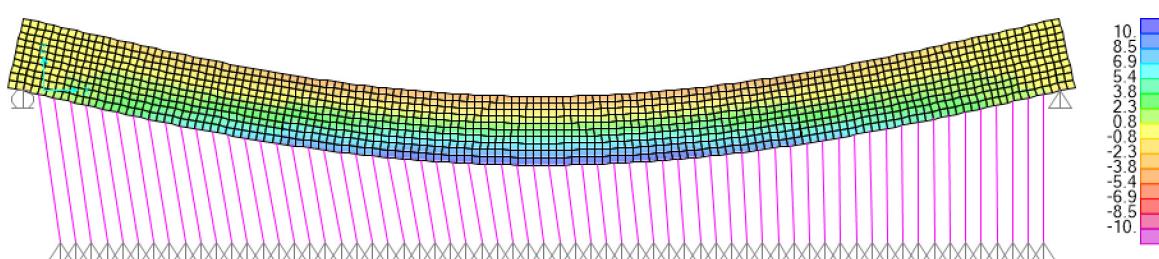
was modeled with linear elastic materials using HYSD-Fe500 rebars and M45 concrete. In total, 535 nodes, 191 shell elements, and 272 frames were created during finite element analysis. The deck was considered as a unique section with homogeneous properties, with a cross-sectional area of 10.78 m^2 , transversal inertia of 5.38 m^4 , and vertical inertia of 75.9 m^4 . The bridge was restrained with hinges in order to ensure the equilibrium of the entire system under the vertical and horizontal loads. Under the entire bridge span, vertical elements of 2" diameter and a steel section of a partial length of 500 mm at a longitudinal spacing of 300 mm were deployed to simulate the temporary supports as observed in the field. The hinges were embedded in the elements in order to introduce more degrees of freedom in the model, which improve convergence when multiple hinges fail at the same time. In addition, stiffness-proportional damping was considered in the analyses (dead, modal, and linear elastic). In particular, the mass and self-weight loads were applied on the shell elements as uniformly distributed load intensities over the plane of the element. The magnitude of the self-weight is equal to the weight density multiplied by the shell thickness. Different ground displacements were provided in the falsework joints, ranging from 10 mm to 300 mm, and tensile stress was checked for corresponding displacement values. Initially, the props were carrying the dead load properly, with approximately 59 KN/m of reaction under each of the two main beams. As the settlement gradually increased, the reaction of the props towards the ends decreased, while the reaction on props towards the center increased. At 10.75 mm central deflection of the beam, due to the settlement of prop support, 3.4 MPa of tensile stress is induced at the bottom of the beam. The bearing prop reaction near the center is increased to 117 KN/m. At 20.6 mm central deflection of the beam due to the settlement of prop support, 7.53 MPa of tensile stress is induced at the bottom of the beam. However, if the beam is not cracked, the prop reaction near the center again decreases to 94 KN/m. Further settlement analysis reveals that there would be a maximum of 29.46 mm deflection of the beam with a maximum tensile stress of 11.49 MPa at the bottom of the beam. However, this stage was never achieved due to the early tensile rupture of the beam. The flexural crack must have initiated at about 15 to 20 mm of central deflection, after which the moment of resistance of the section dropped to near zero and the collapse of the span occurred. It is observed that Span-2 would fail in tension even at 50 mm prop displacement, which is fairly lower than the displacement observed in the field (250 mm). Figures 30 and 31, respectively, represent the distributions of tensile stresses for 50 mm and 10 mm settlement scenarios. The tensile capacity for M45 grade concrete is expected to be much lower than the tensile stresses that can occur in the failure regions. The finite element models effectively captured the main failure locations observed in the field, as shown in Figures 30 and 31.

Figure 30. Tensile stress distribution in Span-2 for 50 mm-settlement scenario.

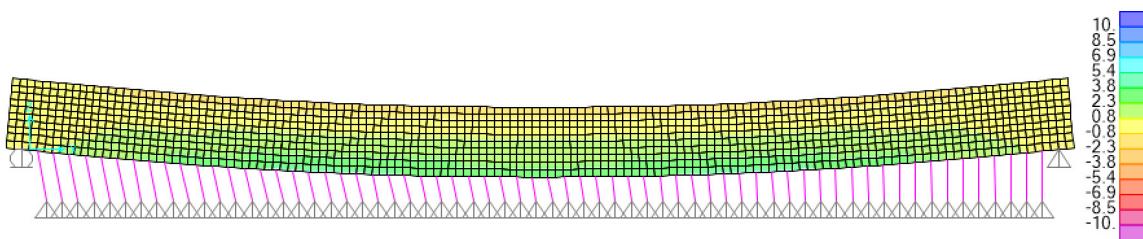
Figure 31. Tensile stress distribution for 10 mm-settlement scenario.
