The Impact of Pollution on Cultural Heritage in the Historic Centre of Porto, Portugal

This investigation aims to study how these factors directly affect the built heritage associated with the Central Portuguese Way to Santiago based on three case studies: Carmelitas Church, São João Novo Church, and Vitória Church.

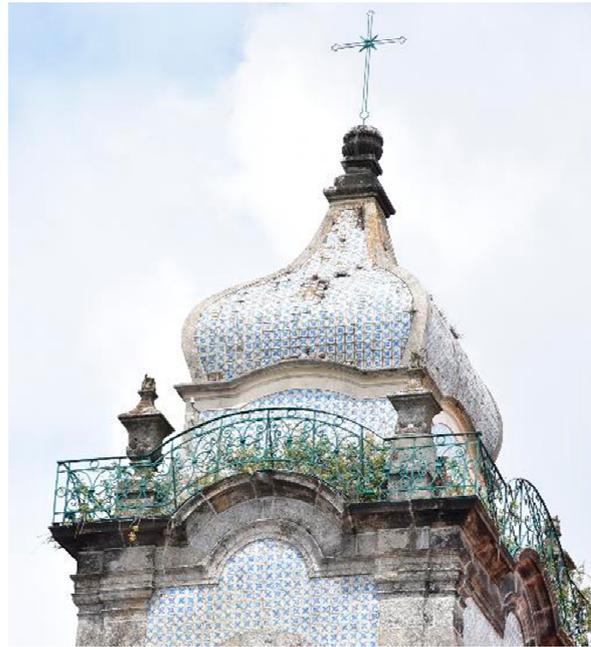
Figure 15. Details of the anomalies present on the south facade of Carmelitas Church. Source: author.

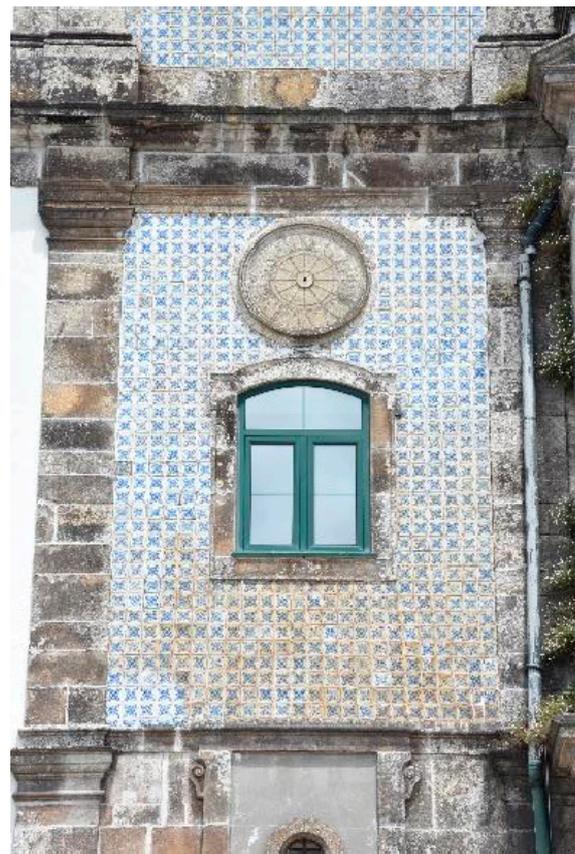
Figure 16. Details of the anomalies present on the south facade of Carmelitas Church. Source: author.

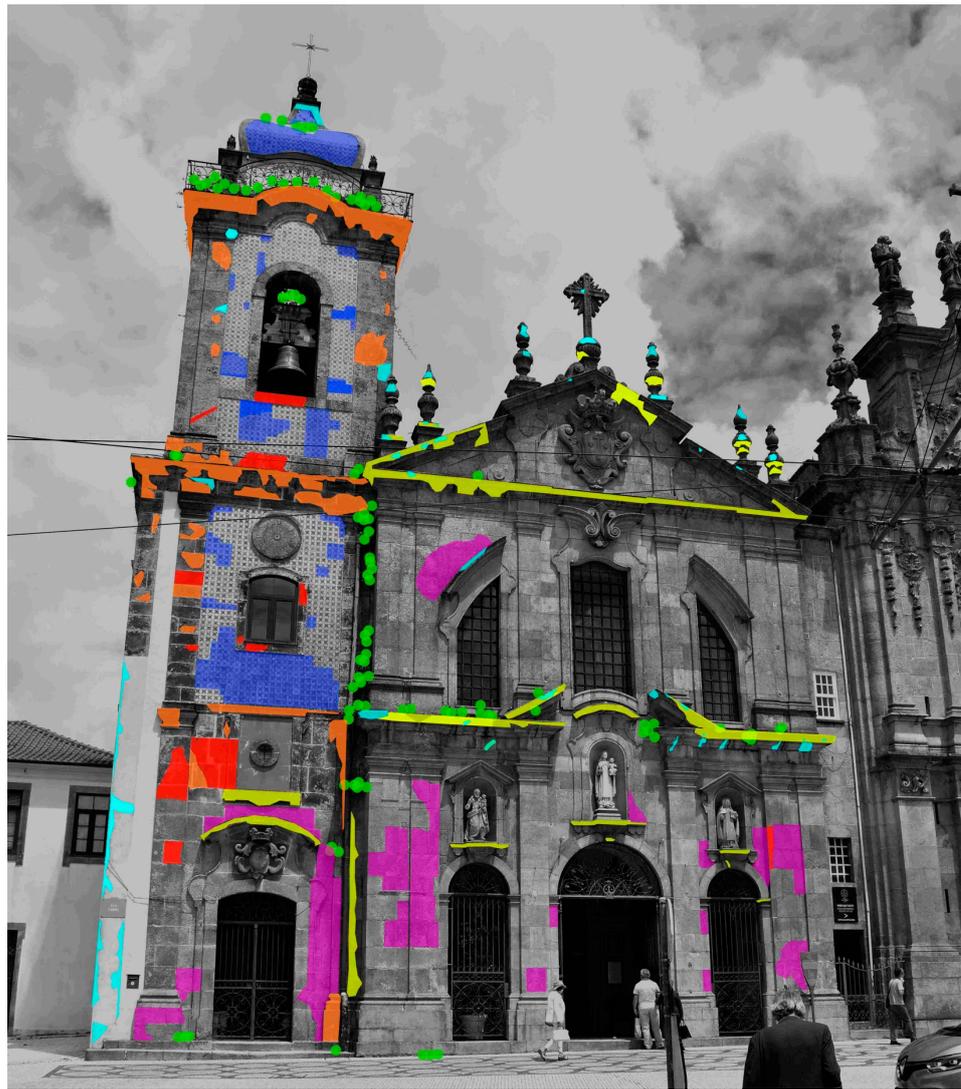
The anomalies mapping (Figure 17 and Table 3) revealed the existence of dirt and black crusts on the main facade, the presence of vegetation (with a greater incidence in the bell tower), humidity, cracking, and detachment of the glaze on the tiles, and, finally, chromatic changes, scaling, granular disintegration, and biological colonisation in stone masonry.

Figure 17. Anomalies map of the front facade of Carmelite Church. Source: Author.

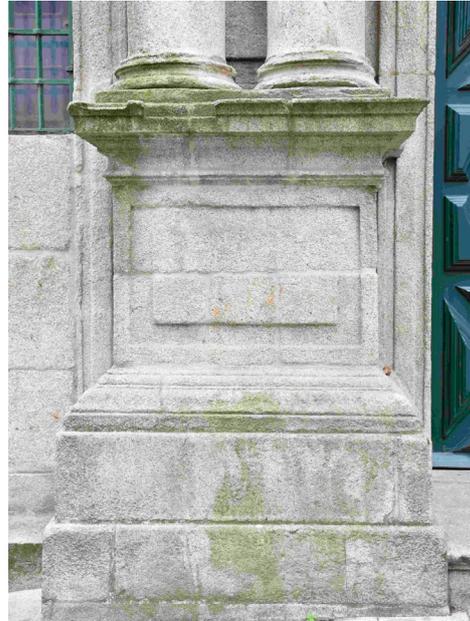
After completing all the photographic documentation (Figures 20–22) and creating the degradation map (Figure 23 and Table 4), we highlight the main pathologies on the main facade of São João Novo Church: biological colonisation, cracks, and humidity, with a higher incidence on the pediments and columns, as well as some lacunae across the entire facade, open joints, and vegetation, with greater predominance in the upper part of the building.

Figure 20. Identification of the various pathologies on the north facade of São João Novo Church. Source: Author.

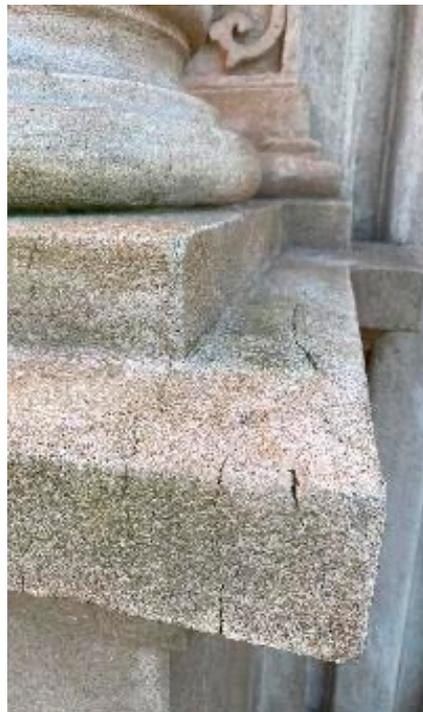
Figure 21. Identification of the various pathologies on the north facade of São João Novo Church. Source: Author.

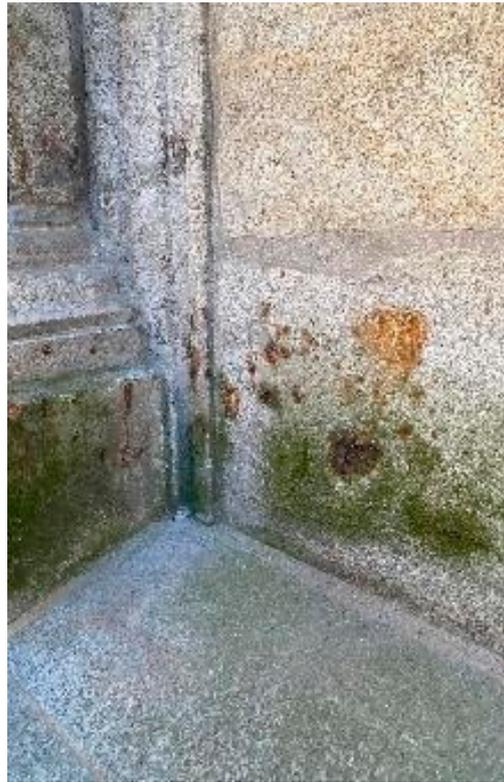
Figure 22. Identification of the various pathologies on the north facade of São João Novo Church. Source: Author.

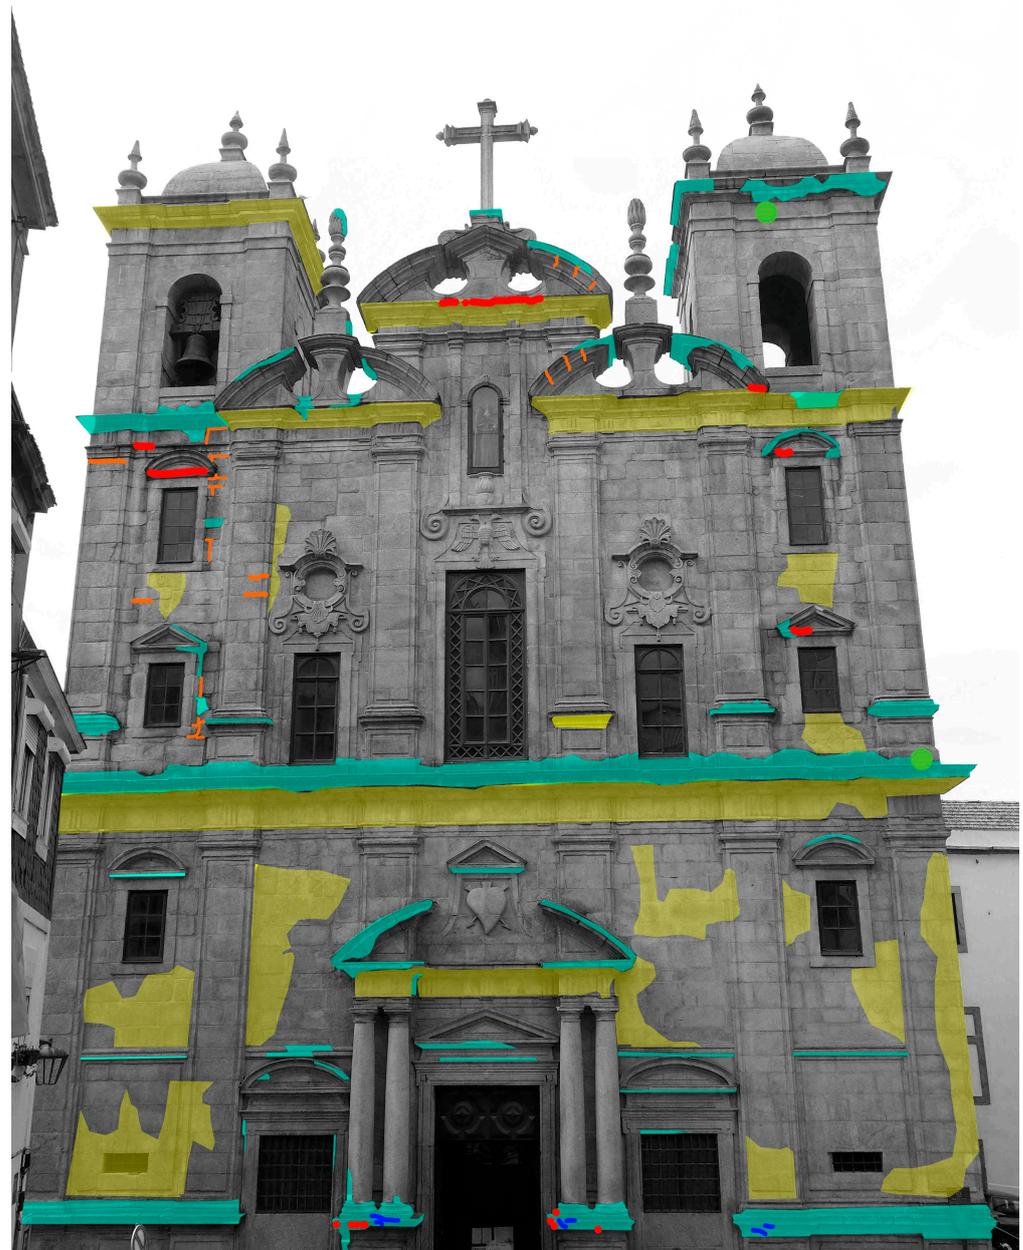
Figure 23. Anomalies map on the front facade of Carmelite Church. Source: Author.

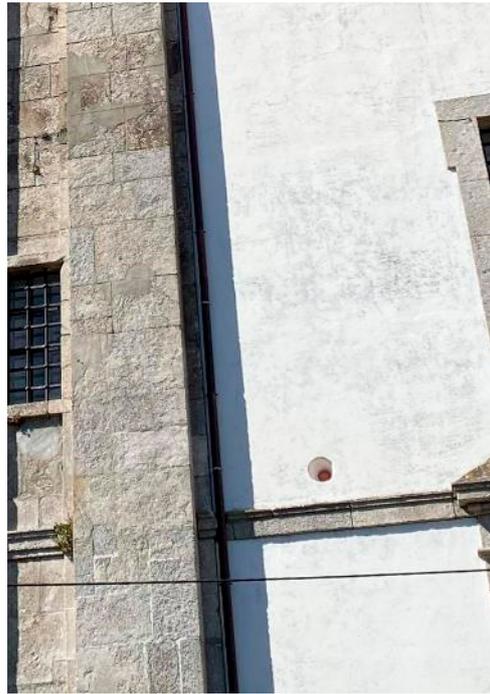
Figure 25. Bullet inlay in the south wall. Source: Author.

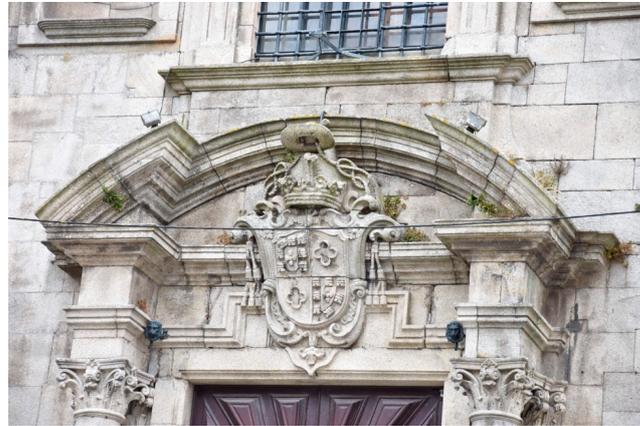
After detailed analysis (Figures 27–30) and mapping of anomalies (Figure 31 and Table 5), the main anomalies identified on the main façade of Vitória Church were vegetation, biological colonisation, gaps, black crusts, dampness, cracks, and platelets.

Figure 27. Identification of the various pathologies on the north façade of Vitória Church, Porto.
Source: Author.

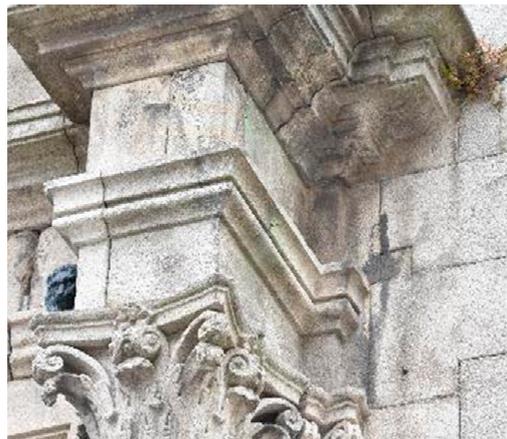
Figure 28. Identification of the various pathologies on the north façade of Vitória Church, Porto.
Source: Author.

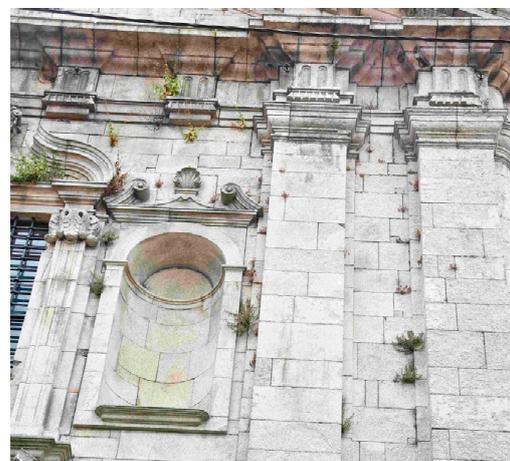
Figure 29. Identification of the various pathologies on the north façade of Vitória Church, Porto.
Source: Author.

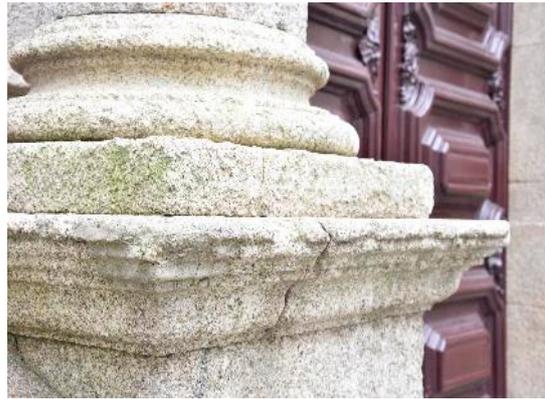
Figure 30. Identification of the various pathologies on the north façade of Vitória Church, Porto.
Source: Author.

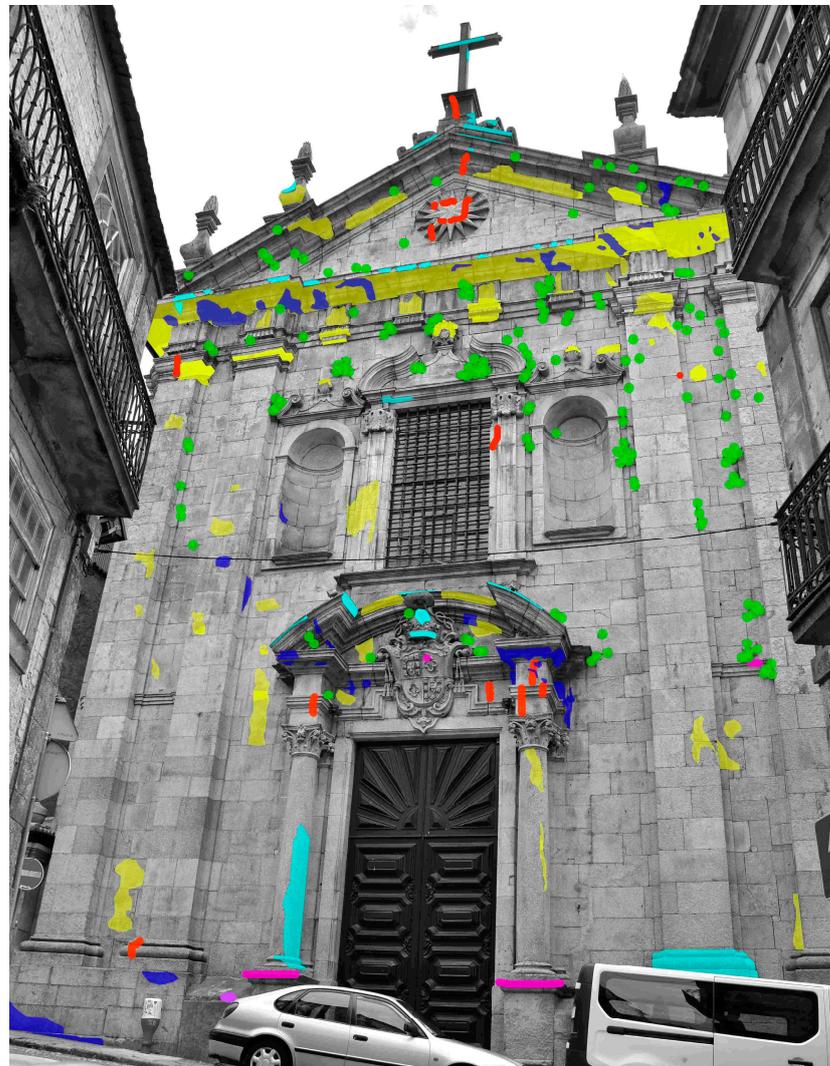
Figure 31. Anomalies map on the front facade of Vitória Church. Source: Author.
