Causes of Ground Settlements in Upper Reservoir of Hydro-Wind Plant of El Hierro and Method Implemented for Soil Improvement [†]

Fabiola Fernández-Baniela ^{1,*}, Daniel Arias ² and Álvaro Rubio-Ordoñez ²

¹ IDOM Consulting, Engineering, Architecture, S.A.U., Avda. Monasterio de El Escorial 4, 28049 Madrid, Spain

Published: 1 November 2018

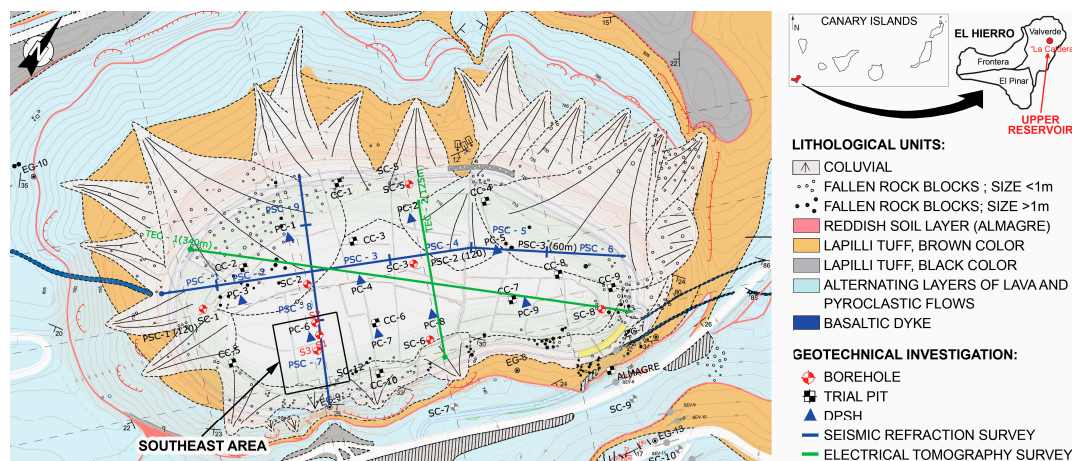
Figure 1. Geological mapping of “La Caldera” place, with the location of site investigations.

is covered by colluvial deposits, derived from the action of erosion and gravity on the upper slopes of the crater (Figure 1). Beneath these recent deposits, a large thickness of soils generated by intense weathering of volcanic materials was identified. In the southeast of the reservoir, by geophysical techniques (PSC-7 to 8 and TEC-1) and rotary boreholes (S-1 to 3), 46.5 m of maximum thickness of soil was identified.

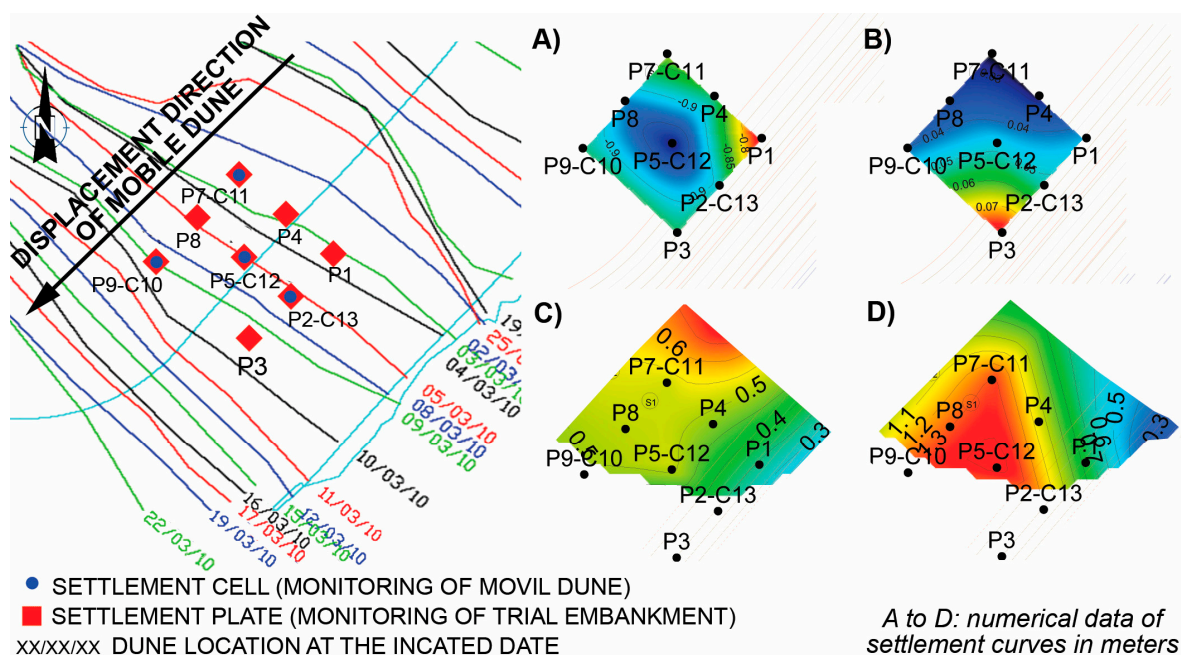
Figure 2. Maps of settlement distribution in the southeast area of the upper reservoir: (A) loading and stabilization stages of the trial embankment; (B) unloading stage of the trial embankment (rebound); (C) loading stage of the mobile dune; (D) accumulated settlement. (Mapping software: SURFER).

Previously to the mobile dune, in the southeast area of the deposit, a trial embankment of 10 m height was built and monitored by eight settlement plates. This provided key information regarding the behavior of these soils under the action of preloading, very useful for the design of the mobile dune execution stages (Figure 2).

The behavior of the soils was mainly of plastic type, producing a maximum settlement of 0.98 m in the center of the embankment (P-5 in Figure 2A) and a maximum rebound of the bottom when removing the embankment of 8 cm (P-3 in Figure 2B) [7].

The settlements generated by the action of the mobile dune in the southeast area of the reservoir were monitored by four settlement cells: C-10 to C-13 (Figure 2C). The settlement varied between a minimum value of 0.42 m recorded in cell C-13 (near the edge of the crater) and a maximum value of 0.68 m recorded in cell C-11 (located towards the center of the crater).

The accumulated settlement in the lousy point of the southeast area of the upper reservoir (Figure 2D), sum of those recorded during the execution of the trial embankment and the mobile dune, reached a value close to 1.5 m.

The selected preloading method was a “mobile dune”, which consists in moving the total volume of earth excavated in the work, to cover, in successive phases, the entire bottom of the reservoir. This would simulate the conditions of the reservoir filled with water.
