Design and Construction of CFRP Rod Panel Retrofit for Impacted RC Bridge Girders

Abheetha Peiris ^{1,*} and Issam Harik ²

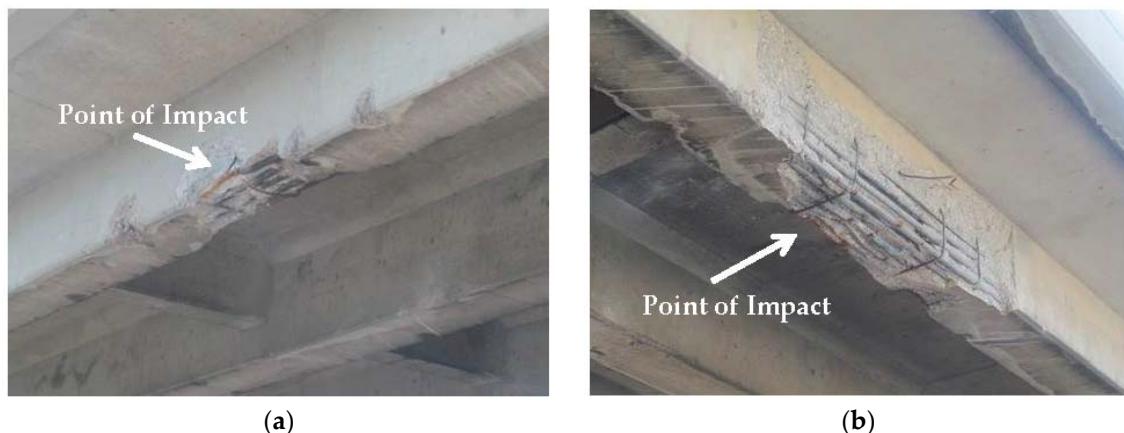
Both exterior girders (G1, G4) over the right lane were impacted, producing spalled concrete and bent reinforcing bars. At the point of impact, the bottom rebar mat of both RC girders consisted of five rebars, each 35.8 mm (1.41 in) in diameter, of which two were bent and yielded (Figure 3). The damaged reinforcement represented 13.3% of the total reinforcing steel available to resist positive bending. Several stirrups for shear reinforcement were also severed during the impact. On both girders, concrete damage to the impacted side appeared minimal, but there was significant concrete cracking and spalling on the girders' back sides. Girder 4 had the most damage, with the concrete spalling spread across approximately 3.7 m (12 ft).

Figure 3. Impact damaged reinforced concrete (RC) girders (a) Impact side of Girder G1; (b) Back side of Girder G4.

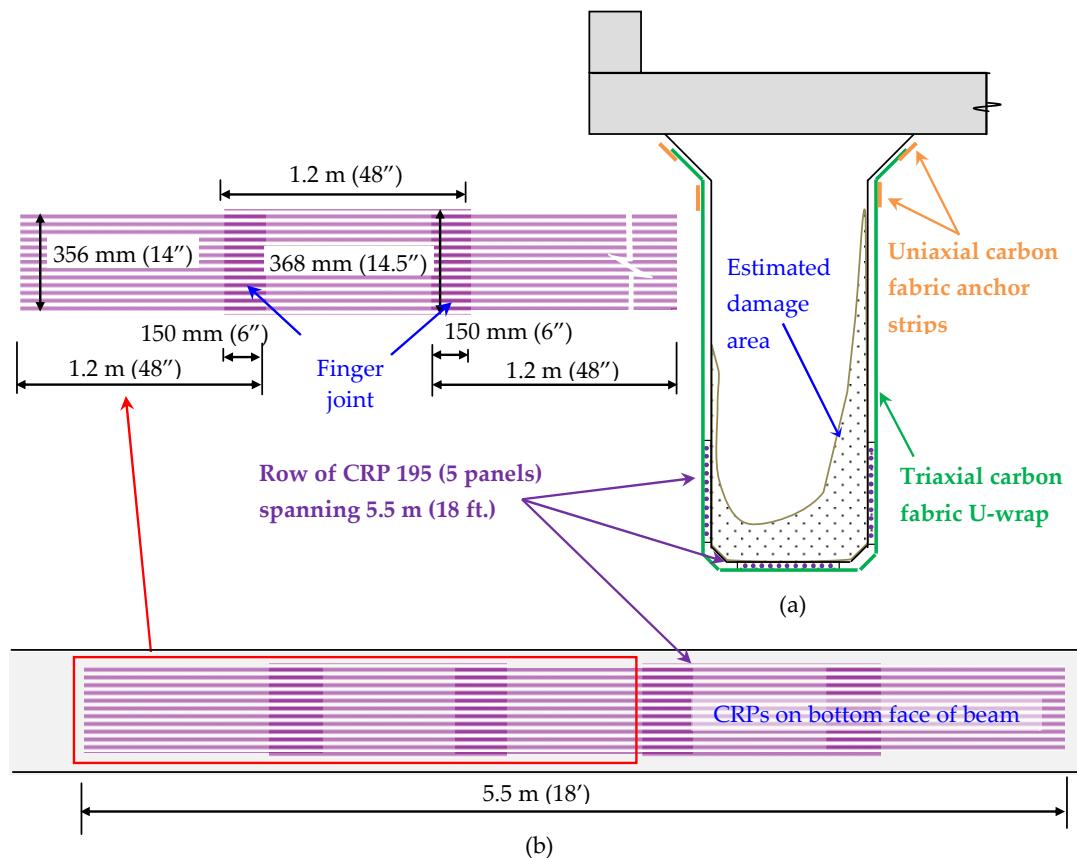
Figure 6. CRP retrofit design **(a)** Section of RC girder; **(b)** Bottom surface view of CRP on girder.

The same panel width for the CRP 195 was deployed on the bottom and sides of the RC girders (Figure 6). Based on the design calculations, the minimum width for the CRP panels should be equal to or greater than 254 mm (10 in). A width of 356 mm (14 in) was selected for the final design. Based on the initial damage inspection, five panels of CRP 195 were to be applied on the bottom surface and the sides of the RC girder (Figure 6). Following deployment, the five panels had a length of 5.5 m (18 ft). The panels extended a minimum distance of 150 mm (6 in) beyond the damaged areas. Figure 6a shows CFRP U-wraps of a triaxial braided quasi-isotropic ($0^\circ, +/ - 60^\circ$) carbon fabric. The U-wraps increase the CRP bond strength [30] and provide additional capacity beyond the one required by the AASHTO design guide [9]. As concrete cover delamination was the observed failure mode for CRPs [27,30], the CFRP U-wraps were expected to increase the capacity of the CRP strengthening system by anchoring the CRP panel ends. Laboratory testing has shown a 25% increase in the ultimate load carrying capacity of RC beams strengthened using CRPs with ends confined with carbon fabric U-wraps when compared to CRP strengthened beams without U-wraps [30]. The fabric's quasi-isotropic nature was expected to strengthen the cracked areas of the beam irrespective of crack orientation. In addition, the triaxial carbon fabric would also contain crushed concrete in the event of future over-height impacts. Small strips of 150 mm (6 in)-wide uniaxial carbon fabric were utilized as anchor strips for the triaxial U-wraps, at the top of the RC girders (Figure 6a).

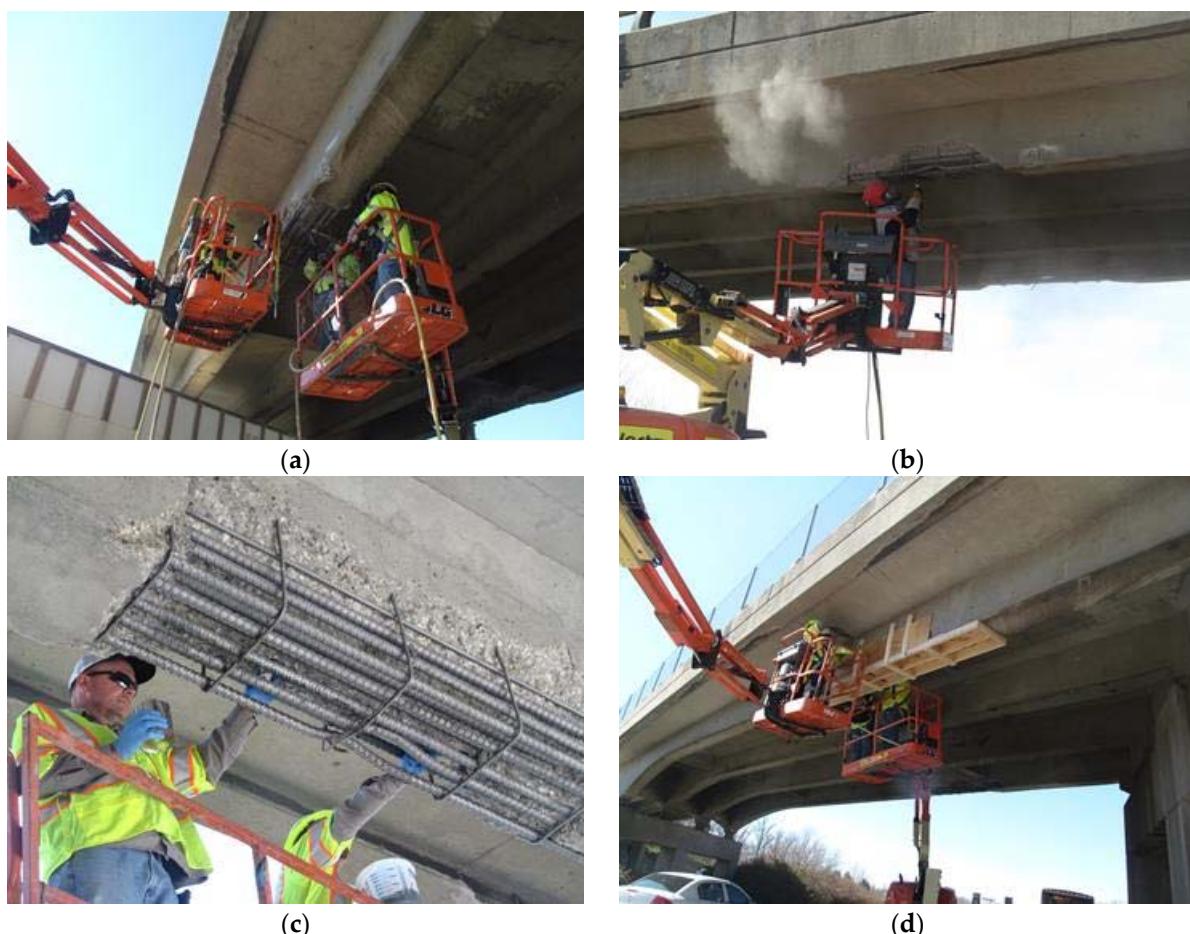
Figure 9. Concrete repair of RC girders (a) Remove loose concrete; (b) Grit blasting steel rebar; (c) Application of primer coating on rebar; (d) Setting up formwork for repair mortar.

The initial part of the retrofit involved removing deteriorated concrete and bringing the RC girders back to their original shapes. Several of the steps involved in the process are shown in Figure 9. All loose concrete around the impacted area was removed using pneumatic chipping hammers (Figure 9a). Then, a saw cut was made along the periphery of the damaged area, and concrete was removed up to the edge of the cut. Concrete was also removed around all the rebar within the damaged area, exposing a minimum of 25 mm (1 in) of non-corroded steel. Shear reinforcement that had been severed was replaced by splicing a new section. Next, all the steel was grit blasted to remove built-up rust (Figure 9b). The concrete surface where the retrofit material was eventually bonded was grit blasted to establish a clean and profiled bond surface. The steel rebars were then wiped down with a solvent and covered in a primer coating to prevent future corrosion (Figure 9c). The following day wooden form work was set up at both girders for placement of a rapid setting repair mortar (Figure 9d). A rapid setting mortar that can reach a minimum compressive strength of 27.6 MPa (4000 psi) within 24 h was selected to minimize construction duration. The mortar was mixed and inserted through openings left at the top of the formwork. Concrete vibrators were inserted through the openings and placed on the forms to ensure consolidation of the repair mortar. Finally, openings at the top were filled using handheld trowels.

The repair mortar was allowed to cure over a weekend, and once the formwork was removed, remaining voids were filled. Excess material and sharp edges were removed using mechanical grinders

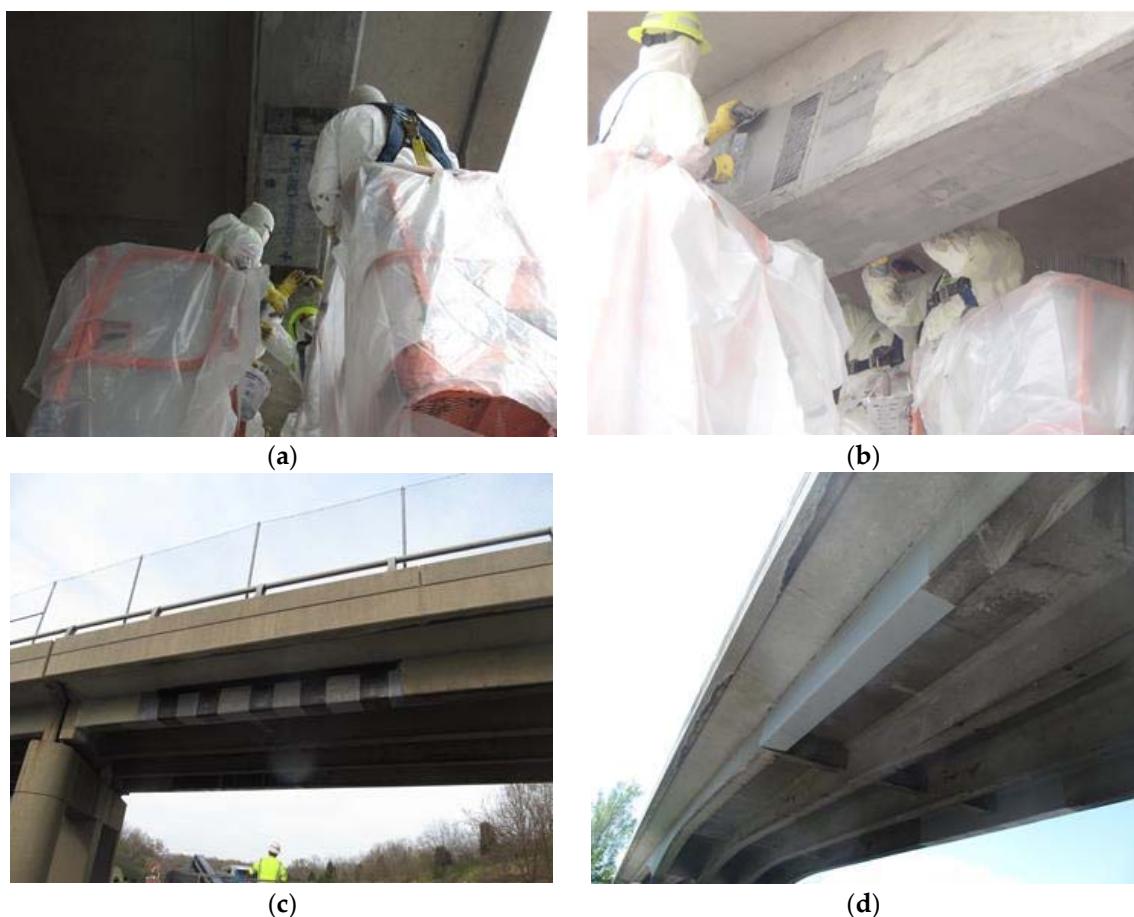
Figure 10. CFRP Strengthening (a) CRP applied to bottom surface; (b) Covering CRP on sides; (c) CFRP U-wraps and anchor strips applied over CRPs; (d) Ultraviolet (UV) protective coating applied over retrofit.

While the initial estimates for the retrofit called for five panels, following the concrete repair work, it was found that four panels with a total length of 4.4 m (14.5 ft) would span the damaged area. This also eliminated the need to strengthen the girders over the adjacent traffic lane. Prior to applying the CFRP material, the RC girders were cleaned by blowing compressed air and then wiped down using a solvent. A two-part structural epoxy was applied to the concrete surface for bonding the CRPs. The epoxy was spread out evenly over the surface using notched trowels, with the thickness being dependent on the CFRP rod diameter. Achieving the required thickness lets the CFRP rods be pressed into the epoxy and be fully embedded. Excess epoxy was spread out over the top of the panel, covering the entire panel in epoxy, except for the finger joint connecting to the adjacent panel. Unlike the application of CFRP laminates, only the epoxy required for an individual CRP panel needs to be applied. Once a panel was attached, the man-lift was moved over to the location of the adjacent panel and the process repeated. Figure 10a captures the application of a CRP on the bottom surface of a RC girder. Figure 10b shows CRPs being applied on to the sides of the girder following the application of CRPs to the bottom of the girder.

Soon after the CRPs were applied, CFRP U-wraps were placed over the finger joint locations in the CRPs (Figure 10c). A wet layup using a saturating epoxy was employed in the CFRP fabric application. An epoxy primer coat was first applied on the vertical surfaces to prevent the fabric from

sliding. As noted earlier, the triaxial CFRP U-wraps were expected to provide additional bond strength to the CRPs. An anchor strip of unidirectional CFRP fabric was placed over the U-wraps at the top of the beam (Figure 10c). The complete retrofit has an ultraviolet (UV) protective coating which was applied over the entire retrofit area after the epoxy had cured (Figure 10d).
