# Full-Scale Blast Tests on a Conventionally Designed Three-Story Steel Braced Frame with Composite Floor Slabs

**Abstract:** This paper summarizes the findings of two full-scale blast tests on a steel braced frame structure with composite floor slabs, which are representative of a typical office building. The aim of this research study was to experimentally characterize the behavior of conventionally designed steel braced frames to blast loads when enclosed with conventional and blast-resistant façade. The two tests involved a three-story, steel braced frame with concentric steel braces, which are designed to resist typical gravity and wind loads without design provisions for blast or earthquake loads. During the first blast test, the structure was enclosed with a typical, non-blast-resistant, curtainwall façade, and the steel frame sustained minimal damage. For the second blast test, the structure was enclosed with a blast-resistant façade, which resulted in higher damage levels with some brace connections rupturing, but the building did not collapse. Observations from the test program indicate the appreciable reserved capacity of steel brace frame structures to resist blast loa

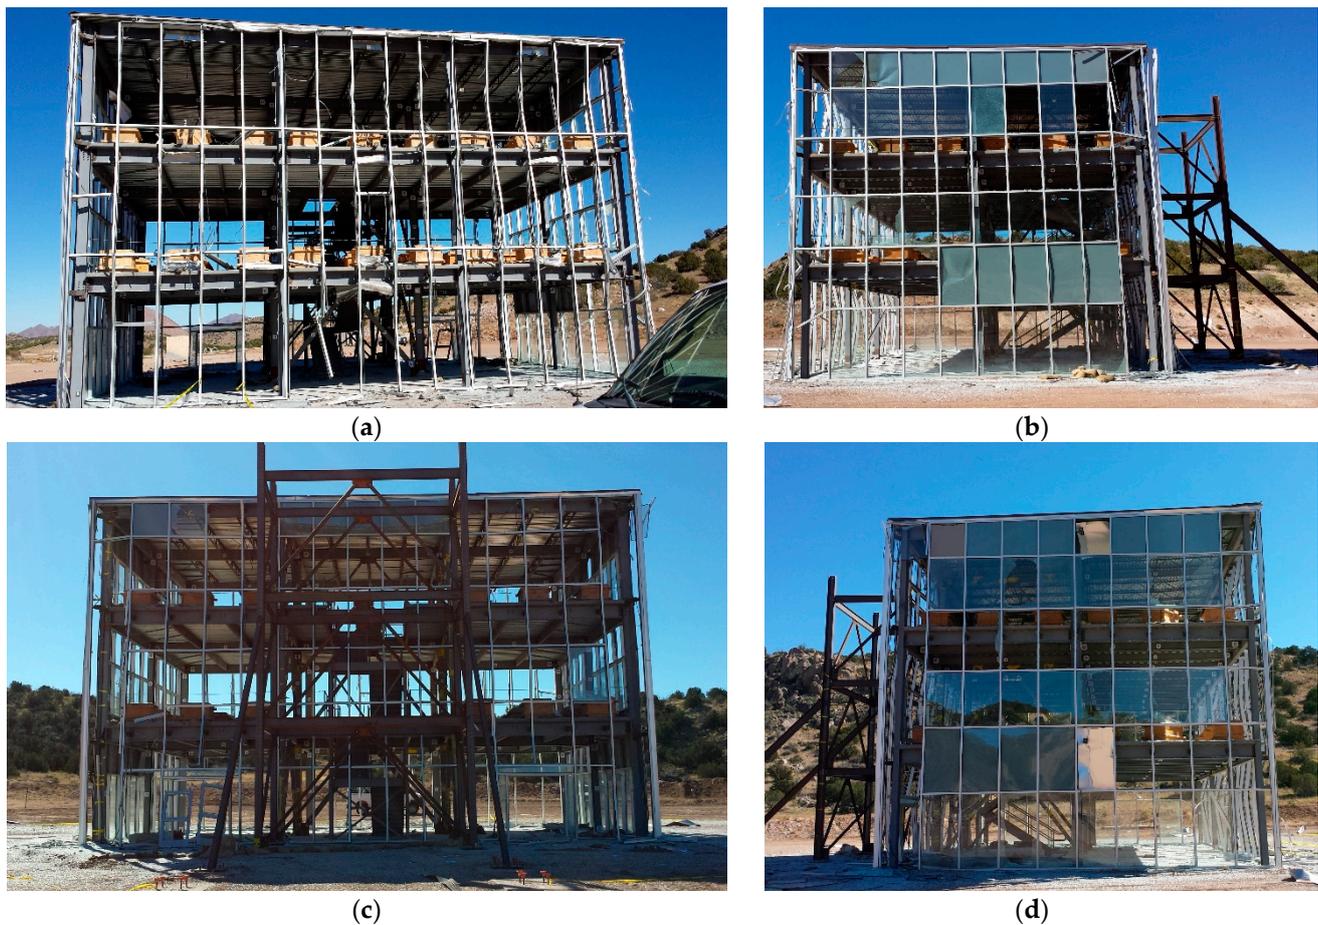
elevation of the building, as shown in Figure 12e,f. Eventually, the exterior curtain wall façade failed almost instantaneously as the blast wave loaded the structure. Views of the post-test condition of the structure can be seen in Figure 13. Specifically, all front and rear elevation glazing completely shattered, and the aluminum mullions were severely damaged. Only a few glazed units remained intact at the side elevations of the building.

**Figure 13.** Test 1—Post-test condition of structure: (a) Front (south) elevation; (b) Side (east) elevation; (c) Rear (north) elevation; (d) Side (west) elevation.

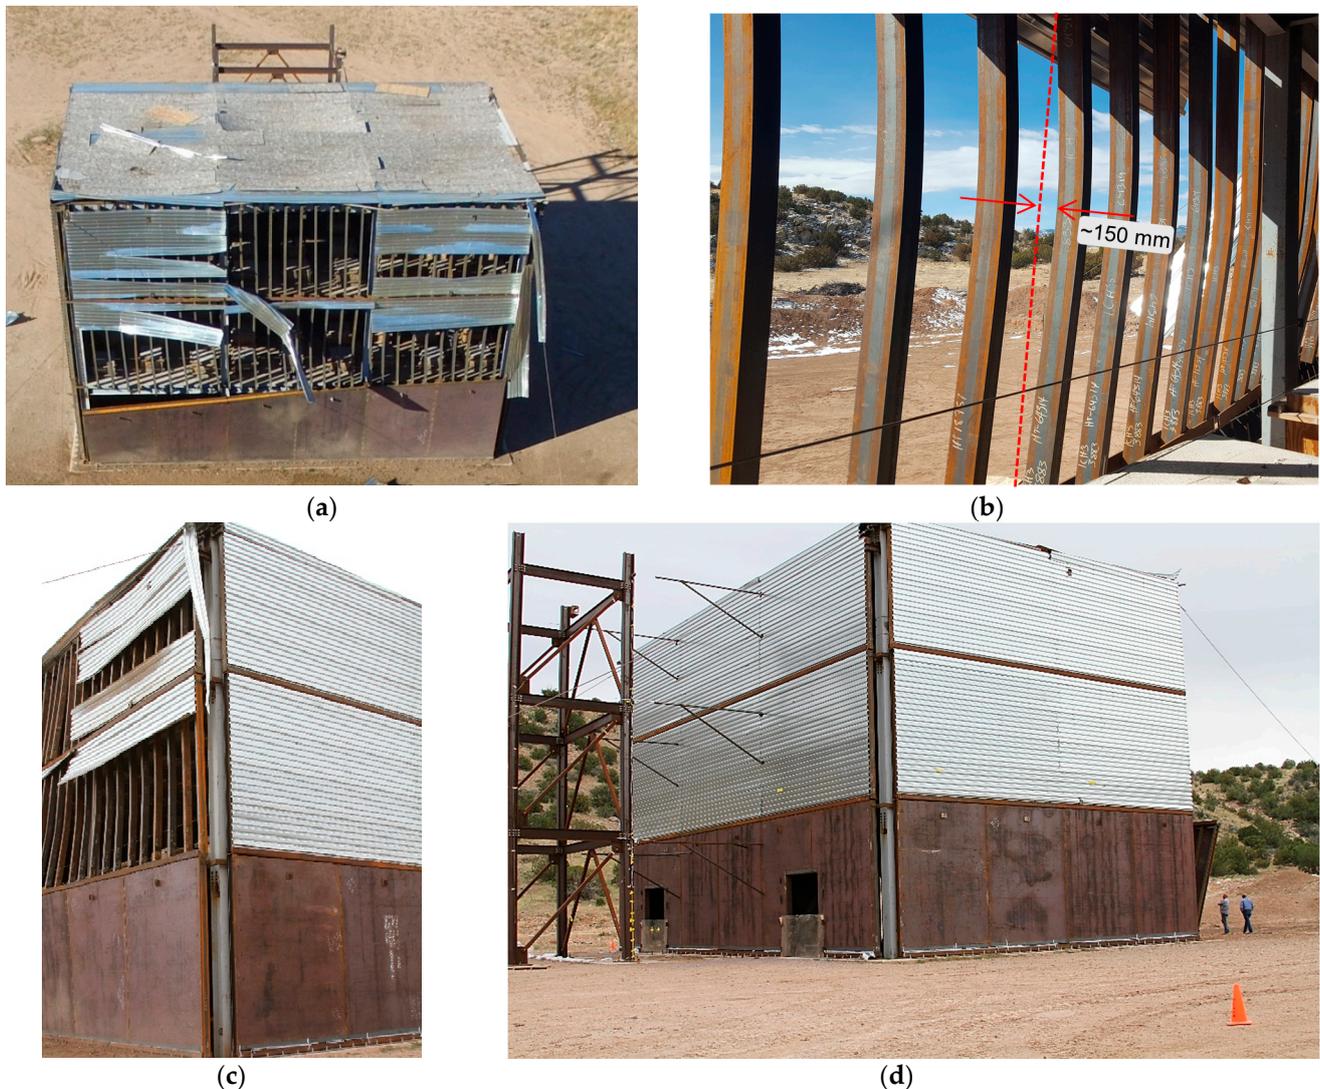
Figure 16 shows the condition of the structure after the test. As shown in Figure 16a, most of the corrugated siding was detached due to the negative phase of the airblast load. Based on visual inspection, the vertical façade members at the second and third floors responded within the expected response limits. As previously noted in Section 3.6, the performance limit was a peak lateral deformation 215 mm or less. In fact, in Figure 16b, the residual plastic deformation of the façade channels was approximately 150 mm.

**Figure 16.** Test 2—Post-test condition of structure: (a) Aerial view of front (south) elevation; (b) View from 2nd floor (looking southwest); (c) Southeast elevation; (d) Northwest elevation.

Most of the façade connections at the second-floor level failed where the façade channels slipped out of the track during the rebound (Figure 5c). The connections at this level failed due to the higher dynamic reactions caused by the composite action of the 16 mm thick steel plate that was welded to the first-floor vertical façade channels (Figure 5b). Specifically, some bolts that connected the vertical channels to the frame ruptured in direct shear during the inbound response. During the negative phase of the airblast, the façade ends were not positively connected to the structure anymore, causing a zipper-type failure mode with the façade detaching from the frame. This connection failure did not affect the inbound blast load that was transferred to the steel frame. During the inbound response and as bolts ruptured, the façade channels transferred the blast load to the structure through direct bearing action with the edge of the concrete slab, since the

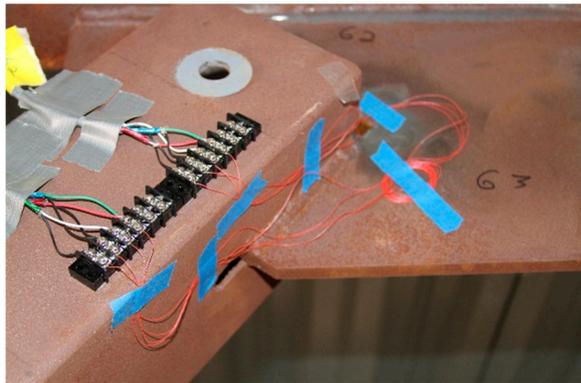
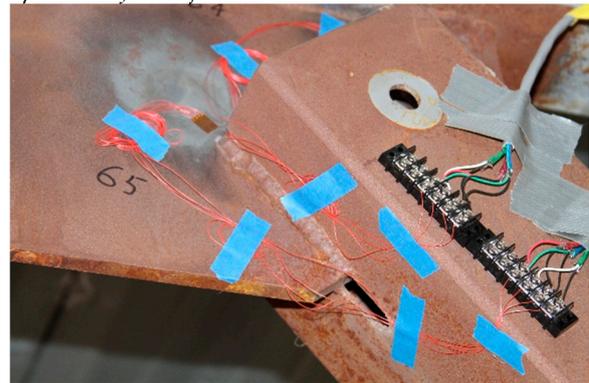
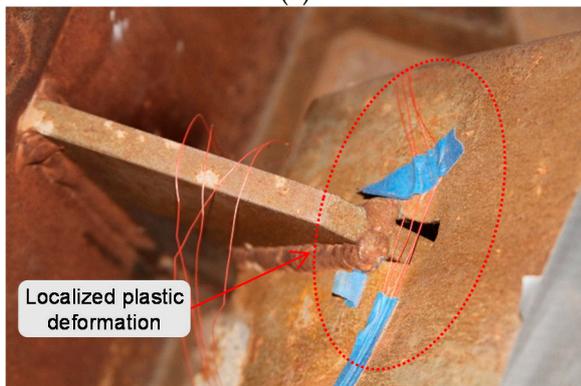
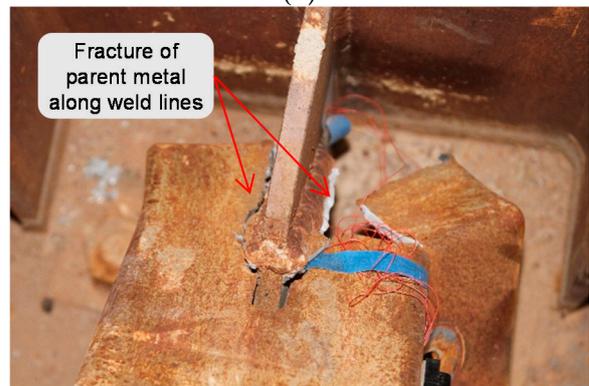
**Figure 17.** Test 2—First floor brace connections at column line B: (a) Top gusset joint closer to column B3; (b) Top gusset joint closer to column B2; (c) Base gusset joint with column B3; (d) Base gusset joint with column B2.

Finally, Table 6 shows the peak measured brace forces based on the recorded data from the 24 strain gauges that were attached to each one of the 12 braces that resisted load in the blast direction (Figure 8). The peak forces for all braces were recorded during the first inbound response cycle. Consequently, for each pair of braces, the negative value is at the brace member in compression and the positive value is for the conjugate brace that was in tension. It is also noted that the base connections of SG3, SG4, SG15, and SG16 that were attached to the brace members completely ruptured (Figures 17d and 18c).

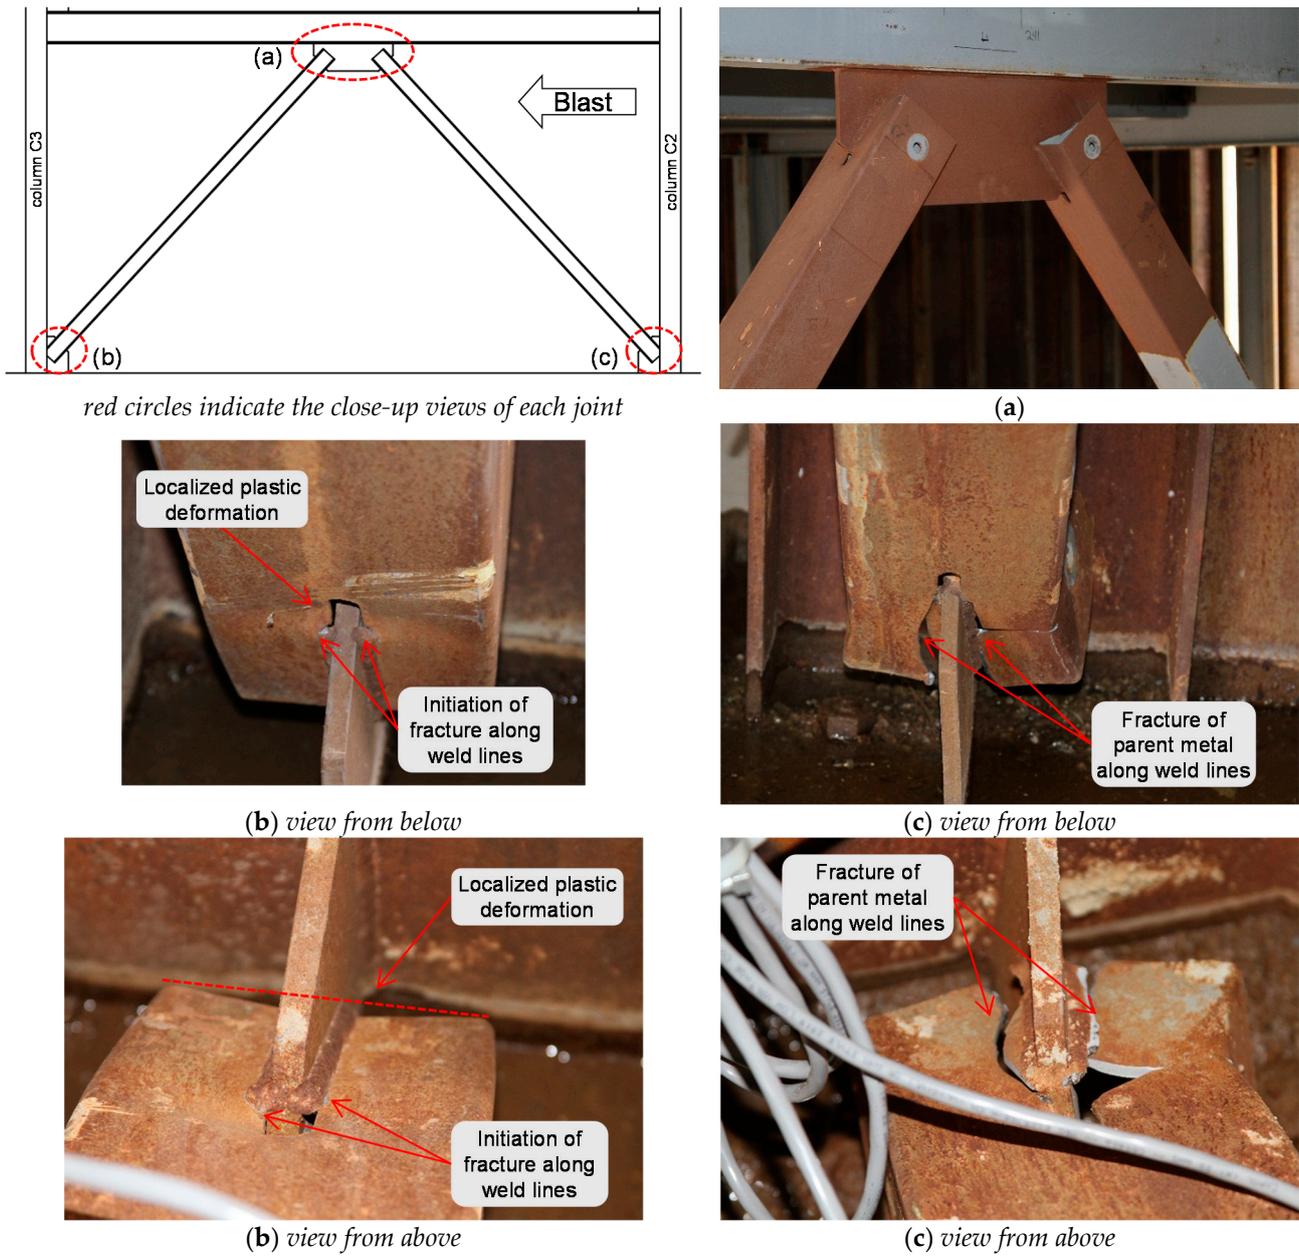
**Figure 18.** Test 2—First floor brace connections at column line C: (a) Top gusset joints; (b) Base gusset joint with column C3 (see Figure 19 for a magnified view); (c) Base gusset joint with column C2.

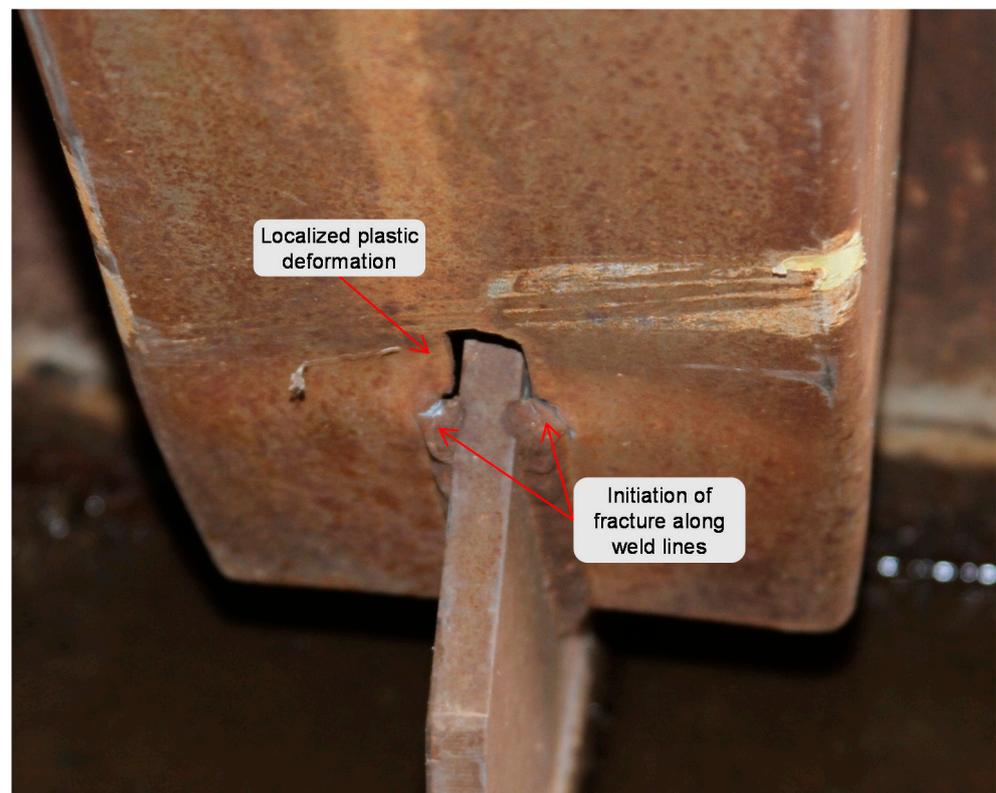
**Figure 19.** Magnified view of Figure 18b.

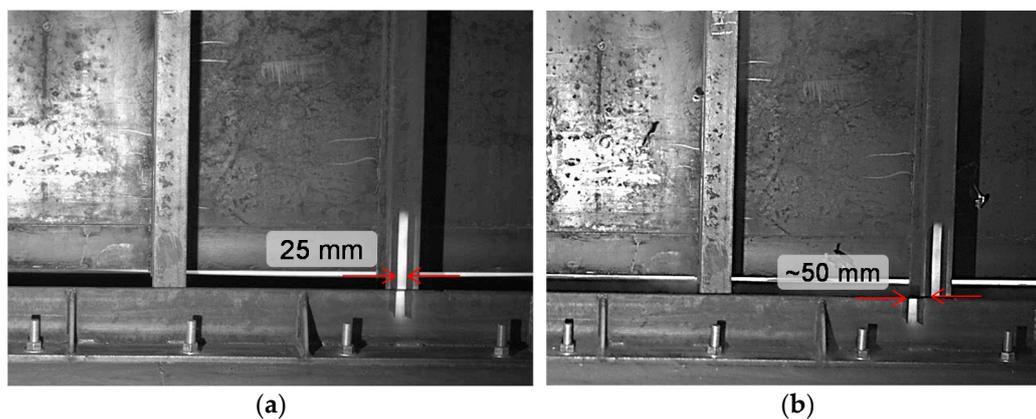
As mentioned earlier, to eliminate the participation of the relatively strong façade in the resisting lateral load, the base connection of the curtainwall façade at each floor level was designed to move along (slide) with the floor above (Figure 5c). Footage from high-speed video cameras that were focused on the base connections of the curtainwall façade at the west side of the building were reviewed, and it was confirmed that the façade was moving along with the floors. Figure 21 shows the motion relative to the base channel lateral displacement of the first-floor curtainwall façade at the west side of the building. The relative motion at 125 ms was estimated to be  $\approx 50$  mm, which was in phase with the measured displacement of the second floor at the same time (Figure 20a).

**Figure 21.** Test 2—Close-up views of the base sliding connection (south to north direction) of the first-floor curtainwall façade at the west elevation of the building (high-speed camera inside the building looking west): (a) Time = 0 ms; (b) Time = 125 ms after detonation.

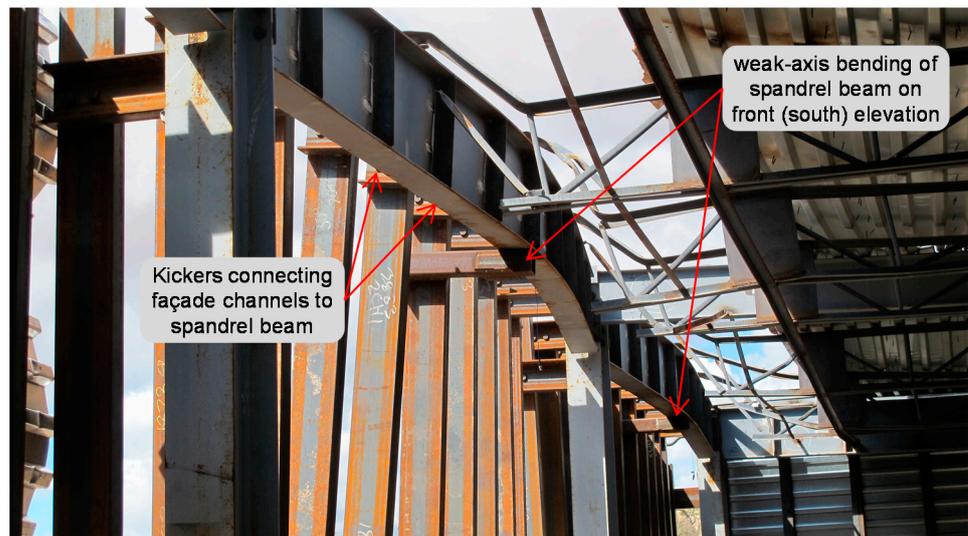
The peak-reflected specific impulse on the front (south) face of the building (Figure 10) was  $1500 \text{ kPa} \times \text{ms}$ , which was approximately 10% higher than the impulse during the first test. As with the first test, the impulse value was taken as the average from the 11 PGs that were installed on the front elevation of the building. Multiplying this value with the front face dimensions of the building, 18.3 m wide and 12.3 m tall, the reflected impulse was  $350 \text{ MN} \times \text{ms}$ . Unlike the conventional glazed façade during the first test, the blast-resistant façade absorbed most of the blast impulse that was eventually transferred to the LFRS of the building. Unfortunately, the loads cells that were installed to measure the dynamic reactions that the façade transferred to the frame (Figure 9b) were damaged during the test, and the recorded data were not valid. Nonetheless, the higher impulse that the nonfailing façade transferred to the building frame, compared to Test 1, was evident from the generally higher lateral deflections and the partial failure of the first-floor brace connections (Figures 17 and 18). Additionally, the higher impulse that was transferred to the building was also reflected on the response of roof spandrel beams on the front (south) elevation of the building, as shown in Figure 22. The roof spandrel beams had an appreciable level of permanent lateral deformation i.e., weak axis bending, of approximately 300 mm. Conversely, the same spandrel beams after the first test did not have any permanent deformation. Since the spandrels at the lower floors were connected

to the concrete slab through shear studs, their weak axis bending capacity was higher; hence, they did not sustain any plastic deformation about their weak axis.

Figure 22. Test 2—View from 3rd floor looking at the bent spandrel beams of roof.
