# Architectural, Constructional and Structural Aspects of a Historic School in Greece. The Case of the Elementary School in Arnaia, Chalkidiki

Vasiliki Pachta <sup>1,\*</sup>, Vasiliki Terzi <sup>2,†</sup>

<sup>1</sup> Lab. of Building Materials, School of Civil Engineering, Aristotle University of Thessaloniki, 54124 Thessaloniki, Greece

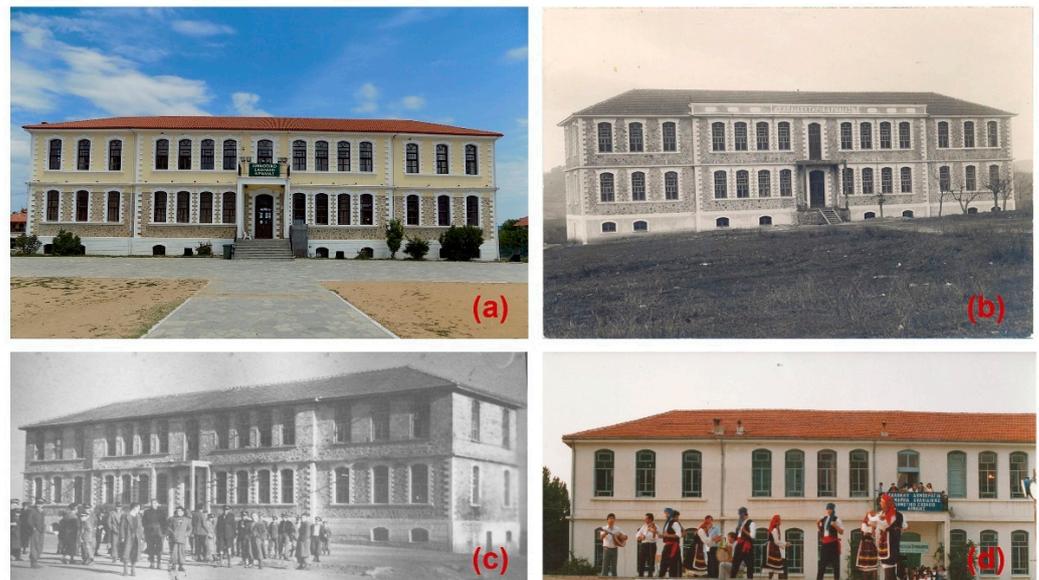
**Figure 3.** The elementary school of Arnaia (1928): (a) Main façade (S); (b) main façade (S), in a historic photo of 1931 (before the earthquake); (c) the school building in the early 1940s (after the earthquake); (d) the school building in 1984 (during a local festival).

During the earthquake of 1932 (~7 Richter), which resulted in extreme catastrophes throughout the whole area [29], the building experienced severe damages. According to the information given by the director of the school (no relevant research data was found), the damages were more intense in the 1st floor and the SE part of the building. They mostly concerned cracks in the masonry walls and render detachments that were immediately repaired (the school continued to function in the same year). As presented in Figure 3c (taken some years after the earthquake), the frames of the 1st floor openings were removed (probably due to detachments), as well as the large inscription on the roof.

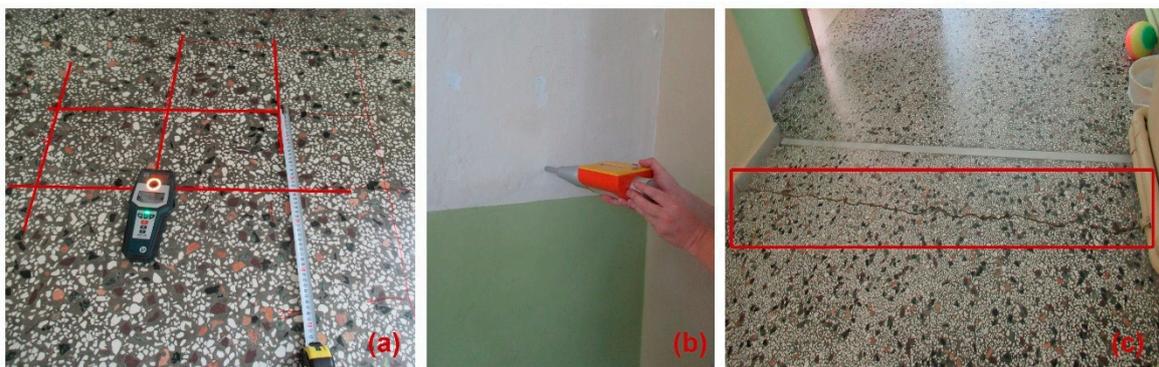
Regarding the reinforced concrete elements of the construction, the profometer measurements gave valuable information (Figure 7a). From the comparative evaluation of the on-site inspection and the test results, it was concluded that reinforced concrete was used for the partial construction of the floor slabs and the staircases (Figure 6d). The concrete slab of the ground floor was extended in the corridors and was covered with the typical cement mosaic of this period. The reinforcement comprised a 24 cm × 24 cm mesh, as identified by the profometer (Figure 7a). In the eastern part of the building, a secondary reinforced concrete slab was recorded (below the wooden floor) that was put in lower than the central slab level (around 15 cm). This (according to oral testimony) was constructed during the repair works of 1950–1960, in order to further assess the damages due to the earthquake. The southern part of the building, where the classrooms are located has a wooden floor, supported by wooden beams.

**Figure 7.** Non-destructive testing implemented and pathology symptoms. (a) Profometer measurements in the ground floor concrete slab (corridor) indicating the type and dimensions of the reinforcement; (b) Schmidt hammer tests on the external walls of the ground floor; (c) Horizontal crack in the concrete slab of the ground floor (elongate corridor, alongside the pillars).

According to the measurements attained by the Schmidt hammer on the various sides and constructional types of the building (Figure 7b), it was concluded that there was a relative range of values (Table 1). This was probably due to the types of the building materials, as well as to their state of preservation. The high estimated compressive strength values have also been noted in the literature [26,27] and should be verified by laboratory testing. Generally, this method can provide valuable comparable results related to the type and state of materials that should be further assessed.

The state of the building was generally in good condition. Few damages were recorded, mainly concerning detachments of renders near to the ground level and horizontal cracks recorded in the R/C slab of the ground floor. These cracks had a range of 0.2–1 cm, were mostly identified alongside the pillars (above the beams) (Figure 7c) and should be further recorded.

Therefore, it was asserted that the strength level of the concrete slab was much lower than the indication given by the Schmidt hammer test and around 10–14MPa. This should be further confirmed by coring samples and strength determination through laboratory testing.

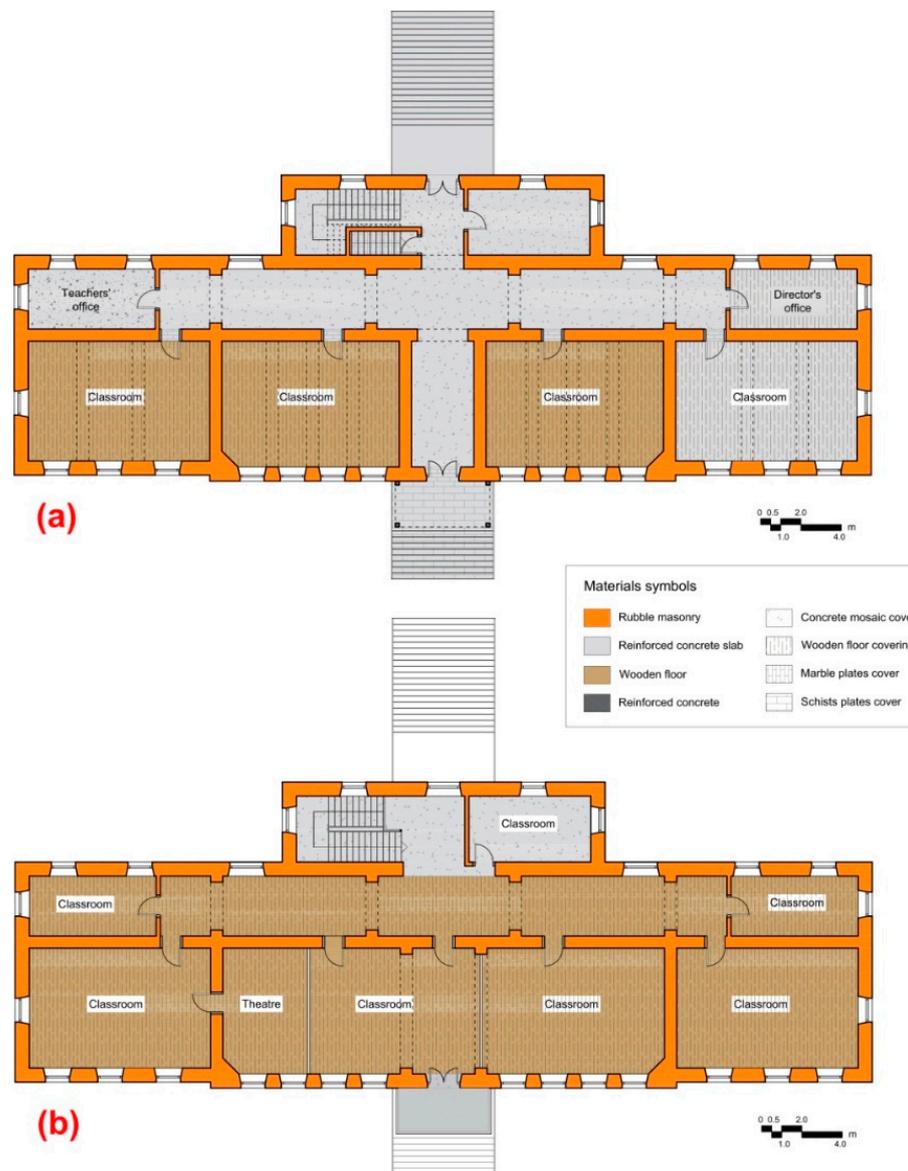
The mapping of the building materials identified on the ground and the 1st floor is schematically presented in Figure 8. In these designs there is information on both the types of the floors and their coverings.

**Figure 8.** Mapping of the constructional types and materials of the stone school building: (a) Ground floor; (b) 1st floor.

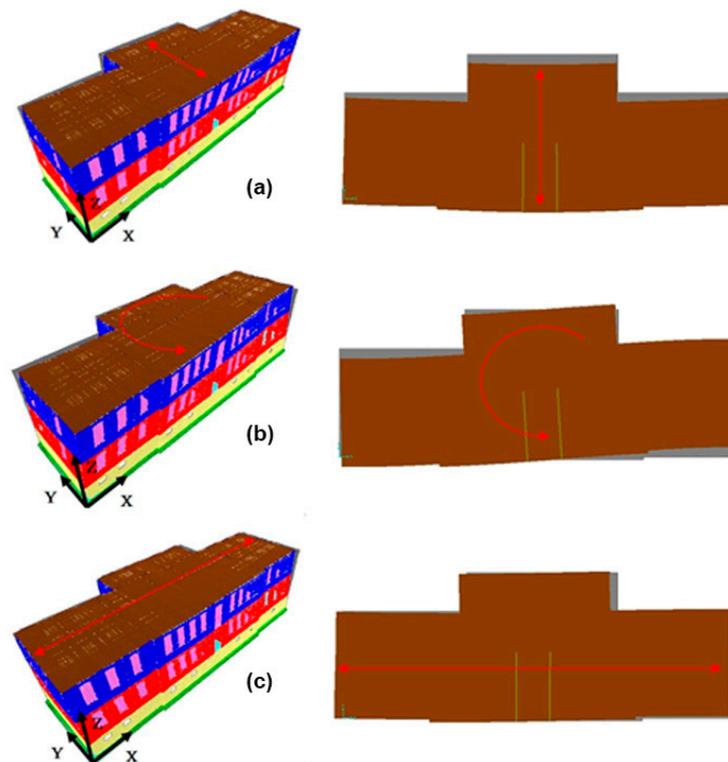
Figure 10 depicts the first three eigenmodes of the masonry building. The fundamental eigenmode corresponded to translation at the Y axis, which was perpendicular to the elongated axis, and the translational mass participation ratio at the same axis was 52.705%. The second eigenmode corresponded to torsion, rotation around the Z axis, and the mass moment of inertia participation ratio around the same axis was 48.267%. The third eigenmode corresponded to translation at the X axis, which was the elongated axis of the structure, and the translational mass participation ratio at the same axis was 63.913%.

**Figure 10.** The first three eigenmodes of the masonry structure: (a) 1st eigenmode, translation at Y axis,  $T_1 = 0.184$  s; (b) 2nd eigenmode, torsion,  $T_2 = 0.154$  s; (c) 3rd, translation at X axis,  $T_3 = 0.121$  s.

The torsional mode was attributed to the distribution of the masses at each floor. In particular, the first plan consisted of wooden and reinforced concrete plates with different coverings, wood and mosaic, respectively. Therefore, the masses due to self-weight of the plates and their coverings were not symmetrically distributed. The arrangement of the vertical structural members (walls) was indeed symmetric. However, the arrangement in the horizontal planes was not.

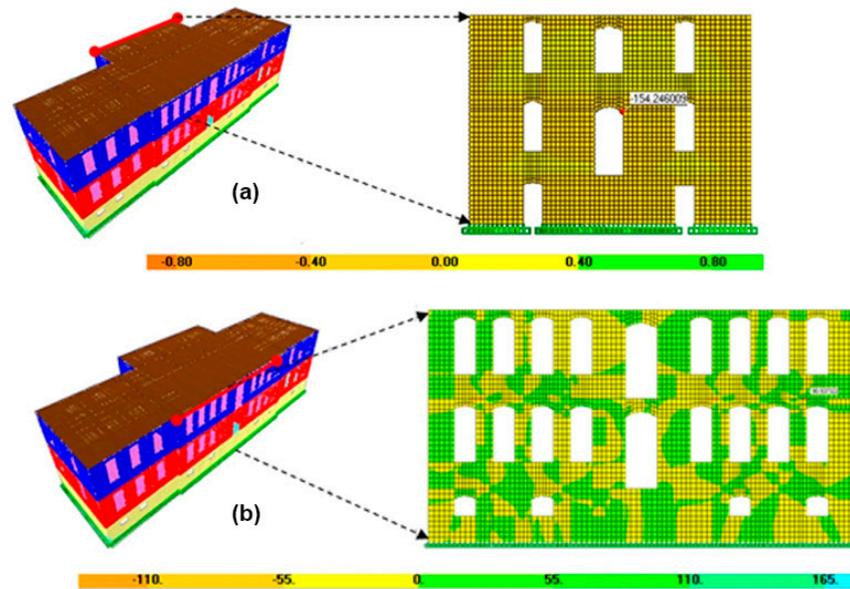
**Figure 12.** Persistent design situations. Loading combination:  $1.35 \cdot G + 1.5 \cdot Q + 1.5 \cdot 0.5 \text{ snow}$ ; (a)  $\max(s_{22}) = -154.260 \text{ KPa}$ ; (b)  $\max(s_{12}) = 90.937 \text{ KPa}$ .

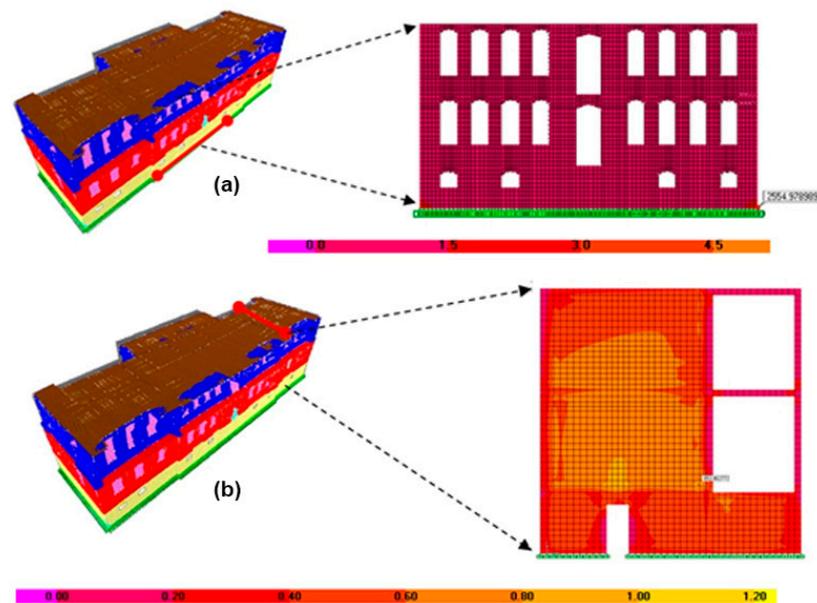
**Figure 13.** Seismic design situations: (a) Loading combination:  $G + 0.6 \cdot Q + 0.3 \cdot EX \pm Y$   $\max(s_{22}) = 2254.979 \text{ kPa}$ ; (b) Loading combination:  $G + 0.6 \cdot Q - 0.3 \cdot EX - Y$   $\max(s_{12}) = 853.803 \text{ kPa}$ .

The preservation state of the building was generally good, with limited damages concerning render detachments and some cracks in the concrete slab of the ground floor. The critical aspects (also identified by the structural assessment) were concentrated in the eastern part of the building (damaged during the 1932 earthquake), where past repair works were implemented, as well as in the walls' conjunctions.
