# Towers on the Earthen Foundation: New Insights by the Excavation and Boring Survey at the Bayon Temple

Ichita Shimoda

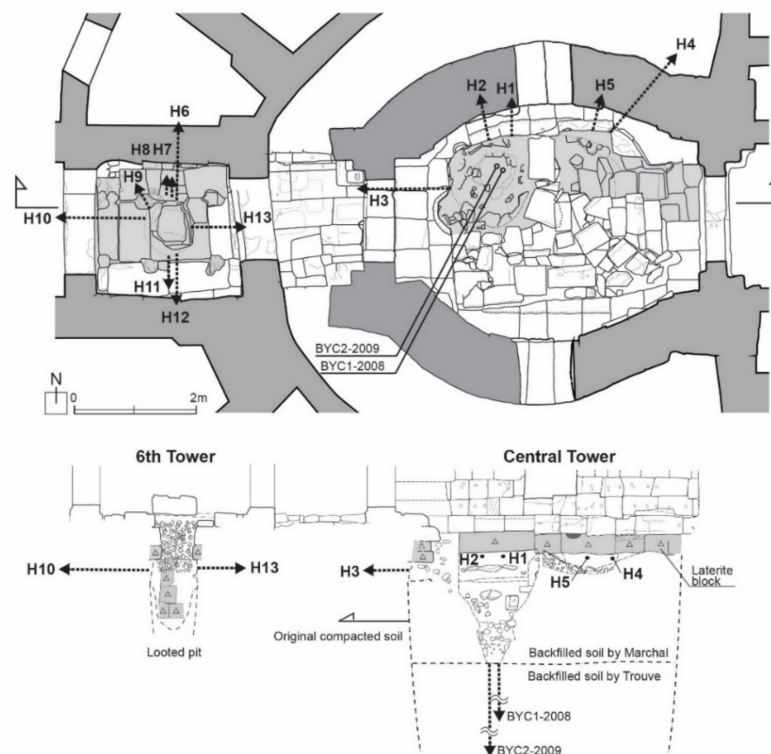
**Figure 3.** Plan and section of the archaeological excavation survey in the central tower and the 6th tower (H1–H13 show the locations where hand auger tests were conducted).

By removing the upper layer of backfill soil, it became possible to observe the structure directly beneath the floor level of the north wall in the chamber. A layer, or two layers in some places, of laterite blocks approximately 30 cm thick was confirmed paved below the bottommost sandstone blocks of the wall (Figure 3). The laterite blocks were brittle on the surface and roundish. It was assumed that they were exposed during a past survey or during a looting and had progressively weathered. Brown, sandy compacted soil was confirmed below the laterite layer. It contained gravel that was approximately 20 cm in diameter from conglomerate rocks and a thin 3–5 cm layer of silty clay, and was estimated to have a bearing capacity of roughly 800 kPa when measured using a Yamanaka soil hardness meter. To verify the existence of a stone support structure directly beneath the wall, a hand auger was inserted horizontally at the level below the laterite layer in a total of five spots. In three spots (H1, H2, and H5), the hand auger came up against gravel and the drilling was stopped, but in two spots (H3 and H4), the hole was able to be drilled through to the adjacent chamber from beneath the wall. In other words, there was no masonry structure beneath the wall of the central chamber to directly support the wall.

At the 6th tower, an excavation was conducted down to a depth of approximately 2.5 m from the floor level. As at the central tower, laterite layers were found below a pavement of two sandstone layers. There was a maximum of five layers of laterite in some places, arranged in irregular fashion. This feature resembled the structure of the laterite layers beneath the bottom layer of the wall that was confirmed in an excavation conducted in the chamber of the 12th tower in 1937. The compacted soil beneath the laterite layers was examined by horizontally inserting a hand auger at a total of eight spots (H6–H13). At most spots, the drilling was blocked by gravel that was mixed in the compacted soil. However, at the survey spot where the hand auger was inserted horizontally toward the north side (H6), the hole penetrated the soil beneath the wall. Therefore, it was confirmed that no masonry support structure existed directly beneath the wall, as was found in the central chamber.

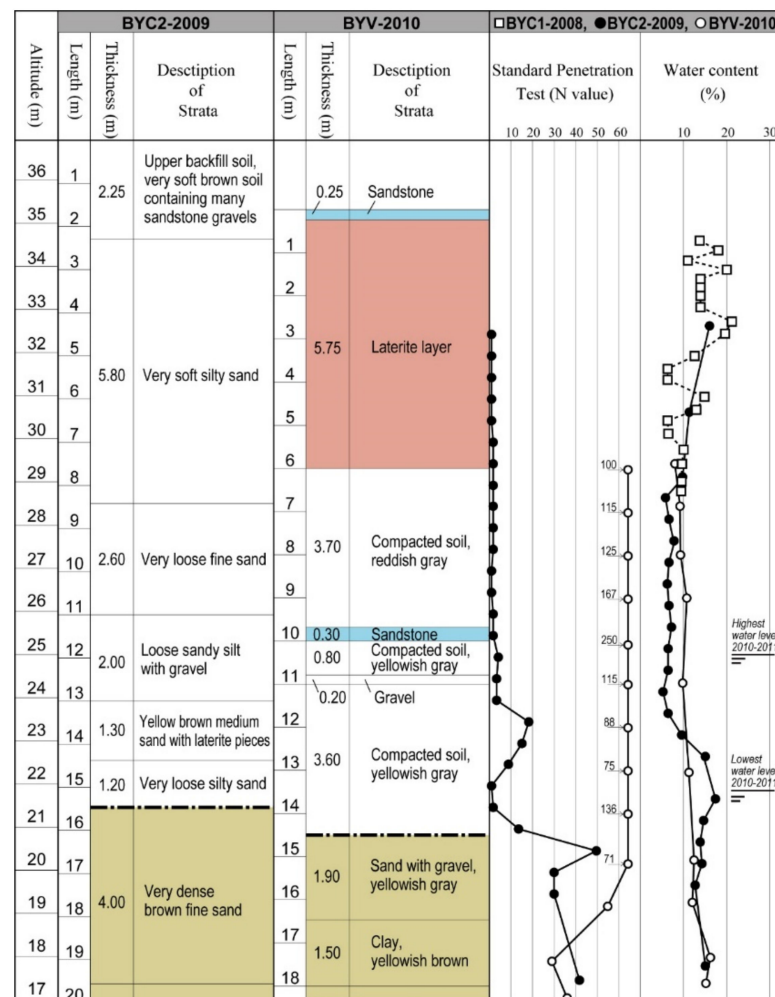
**Figure 4.** Boring log and N-value of the standard penetration tests of the vertical borings (BYC2-2009 and BYV-2010), and water content of sampled soils from the borings (BYC1-2008, BYC2-2009 and BYV-2010).

The N-values were extremely low down to a depth of 13 m (altitude of 24 m), and the backfill soil was noticeably loose. At a depth of 13–14.5 m, there was a topical increase in the N-value, and laterite chips were found mixed in the sampled soil. At 14.5–15.1 m, the N-value dropped once again, then rose drastically at depths below 15.5 m. As the excavation conducted in the 1930s presumably did not reach down to the natural ground, it was thought below the backfill soil there is soil that was disturbed during a looting in the past, followed by original compacted soil, and the natural ground, in this order. No clear differences among these soil layers were confirmed in the observation of the quality of the soils collected in the boring test, but it is assumed that the soil down to a depth of 13 m is was backfill soil from a past excavation survey, the soil at depths below 15.5 m that exhibited high N-values is the natural ground, and between the two is a layer of soil that was disturbed during a looting.

Figure 4 shows the water content ratios of soils sampled in the hand auger and machine boring tests conducted in the central chamber. The hand auger test was conducted during the rainy season, in August 2008, and the machine boring test was conducted during the dry season, in March 2009. Although the seasons differed, the water content ratio at depths of 4–8 m (altitude of 29–33 m) was practically the same in both tests. This showed that there is no change in the water content of the backfill soil between the rainy season and dry season, at least at that level. The water content ratio of the soil sampled in

the machine boring test was around 6% down to a depth of 13 m (altitude of 24 m), but surged to around 15% below that. As of March 2009, it is presumed that the groundwater level is at around a depth of 14 m (altitude of 23 m).

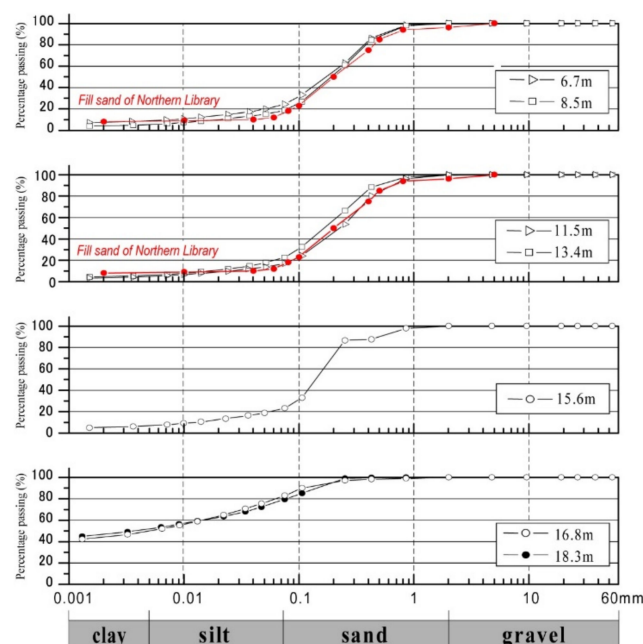
**Figure 6.** Grain size distribution of core sampled soil at BYC2–2009 (red line shows the grain size distribution of soil from the platform of Northern Library of Bayon).

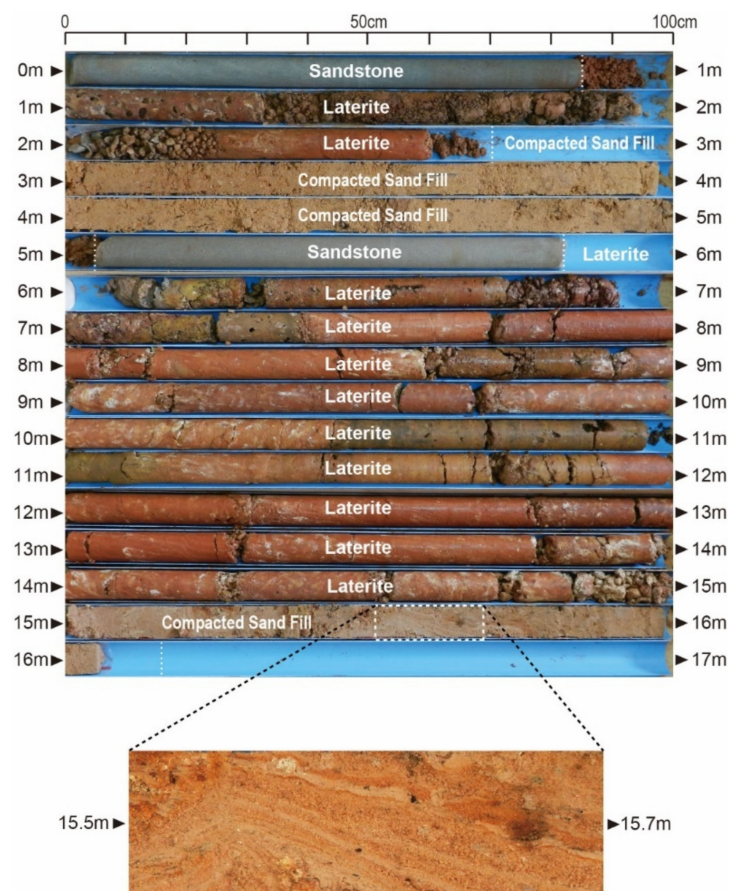
Figure 9 shows a record of cores sampled from BYHS–2012. It is worthy of mention that the compacted soil at a depth of 15.5–15.7 m displayed a laminate structure. Horizontal stratification that appears as a result of compacting, in which sand is laterally sprinkled and tamped down, has also been confirmed in the past during the dismantlement of the northern and southern Libraries, but it is difficult to imagine that the banded structure seen in the photo was made by the compacting method. Rather, it is thought that the banded structure was formed by a chemical weathering effect caused by the flow of seeping water inside the platform earth fill after the platform was constructed. Indeed, traces of chemical weathering, such as seeping, leaching, and sedimentation, were found inside the earth fill.

**Figure 9.** Core sampled from BYHS–2012 (above) and enlarged photo of a portion of compacted sand fill between 15.5 m and 15.7 m (below).

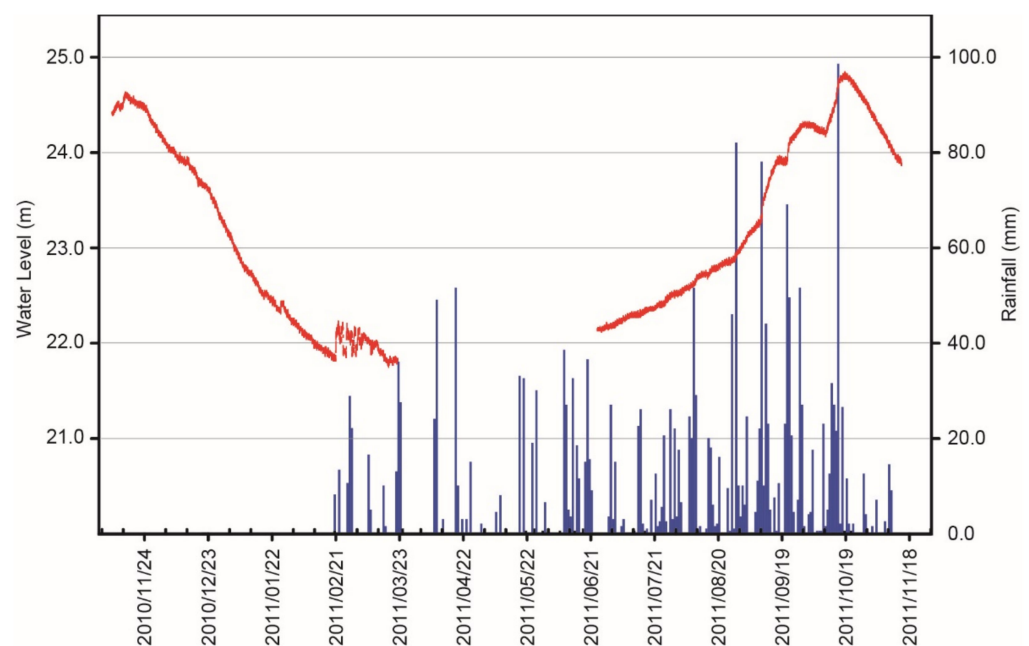
**Figure 10.** Water level monitored in the boring core of BYV-2010 under the central terrace of Bayon and rainfall in Angkor Wat from November 2010 to November 2011 (monitoring data of water level are lacking between the middle of March to the end of June 2011).

The region is largely divided into the rainy season, from May to November, and the dry season, from December to April, and groundwater level fluctuates between these two seasons. During the measurement period, groundwater level was the lowest at 21.8 m in February and March and highest at almost 25 m at the end of October, such that there was a roughly 3 m fluctuation over the year. Figure 4 shows these groundwater levels together with the water content ratio, and indicates that ground-water level fluctuated to a level roughly 1 m above the lower layer of compacted soil. It should also be noted that the groundwater level measured in the past in the vicinity of Bayon Temple fluctuated between altitudes of 18 to 23.5 m over the year [19], so groundwater level directly beneath the terrace is assumed to fluctuate at a higher level than its surrounding area.

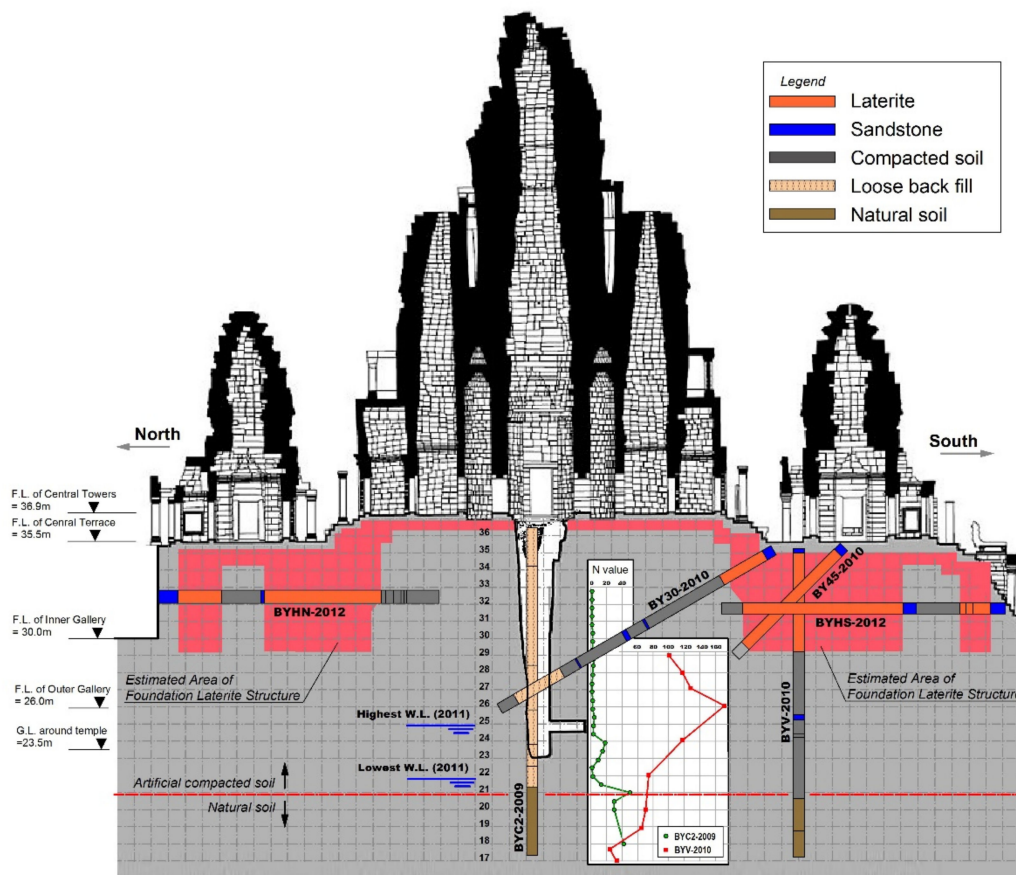
**Figure 11.** Estimated area of the foundation laterite structure in the north–south section of the central terrace with boring logs and N values of standard penetration tests at BYC2–2009 and BYV–2010 (section drawing of upper structure is based on Dumarçay [8]).

No laterite or sandstone foundation structure was found directly beneath the central group of towers, but a laterite foundation structure is thought to exist on the outskirts of the central group of towers. The laterite foundation was found to be asymmetrical between the north and south sides, with the north side measuring 7 m in width and the south side measuring 9 m. The height of the laterite foundation structure on the south side is estimated at approximately 6 m, judging by the boring logs from BYV-2010 and BHY2-2010. This dimension roughly corresponds to the height of the central terrace.

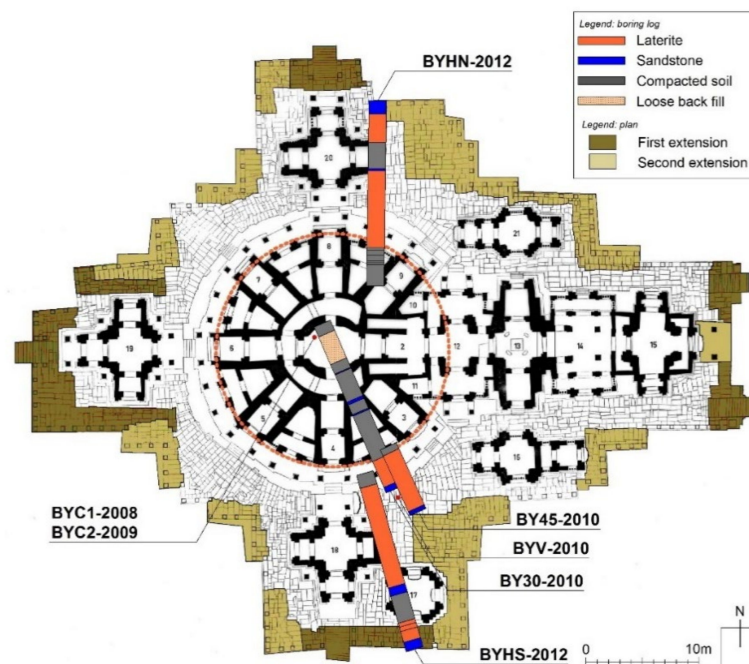
**Figure 12.** Plan of the central terrace with the locations of the boring surveys and boring logs from the diagonal and horizontal borings (extension areas are followed by Cunin’s implication [20] and the plan of the central terrace is based on Dumarçay [8]).
