Characterization of the Stone Masonries and Evaluation of the Environmental Impact in Panamá Viejo: A Contribution for the Conservation of the Monumental Complex

Keywords: building material characterization; environmental impact; deterioration process; weathering; Panamanian heritage; historical monumental complex

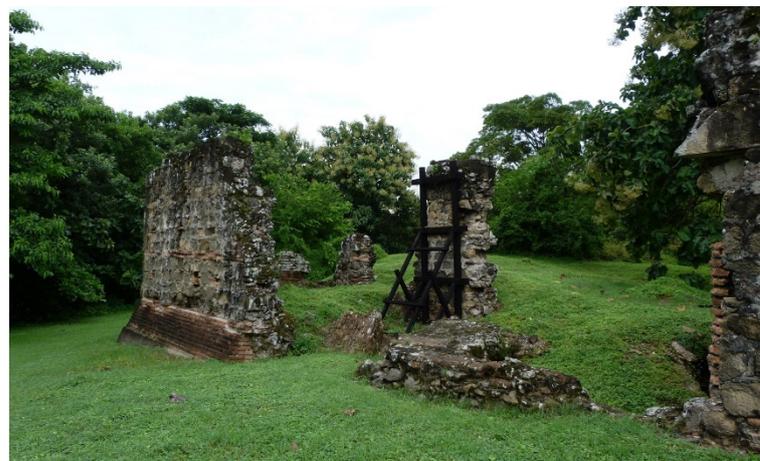
Figure 2. Walls of the Casas Reales Complex. The bottom part still shows the erosion due to the tides “carving” effect.

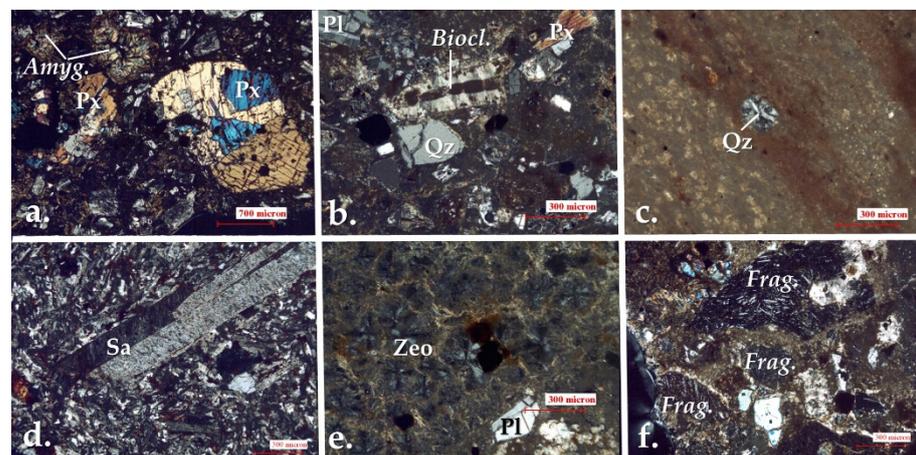
Figure 4. Micrographs of thin sections of samples observed by polarized light microscopy (PLM)-cross-polarized light (xpl): (a) PV FN 5 sample: altered pyroxene cluster, amygdale filled with secondary minerals, in a basaltic andesite; (b) PV FC 7 sample: foraminifera bioclast, quartz, plagioclase and pyroxenes fragments in a polygenic breccia; (c) PV FC 9 sample: a chalcedony filling an amygdale, surrounded by iron oxides in an altered volcanic rock; (d) PV CT 2 sample: sanidine and metal oxides in a rhyolite; (e) PV TC 4 sample: diffused zeolitization in a tuffite; (f) PV CC 4 sample: fragments of basaltic/andesitic lithoclasts in a breccia.

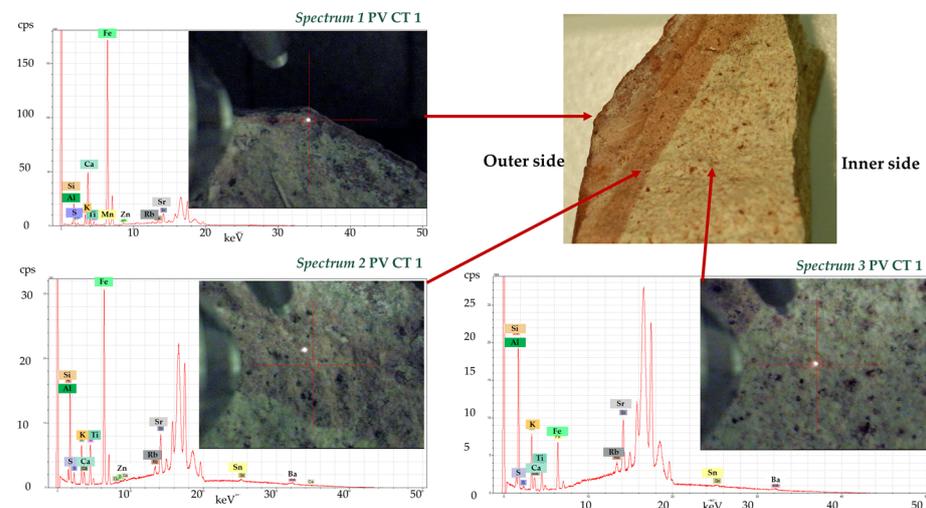
It was observed that this rhyolite was characterized by sanidine alteration and the presence of iron oxides and/or hydroxides. These formations have a reddish hue, which is often observed to be more concentrated in the external part of the specimens. These alterations were also detected in polygenic breccias and in rhyodacites (e.g., Figure 4c). In sample PV CT 1, a rhyolite fragment, different oxidation in the outer part and the inner part was clearly visible to the naked eye. Non-invasive X-ray fluorescence micro-analysis

showed the different intensity of the Fe peak, highlighting higher external oxidation (Figure 7).

Figure 7. Spectra obtained by X-ray fluorescence non-invasive micro-analysis (μ XRF) of the PV CT 1 sample. From the outer side (spectrum 1) to the inner part (spectrum 3).

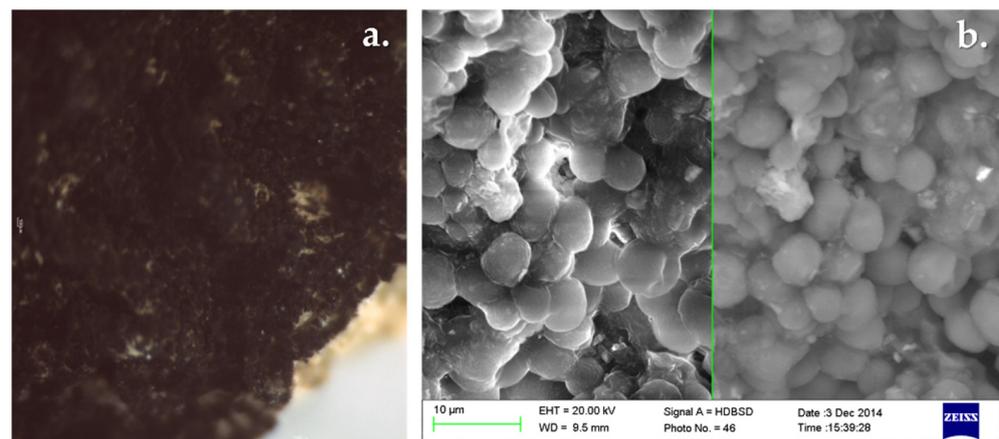
On tuffites and polygenic breccias of the masonries, and in an outcrop of basaltic andesite, black patinas were observed by the naked eye. Then, they were investigated under stereo and scanning electron microscopy, revealing bio-deterioration activity, ascribable to cyanobacteria colonization (Figure 9).

Figure 9. (a) Stereo photomicrograph of PV TC 4 sample, showing a superficial black algal patina; (b) Scanning electron microscopy (ESEM) photomicrographs (left: secondary electrons detector-SE; right: backscattered electrons detector-BSD) of PV TC 4 sample, detail of the superficial black algal patina.

The presence of black algae on these monuments was already observed in the work of Torres Montes [33], where “alga negra”, a cyanobacteria (*Oscillatoria* sp.) [49], was described. The algal presence is facilitated by the bio-receptivity of the substrate, determined by features such as porosity, surface roughness, and hygroscopicity [50]. These characteristics can also indicate a material prone to wettability. Considering the impact on the stone, the “alga negra” does not represent a direct danger for the material, but it can be a substrate for other bio-deteriogens, and it can trap and retain pollutants. Furthermore, it suggests the presence of high moisture.

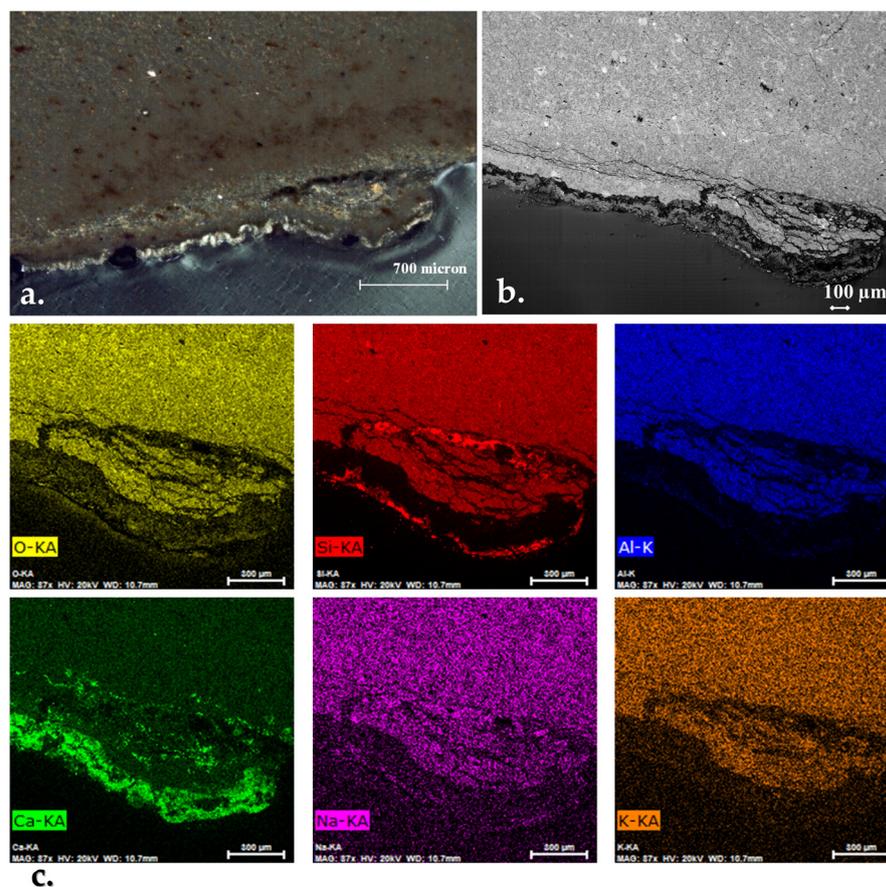
The rhyodacite of the PV SjdD sample, mainly formed by clinoptilolite— $M_{3-6}(Si_{30}Al_6)O_{72} \cdot 20H_2O$, where $M = Ca, K$ or Na [52]—showed a detached part. Along the internal surface, a whitish patina was identified as well (Figure 10). Under polarized light microscopy (PLM), the aspect was irregular, showing decohesion and a different thickness. The mechanical stress due to the reaction process, responsible for the patina formation, is clearly visible by scanning electron microscopy (ESEM) (Figure 10b). In addition, the microchemical investigation, performed by energy dispersive X-ray spectrometry (EDS), identified Ca as the principal element present in the patina, also with the presence of O, suggesting a composition mainly formed by calcium carbonate (Figure 10c). The development of calcite, as a precipitated secondary mineral, was also supported by its identification in the masonry mortars previously studied [13].

Figure 10. Thin section of the PV SJDd sample showing an altered patina: (a) PLM-xpl micrograph; (b) ESEM micrograph; (c) ESEM-energy dispersive X-ray spectrometry (EDS) microchemical compositional maps.
