Forensic Geology Applied to Decipher the Landslide Dam Collapse and Outburst Flood of the Santa Cruz River (12 November 2005), San Juan, Argentina

Abstract: A well-known landslide dam that collapsed and generated a large outburst flood is used to show the importance of forensic geology analysis, which is the on-site multidisciplinary study of geohazards carries out as soon as possible after their occurrence; this study is focused on understanding the complete spectrum of all mechanisms that caused the disaster. Diagnostic elements of all natural processes fade with time, allowing for progressively divergent interpretations that may impact the appropriateness of potential mitigation actions, as we demonstrate. The multidisciplinary field control of the abrupt rupture of a natural dam on the Santa Cruz River on 12 November 2005, that released c. 37 million m³ of water and sediment, can radically change the interpretation of how this dam collapsed. In situ sedimentological, geomorphological and topographical analyses of the remains of the collapsed natural dam suggest it was built in two mass-wasting episodes instead of one, as previously interpreted, involving different slide materi

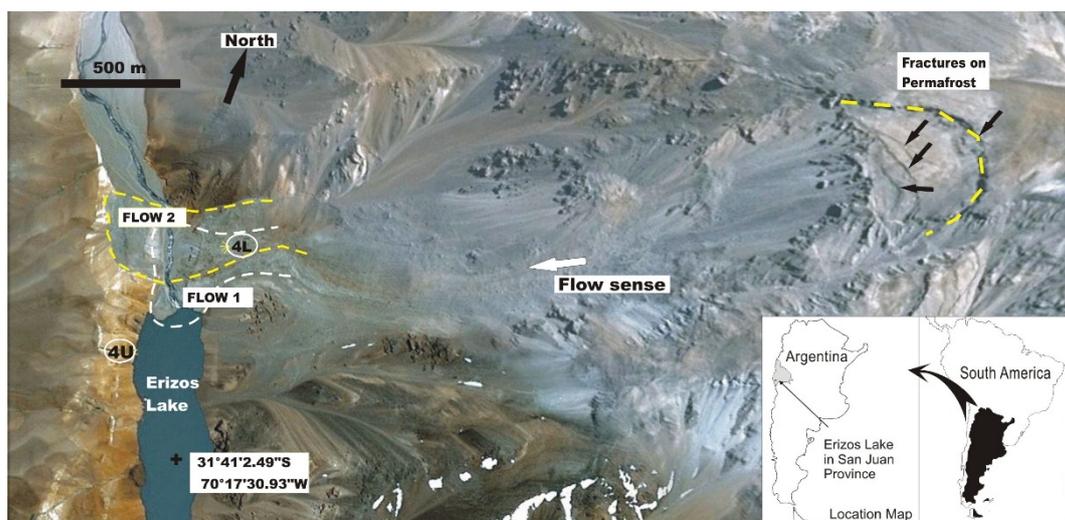
Figure 1. Satellite image of the landslide location, avalanche runway and mixed flows forming the dam complex. It shows the source area with a potential reservoir of permafrost, rock and debris limited by tensional cracks (grey arrows) that define a large block that already descended 35 m. The extent of Flow 1 and 2 deposit remains observed in the field is indicated. The cross marks the point of the coordinates. Viewpoints of ground photomosaics are indicated as 4U and 4L (see below).

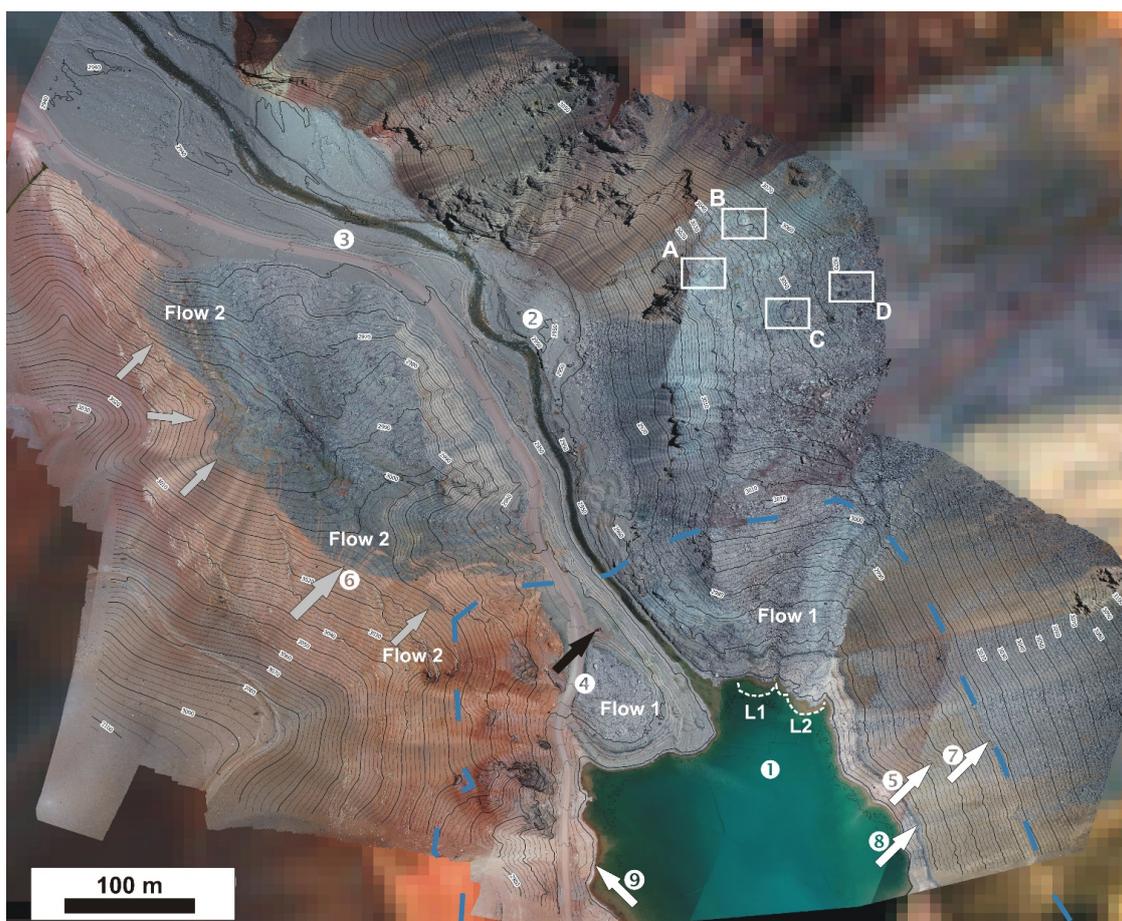
Figure 2. High-resolution topographic survey (6.94 cm GSD) processed with Pix4D to analyse the altimetric relationships of different elements related to the natural dam collapse. (A–D) Rectangles indicating higher resolution captions details of permafrost boulders relicts (see below) White arrows indicate the position of the highest intermediate and the water level mark developed over 15 years after the flood draining event. The additional 8 m-level drop is due to road-building actions. Black arrow points to a known reference (truck is 5.5 m long). Grey arrows indicate different lobes of Flow 2, the largest one shows the highest topographic reach of Flow 2 deposits. L1 and L2 are Flow 1 lobes that clearly extend into the lake depth. The photomosaic made by 340 drone images is draped over the image showing the largest attained area of the Erizos Lake, marked by the hatched blue line. Encircled numbers identify the positions of features mentioned in Table 1.

Since the closure point was 3009 m.a.s.l., and the maximum lake level was 3007 m.a.s.l., the dam could not have been overtopped unless the dam height decreased along the valley centre line. Dam compaction is unlikely due to the scarce matrix and boulder-like nature of the deposit; although, permafrost block melting or snow melting would be possible. However, overtopping would have created initial sediment-laden flows, generating a high-sloping fan downslope of the dam. Subsequent backward erosion, lowering the dam height, would create successive incised accumulation terraces, with progressively shallower slopes with lower altitude, when projected towards the dam crest. This was not the case, as the first flood terraces were only 2–3 m higher than the final river course and there is no evidence of the hypothetical overtopping. The first depositional terrace occurred at c. 2950 m.a.s.l. and expanded all the valley width after the exit of the incised canyon, covering passively the more distal deposits of Flow 2.

Even if it was a sudden rupture, the exact process of collapse is a matter of debate, since there is no information about the last stages of the dam/lake complex evolution. Due to the stabilised water level at 3007 m.a.s.l. (Figure 2), a long-lasting, steady-state lake charge and discharge is suggested. Both Flow 1 and Flow 2 were superimposed over pre-existing debris dams that were incised before 2005 and formed a canyon elaborated over these colluvial deposits (Figures 2 and 9). Therefore, it is highly likely that the material underlying the 2005 dam was quite porous and allowed a significant amount of water to pass through it. This possibility is consistent with the fact that the lake’s maximum level never reached the spill point at 3009 m, but seems to have been stable at 2–3 m below the spill point of Flow 2, according to the 3D-UAV model (Figure 2). Given this

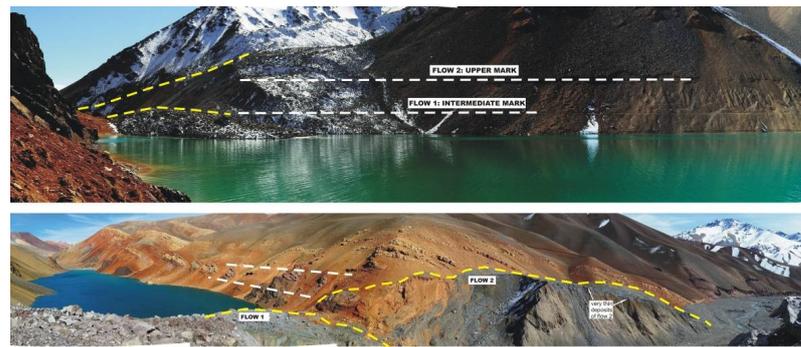
Figure 4. Two ground-acquired photomosaics showing the dissected dam and the interpreted flows from different perspectives. Viewpoints are indicated as 4U for the upper photomosaic and 4L for the lower one in Figure 1. Both mosaics show the two most important water level marks (white dashed lines) and the top of the two different flow deposits (yellow dashed lines). Upper mosaic: Shows the match between major lake-level water marks and the two deposits recognized in the field survey. Compare this mosaic with Figure 2. Lower mosaic: Taken from the avalanche couloir to the distal end of the flows. Arrows point to the opposite wall of the pre-existing canyon wall, reworked by the 2005 flood. Erosive cut shows older mass-wasting deposits, covered by local derived talus sediments (reddish) and only very thin remains of the Flow 2 deposit at the canyon wall shoulder (arrows).

As mentioned above, the deposits corresponding to Flow 1 underwent the elutriation of the finer-grained fraction in the up-valley side, suggesting some wave action along the ascending lake shore. This was not observed in the top of the remaining deposit that was dissected by the evacuating flood forming a wide channel, with c. 10 m-deep scouring of the Flow 1 top. Along this evacuating channel, several inclined surfaces can be reconstructed (Figures 4 and 7), suggesting a progressive incision along with immediate deposition at the canyon exit. Flow 1 top coincides roughly with the most significant intermediate lake level mark on the valley sides (Figures 4 and 5). Parts of the Flow 1 deposit slid downslope a few meters following the lake draining events, as suggested by concave slip surfaces along the upstream sector of the dam (Figure 4).

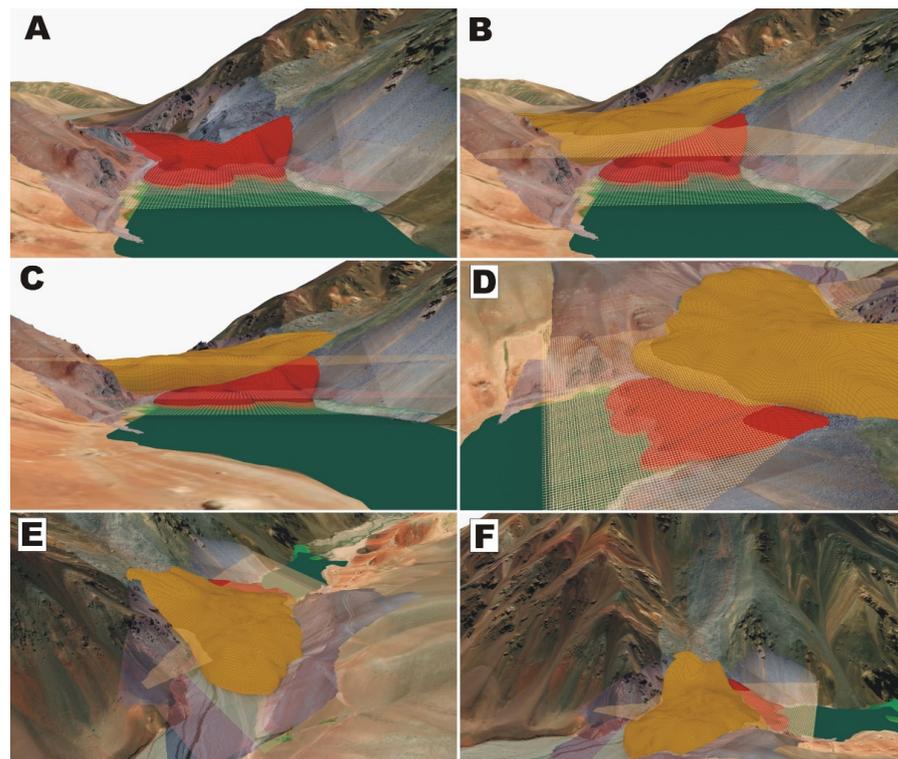
Figure 5. Virtual 3D recreation of the dam complex and the 3 important lake levels defined by the horizontal grids: maximum—3007; intermediate—2972; after the flood—2972; lake level now—2949 m.a.s.l. It was recreated using the Flow 1 and 2 deposits extent based on the field survey of their boundaries and the potential depositional slope for similar types of deposits. (A) Interpreted Flow 1 deposit (red) and observed intermediate lake level (upper grid), showing a good match. (B) Interpreted Flow 2 deposit (yellow) overlying Flow 1 deposit and observed upper lake level mark (uppermost grid). (C) Same as (B), viewpoint slightly below upper lake level showing that lake level would never attain the dam spill point. (D) Same as (B), viewpoint at the left side of avalanche channel. (E) Same as (B), viewpoint from downstream of the natural dam. (F) Same as (B), viewpoint from the opposite side of avalanche channel.

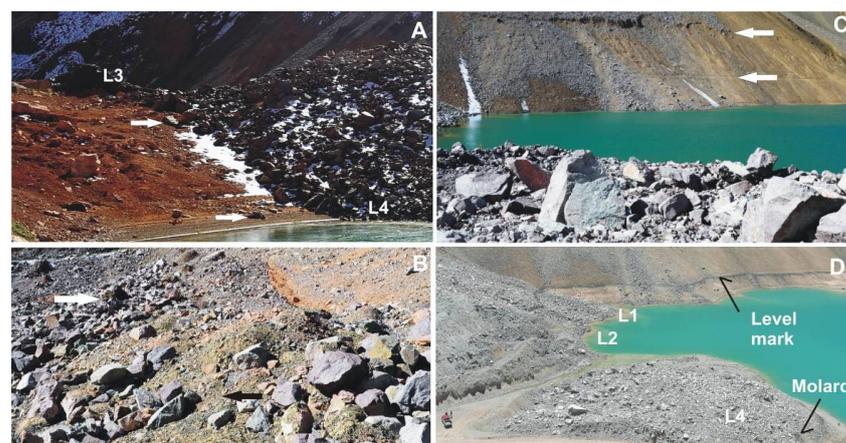
(c) Source: in addition to the angular rock fragments of all sizes up to a maximum of three meters in diameter, some molards were recognized (Figure 7), which imply a minor contribution from ice-cemented permafrost [20,21]. In some cases, these ice-cemented blocks were formed almost directly with the fragmented rocky substrate, so their disintegration did not generate the typical conical molards but were observed as groups of disaggregated rocks that protrude from the deposit.

Figure 7. Details of Flow 1 deposit. (A) Distal-preserved front of Flow 1 showing two lobes (L3 and L4) with their frontal slopes and a few outrunners (white arrows). (B) A view of the texture of the deposit showing patches of matrix-rich debris (black arrow), while in other sectors it is almost absent (white arrow). (C) Outlook of the chaotic rocky deposit on top of L3. Largest boulder in the foreground is 1.5 m diameter. (D) Present day drained lake and altered dam showing part of the road and lobes (L1 and L2), also shown in Figure 2. Note the remaining molard and the preserved water level mark created after 16 years of stable lake level.

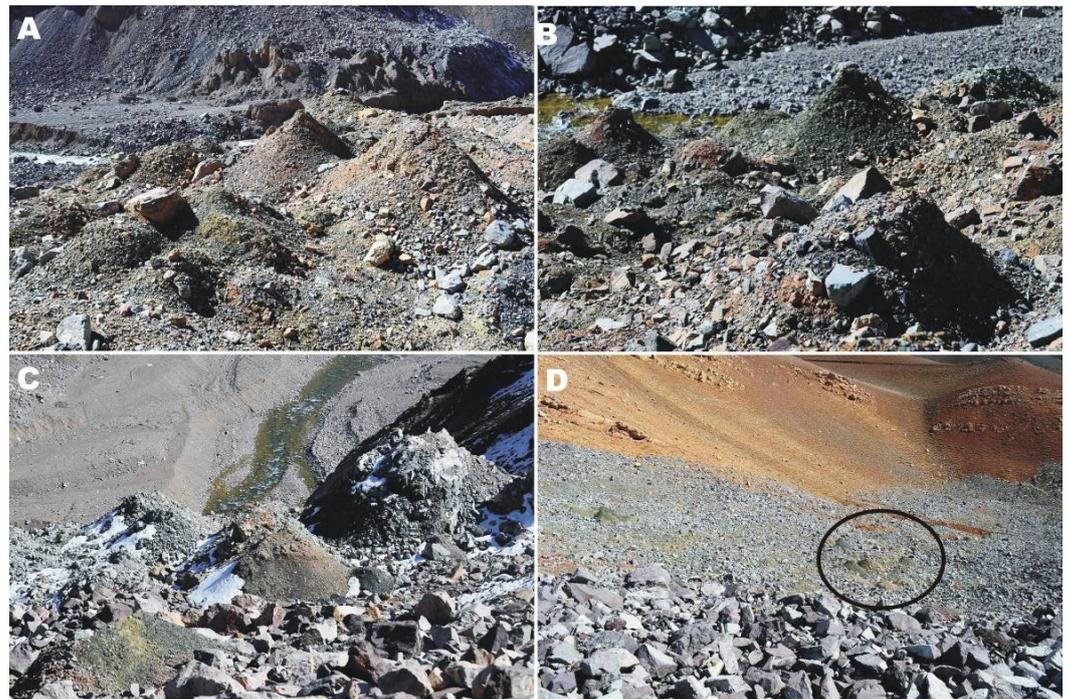
The flow marks observed along the avalanche channel in coincidence with the lower deposits, and the presence of molards all along the runway of Flow 2 (Figure 8), indicate it was sourced partially from permafrost. This flow seems to have originated in the area of extensional fractures that occurs near the upper limit of the source area, at 4400 m.a.s.l. (Figure 1). There is a slightly different colouration of this deposit that extends through the avalanche channel until its top, which allows differentiation of this flow path from that of Flow 1. The area of initiation of Flow 2 is thus 300 m above the minimum height of permanent freezing. It is likely that the freeze–thaw regime may have played an important role in opening or holding open the observed tensile fractures in the source area (Figure 1), and thus on initiating or adding mass to landslides moving down this avalanche channel. Presently, there is a sector at the source area (initial part of the avalanche channel) that has subsided c. 35 m and tensile semi-circular fractures are bounding it. We estimate that about 9,800,000 m³ of rock, debris and permafrost is enclosed in this potential landslide reservoir. Penna et al. [13] made calculations of potential future failures at this upper scar finding comparable volumes. The listric cracks that may allow a new failure are easily seen in most satellite images. Thus, it is a matter of time and the degree of permafrost degradation until the next large landslide at this locality is triggered.

Figure 8. Molards (debris cones) produced by the melting of the ice-cement boulders in the dam. (A,B) Molards developed within the evacuating channel, from lagged ice-cemented boulders left by the outburst flood. (C) Molards located within the avalanche channel (see details below). (D) Molards present over the deflated and thin Flow 2 deposit, that drape the bedrock at the opposite valley margin (distal end).

In the primary river course, the maximum size reaches c. two meters (Figure 8), while in the proximal parts (before the canyon proximal wall), the largest molards suggested permafrost boulders of up to six meters in diameter (Figure 10). Moreover, we observed a few rock fragments of up to four meters. This deposit does not present a matrix of any kind, except in the places where molards are observed, as they supplied finer-grained fragments when degraded. The outstanding rock fragments tend to be more angular and larger than those from Flow 1, suggesting a lower effect of clast interactions and abrasion during transport for Flow 2.

In case of the Erizos Flow 2, the presence of many permafrost blocks or frozen active layer fragments, evidenced by the numerous molards (Figures 8 and 10), indicate that the collapse of a large slab of frozen ground initiated the snow avalanche. Slope instability due to permafrost degradation was investigated by various authors [14,41,46–48]. Perhaps the additional load of the snowpack on the soil fostered the collapse, as 2005 was the year with the highest snow precipitation within the last 20 years, as shown by our revision of MODIS/Terra imagery for this area. All evidence indicates that Flow 2 was initiated as a minor landslide and involved a thick snow mantle on the way. Landslides on snowpacks show remarkably large travel distances with low turbulence in the displaced mass, high velocities and momentums and collect snow on their runway, while a small percentage of the total snow content melts due to friction heat [49–51]. Snow content increases volume, water content increases entrainment of material from the path of the landslide and snow lowers the basal friction [52]. Schneider [51] investigated the "frictional behavior of granular gravel-ice mixtures" in a laboratory and observed that the bulk friction coefficient linearly decreases with ice content, and that the transformation from a dry granular flow to a debris-flow-like movement occurs when the ice content exceeded 40% by volume. This explains why Flow 2 built lobes in a fashion similar to a debris flow.

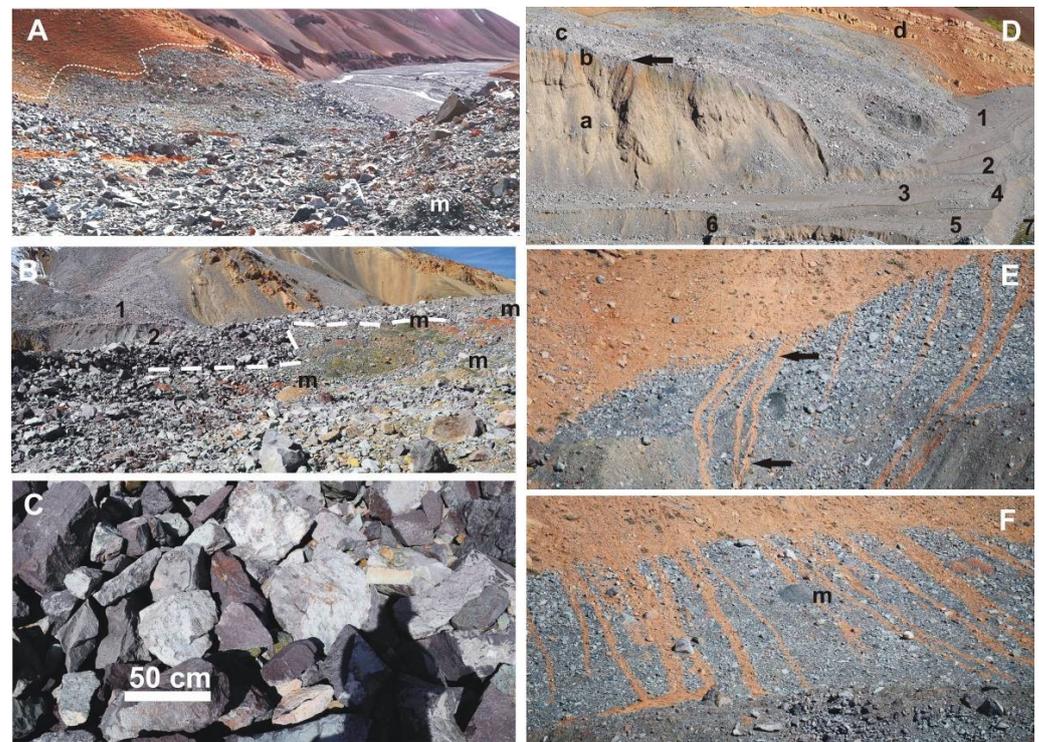
(Figure 9D). Over this shoulder, remains of Flow 2 are present up to 3009 m.a.s.l. over the valley margin. These remains do not show any indication of post-depositional flow over its top.

Figure 9. Details of Flow 2 deposit. (A) Lobate boundary of Flow 2 at its more distal reach. Note the sheet-like shape and sparse molards (m). (B) Minor changes on the thickness of Flow 2 (hatched line) suggest the existence of internal lobes. It also shows the irregular distribution of molards (m) across the deposit. Numbers 1 and 2 point to the shoulders of the pre-existing incised canyon that Flow 2 would have completely filled up. (C) A view of the lack of fines and lack of effect of abrasion on boulders of Flow 2 deposit. Scale bar is 50 cm. (D) A view of one of the canyon walls (marked 1 in (B)), showing it was excavated over previous mass-wasting deposits (a) partially covered by reddish scree (b), derived from the sedimentary Mesozoic units (d), and topped by the thin deposit ascribed to Flow 2 (c). Note also the depositional terraces formed by the outburst flow, numbered 1–6, with 7 being the 2012 river level. (E,F) Views of the distal end of Flow 2 deposit where it is abnormally thin, as shallow rilling exposed the underlying Mesozoic red beds.

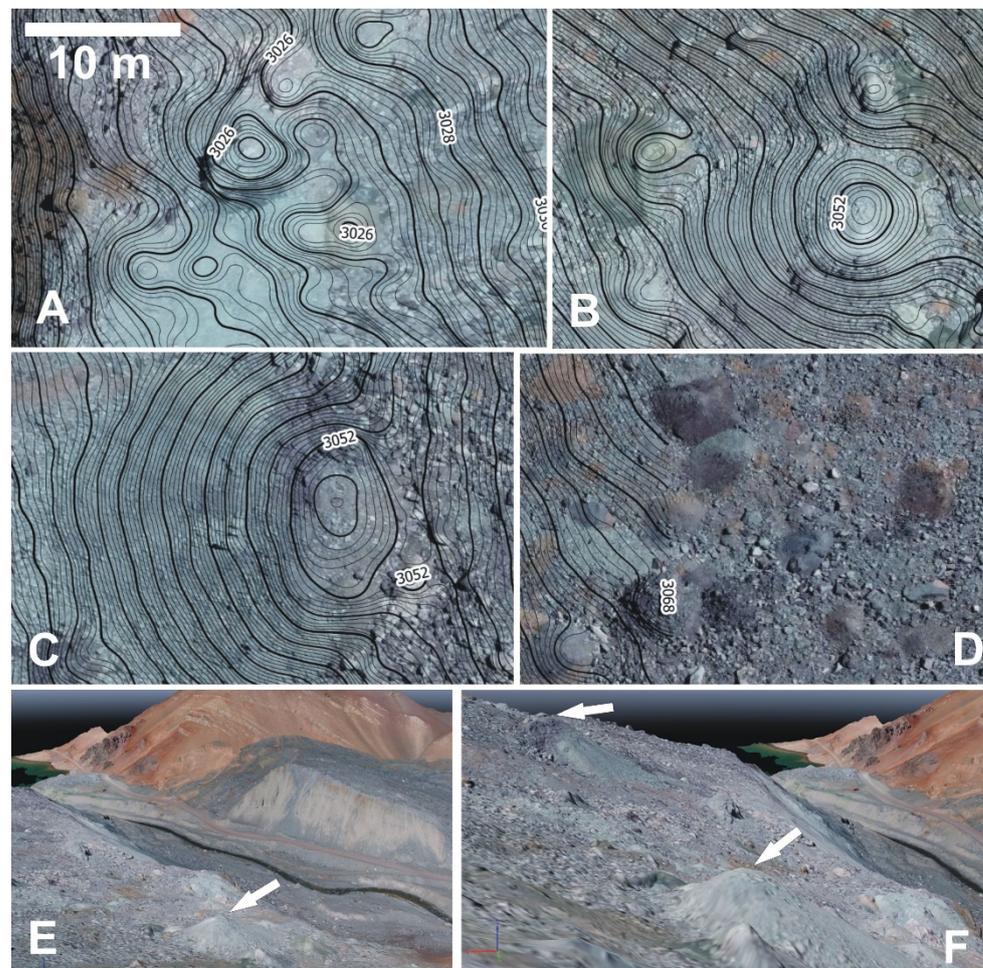
Figure 10. Detailed topography showing the 3D expression of molards. Location of (A–D) are shown in Figure 2. Main contours every 1 m, smaller every 20 cm. (A) Shows a rocky molard (centre of caption) that did not completely degrade into a cone. Note the slope change at the edge of the canyon and the easy identification of molards when they do not show chromatic contrast, as in (D). (B,C) Two of the largest molards that created colluvial microtalus aprons c. 10 m high downslope, and only 2 m up the general slope. (D) Caption at the limit of the survey showing a wide range of colours denoting a mixed composition of molards. (E,F) Virtual recreation of molards using the DEM and the surveyed photomosaic.

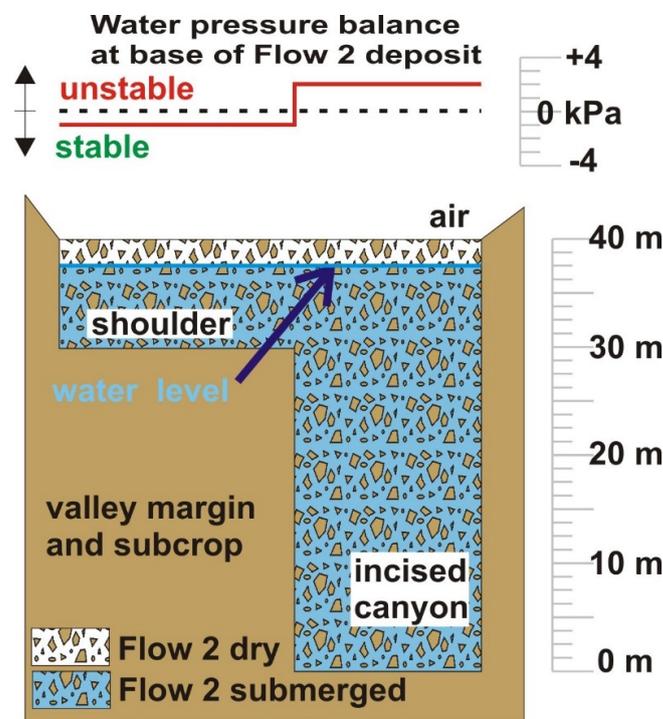
potential steady-state situation, the dam should not be broken unless a dynamic process was happening at the same time in the dam. We interpret that the summer ablation created the instability reducing the weight of the dam, until the weight of the dam equilibrated with the hydrostatic pressure of the water, floating a part of it. Only the central strip of the dam, coinciding with the trace of the pre-existent canyon, collapsed. Thus, it is possible that it was the dam ablation process that caused the imbalance, as illustrated by Figure 11.

Given the uneven lower topography, we can interpret that the thicker segments of Flow 2 would be more unstable as it had deeper portions submerged. A simplified scheme of the situation of an icy dam filling a deep pre-existing canyon and spreading over elevated shoulders is shown by Figure 11. Pressure on an object submerged in a fluid is $p = \rho \times g \times h$, where ρ is the density of the fluid, g is gravity acceleration and h is the height of the fluid above the object. We used the arbitrary density of 0.9 g/cm^3 for the Flow 2 deposit, based on the estimated 10% of debris, whose density is c. 2 g/cm^3 mixed with compressed firn of 0.8 g/cm^3 . This simplified geometrical array of the reality portrayed in Figure 2 shows that the pressure at the base of the deposit sealing the canyon is higher, making it the logical avenue for floating that section of the dam. Considering a 30 m-deep canyon, and that the Flow 2 deposit is 10 m thick over the shoulder, with a water level 2 m below the top of Flow 2, we can see that the water pressure at the base of deposits located over the shoulder is negative. The pressure exerted by the deposit is 88.3 kPa, and the water is 78.5 kPa at the base of Flow 2, making that scenario stable. However, the same calculation at the base of Flow 2 within the canyon, with a hypothetical 40 m-thick deposit and 38 m of water column, gives 372.8 kPa for water and 353 kPa for the deposit. In this situation, only the dam section along the canyon would be floated some time before, when the water reached the 36 m point, that equalized the pressures. The water level would need to reach 39 m to remove the dam lying over the shoulder, explaining why the laterals were untouched by the evacuating flood.

Figure 11. A simplified scenario to portray the uneven distribution of hydrostatic pressure along the base of Flow 2 deposits, due to the pre-existence of the incised canyon. The pressure balance between the dam and water is shown by the upper curve (arbitrary density for the snow avalanche dam of 0.9 g/cm^3 was used), showing that the dam over the shoulder is stable, while along the incised canyon the situation is inverse, that dam section would have been floated before reaching the portrayed scenario.
