Seismic Hazard Implications of the 2025 Balıkesir Earthquake of M_w 6.1 for Western Türkiye

Keywords: Balıkesir earthquake; seismic hazard; ground motion; Türkiye; structural damage; site effects; TBEC-2018

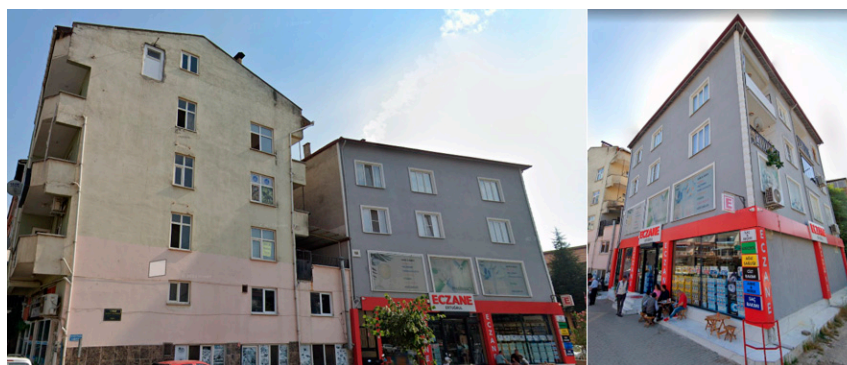
**Figure 9.** Pre-earthquake images of the RC structure that totally collapsed.

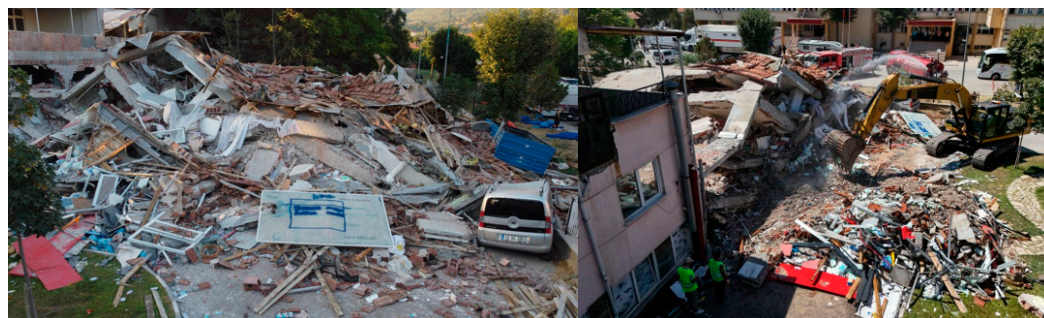
Post-earthquake images of the building are shown in Figure 10. The images show the severe collapse of a reinforced concrete (RC) building following the Balıkesir earthquake.

Figure 10. Post-earthquake images of the RC structure that totally collapsed.

This building, which suffered a total collapse, was constructed before 2000 and had a four-story reinforced concrete structural system. The first two floors of the building were used for commercial purposes, while the upper floors are residential. This, in particular, led to the variation in the amount of infill walls used between floors. It can be said that the building had soft story situation, relatively. The building suffered a total collapse due to a side collapse (accordion). The primary cause of this type of collapse is the occurrence of plastic hinge formation in columns before beams, i.e., the strong beam-weak column approach. However, earthquake regulations require columns to be stronger than beams [56,59]. Furthermore, factors such as lack of transverse reinforcement, low-strength concrete, and poor workmanship played critical roles in this type of collapse. Structures subjected to this type of collapse lack the reinforcement detailing and concrete material quality necessary to ensure ductile behavior, and lack proper shear wall positioning to ensure rigidity. Consequently, they experience excessive horizontal displacements and collapse before completing Mode-1 motion [62]. The combination of negative factors that directly reduce earthquake performance made damage and destruction much easier.

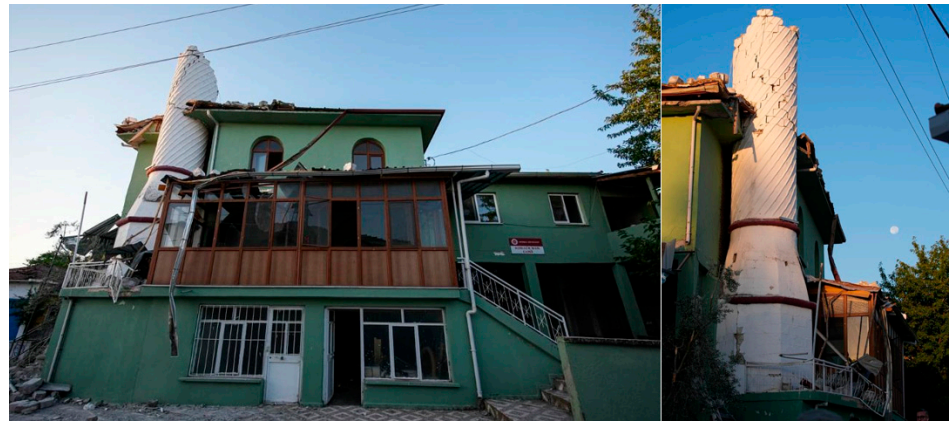
Figure 11. Front and side views of a minaret after the Balıkesir earthquake, showing damage to the minaret and partial collapse of the mosque.

In addition, the observed failure of cultural heritage masonry structures, such as mosque minarets, highlights the urgent need for tailored retrofitting strategies that respect architectural heritage while enhancing seismic resilience. Lessons drawn from recent destructive earthquakes in Türkiye and comparable Mediterranean regions underline that seismic hazard is not merely a matter of ground motion intensity but is strongly conditioned by construction practices and maintenance culture.

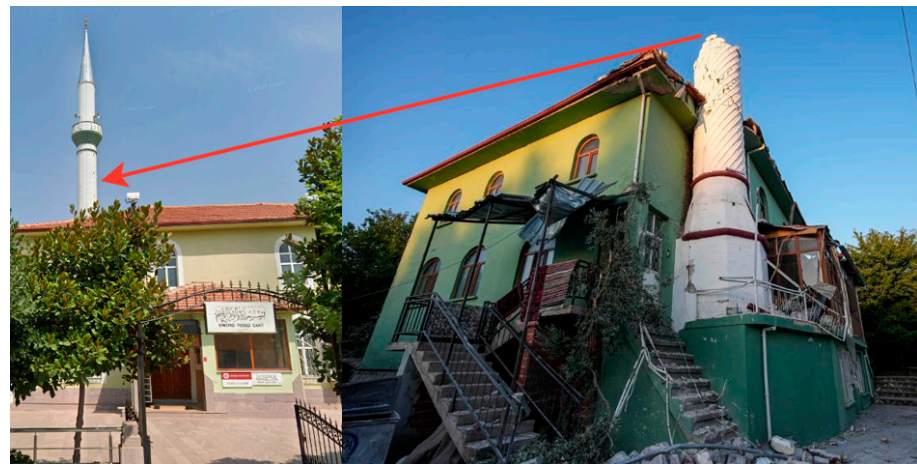
Figure 12. Pre and post-earthquake images of the minaret.

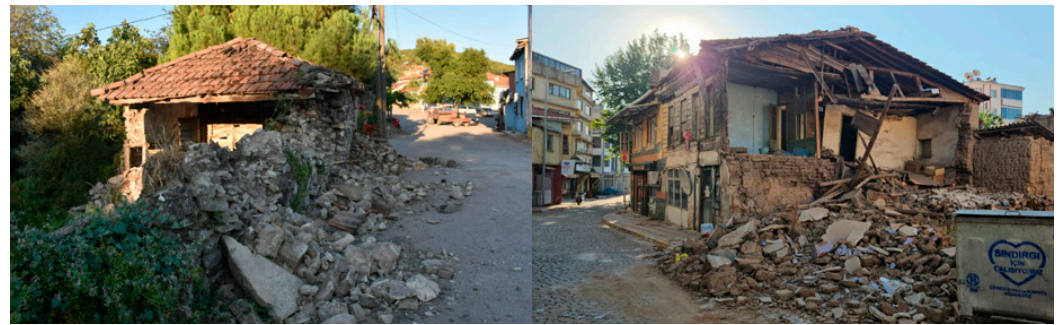
Out-of-plane behavior of structural walls in masonry structures typically occurs when a wall moves out of its own plane under horizontal forces such as earthquake loads, wind forces, or ground settlement. This situation poses a serious threat to the integrity of the structure. During an earthquake, weak or flexible floor systems, particularly those that cannot provide a rigid diaphragm effect, and walls not connected by adequate clamping and anchoring, reduce out-of-plane stability. Furthermore, excessive wall height-to-thickness ra-

tios, low material strength, weakening of mortar bonds over time, and the lack of adequate tie beams at the edges of openings can trigger such movements. Out-of-plane behavior can result in sudden wall collapse, crack propagation, joint failure, and partial or complete collapse of the entire structure. Therefore, clamping, horizontal bond beams, and rigid floor connections that enhance the integrated behavior between structural elements are critical for preventing out-of-plane movement in masonry structures [69–77]. Examples of out-of-plane wall damage are shown in Figure 13. While both buildings in the example are used as residential, one is 1-storey and the other is 2-storey.

Figure 13. Out-of-plane wall damage samples.

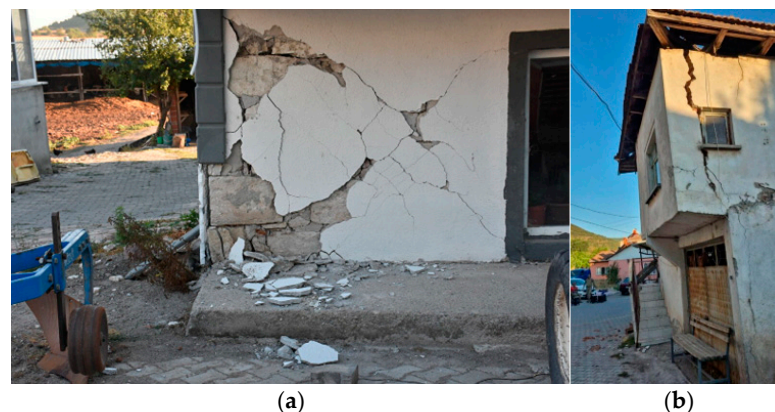
Examples of cracks and delamination damage occurring in the heavy overhang section of wall cladding in the structures are shown in Figure 14.

Figure 14. (a) Wall cover damage; (b) heavy overhang damage.
