Morphological Characteristics of Catalyst Layer Defects in Catalyst-Coated Membranes in PEM Fuel Cells

Abstract: Catalyst layer defects and irregularities in catalyst-coated membrane (CCM) electrodes affect the lifetime of polymer electrolyte membrane fuel cells (PEMFCs) during their operation. Thus, catalyst layer defects are important concerns for fuel cell manufacturers and prompt the development of quality control systems with the aim of fabricating defect-free electrodes. Consequently, the objective of this study is to gain a fundamental understanding of the morphological changes of real catalyst layer defects that have developed during CCM production. In this paper, missing catalyst layer defects (MCLD) formed during the decal transfer process are investigated through a nondestructive method using reflected light microscopy. The geometric features of the defects are quantified, and their growth is measured at regular time intervals from beginning-of-life (BOL) to end-of-life (EOL) until the OCV has dropped by 20% of its initial value as per a DOE-designed protocol. Overall, two types of degradation are observed: surface degradation caused by catalyst erosion and crack degrad

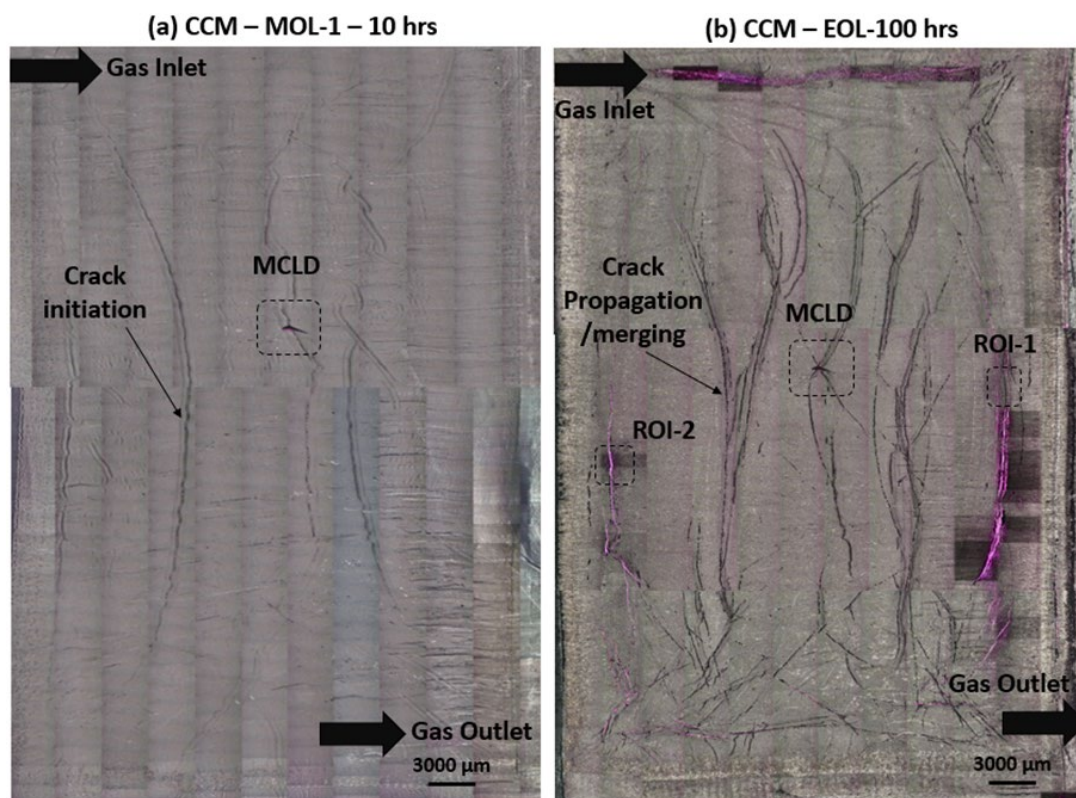
Figure 3. (a) Stitched optical microscopic image of CCL of defective CCM with MCLD captured after (a) 10 h (MOL-1) and (b) 100 h of OCV-AST (EOL). Locations ROI-1 and ROI-2 are specifically selected to investigate the delamination of CL.

Crack growth and propagation were observed in this study to occur during three stages: crack initiation at MOL-1 (10 h), crack propagation at MOL-2 (50 h), and crack propagation/merging/delamination at EOL (100 h). As shown in Figure 3a, the number of cracks observed at MOL-1 was relatively modest. The stitched microscopic image of the aged CCM after 100 h of OCV-AST shown in Figure 3b revealed that many new cracks had formed and that they had propagated significantly by the time EOL was reached. Two regions in the EOL sample denoted as ROI-1 and ROI-2 had been specifically selected for closer examination of the damage to the catalyst layers. ROI-1 corresponded to an area where cracks had severely propagated in the catalyst layer. ROI-2 was an area where delamination had occurred as a result of crack propagation caused by membrane swelling.

The depth of the catalyst layer defect in ROI-2 had been determined using Z-profile and 3D imaging. This analysis showed that the catalyst layer in these areas had not been completely removed and that the delaminated or detached material amounted to ~50–70% of the original thickness over an average width of ~50 μm –150 μm , leaving behind thin portions of the catalyst attached to the electrolyte membrane. Furthermore, large catalyst layer pores with an average diameter of ~25 μm were observed in the leftover thin catalyst layers. Further examination of this type of delamination in CCMs and an image of the pores present in the remaining CL after delamination are presented in Section 3.3.2.

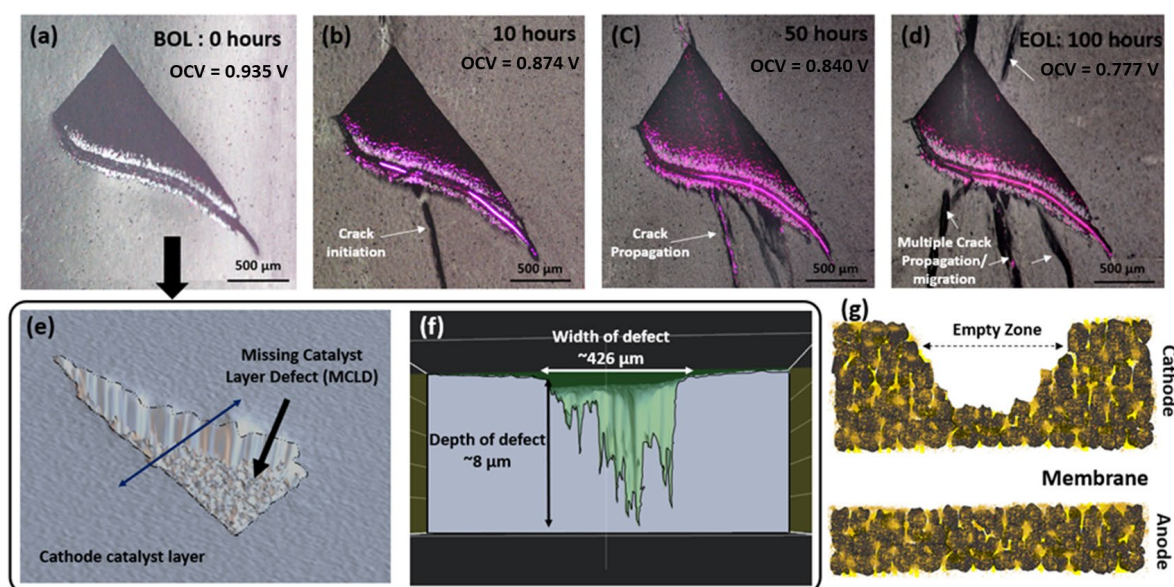
Figure 4 shows an overview of the morphological changes of an MCLD (dark triangular area) originally formed due to improper decal transfer. The MCLD here was the same as the one shown in Figure 3, except that the details of its structure were now clearly visible due to the much higher resolution of the image. The detailed geometric growth of the MCLD during OCV-AST analysis is shown in Figure 4a–d at BOL (0 h), MOL-1 (10 h), MOL-2 (50 h), and EOL (100 h). During the initial investigation of the unused defective CCM at BOL, the entire MCLD was found to cover a geometric area of 757,016 μm^2 . It should be noted that some catalyst still remained over most of the MCLD surface at the outset. As the sample aged, the propagation of defects at the corners of the MCLD appeared to proceed by the development of sharp cracks and degraded areas at its edges. A study by Pestrak et al. showed that the deformation of the electrolyte membrane had a strong influence on the structural changes of the catalyst layers in CCMs [32]. The results observed in our study supported the idea that the deformation of the membrane had a direct influence on the crack formation and areal growth of the catalyst layer defect from MOL to EOL. The image analysis shows that the total defect area (dark triangular area) increased by 5.4% between BOL and MOL-1, 11.25% between MOL-1 and MOL-2, and 1.6% between MOL-2 and EOL. For a better view of the defect cross section, a 3-D diagram of the MCLD is depicted in Figure 4e, while a cross sectional view showing the depth of the defect as one moves along the blue line indicated in Figure 4e is presented in Figure 4f. The width of the defect is measured to be ~426 μm across the blue line. Note that the depth of the defect is not uniform presumably due to the nonuniform removal of the catalyst during the decal transfer step. Figure 4g presents a schematic image of a cross section of the MCLD to provide a better view of the defect in the CCL.

Figure 4. Images of defect growth in an MCLD in a defective CCM-1 (a) BOL at 0 h, (b) MOL-1 after 10 h OCV-AST, (c) MOL-2 after 50 h OCV-AST, (d) EOL after 100 h OCV-AST, (e) 3D graphical view

of MCLD with active area of $757016 \mu\text{m}^2$ on CCL, (f) cross-sectional view of MCLD showing dimensions of depth, and (g) schematic view of MCLD in CCL across the CCM-1.

Two changes were observed in the first image analysis carried out at MOL-1. First, as shown by comparing Figure 4a,b, crack initiation occurred in the catalyst layer, most likely due to the deformation of the membrane. Second, a significant amount of catalyst had been lost inside the MCLD, as reflected in the significant increase in the pink area in Figure 4b relative to that in Figure 4a. The loss of catalyst particles in the local defect sites stemming from catalyst erosion would significantly facilitate gas crossover of H₂ from the negative side to the positive side of the cell, which was one possible cause of the voltage loss at MOL-1.

A comparison of the dark triangular area in Figure 4b with that in Figure 4a shows that the MCLD grows by 5.9% with an aspect ratio of 4.4 over the first 10 h. The cumulative total areal growth of the MCLD (black curve) and the total catalyst loss inside the MCLD (pink area) with respect to time are shown in Figure 5b. Furthermore, the total pink area inside the MCLD increased by more than 2000%, indicating extensive catalyst degradation within the defect.

The effect of catalyst erosion was observed mainly inside the MCLD between BOL and MOL-1 (Figure 4a–d), as determined from the quantitative analysis of the growth of its area (total pink area) over time (Figure 5b). The area of the MCLD increased by ~2000% from its initial value by the time that MOL-1 was reached, but only by 2.7% more between MOL-1 and MOL-2 and 0.8% between MOL-2 and EOL. This trend showed that the weakly bonded catalyst particles at defective sites eroded rapidly in the early stages of operation before quickly stabilizing. This observation suggested that the particles inside the defective area may not be completely impregnated with the catalyst since they did not undergo uniform thermal compression during hot pressing. This causes poor bond strength between adjacent catalyst particles and intact sulphonic acid groups (ionomers) that enabled gradual detachment of the catalyst during cell operation. A complete overview of the degraded area of MCLD is clearly seen in Figure 6b captured under transmitted light mode. The intensity of the light increased across thin areas where the catalyst was lost and the pink area inside the MCLD slowly grew. However, our investigation of various defective CCMs showed this same type of catalyst loss was not exhibited in all the MCLD areas and that this phenomenon depended on defect dimensions, thickness, and location. Although the structural changes at BOL were difficult to estimate, they ultimately affected the integrity of the catalyst layer in the CCM electrode.

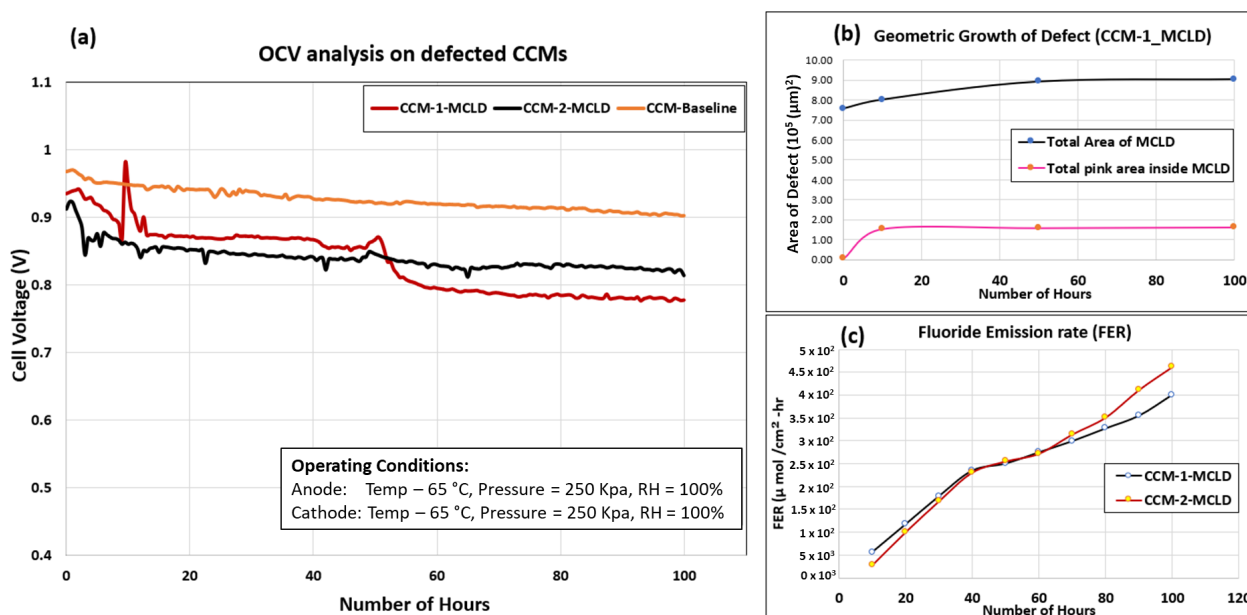
Figure 5. (a) OCV measurement of defective and nondefective CCMs, (b) areal growth of MCLD, and (c) fluoride emission rate (FER) at the cathode over the course of 100 h OCV-AST (Figure 4a–d).

A primary focus of this study was to investigate the relation between the evolution of the MCLD and its loss in OCV as the CCM ages. As shown in Figure 5a (red line), CCM-1-MCLD experienced a noticeable voltage degradation of 7.4% over the first 10 h of operation as its voltage decreased from 935 mV to 865 mV. A particularly noticeable voltage drop of 36 mV from 901 mV to 865 mV between the 9th and 10th hours of OCV was observed. To determine if this loss in performance was reflected in a change in the MCLD, we carried out an image analysis of the CCM after the 10th hour (i.e., MOL-1). Further image analysis was performed on the aged CCM after 50 h (MOL-2) and 100 h (EOL) when the OCV was observed to drop by 10.1% and 17.8%, respectively, with respect to its initial voltage.

Over the interval between MOL-1 and MOL-2, the OCV diminished at a rate of 0.85 mV/h from 874 mV to 840 mV. However, minimal growth of the MCLD was observed over this period. Most of the CCM damage appeared to involve the propagation of cracks in the catalyst layer (compare Figure 4b,c). At this stage, the MCLD area (dark triangular area) shown in Figure 4c increased by 11.3%, relative to that measured at MOL-1 with an aspect ratio of 4.11, whereas the growth of the pink area increased by only 2.7% with respect to MOL-1 (Figure 5b). Overall, the catalyst loss in the defect appears to have stabilized between MOL-1 and MOL-2.

Over the last interval from MOL-2 to EOL after 100 h of testing, the OCV dropped from 864 mV to 777 mV corresponding to a degradation rate of 1.74 mV/h. During this period, previously initiated cracks propagated significantly, and new cracks formed on the catalyst layer surface. Figure 3b showed the overview of the damaged catalyst surface with severe cracks at the inlet, center, and outlet locations. According to Figure 4d, no significant change to the MCLD area (dark triangular area) was observed. The pink area within the MCLD increased by only 0.8%, with respect to MOL-2. Numerous new cracks formed, while some merged in the area near the MCLD due to the deformation of the membrane. To conclude, the MCLD was found to grow rapidly during MOL-1, most likely due to chemical degradation that led to catalyst erosion inside the defect (as reflected by the significant growth of the pink area during MOL-1) before the degradation stabilized over the remaining period until the EOL (Figure 5b). It is interesting to observe that the differences in the OCV responses for the defect-free and defective samples followed a similar trend. As evident in Figure 5b, the largest difference in the responses was during the first few hours of the OCV-AST when the presence of the MCLD led to a significant decrease in the OCV. Thereafter, the decline of the OCV followed a similar trajectory in the case of the defect-free and defective CCMs. The largest drop in the OCV coincided with the period when the MCLD was growing most rapidly. Based on these experiments,

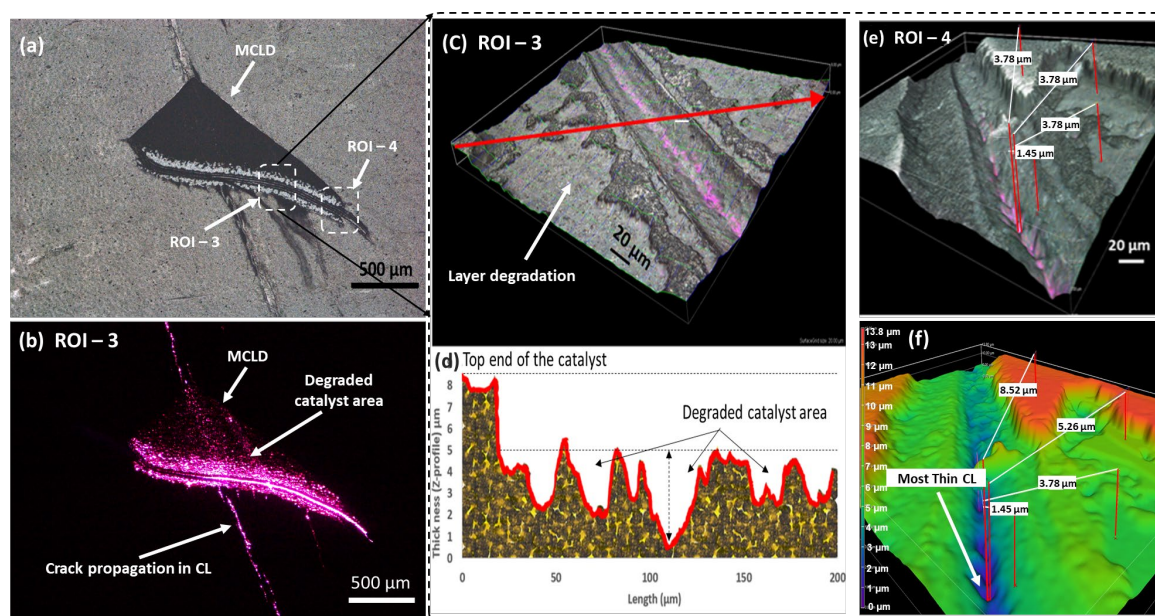
Figure 6. (a) Reflected microscope image of MCLD at MOL-2 indicating selected regions ROI-3 and ROI-4; (b) transmitted light microscope image of MCLD with pink area indicating degraded catalyst

due to chemical degradation during fuel cell operation; (c,e) are 3D microscopic visualizations of enlarged regions ROI-3 and ROI-4, respectively; (d) Z-profile/height scan showing variation in thickness of degraded catalyst layer surface along the red line in Figure 6c; (f) colour mapping of morphological features of degraded catalyst layer: blue area represents thinnest catalyst, green represents uneven surface of degraded catalyst layer, orange represents nondegraded catalyst layer.

Regions ROI-3 and ROI-4 located at the middle and edge of the defect (Figure 6a) were selected for closer examination using transmitted and reflected light to characterize surface degradation within the MCLD. The catalyst surface in these two regions had clearly become irregular due to chemical/layer degradation inside the MCLD (Figure 6e,f). Previous studies have shown that these effects can be caused by ionomer leaching from the catalyst layers and H_2O_2 (hydrogen peroxide) formation at the defective catalyst sites [33].

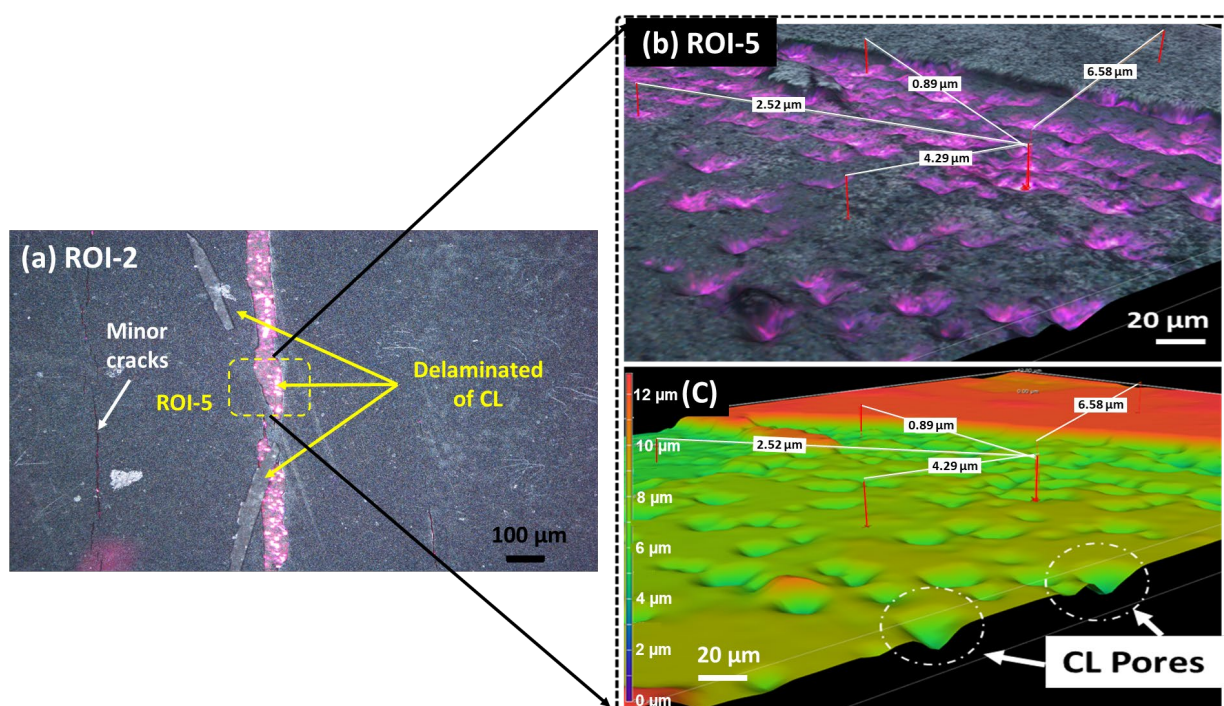
Figure 7a shows evidence consistent with catalyst layer delamination having occurred at ROI-2. Kai et. al. showed that static and humidity cycling caused deformation of the membrane and extensive crack propagation in the catalyst layer [39]. When a membrane underwent swelling, its pores gained moisture from the reaction gases and became thicker. In this situation, the catalyst layer could have difficulty accommodating the pressure developed by the membrane with the result that surface cracks form. The opposite effect occurred during shrinking/drying, i.e., the pores of the electrolyte membrane lost moisture, and the membrane shrank in thickness, causing the catalyst layer cracks to collapse or merge [18]. Ultimately, the combined effects of crack propagation and merging can cause delamination and detachment of the catalyst layer from the membrane.

Figure 7. Microscopic images of crack propagation on the CCLs at EOL: (a) delaminated catalyst layer, (b) ROI-5: 3D enlarged view of delaminated and degraded catalyst layer, and (c) color mapping of delaminated area of ROI-5 showing catalyst layer pores.

Even after 100 h of OCV-AST operation, it was observed that cracks had not propagated significantly in the vertical direction (i.e., not increased in depth) and had not penetrated beyond ~50–70% of their thickness (Figure 7a). Crack penetration and delamination had affected 50–70% of the catalyst layer. Closer visual examination at 100× magnification was conducted on a specific delaminated region labelled ROI-5 within ROI-2 (Figure 7a). A view of ROI-5 is presented in Figure 7b,c showing that a portion of the catalyst layer detached from the surface crack. Several Z-profile measurements across the delaminated areas on the CCM (inlet, middle, and outlet areas) were carried out to estimate the thickness of delaminated catalyst layers. This analysis revealed that the average thickness of delaminated CLs that originally ranged from 10–15 µm has decreased to 2–6 µm at EOL (some of these regions are shown in Figure 7a). The pink areas in Figure 7b represent the thinnest areas where the transmitted light could pass through the solid catalyst layers. The map showing the height of the catalyst layer in region ROI-5 is presented in Figure 7c. The orange areas represent defect-free catalysts, while the green areas correspond to defective catalyst remaining after delamination. The possible causes of the surface delamination may be traced back to the hot press step during fabrication. The uppermost catalyst surface that is first exposed to the hot plates during CCM fabrication presumably has

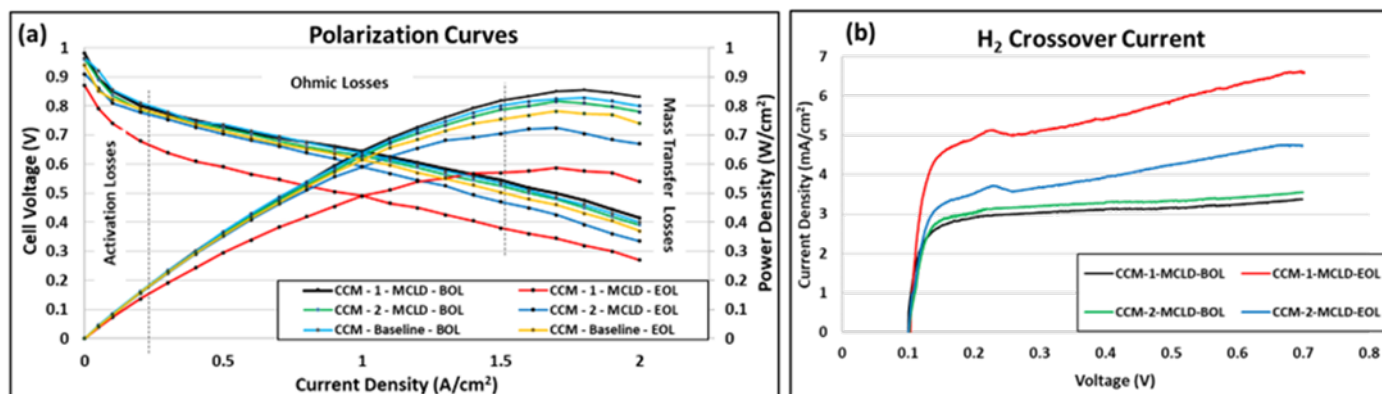
Figure 8a shows the polarization curves obtained using defective CCMs containing MCLDs (CCM-1 and CCM-2) and defect-free CCM (baseline) at BOL and EOL. The experiment was carried out at 90 °C with a relative humidity of 80%/80% on the anode/cathode sides by increasing the current density from zero up to a maximum of 2 A/cm². The same CCMs examined at BOL are characterized later at EOL after undergoing 100 h of OCV-AST, as discussed in Section 2.2.3. The curves indicate that the polarization of the cell at BOL was not strongly affected by whether or not the CCM contained a defect. However, once the cells were subjected to the OCV-AST, the degradation in performance at EOL was much larger in the case of CCM-1-MCLD (red) compared to CCM-2-MCLD (blue) and CCM-baseline (yellow). In the case of CCM-1-MCLD, a significant drop in polarization curves was observed from CCM-1-MCLD-BOL (black) and CCM-1-MCLD-EOL (red), where its OCV reduced by 11.6% from 982 mV to 868 mV (loss of 114 mV) on going from BOL to EOL. This voltage loss was presumably associated with gas crossover through damaged areas in the electrode. At a current density of 0.1 A/cm², the cell voltage was reduced by 12.1% (102 mV), from 843 mV to 741 mV, after undergoing the OCV-AST. This voltage loss is attributed to reduced electrocatalyst activity. Additional causes for losses in the activation region were catalyst erosion, ionomer leaching, and loss of active catalyst through delamination, as discussed in Section 3.3. Not surprisingly, larger shifts in the voltage and power curves were observed at a higher current density of 2 A/cm², i.e., voltage drops from 415 mV to 270 mV and peak power density decreases from 830 mW to 540 mW in the mass transport region. The observed trend in CCM-1-MCLD in the activation,

Figure 8. (a) Polarization curve of CCM-1, CCM-2, and CCM-baseline operated at 90 °C and 80/80% RH on anode and cathode at a pressure of 250 kPa. (b) Hydrogen crossover current of defective CCMs (CCM-1 and CCM-2) obtained at a scan rate of 2 mV/sec.

Hydrogen crossover was strongly related to the condition and durability of the fuel cell electrode. Furthermore, its effect was heightened when electrodes were tested under OCV when H₂ consumption at the anode was negligible. Under these conditions, H₂ slowly diffused through the electrolyte membrane, reacted at the cathode, and thereby reduced the cell potential. The transport of H₂ was obviously easier if the catalyst layer and membrane contained defects and pinholes. At the same time, the crossover of gas from the anode to the cathode and vice versa can lead to the formation of H₂O₂ which further decomposes ionomer in the catalyst layers. The overall health of the electrode at BOL and EOL can be characterized by measuring hydrogen crossover at regular intervals. The black and green curves in Figure 8b show that the crossover current density of

$\sim 3\text{mA}/\text{cm}^2$ measured at BOL was stable for CCM-1 and CCM-2 at voltages above 0.2 V, indicating that the CCM was intact even in the presence of MCLD. Once the CCM was aged for 100 h during the OCV-AST, a significant rise in the crossover current density was observed at all voltages. The blue curve corresponds to CCM-2-MCLD-EOL, while the red curve represents CCM-1-MCLD-EOL in Figure 8b. This significant increase in the crossover current in CCM-1-MCLD-EOL was likely caused by the propagation of cracks and catalyst layer defects that led to pinhole formation in the membrane.
