# Weld Seam Failure Analysis of a Natural Gas Pipeline Reducer: Implications for Oil and Gas Transportation Safety

Ensuring the integrity of weld seams in pipeline components is critical for the safe and reliable transportation of oil and natural gas. This paper presents a systematic failure investigation of a cracked weld in a reducer located at a natural gas transmission station in Western China, aiming to identify the failure mechanism and assess its implications for pipeline safety management. A comprehensive analysis was conducted using macroscopic examination, chemical composition analysis, mechanical property testing, metallographic observation, and microscopic fracture characterization. The results reveal that the heat-affected zone (HAZ) exhibited abnormally high hardness (up to 588 HV0.1), indicating insufficient toughness that made it susceptible to cracking. The base metal showed a high carbon equivalent (CEV), placing it in the “difficult-to-weld” category and increasing its sensitivity to improper welding thermal cycles. On-site investigation further identified significant deficiencies in welding process control, including inadequate preheating, improper interpass te

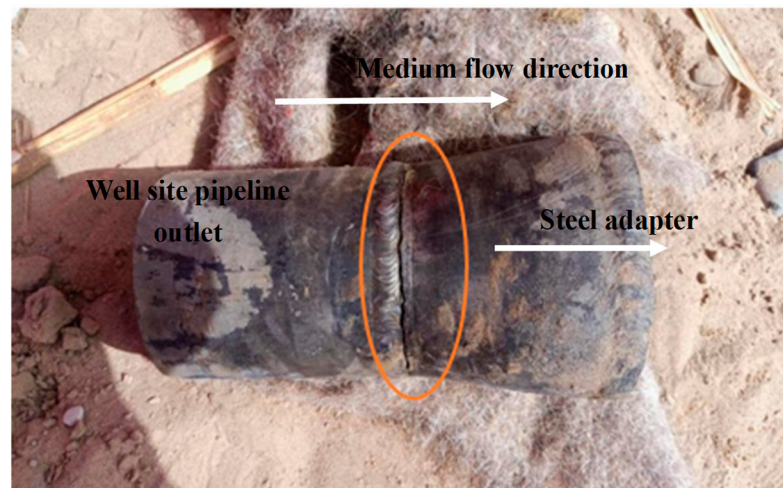
On 18 October, a crack occurred at the weld toe of the circumferential weld on the small end side of the upstream reducer of the steel conversion joint of the gathering pipeline. The failure location was in the direction from 9 o'clock to 3 o'clock, as shown in Figure 1.

**Figure 1.** Failed sample.

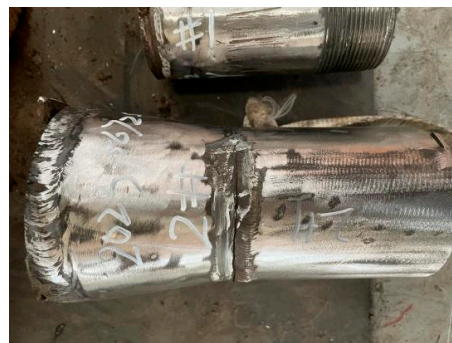
The submitted test specimens consisted of a straight pipe and a reducer, each approximately 10 cm in length. The circumferential weld on the reducer side showed a crack, with no obvious plastic deformation at the crack. There were no signs of overheating or weld spatter at the lower part of the weld, as shown in Figure 2. Upon longitudinal sectioning of the specimen, the circumferential weld between the straight pipe and the reducer was well-formed, and no obvious localized corrosion was observed on the inner surface, as shown in Figure 3.

**Figure 2.** Macroscopic morphology of the outer surface of the sample.

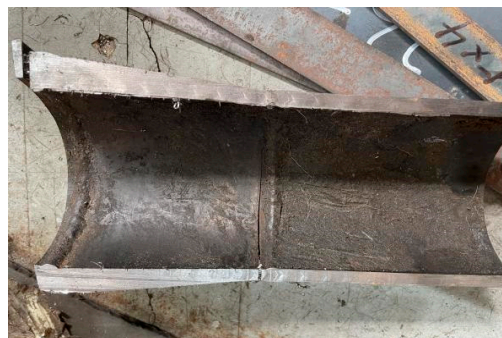
**Figure 3.** Macroscopic morphology of the inner surface of the sample.

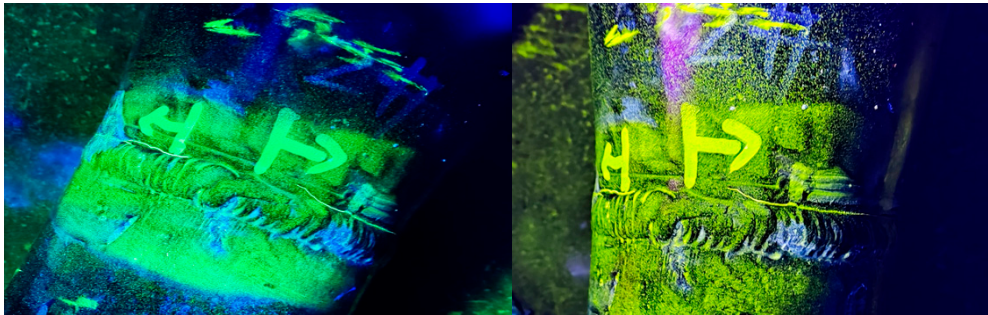
According to “Magnetic Particle Testing Standard Guide E709”, magnetic particle testing was performed on the outer surface of the reducer. It was found that no obvious cracks were found except at the location of the weld crack, as shown in Figure 5.

Figure 5. Magnetic particle inspection photograph of the outer surface of the reducer.

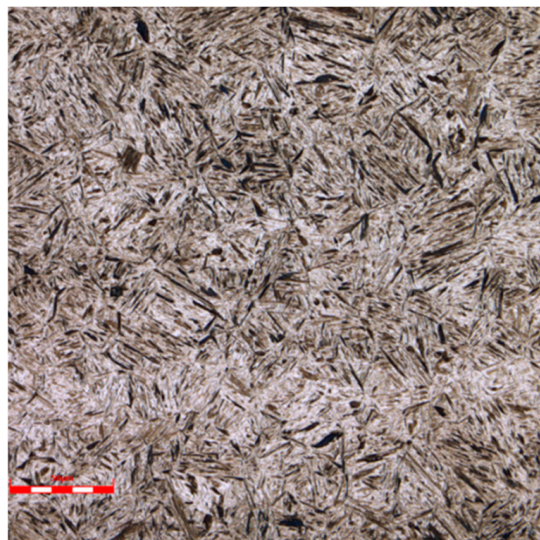
Metallographic samples were taken from the straight pipe, reducer, and circumferential weld, totaling six samples. According to “Inspection methods of microstructure for metals”, “Determination of ferrite grain size for cold rolled low carbon steel sheets”, and “Standard Test Methods for Determining the Inclusion Content of Steel”, the samples were analyzed for microstructure, grain size, and non-metallic inclusions using a MeF3A metallographic microscope and an OLS 4100 laser confocal microscope. The results are shown in Tables 5 and 6, and the metallographic structures are shown in Figures 6–9. The results show that the reducer’s metallographic structure is tempered sorbite with a grain size of 9.5; the straight pipe’s metallographic structure is ferrite and pearlite with a grain size of 7.5; and the circumferential weld exhibits a combination of acicular ferrite and polygonal ferrite. Observation of the cross-sectional sample of the crack revealed two cracks located in the heat-affected zone, extending from the inner wall to the outer wall, exhibiting predominantly transgranular morphology, with fewer secondary cracks and bifurcations, as shown in Figures 10 and 11. The long crack originated from the inner wall, penetrated the wall thickness, and displayed a distinct folded morphology; the short crack also originated from the inner wall, with a thicker root and a thinner tip.

**Figure 8.** Tissue of the heat-affected zone of the large and small heads (50  $\mu\text{m}$ ).

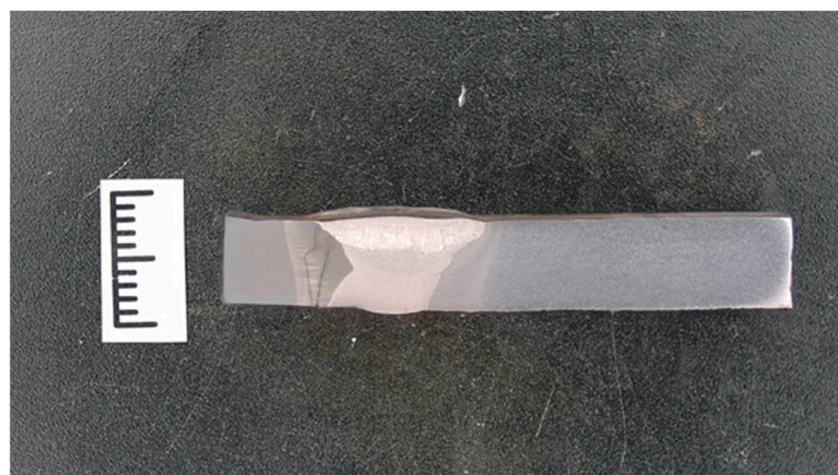
**Figure 10.** Crack morphology at low magnification (1 mm).

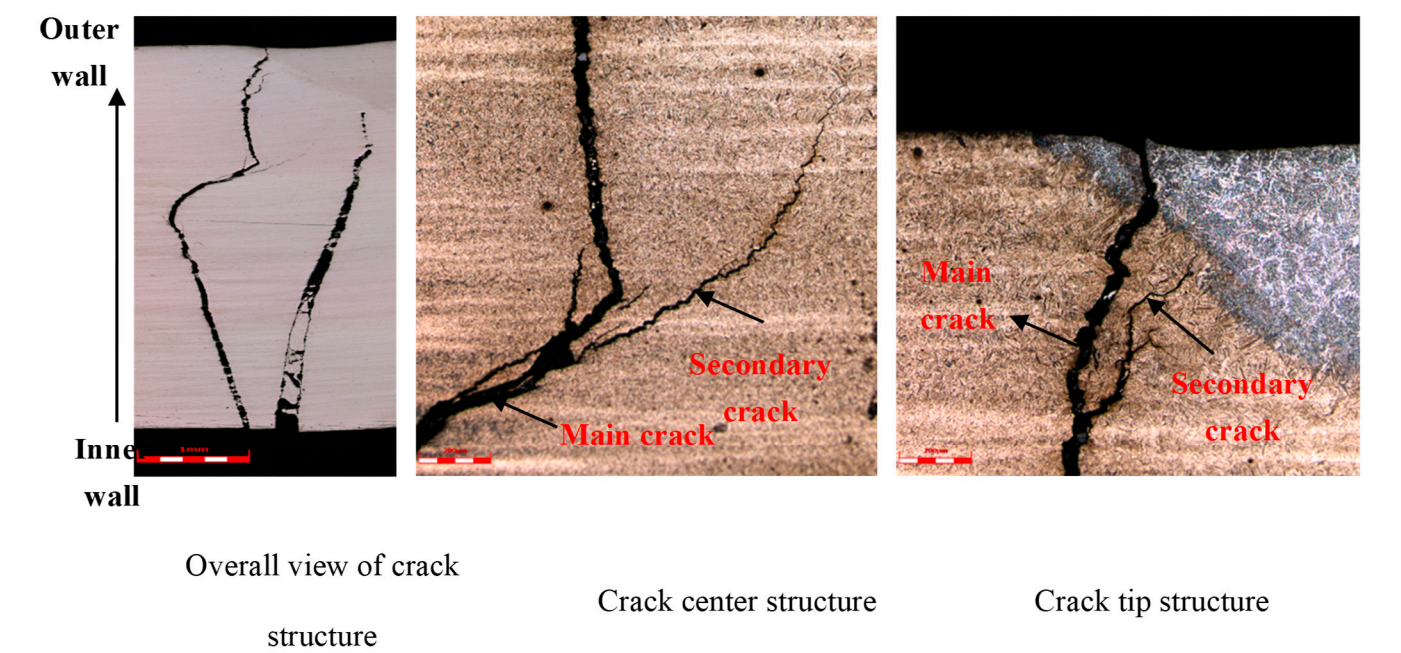
**Figure 11.** Microscopic morphology of the crack (The scale bars from left to right are 1 mm, 200 μm, and 200 μm, respectively).

Macroscopic and microscopic analysis of the cracks reveals that the circumferential weld crack occurs in the HAZ, originating from the inner surface. The main crack exhibits a transgranular morphology, with few secondary cracks and bifurcations, exhibiting characteristics of brittle fracture. According to the crack energy dispersive spectroscopy (EDS) results, there is no significant hydrogen sulfide corrosion in the crack initiation region. Although sulfur (S) is present at the root and middle of the main crack, the tip of the

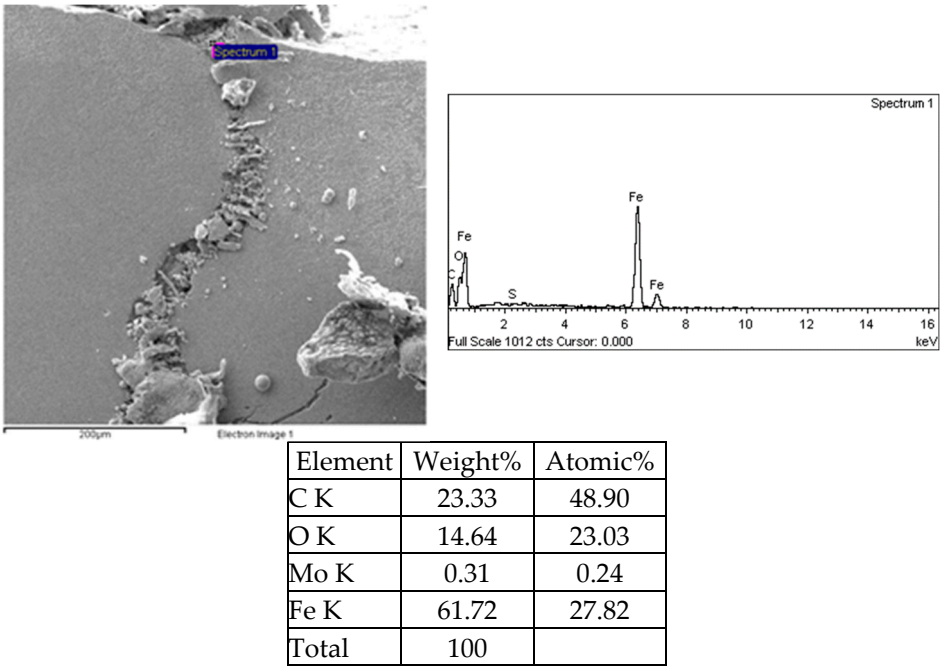
Figure 13. Morphology and elemental distribution at the crack root.

Samples were taken from the crack in the circumferential weld at the large and small ends. The morphology of the crack root, middle, and tip was observed and analyzed using a TESCAN VEGA II scanning electron microscope and its accompanying XFORD INCA350 energy dispersive spectroscopy (EDS) analyzer. The electron microscope observation time was 10 h, and 14 samples were analyzed using EDS. The results are shown in Figures 14–16. The crack root and middle mainly contained C, Fe, S, and O elements, while the secondary crack tip contained C, Fe, Mo, and Mn elements, but no S element.

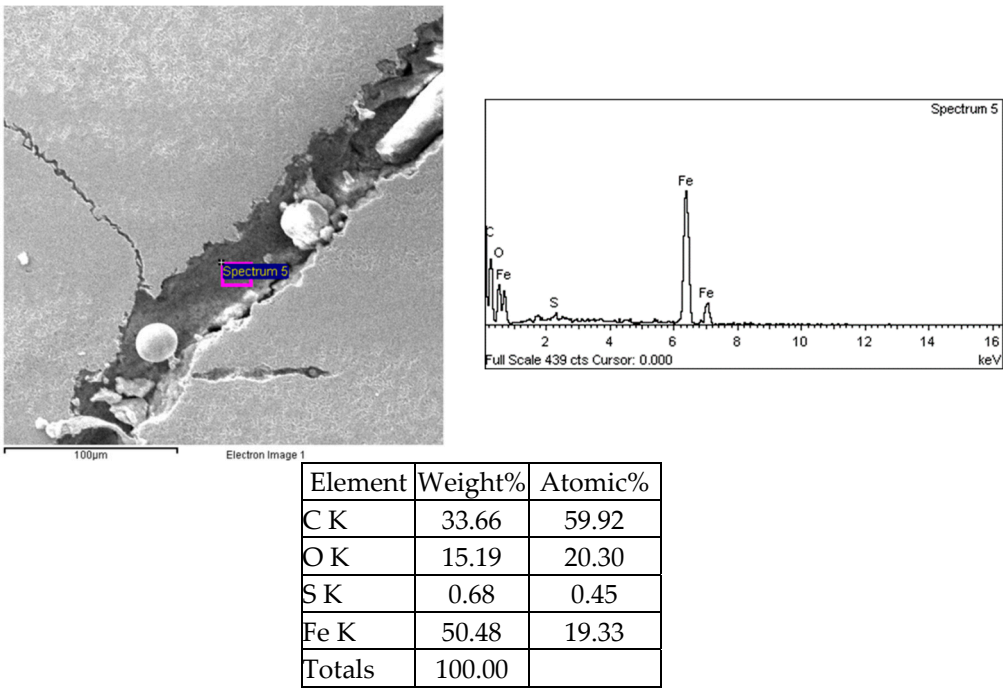
Figure 14. Morphology and elemental distribution of the crack center.

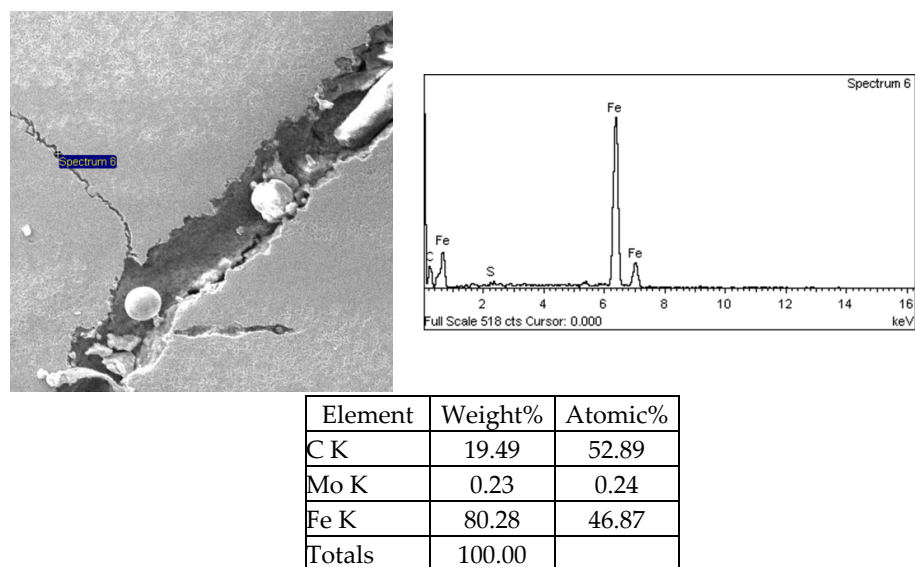
**Figure 15.** Morphology and elemental distribution of the secondary crack tip (left).

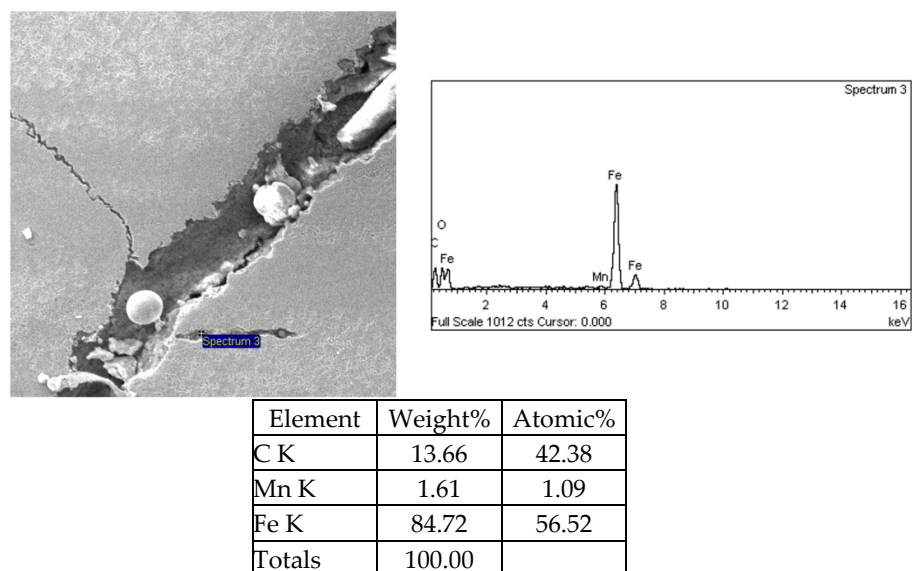
**Figure 16.** Morphology and elemental distribution of the secondary crack tip (right).

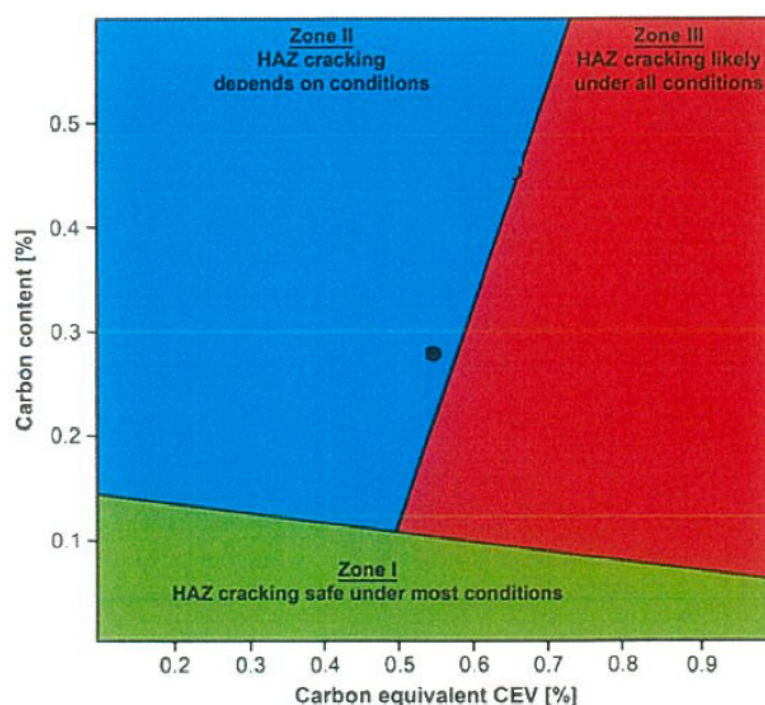
According to the welding heat-affected zone cracking tendency chart recommended by the IIW, as shown in Figure 17, the cracking of the heat-affected zone is related to the carbon content and carbon equivalent of the material. The carbon content of the reducer is 0.39%, and the CEV is 0.808%, so the heat-affected zone of the reducer is in a crack-prone area.

**Figure 17.** Crack diagram of the heat-affected zone during welding.
