# Analysis of the Failure of the Rotating Support Girder of a Spreader Bridge <sup>†</sup>

This paper describes an example of a failure of the rotating support girder of a spreader bridge. The root cause of the damage was buckling of one of the girder's plates. This caused plastic deformation, which made the continued safe operation of the machine impossible. An FEM analysis was performed to determine the probable cause of the failure. Conclusions and recommendations are also presented in the paper to prevent similar failures in the future.

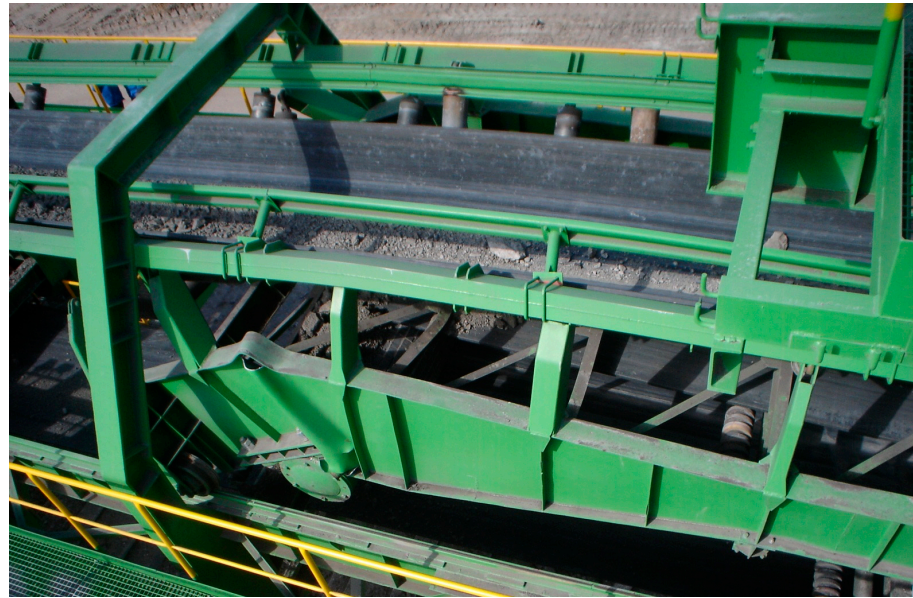
**Figure 1.** Belt conveyor failure due to buckling phenomena.

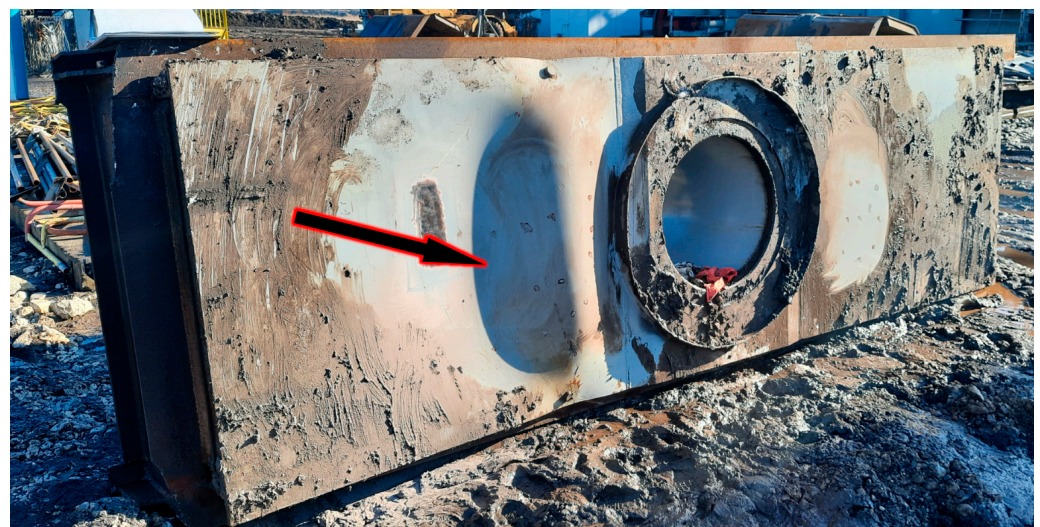
In Figure 5, a disassembled rotating support girder is presented. In the area marked by the arrow, plastic deformation is clearly visible. It has a characteristic shape that is typical of buckling forms in steel sheet structures [11]. With reference to the investigation from the previous paragraph, material defects, corrosion, and design inconsistencies should be excluded from the probable causes of failure. The tests performed did not show any deviations from the assumed parameters.

**Figure 5.** The rotating support girder after disassembly. The buckling area is marked with a black-red arrow.

As the calculations showed, in the cases both with inclination and without inclination, the values of the buckling coefficients significantly differed from each other. In the case analyzed, for HZS4, assuming that the machine traveled, the safety factor was at the limit of an acceptable value. The described machine does not always work on a well-prepared surface, which may cause local exceedances of the acceptable inclination of 5%. Therefore, there is a likelihood that the phenomenon that is presented in Figure 5 will occur. It should also be emphasized that the machine has been in operation for 40 years. Taking into account the time that elapsed from the start of use to the moment of failure, the following recommendations were presented. The first recommended step is to design a new rotating support girder with superior buckling resistance. It is also recommended that the ground be prepared more thoroughly to ensure that the risk of encountering a slope greater than allowed by the standards (5%) can be minimized. It is also suggested that

the entire support system be redesigned and replaced with a modernized version. Due to the expected lifetime of operation of the examined technical facility, these measures were considered economically unjustified.

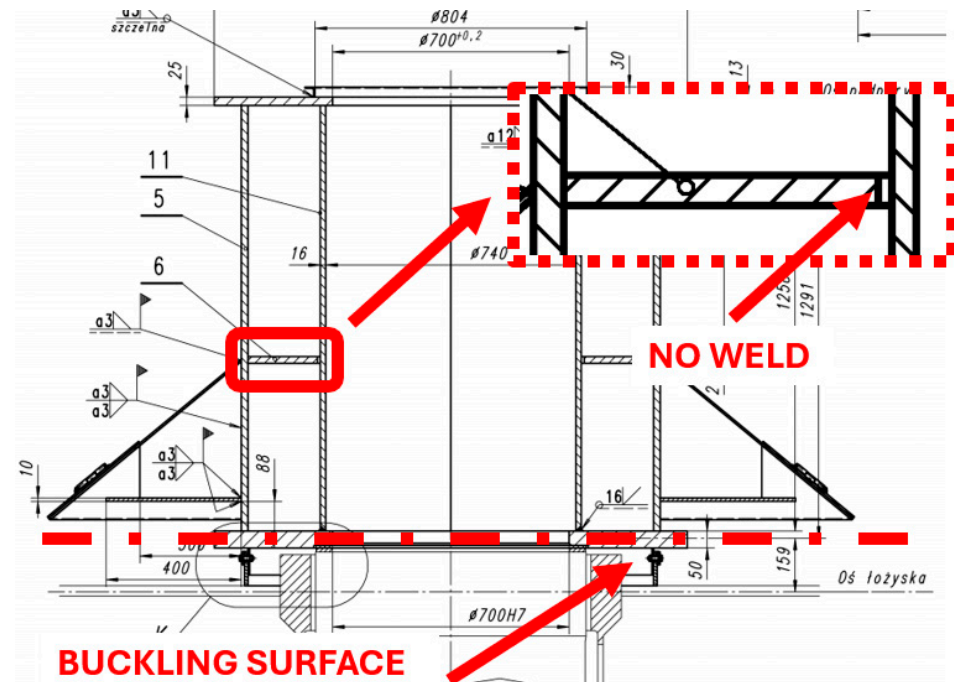
An analysis of the technical documentation of the deformed element revealed an area of interest, which is shown in Figure 6. The horizontal steel plate that forms the profile of the box section is not welded to the vertical tube of the drum that transfers vertical loads to the plain bearing. The purpose of this bearing is to allow the superstructure of the bridge to rotate in relation to its substructure. Such a construction solution significantly affects the stiffness of the entire structure. For this reason, we decided to perform an FEM analysis to verify the original design.

**Figure 6.** Location of an incomplete connection (no weld) of the box section forming the rotation support girder.

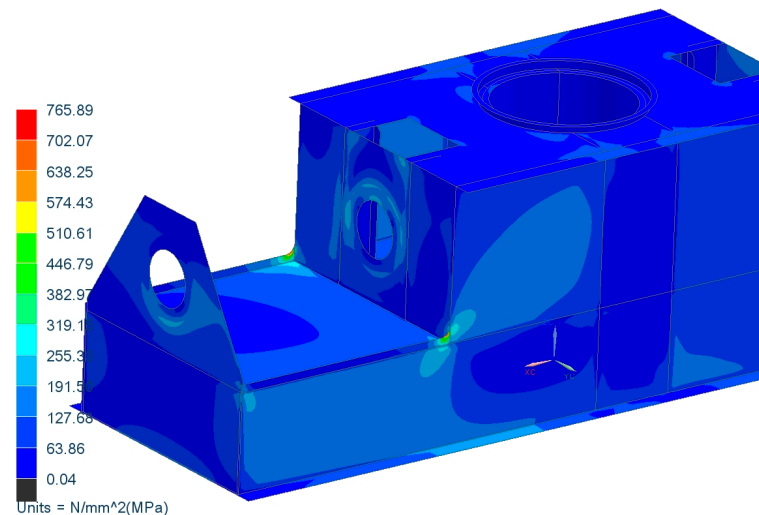
**Figure 8.** Equivalent Von Mises stress distribution in MPa—linear material model.

The FEM analyses of material strength showed one region with a yield strength exceeding that of the original material, assuming that we had a linear model of the material. It did not occur in the area where the failure occurred, nor at any of the critical points of the structure. The machine owner performed his own NDT testing of the identified area, which did not show any cracks in the material. This indicates that the strength of the material has not been exceeded. There was a local phenomenon of strengthening of the material as a result of plastic deformation. The value of the buckling coefficient for the analyzed case was also higher than the standard recommendations; for HZS 4 it was 1.86 and for HZS6 its value was 4.31. According to the available technical and operational documentation of the stacker, it is allowed to operate at an incline. The above analyses carried out do not include inclination. Therefore, additional analyses were performed, taking the slope angle into account. The tilt caused an uneven distribution of the reaction force between the left and right sides. The calculations assumed a slope of 5% (due to travel-HZS4) and 3% (based on work involving the extraordinary excavated material—HZS6). The following reaction forces are assumed according to Table 1.

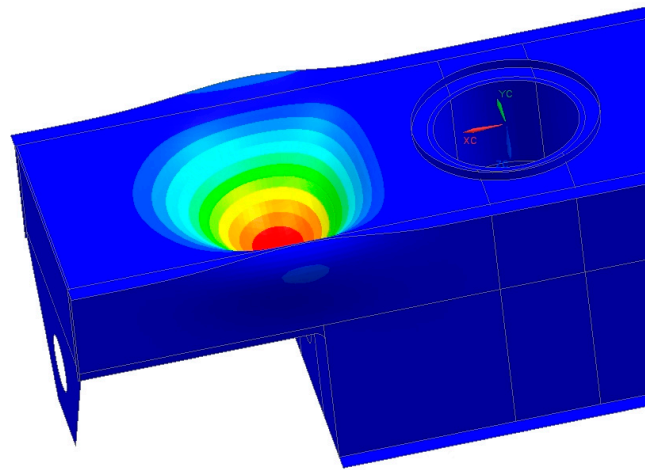
the carrying structure of the bridge superstructure were also taken into account; these were HZS4-5 786 469 N and HZS6-4 637 830 N. The difference in the total reaction forces is due to the fact that in the traveling case there is one less support point. Figures 8 and 9 shows the stress plot for the HZS4 case and the buckling shape for the HZS4 case. It should be emphasized that, according to the standard guidelines, the permissible buckling coefficient should be  $\geq 1.5$ . Obtaining a buckling factor of 1 in the calculation means that the object will transfer the assumed load without buckling. Obtaining a value below 1 means that the buckling phenomenon will occur. For example, for a factor of 0.9, this means that 90% of the assumed load in the calculation can be transferred. A similar relationship has been identified for coefficients greater than 1. Obtaining a negative result means that the buckling phenomenon occurs in the opposite direction of action of the loads.

**Figure 9.** Buckling shape for factor 1.86 for HZS4 horizontal position.

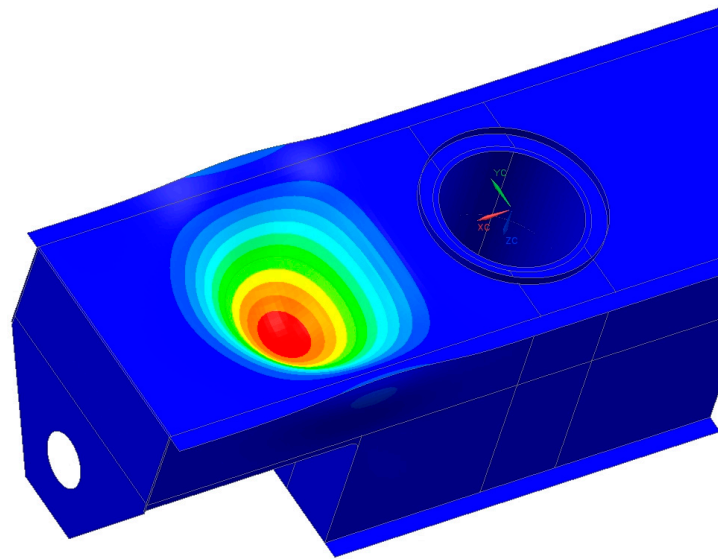
After taking into account the non-uniform distribution of reaction forces according to Table 1, the following results were obtained for the buckling analysis. It turned out that inclination has a significant impact on the recorded values of the buckling coefficients. It is an important component that determines their values. For the case of HZS4 in the incline, the value was 1.51 (Figure 10), and for the case of HZS6 in the slope, the value was 2.59 (Figure 11). These values were significantly lower than those obtained for the horizontal position, which was characterized by an even distribution of reaction forces to the rotating

**Figure 10.** Buckling shape for the factor of 1.51 for HZS4 in inclination.

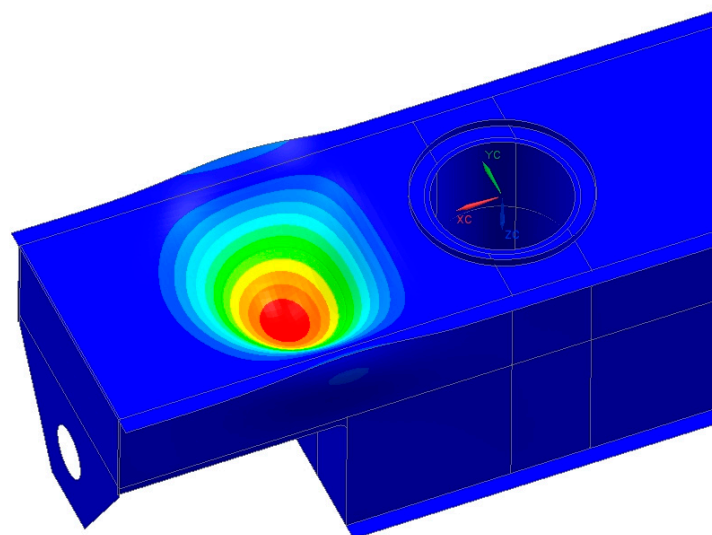
**Figure 11.** Buckling shape for a factor of 2.59 for HZS6 at inclination.
