# CT Scans of Asbestos Cement Pipes to Support the Development of Better Condition Assessments <sup>†</sup>

Karel van Laarhoven \* and Claudia Quintiliani

KWR Water Research Institute, Groningenhaven 7, 3433 PE Nieuwegein, The Netherlands;

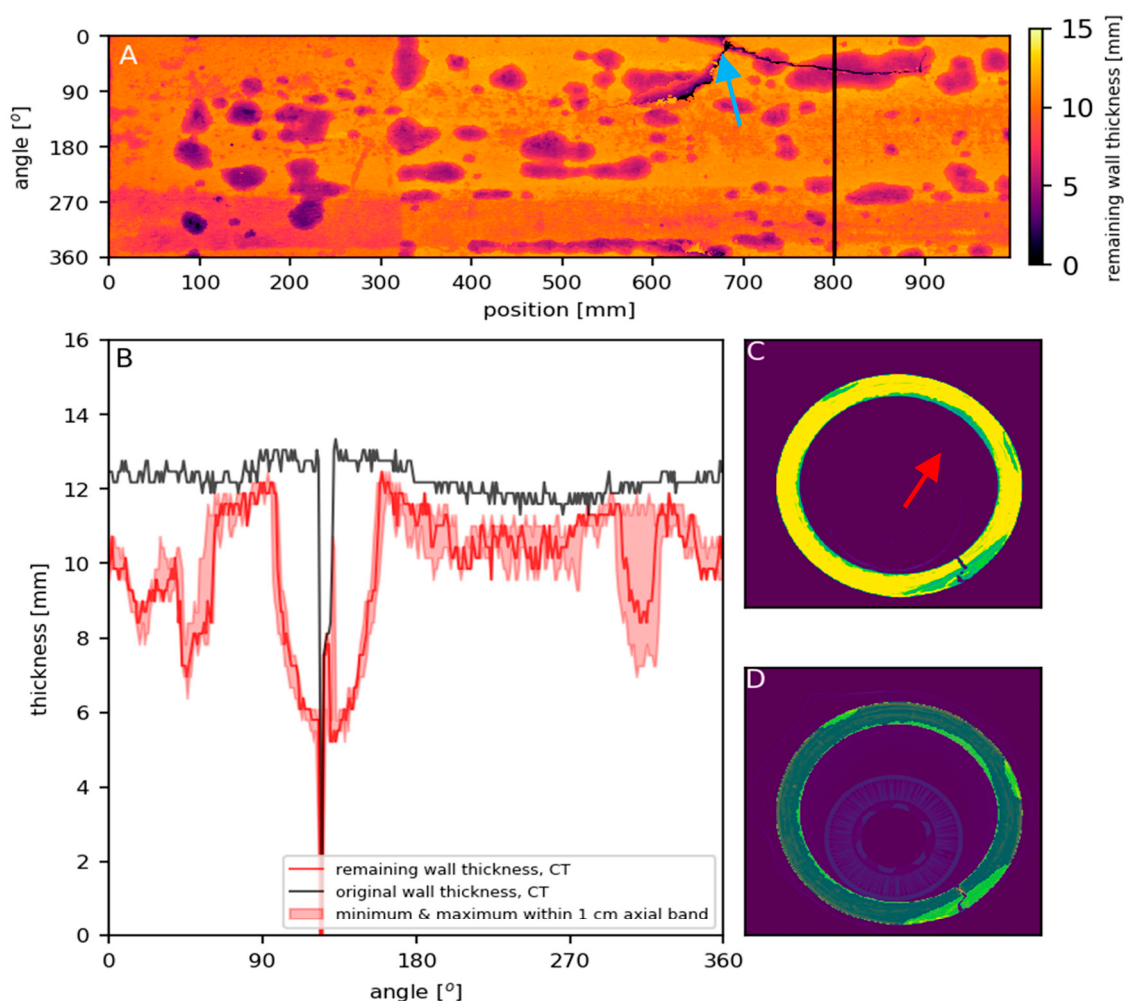
**Figure 2.** Impression of the information present in the CT-scan of pipe 177598.

Once the CT slices of a field sample are processed and converted to the remaining wall thickness data as illustrated in Figure 1, an overall impression of the pipe degradation can be constructed. Figures 2 and 3 give two examples of the analyses made to summarize the information present in a complete CT scan. Figures 2A and 3A display height maps that summarize the distribution of degradation across the pipe surface. Color represents the remaining wall thickness at a given position in the pipe as marked by the axis in terms of angle and distance along the length of the pipe segment. The lines of extremely low-value pixels clearly identify cracks in the pipe (blue arrow in Figure 2A).

The black vertical lines in Figures 2A and 3A mark the locations of specific slices in the respective CT scans that are shown in Figures 2C and 3C (color scale from blue to yellow indicating low to high radio densities). In Figures 2D and 3D, the highlighted areas mark the degraded material visible in

the slice, as determined by the image-processing algorithm. The graphs show the profiles obtained from these slices for the wall thickness (Figures 2B and 3B, black) and the remaining wall thickness (Figures 2B and 3B, red).

Clear but distinct patterns of locations with reduced remaining wall thickness are recognizable for both pipes. The remaining wall thickness of the pipe in Figure 2 displays a spotty pattern across the pipe surface, which corresponds to many localized areas of external degradation (also recognizable in the CT slices displayed in Figures 1A and 2C). A band of reduced wall thickness is also visible across the full length of the pipe between 270° and 360°, which corresponds to an area of internal degradation (marked by the red arrow in Figure 2C). In Figure 3, the external degradation is drawn out in a thin band across the surface (the darker area marked by the green bracket in Figure 3A). The internal degradation is present far more homogeneously across the surface than in Figure 2, but again a pattern of bands of different levels of degradation across the pipe length is visible.

Presumably, the localized nature of the external degradation in Figures 2 and 3 is related to the corresponding distributions of aggressive soil components around the pipe when the pipes were in use. The inhomogeneous nature of the internal degradation is more remarkable, however, since the leaching of calcium hydroxide from the AC pipes into the drinking water is typically understood to be a diffusion-controlled process that occurs homogeneously across the pipe surface [6]. Nonetheless, the patterns described above were typical for the 32 pipes that were scanned in total. Thirteen pipes displayed inhomogeneous internal degradation, while only eight of the pipes displayed the expected pattern of homogeneous internal degradation. Nineteen of the pipes displayed inhomogeneous external degradation.
