Microstructural Examination of Molten Marks on Copper Wire for Fire Investigation

Keywords: fire investigation; molten mark; microstructure; forensic; surface morphology

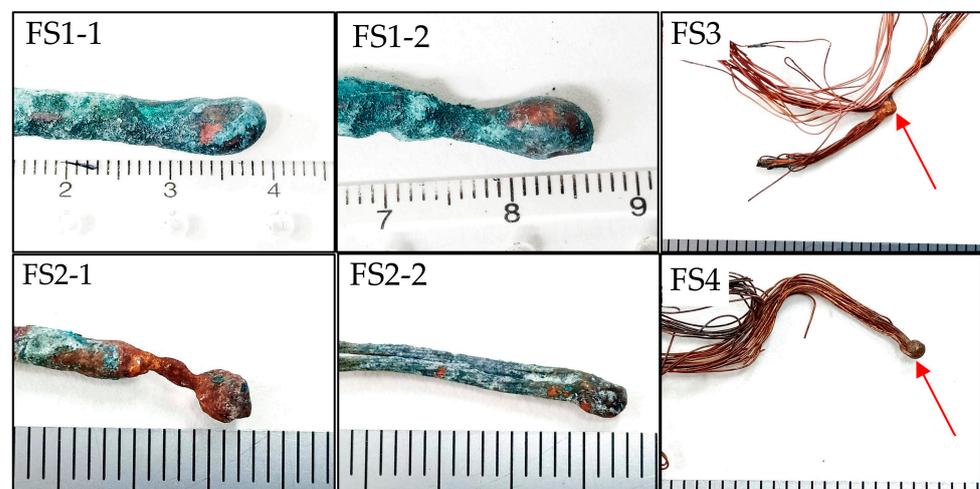
Figure 1. The molten marks on copper wires collected from real-world fire scenes.

Initially, the typical exterior features of the molten marks on copper wire from real fire accidents were evaluated. Figure 1 shows stranded wires melted together across wires in cases FS1-1 and FS1-2. In case FS2-1, the molten mark had irregular melting and a rough surface. In case FS2-2, the two strands of wire were melted together at the wire's end. The stranded wire was melted onto another wire at a specific contact point and formed a round shape in case FS3. The molten mark shape in case FS4 was round, and the boundary between the unmelted/melted interface was noticed. These common appearances will be interpreted in conjunction with other investigations and summarized later.

In case FS3, there is a localized point of contact between two copper conductors, as pointed out by the arrow in Figure 1. The exterior of this molten mark exhibits sharp demarcation between the melted and unmelted areas of the conductor and a round shape. These features are normally exhibited for electrical arc-damaged conductors, as reported by NFPA 921 [15]. In the overview photographs, columnar grains can be seen developing from one side to the other due to rapid solidification. The microstructures at high magnification exhibit blurred copper dendrites inside the columnar grains. The copper dendrites are hardly noticeable because the sample was exposed to fire. From the definition of PMMs by Lee et al. [2,4,6], PMMs are generated at room temperature and rapidly cooled to room temperature before a fire that is located at the fire origin. As a result, this sample has columnar grains growing from one side to the other. Therefore, it is likely to be a PMM formed at the fire origin.

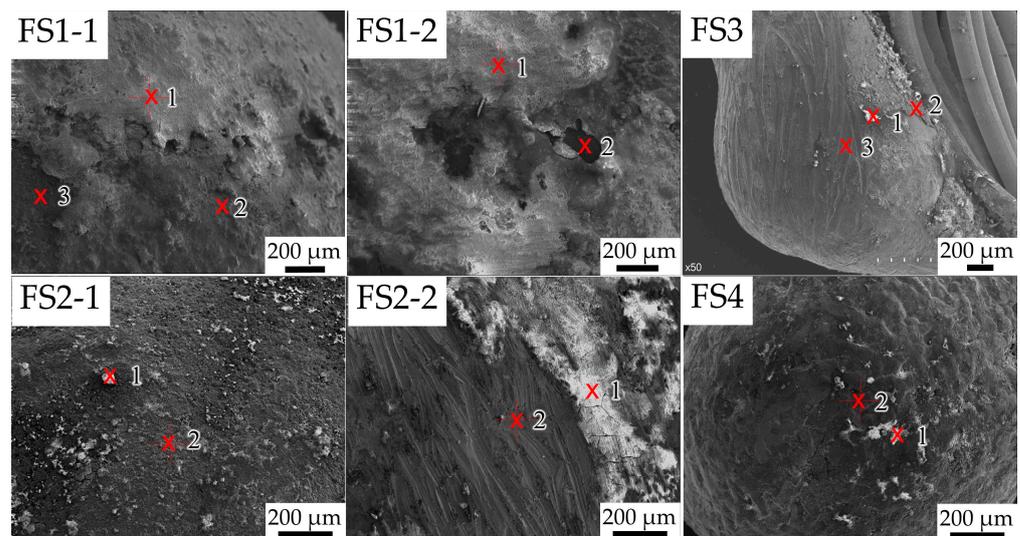
The exterior surface of the samples from real fire scenes was severely damaged and contaminated. It could be caused by fire events or while collecting evidence, as depicted in Figure 2. They were not in an adequate condition to observe the original surface characteristics. Nevertheless, elemental analysis via EDS on the surface is a preliminary examination to determine which elements are contained on the molten mark's surface, and experimental results might well reveal the source of these samples. EDS analysis was carried out from the molten mark's outer layer (labeled with 1) to its inner layer (labeled with 2 or 3).

Figure 2. Surface morphology of the molten marks on copper wire.

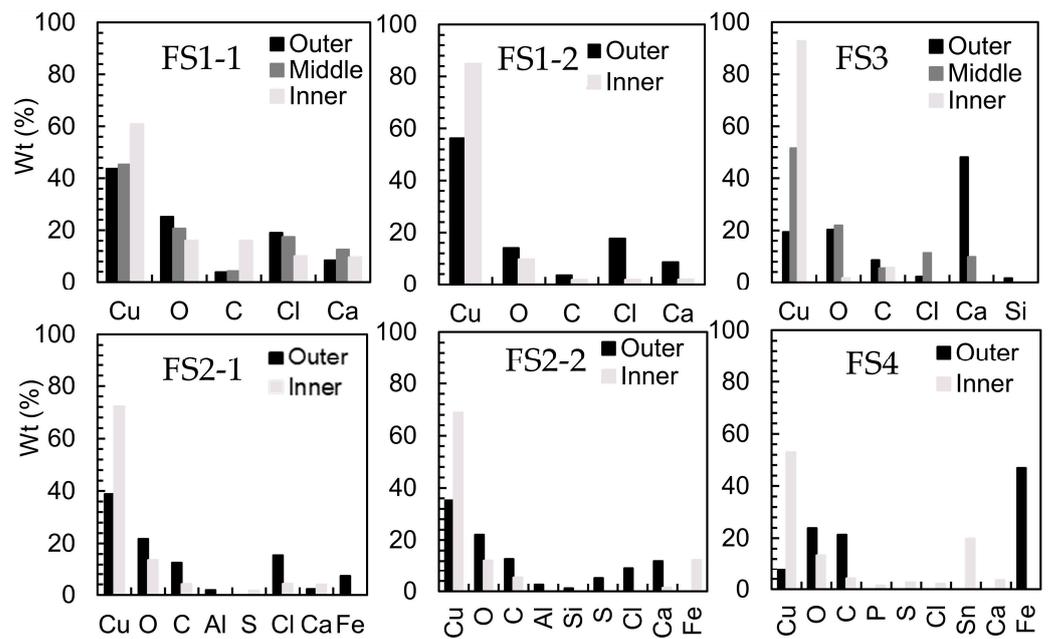
Figure 3 depicts the elemental analysis results on the surface of molten marks from actual fire sites. Copper and oxygen are the two major elements in all molten marks. Oxygen content, in most cases, is clearly the highest at the outer surface and gradually reduces at the inner surface, whereas the reverse applies for copper content. This is the result of oxygen absorption from the surrounding air into the molten mark [5,9]. Carbon, chlorine, and calcium are the minor elements. Figure 4 shows the elemental mapping of Cl and Ca, concentrating on the copper oxide layer. Cl was reported to be emitted from burning PVC insulation, while Ca was released into the atmosphere by ash-forming processes such as wood combustion [14–16]. C mostly comes from ambient CO₂ during the fire, and the remaining C on the wire's surface is due to wire combustion [10]. Additionally, several residual elements were detected via EDS on the surface of the molten mark from real fire accidents, including Al, Si, P, Fe, S, and Sn. The residual elements are almost similar in samples collected from the same fire scenes (FS1-1 and FS1-2, and FS2-1 and FS2-2).

Figure 3. Elemental analysis via EDS on the surface of molten marks.

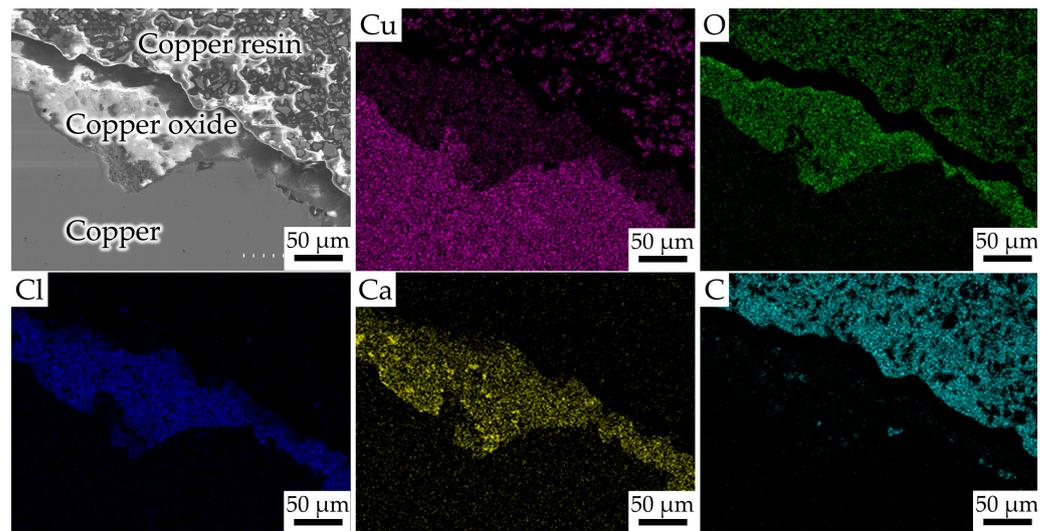
Figure 4. Elemental mapping on the longitudinal section of the molten mark in case FS1-1.

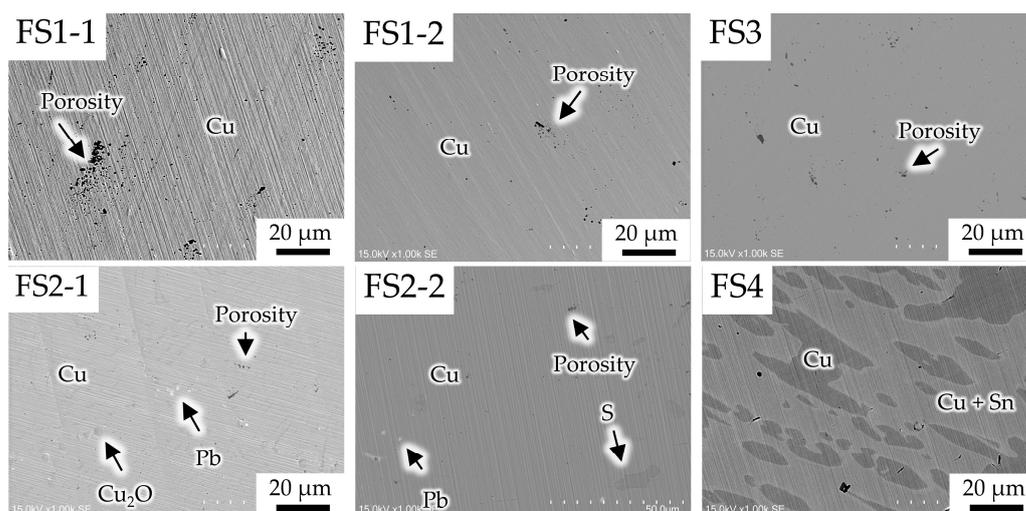
Figure 5. Microstructural compositions of the molten marks.

Cases FS1-1 and FS1-2 have comparable compositions because they were obtained from the same fire sites. Case FS2-1 revealed the presence of Cu_2O precipitates due to the heat treatment of copper and oxygen in fire and Pb. Pb has been used as a component in electronics [17,18]. In the microstructure, this Pb has a noticeably different metallic color. This could imply that copper wire is directly beneath the material, including Pb, that melted and fell onto the copper wire during a fire and cooling process [15]. On the other hand, case FS2-2, which was collected from the same fire scene as case FS2-1, reveals different alloying elements, including S, but no Cu_2O . The two samples could have been gathered from various locations within the same fire scene. The existence of various residual elements in the microstructure could reflect the surrounding materials during molten mark formation. In the case of FS3, the microstructure has no other residual elements. This is identical to the structure of cases FS1-1 and FS1-2. The unetched microstructure of case FS4 is different from those of the others, having Cu in the bright area and Cu + Sn in the dark area. In general, Sn-Pb has been utilized as a solder for connecting electronic components [14,17,19]. Thus, the copper wire with solder may have an alloying area and a rounded end. These effects are caused by the interaction of copper and solder from rapid melting and solidification in the atmosphere [15].

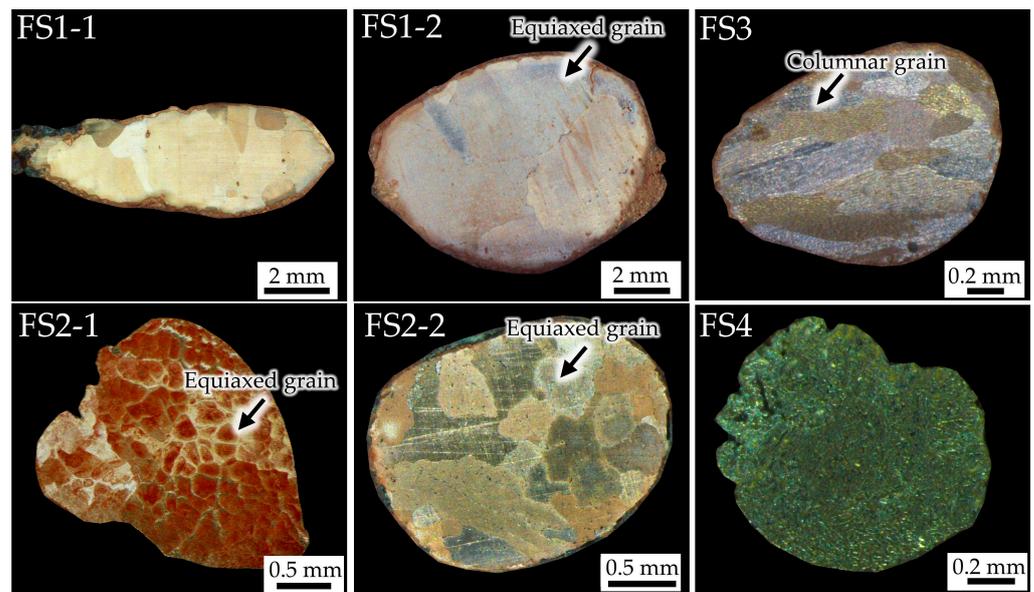
Cases FS1-1, FS1-2, and FS2-2 in Figure 6 show similar equiaxed grain structures as a result of annealing in a firing atmosphere and slowly cooling down [7,8,20,21]. In case FS2-1, oxygen-rich grains are discovered, which may imply a high level of ambient oxygen at the fire site during formation. Interestingly, Figure 7 depicts the microstructure of case FS3, which appears to be a blurred dendrite in a columnar grain. The columnar grain formed in the longitudinal section indicates a rapid heat transfer from one side to the other. This structure indicates a rapidly solidified molten mark. The fire effect causes the blurred dendrite. Because of imperfect dissolution, traces of dendrite still remain in the structure [22–25]. In addition, small black points within the grain represent gas porosities caused by the dissolution of hydrogen, oxygen, or nitrogen into liquid copper during solidification. Furthermore, the microstructure of case FS4 is unfamiliar, and grain boundaries are not visible. A grain boundary commonly appears after etching with FeCl_3 solution if the molten mark contains major elements of copper and oxygen. However, the presence of copper and tin was a major element in this sample, instead of copper and oxygen, and as inspected via EDS, the microstructure of this sample is different from others.

Figure 6. Etched microstructure of the molten marks (overview).

Cases FS1-1 and FS1-2 exhibit the same grain structure and composition, as depicted in Figures 5–7, because they were collected from the same fire scene. The presence of a grain structure indicates that these two molten marks were melted above the melting point and solidified.

For cases FS2-1 and FS2-2, although these two samples were gathered from the same field, the typical microstructure is entirely different. FS2-1 contains oxygen-rich grains, implying that it was melted above the melting temperature in a powerful oxygen environment and slowly solidified. On the other hand, FS2-2 has no oxygen-rich grains, but the residual element S was found in the microstructure in addition to Pb, as illustrated in Figure 5. It was claimed that they were obtained from different surrounding areas but from the same fire scene. Moreover, the presence of residual elements implies that the fire accident occurred before these molten marks were generated on copper, then the surrounding materials were melted and dropped onto that copper wire. Thus, this molten mark was not caused by the fire accident [15].

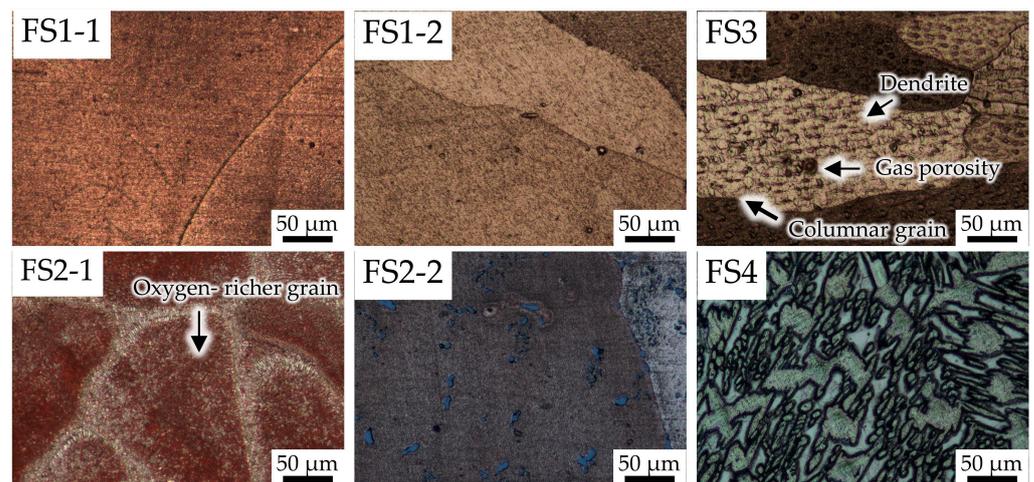
Figure 7. Etched microstructure of the molten marks under magnification 200 \times .
