# Article Analysis of the Technical Condition of a Late 19th Century Public Building in Łódź

Wioletta Grzmil \*D, Justyna Zapała-Sławeta D and Jagoda Juruś D

Faculty of Civil Engineering and Architecture, Kielce University of Technology, 25-314 Kielce, Poland

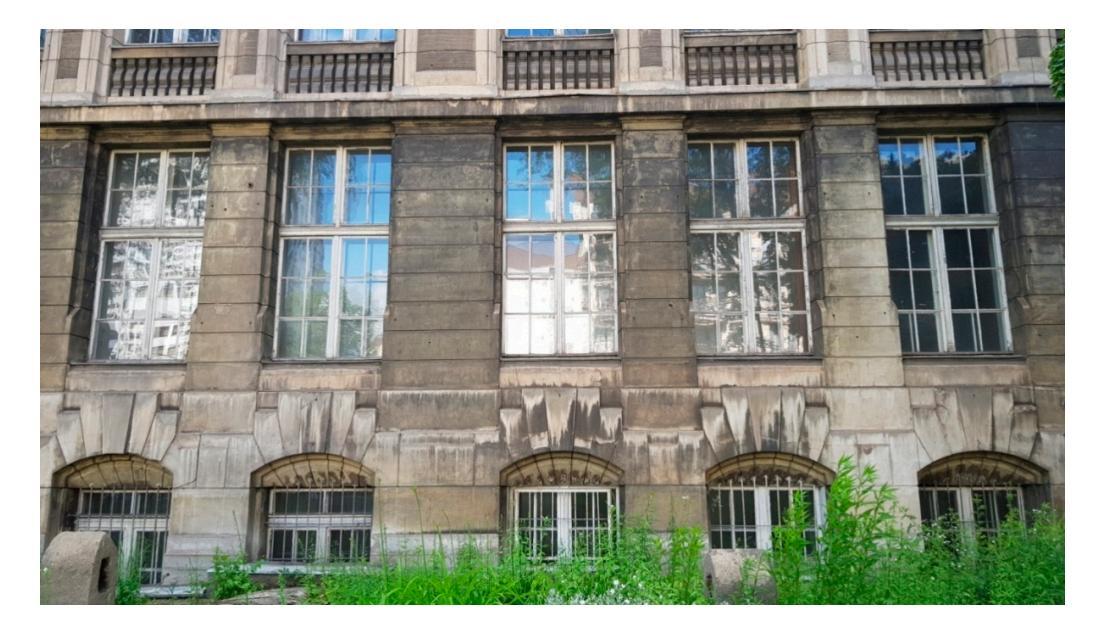
An analysis of the condition of the building facade, located in the city centre directly among streets with heavy traffic, showed that the building has been exposed to pollutants from the air, i.e., car-exhaust fumes, and in previous years also industrial fumes containing sulfur and nitrogen oxides, as well as dust and soot from buildings using coal-fired stoves. This has resulted in dark or black deposit layers on the facades. The deposits have had a destructive effect on porous materials, e.g., bricks, plaster, and roof tiles (Figure 5).

Figure 5. Part of the southern façade, with dark and black deposits visible.

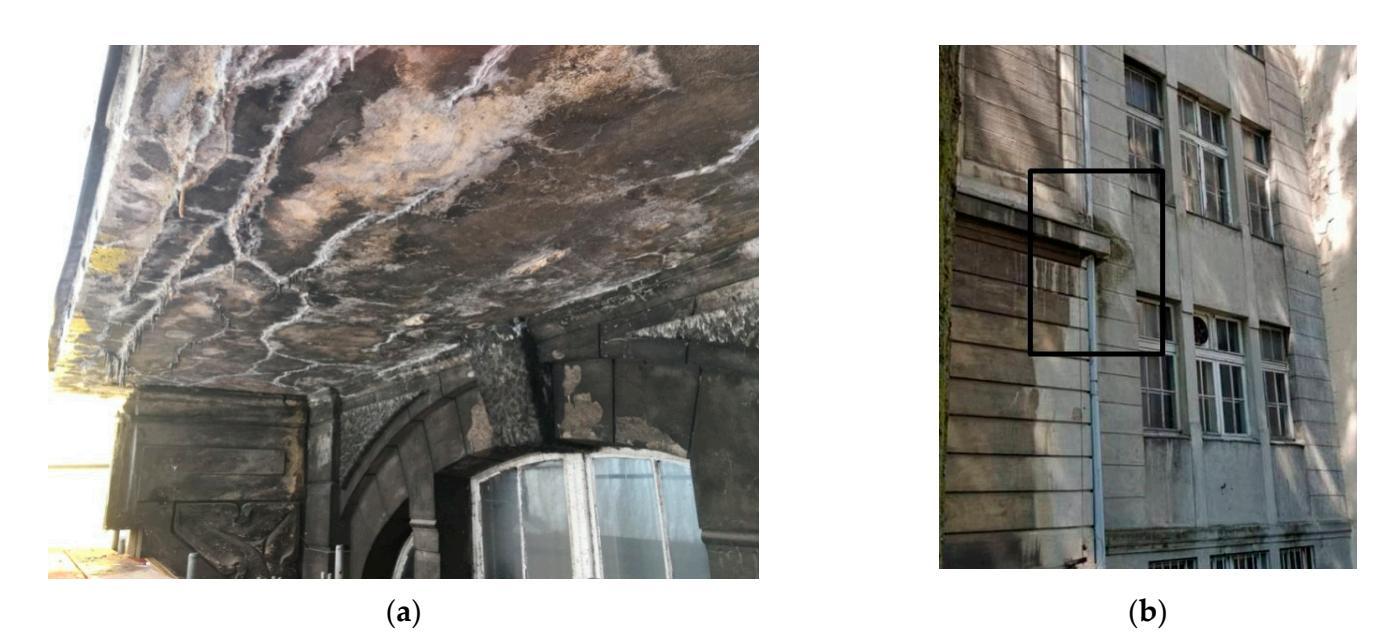
The facades show numerous cracks in the masonry and cavities. The plaster is in a very bad condition. Superficial defects in the plaster are visible, due to the large cavities and damaged flashings (i.e., window sills and gutters), which have caused individual layers to separate, exposing the bricks in permanently damp areas. The increased moisture from rainwater has caused biological corrosion of the plaster, manifesting itself in crumbling, delamination, and peeling, and consequently in the plaster falling off the brick wall (Figure 6).

Figure 6. Dampness of the balcony (a) and the building walls (b).

An external visual inspection of the condition of the structure indicated damage to the building's facade. The cause of the damage shown in the example Figures 4 and 5 may be the lack of weatherproofing and the resulting dampness of the building components.

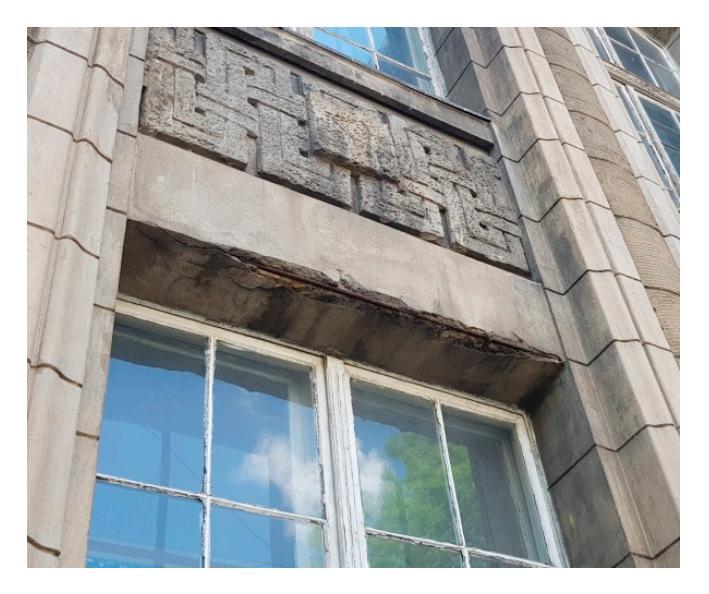
Corrosion of the reinforced concrete structure is visible on the eastern and southern facades. The layer around the reinforcement has been destroyed there, and the corroded rebar is visible (Figure 7).

Figure 7. Damage to the layer around the reinforcement—visible rebars.

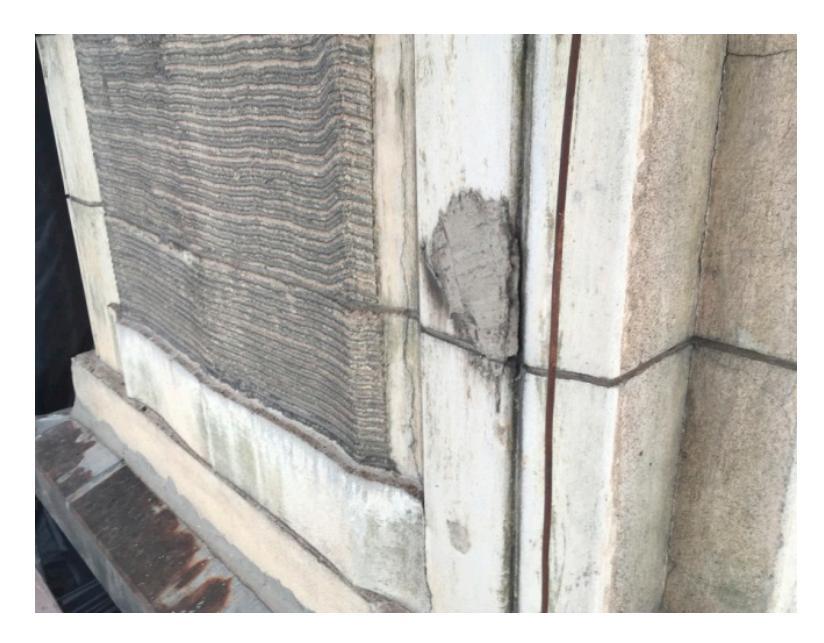
Numerous cavities and areas replastered with secondary cement mortar are visible on all facades of the building (Figure 8).

Figure 8. Cavities and areas replastered with secondary cement mortar.

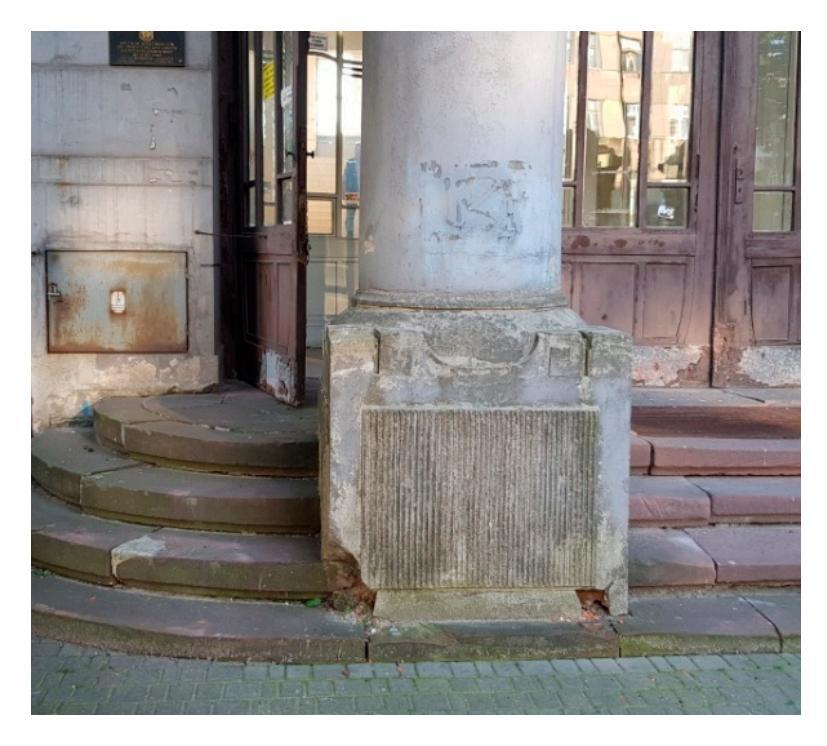
The exterior stairs, on the eastern and southern facades, were constructed of red sandstone. Their surface shows damage and cavities, and there are mosses, algae, and lichens due to the long-term presence of moisture (Figure 9).

Figure 9. Damage and cavities in exterior stairs made of red sandstone.

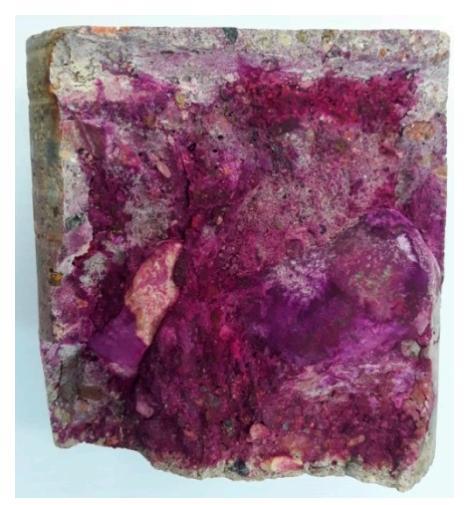
The tests showed that the thickness of the near-surface layer of concrete that was not stained in the phenolphthalein test reached 3 mm in the top part of the floor slab, while the depth of concrete carbonation in the bottom part of the floor slab was 10 mm (Figure 14). The top layer of the floor slab had been covered with xylolith flooring that contained magnesia cement, which may have influenced the small depth of carbonation.

Figure 14. A photograph showing a concrete fracture with a phenolphthalein solution applied.
