# Article Identification and Chemical Characterization of Insoluble Contaminants in Hemodialysis Water Treatment

# Sebastian Mas <sup>1,2,\*</sup>, Jesús Egido <sup>1,2,3</sup>, Alberto Ortiz <sup>1,3</sup>, and Emilio Gonzalez-Parra <sup>1,3</sup>

Received: 2 March 2018; Accepted: 9 April 2018; Published: 16 April 2018

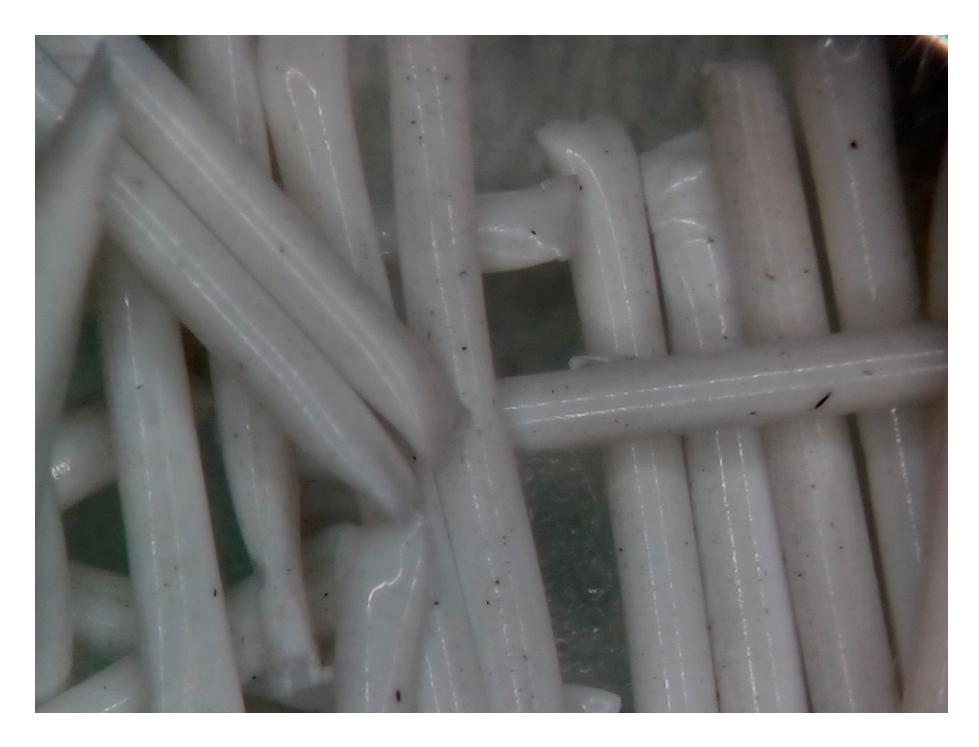
Ultrafilters from two centers showing signs of contamination were received in the IIS-FJD Renal research laboratory within a one-year period. Macroscopically, they were similar. At  $20 \times$  magnification, the presence of soot-like particles was observed on the fiber surface in both of the samples (Figure 2).

Figure 2. Optical microscopy view of ultrafilter fibers extracted from their case (Original magnification  $20 \times$ ).

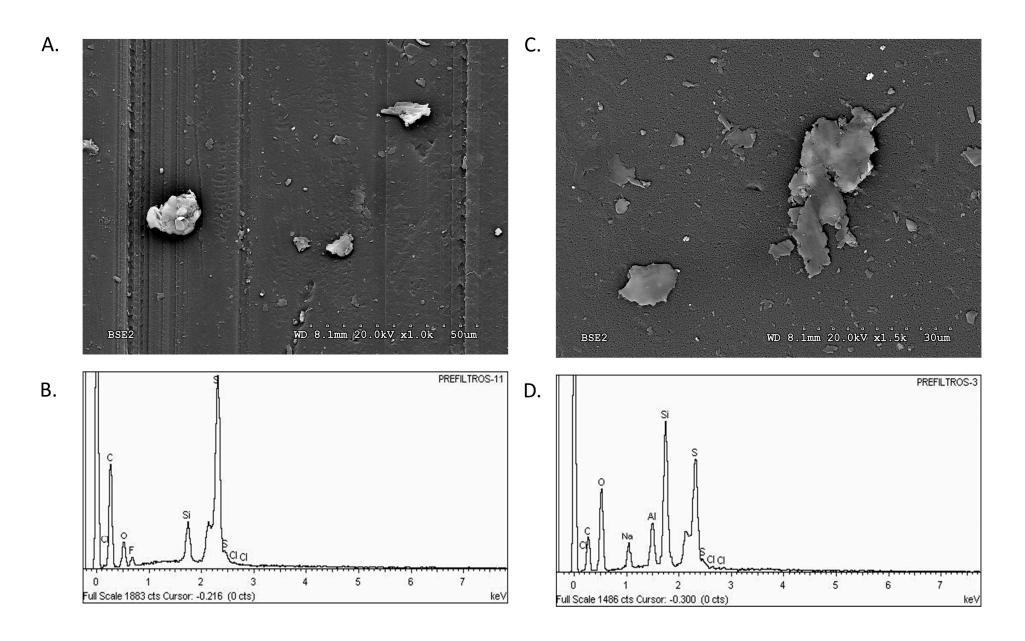
In the microscopic analysis, soot-like black particles were observed. Ultramicroscopic analysis using SEM showed scale deposition in more than 50% of the surface of the membrane (Figure 3A,C). A general (Figure 3B) and focused (Figure 3D) elemental chemical analysis showed a similar composition, which is rich in silica in combination with oxygen, magnesium, sodium, or chlorine, as consistent with the presence of silicates.

**Figure 3.** Electron microscopy images of particles found on ultrafilters from dialysis center 1. (**A**) General view of deposits on the membrane. (**B**) Elemental chemical composition. (**C**) Magnification of deposit scales on the membrane. (**D**) Elemental chemical composition of contaminant shown in (**C**).

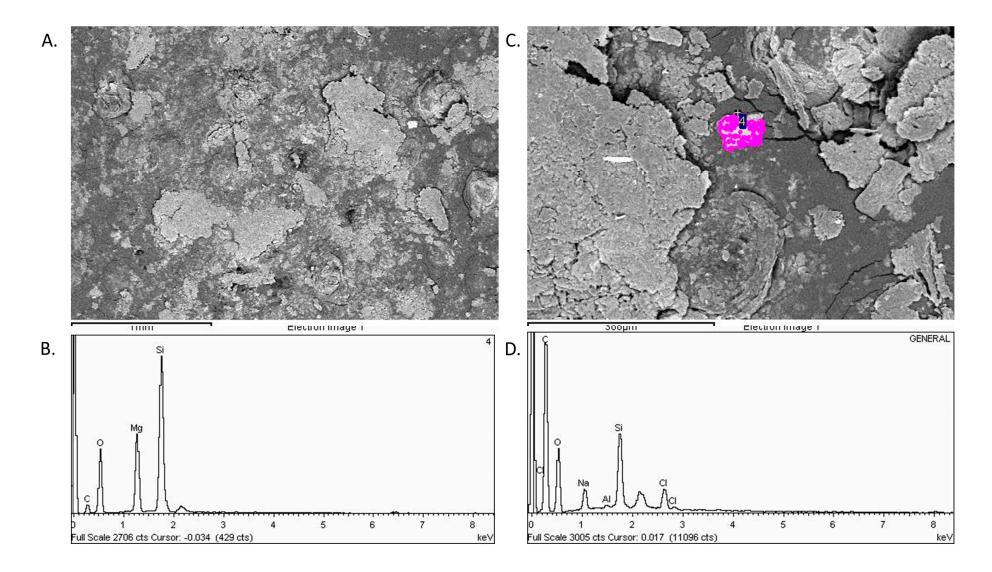
The microscopic analysis of the soot-like particles in ultrafilters from DC2 disclosed particles that were identical to those in DC1 ultrafilters, although the amount was lower. Analysis of relatively large areas disclosed the presence of carbon, oxygen, and sulfur, as consistent with components of the dialyzer membrane polymer (polyethersulfone). Additionally, this analysis disclosed traces of silica, whose signal increases as the analysis focused on specific particles. As in the previous case, the presence of silica was associated with an increased signal for oxygen, aluminum, and alkaline metals (Figure 4).

**Figure 4.** Electron microscopy images ultrafilter fibers from Dialysis center 2. (**A**)  $1000 \times$  magnification showing flake-like particles. (**B**) Elemental composition of the particles in (**A**). (**C**)  $1500 \times$  magnification of another particle and (**D**) Composition of the purple particle in (**C**). Particles in (**B**–**D**) have a higher signal for Si, O, Al, Na, and K.

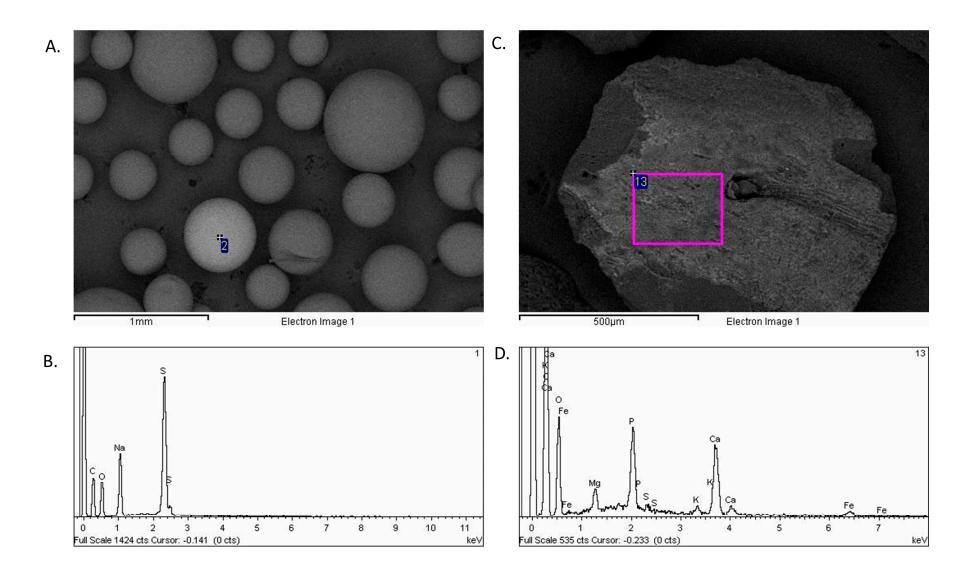
The ion-exchange resin and activated carbon filters were analyzed to assess the possibility of leakage of carbon filters and resins into the water treatment circuit. Figure 5 shows the electron microscopy image of resin filter particles (Figure 5A) and their chemical composition (Figure 5B). In the composition analysis, no signal is observed for aluminum or silica, which were characteristic of the soot-like contaminating particles.

**Figure 5.** Electron microscopy images of water purification components. (**A**) Image and (**B**) composition of the ion exchange resin. (**C**) Image and (**D**) composition of activated carbon.

Similarly, Figure 5C shows an electronic micrograph of one of the activated carbon particles from the water purification system. The elemental analysis revealed the presence of many components other than carbon, such as phosphorus, calcium, magnesium, and even iron ions. But, as in the previous case, both aluminum and silica were absent. This suggests that neither the resin nor the activated carbon in the water purification system are the origin (at least in appreciable quantities) for the contaminating particles that were identified in the ultrafilters.
