# Damage Evaluation and Seismic Assessment of a Typical Historical Unreinforced Masonry Building in the Zagreb 2020 Earthquake: A Case Study—Part I

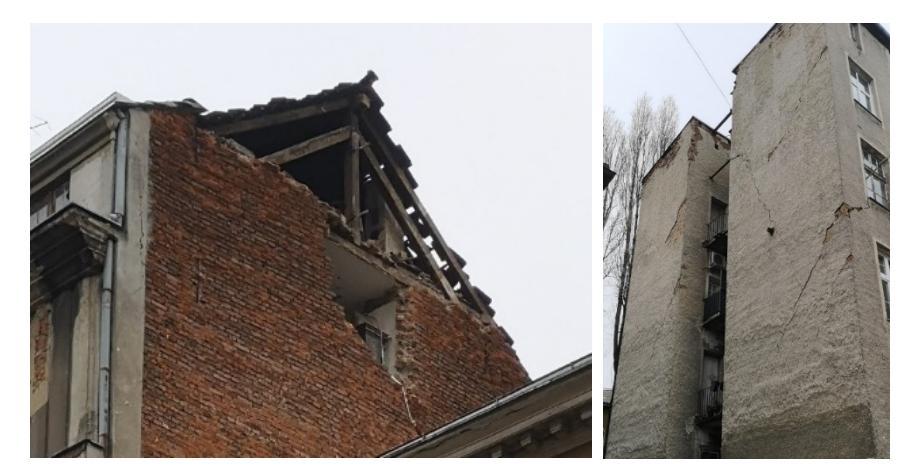
The first inspection of the building was carried out on the day of the earthquake, 22 March 2020, and the building was categorized as temporarily unusable. Severe damage to partition walls, and moderate damage to most load-bearing walls except for the courtyard wall that was severely damaged, was observed. The gables in the attic space of the building and the chimneys were also severely damaged. Slight damage was recorded to the floor

structures, the staircase, and the roof structure, with indications of very severe damage to the chimney and some of the tiles falling off. Photographs of the damage are shown in Figure 6.

Figure 6. Photographs from damage assessment of the building after the Zagreb earthquake.

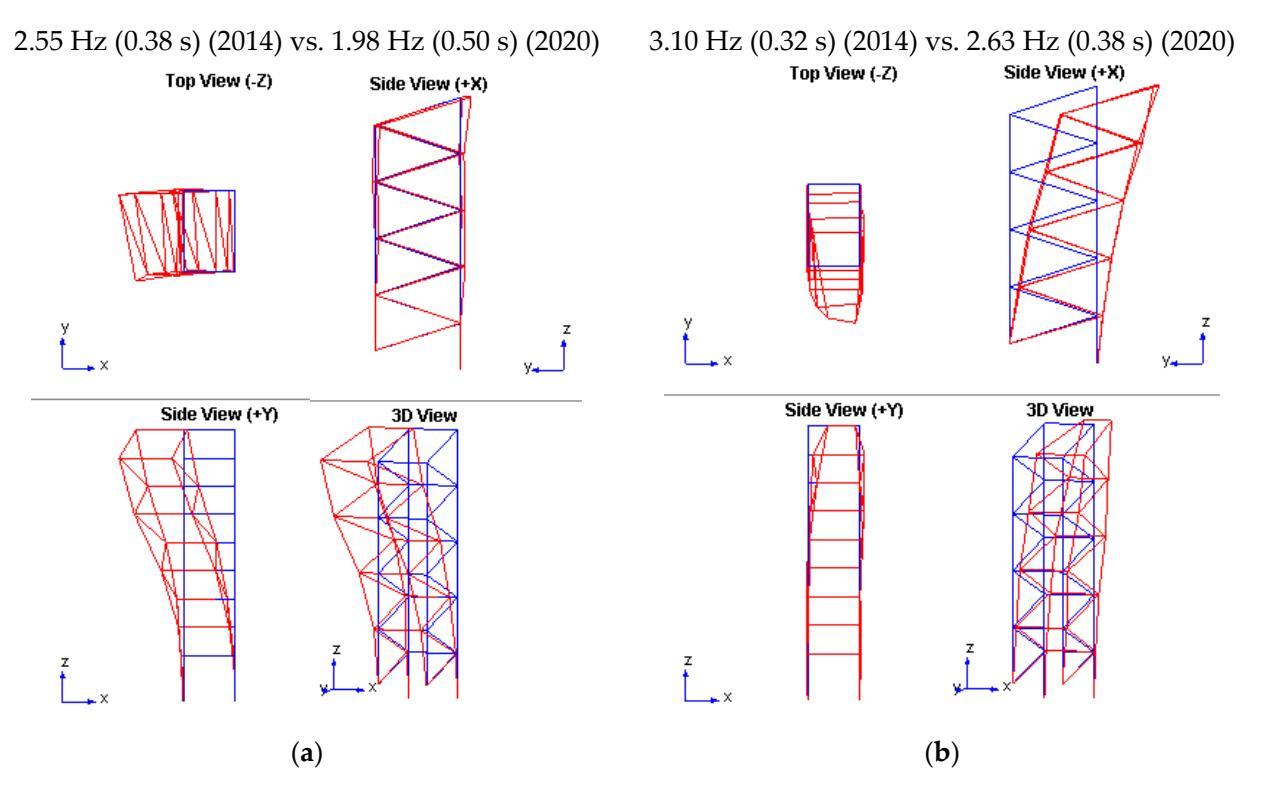
Figure 9 graphically shows the main vibration modes of the building and allows for a comparison of the measurements taken before and after the earthquake in Zagreb. It may be noted that the mode shapes do not change between the two measurement periods (before and after the earthquake). It is obvious that the periods of the fundamental modes of vibration were prolonged due to the damage caused by the earthquake. For example, the first mode of vibration in the X direction (longitudinal direction) was 0.39 s before the earthquake but 0.50 s after the earthquake. This corresponds to a reduction in global stiffness of about 40%. The second mode of vibration, which predominates in the Y direction (transverse direction), had a period of 0.32 s and 0.38 s after the earthquake. Thus, the reduction in global stiffness due to the earthquake damage is about 30%. These data clearly show that the stiffness of the load-bearing elements of the building has decreased.

**Figure 9.** Experimentally obtained (**a**) first (dominant) translation mode shape in y direction, and (**b**) second translation mode shape in X direction. The blue lines represent the undeformed shape, while the red lines represent the deformed shape.

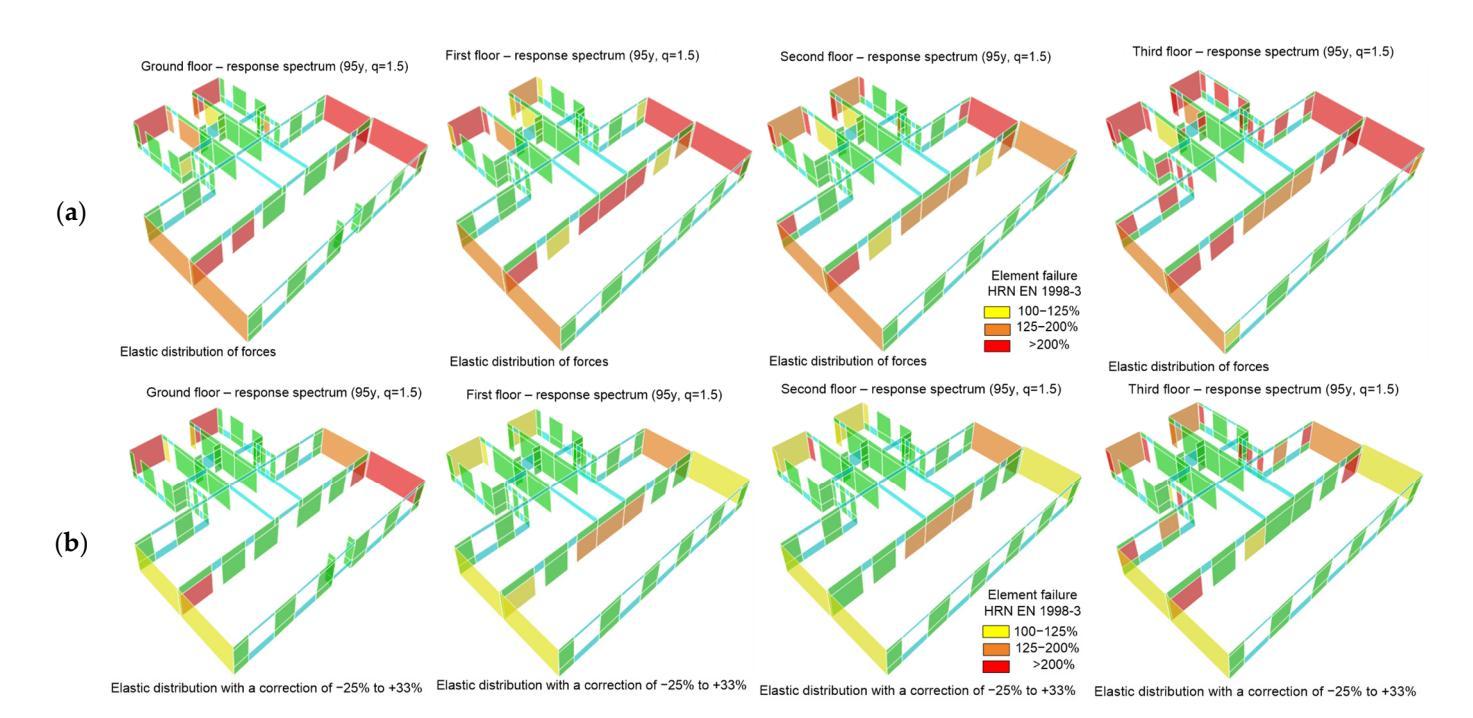
The following Figure 14 shows the results of wall seismic capacity analysis. It is evident that many elements exceed their shear force capacity by more than 200%, with some walls exceeding the load factor by more than 300%, which is well above the permissible values. In order to account for redistribution of forces due to nonlinear behavior of elements in this type of linear analysis, a redistribution of forces in load-bearing elements ranging from -25% to +33% was performed (according to the Eurocode). The condition for the application of the redistribution is that the resultant lateral force is unchanged (same intensity and position in each story). Figure 14b illustrates the outcomes of this redistribution, indicating that it has a beneficial impact on the utilization of the cross-section. It is important to highlight that a 25% reduction in internal forces in the critical element does not necessarily lead to a 25% decrease in utilization.

**Figure 14.** Summary of the wall shear capacity for seismic action with a 95-year return period (behavior factor 1.5) (**a**) without and (**b**) with redistribution performed.

In unreinforced masonry, high forces often lead to a significant reduction in the compressive area of the wall, which is crucial for its resistance to lateral loads. Therefore, a 25% reduction can significantly increase the compressive area and lead to even more of an increase in the element resistance. Besides the resistance of individual elements, it is important to consider the condition of the resultant force during redistribution of the 25% force from critical elements. If the structure has a high degree of static indeterminacy, this is not commonly a problem. However, if there are only a few walls in the floor plan or if there are individual walls that dominate the bearing of lateral loads (typically massive and/or long walls), satisfying the equality of the resultant force can be challenging. In this study, after conducting redistribution of forces in the model, a certain reduction in the utilization of the capacity of the elements was achieved; however, there were still elements exceeding the bearing capacity by over 200%.

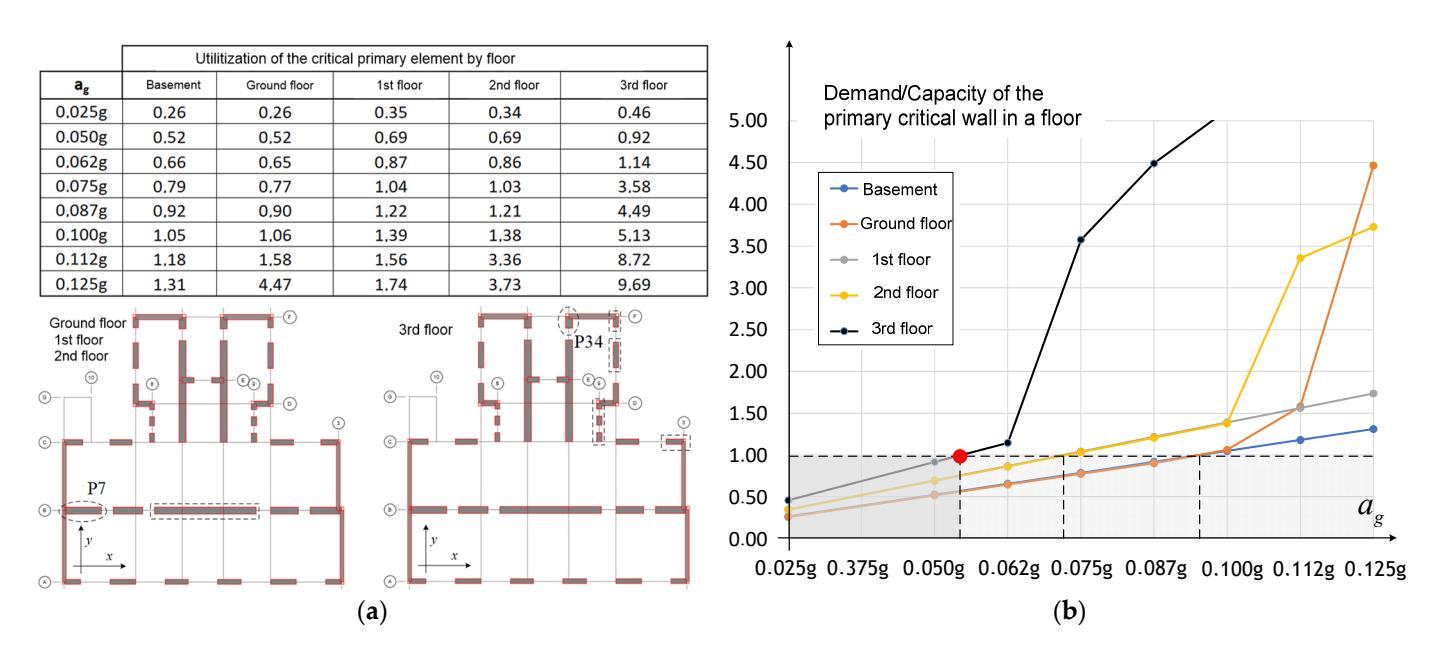
**Figure 15.** Parametric analysis results for  $a_g$ . (a) critical element utilization by story. (b) demand/capacity of the primary critical wall in each story.

The SD limit state of the building was determined based on the critical elements on the 3rd floor, and was found to be only 43% of the demand for  $a_g = 0.125$  g. The SD limit state of critical elements on the 1st and 2nd floors was then found to be 58%, while in the basement and on the ground floor, we found it to be 76% of the 95-year return period ground acceleration.

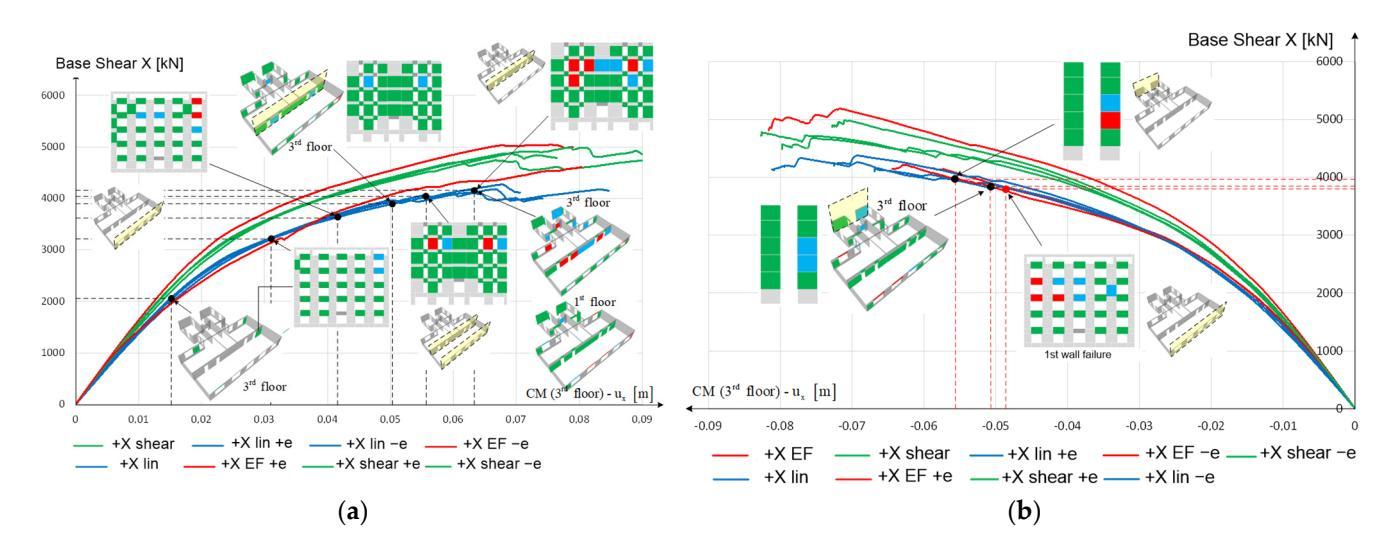
**Figure 17.** Relevant capacity curves of the building: (a) in the +X direction. (b) in the -X direction.

The first failure of a structural element occurred at a base shear force value of 3200 kN (B.S. = 10%) and a displacement of the CM on the 3rd floor of 3.1 cm. Several spandrels were observed to be in the SD limit state at this point. The next significant point was the failure of the spandrels on the street façade of the building at a base shear value of 3700 kN and a displacement of the CM on the 3rd floor of 4.2 cm. At this point, all the piers were still in a state of limited damage. It should be emphasized that these were "weak" spandrels, which are typical for masonry buildings in Zagreb.

The first pier failure occurred at a lateral force value of 4000 kN (B.S. = 12.5%) and a CM displacement of the 3rd floor of 5.1 cm. These were the piers on the 3rd floor in the central longitudinal axis of the building that reached the drift capacity, meaning localized failure of the floor structure could occur. It can be assumed that, at this point, the building was in a state of near collapse and had the highest degree of damage. Global failure occurred at a lateral force value of 4200 kN (B.S. = 13%) and a displacement of the 3rd floor CM of 6.3 cm. It should be noted that the walls of the basement, ground floor, and 1st floor were not critical for a positive direction of lateral force in the X direction.

The capacity curves for the negative X direction of the lateral load are depicted in Figure 17b. Similar to the previous case, the spandrels were the first to reach the SD limit state and so could be considered critical. In this scenario, the failure mechanism of the load-bearing system was initiated with the failure of the western courtyard wall on the 1st and 2nd floors. These walls reached the SD limit state at a lateral force of 3900 kN and a CM displacement of the 3rd floor of 5.1 cm, and their failure occurred when the displacement reached 5.6 cm. These piers were relatively rigid and located far from the CM, exposing them to significant shear forces caused by torsional effects resulting from the asymmetry and eccentricity of the load.

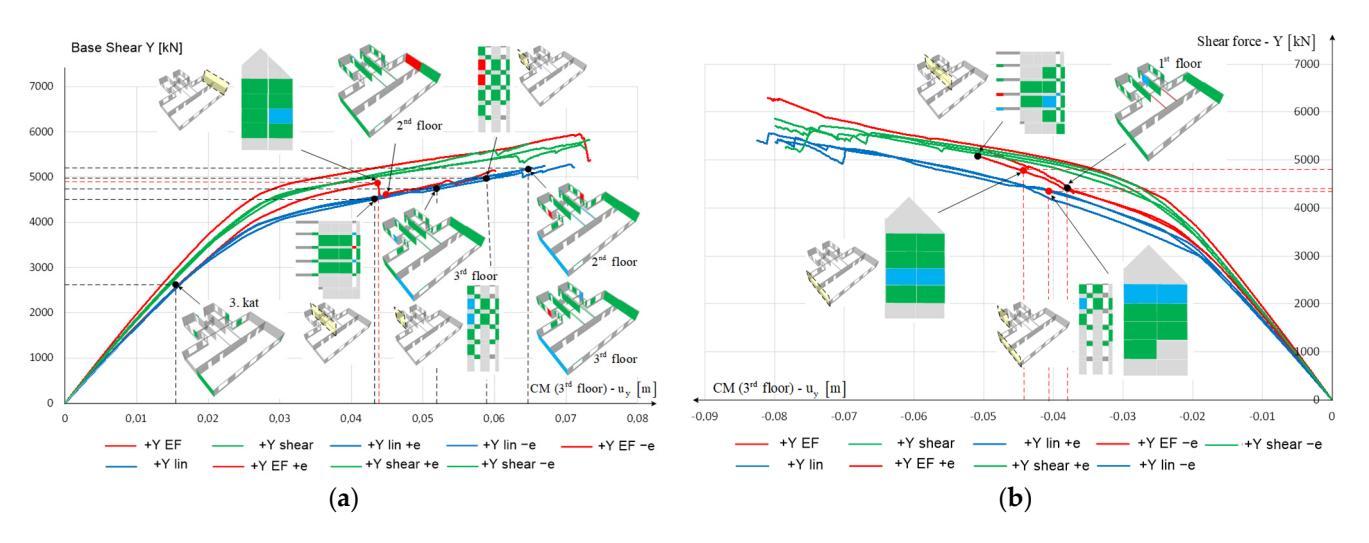
Capacity curves for the positive Y direction of lateral force are shown in Figure 18a. It is evident from the figure that some structural elements experienced an LD state when the base shear reached 2600 kN (B.S. = 8.1%) and the displacement of the 3rd floor CM was 1.6 cm. Primarily, these elements were located on the 3rd floor.

**Figure 18.** Relevant capacity curves of the building: (a) in the +Y direction. (b) in the -Y direction.

Just like the previous load case, applying the load in the Y direction also led to a consistent occurrence of exceeding the limit state for spandrels in terms of the SD. The spandrels that were critical and had limited rotation capacity were located at the edge of the central transverse wall along the staircase towards the west side of the building. The structural piers first exhibited failure when subjected to a lateral force of 4500 kN

(B.S. = 14%) and a displacement of 4.3 cm at the 3rd floor CM. The piers located on the north side of the building's north gable wall were the primary components that initially reached the SD limit state. This included the piers on the 1st floor, followed by the capacity of the piers on the 2nd floor being exceeded. Depending on the eccentricity of the load, the outermost south walls could also be regarded as critical components due to the building's symmetry in this direction. An interesting observation made of the capacity curve was a sudden significant drop (red curve) caused by the failure of the piers of the north gable wall. Despite the failure of several piers, the total lateral force continued to increase as the load increased. The walls of the courtyard façade on the 2nd and 3rd floors were the next elements where the SD limit state was exceeded in the transverse direction. As for the X direction, the building experienced critical pier failures primarily on its upper levels. Although the SD limit state was reached in several elements, the structure still maintained load-bearing capacity and ductility, preventing the building from collapsing. The ultimate displacement of the 3rd floor CM during global building collapse was estimated to be around 6.0 cm. The basement and ground floor walls were not considered critical for action in the positive Y direction.
