The Use of Acoustic Emission to Diagnosis of Fuel Injection Pumps of Marine Diesel Engines

Artur Bejger * D and Jan Bohdan Drzewieniecki *

Department of Condition Monitoring & Maintenance of Machinery, Maritime University of Szczecin, 71-650 Szczecin, Poland

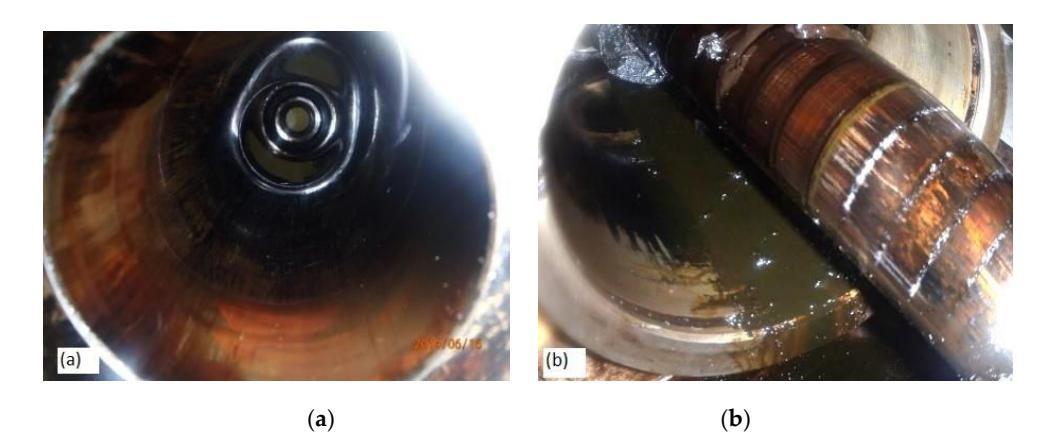
In Mitsubishi UEC engines, lubricating oil used in an engine's lube oil system is fed continuously through an orifice and drilled-sleeve in the FIP barrel to the fuel rack (Figure 1a, yellow field) in order to lubricate and wash down fuel deposits. At the same time, it lubricates and cleans the lower part of the FIP and washes the spring chamber (Figure 1a, green part). If the oil flow is in some way limited (accumulation of sludge, clogged drain line) or there is a fuel leak due to wear of the B-P pair, the lubrication and cleaning of these FIP elements may not be sufficient and may lead to seizure between the fuel rack's control sleeve and barrel and B-P pair jamming, or so-called sticking (adhesive vaccination), disenabling the engine to start, as shown in Figure 3.

Figure 3. The view of a sticking fuel-injection pump (FIP) of Mitsubishi UEC Engine: (**a**) sticking barrel, (**b**) sticking plunger.

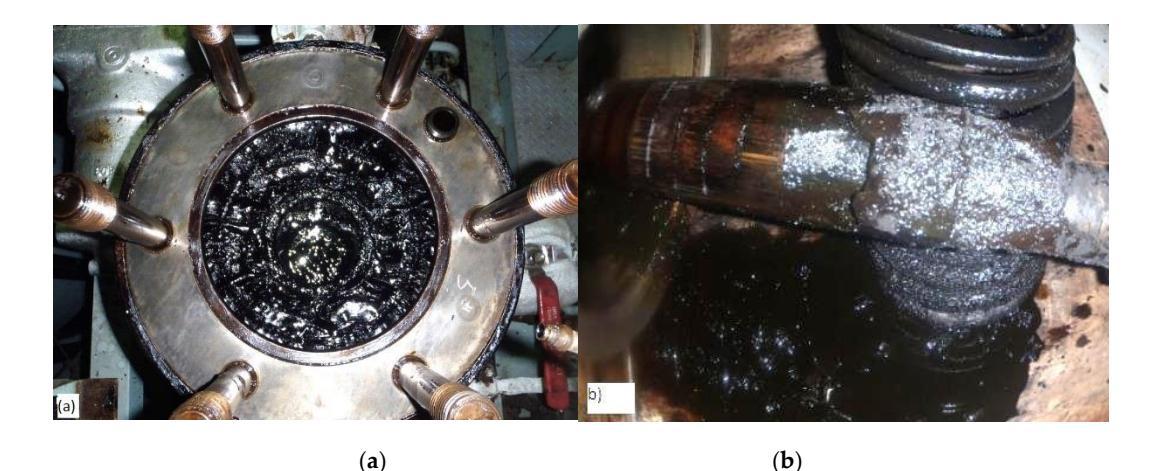
In MAN B&W MC engines, sticking of FIP elements were observed as the result of a decrease in fuel viscosity during engine stoppage (especially in cold climate) and formation of deposits in FIP parts around the suction valve and upper part of the barrel (Figure 1b, red part; Figure 4a). This leads to clogging of the drain/circulating line and causes the VIT rack to stick, not allowing the barrel to move up/down, consequently disturbing fuel injection timing. It is also the reason for the deposition and presence of hardened remains of residual fuel in the lower part of the plunger (Figure 1b, green part; Figure 4b), disenabling the engine to start.

Figure 4. Solid fuel deposits covering FIP of the MAN B&W MC engine in the upper part of the barrel (**a**), and spring and plunger (**b**).

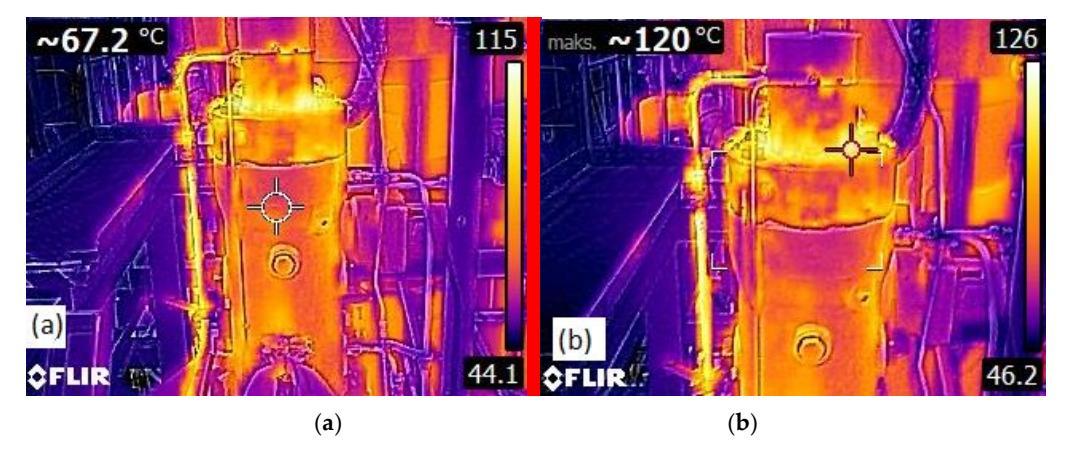
Figure 5. FIP infrared images of the MAN B&W 7S80MC-C engine in thermal MSX mode taken by an Flir E4 camera: (**a**) M/E in stop position temp. at spot meter in the middle of the FIP body, (**b**) M/E running at 85% MCR & 74RPM (full sea speed) temp. aiming at the hottest place of the FIP body.

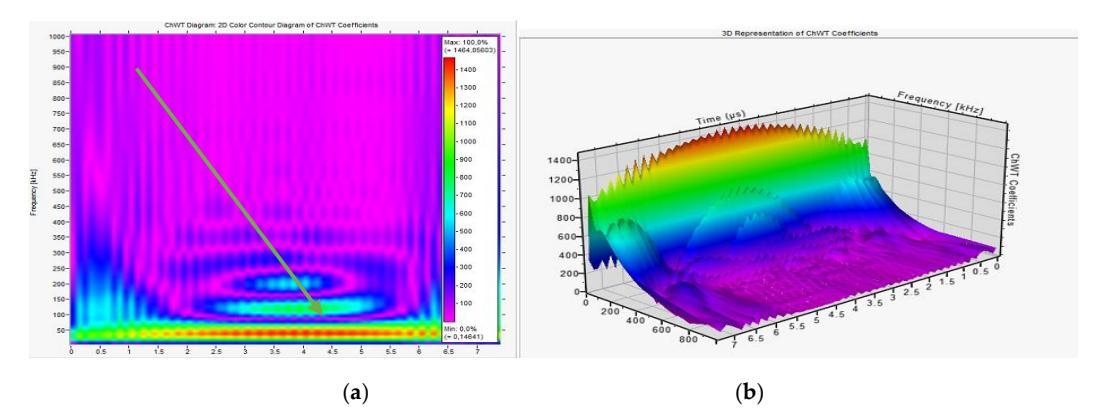
Figure 9. Analysis of AE signal for FIP of Mitsubishi MHI 7UEC85LSII engine, the case for FIP with new precision pair: barrel – plunger B-P (the highest energy occurs in the lower frequency range—of the order of 50 kHz), (**a**) time-frequencies analyses, (**b**) amplitude-time-frequency analyses

In the case of a new injection pump, the analysis of the generation of elastic wave signals of the acoustic emission is similar to a properly working tribological node, i.e., the highest energy occurs in the lower frequency range—of the order of 50 kHz (Figure 9). For increased clearance of the precision pair (Barrel-Plunger) of the pump, additional high-pressure cavitation processes were created and generated an increase in energy at much higher frequencies—on the order of 200–350 kHz (Figure 10).

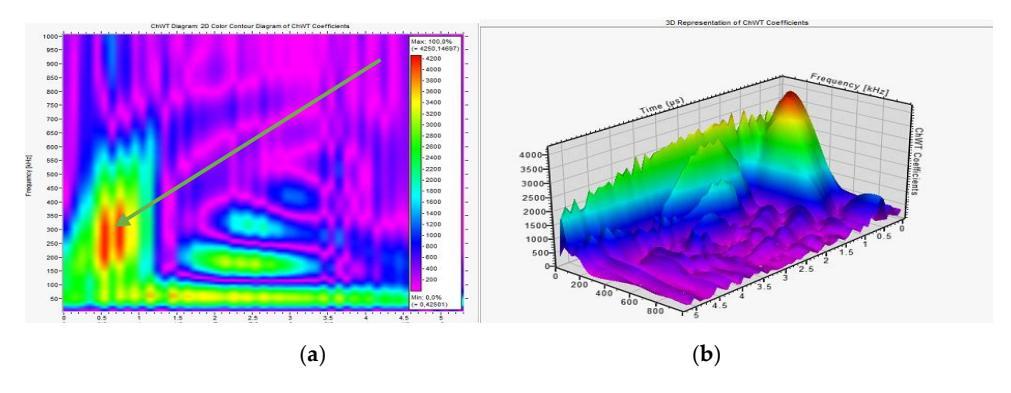
The results are presented in Figure 9 for the case of a new precision pair: Barrel-Plunger (B-P), and Figure 10 for the case of a B-P with enlarged clearance after 11,000 RH, caused by the use of poor quality fuel with high cat fines content. The important differences from a diagnostic point of can be seen in the time–frequency distributions in the analysis presented below. These differences are related to ongoing friction processes and changes in the P-B radial clearance.

Figure 10. Wavelet analysis of AE signal for the FIP of Mitsubishi MHI 7UEC85LSII engine, the case for FIP after 11,000 (RH) and precision pair: barrel-plunger (B-P) with enlarged radial clearance (generating an increase in energy at much higher frequencies—on the order of 200–350 kHz), (**a**) time-frequencies analyses, (**b**) amplitude-time-frequency analyses

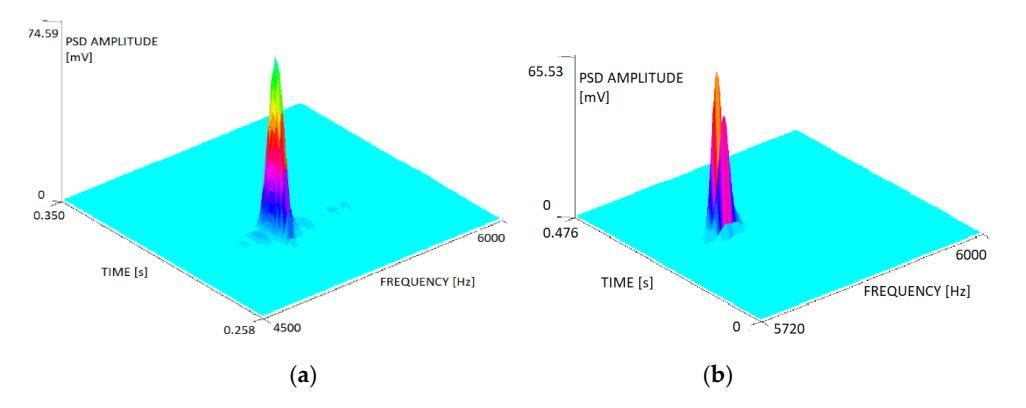
Figure 11. Comparison of power-spectral-density (PSD) analyses of AE signals for the new FIP (**a**) and FIP after 11,000 RH with enlarged radial clearance (**b**) of a Mitsubishi MHI 7UEC85LSII engine.

The power spectral density describes how the power of a signal is distributed over frequency, as the Fourier transform shows the spectral content of a given signal, i.e., the amplitude and phase of harmonics in the measured signal. The PSD analysis helps to isolate the most important harmonic components and to determine the magnitude of amplitudes of those components. The analysis determines the amplitudes of subsequent harmonics (the amplitude spectrum) and/or phase shifts (phase spectrum). There can be noticed differences in PSD amplitudes, clearly indicating the wear in the FIP B-P precision pair. There is also a disturbance observed in the so-called characteristic frequencies generated by the FIP.
