# Article Investigation of the 0.4C-35Cr-45Ni-Nb Alloy after Service in High-Temperature Steam and Hydrocarbons Environment

**Abstract:** The paper presents the results of investigation of the 0.4C-35Cr-45Ni-Nb alloy, which operated in the cracked hydrocarbon feeds and dilution steam at 1125 °C. The material originated from the pyrolytic furnace coil tubes, of which internal walls were in contact with the aforementioned medium, whereas the external walls were in contact with the flue gases. The examination included metallographic and mechanical tests on the material after service exposure, the results of which were compared with the ones obtained for the as-received non-exposed specimens. The metallographic tests revealed changes in the alloy's structure manifested by formation of significant amount of the carbides due to carburization of the alloy from the steam and cracked hydrocarbon feeds side. The central and external parts of the alloy samples (having no contact with the process medium) underwent substantial degradation but within a relatively narrow zone of the material. The investigations of hydrogen and methane content in the alloy showed a high amount of these gases, res

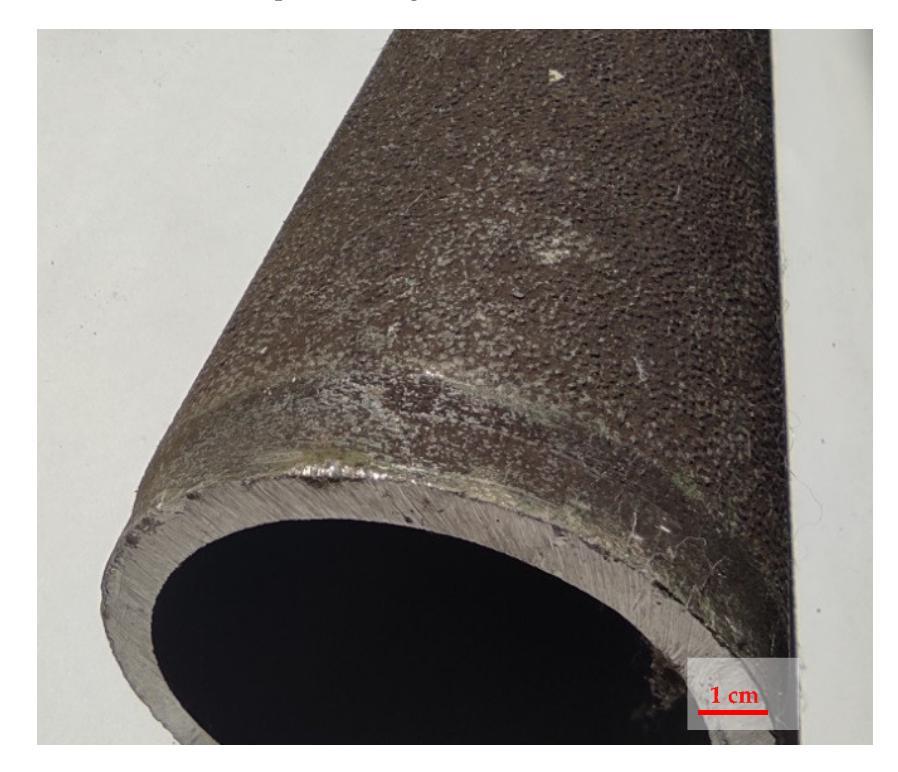
Figure 2. Pyrolytic furnace's coil tube subjected to investigation.

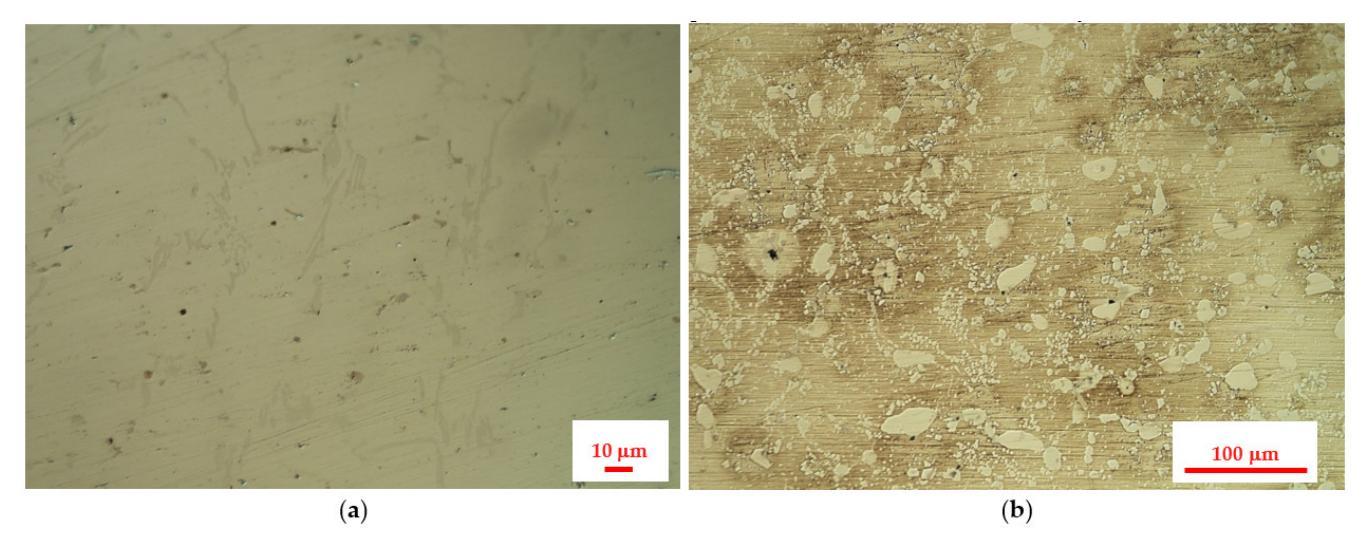
**Figure 3.** Surface images of the 0.4C-35Cr-45Ni-Nb alloy obtained during metallographic investigations: (**a**) as-received reference sample; (**b**) material after 5 years of service in the furnace.

The results of the investigation of the non-exposed reference sample are in accordance with the literature data [6–8]. The metallographic tests revealed carbides present in the form of branched lines (Figure 3a) [9,10]. The SEM image (Figure 4) shows dark structures (spot 1) containing significant amount of chromium and bright structures (spot 3) with higher niobium content with respect to the matrix. Very similar structure and elemental composition of particular phases of the alloy can be found in the paper [8].

In case of the alloy after 5 years of service exposure, one can notice a significant change in the microstructure. There are much more distinct precipitates of the carbides, which occupy a substantial area of the sample (Figure 3b). The change of microstructure results from long-term exposure to the temperature above 805–866 °C and from the influence of the stream inside the coil tubes, which favored carburization [2]. SEM and EDX also reveal chromium-rich phases (spot 1—Figure 5); however, the composition of particular phases differs with respect to the alloys subjected only to an ageing process [2,8]. This fact indicates that the change of microstructure is related to the impact of both aggressive environment and high temperature [11]. No creep process was identified, which suggests a high resistance of the alloy to this phenomenon.

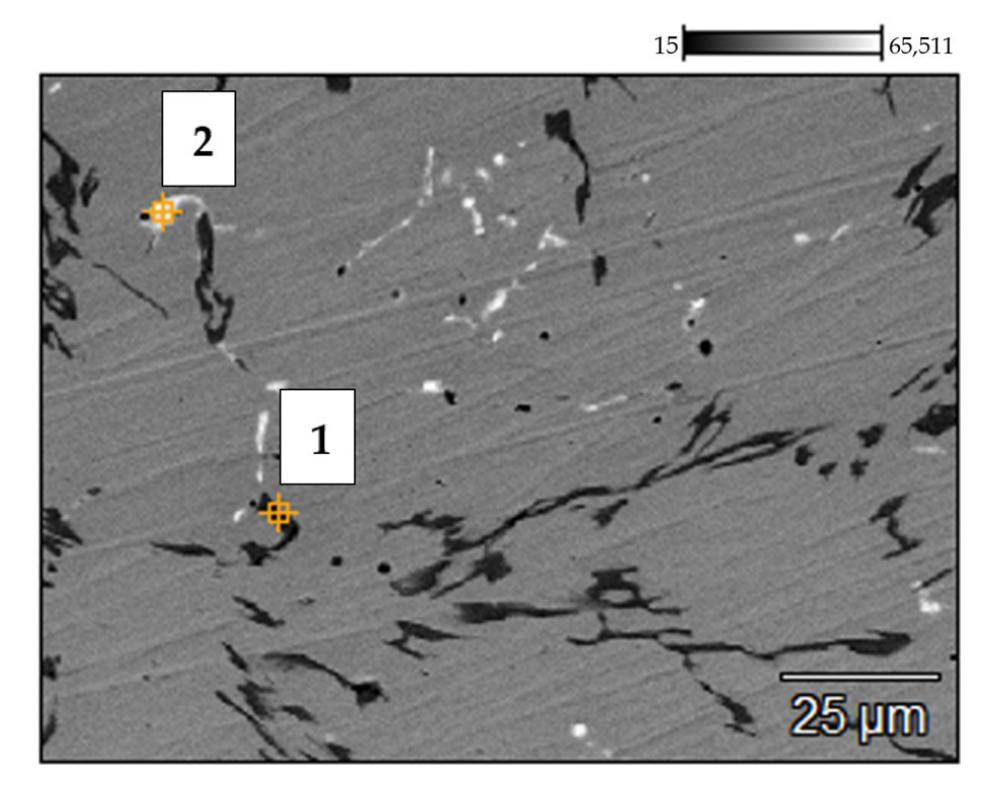
**Figure 4.** Backscattered electron (BSE) mode scanning electron microscopy (SEM) image of the 0.4C-35Cr-45Ni-Nb alloy—non-exposed reference sample's surface. Numbers indicate the spots of energy dispersive X-ray (EDX) analysis.

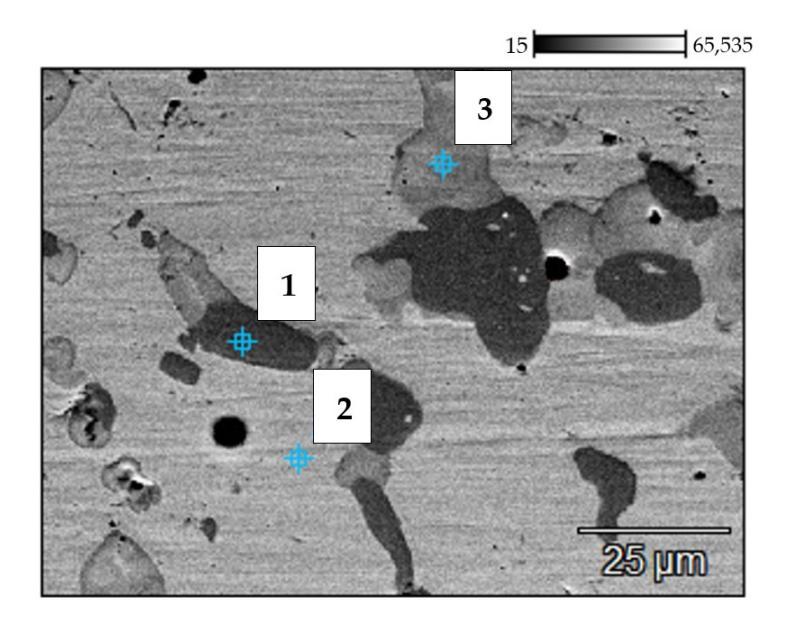
**Figure 5.** BSE SEM image of the 0.4C-35Cr-45Ni-Nb alloy—service exposed sample's surface. Numbers indicate the spots of the EDX analysis.

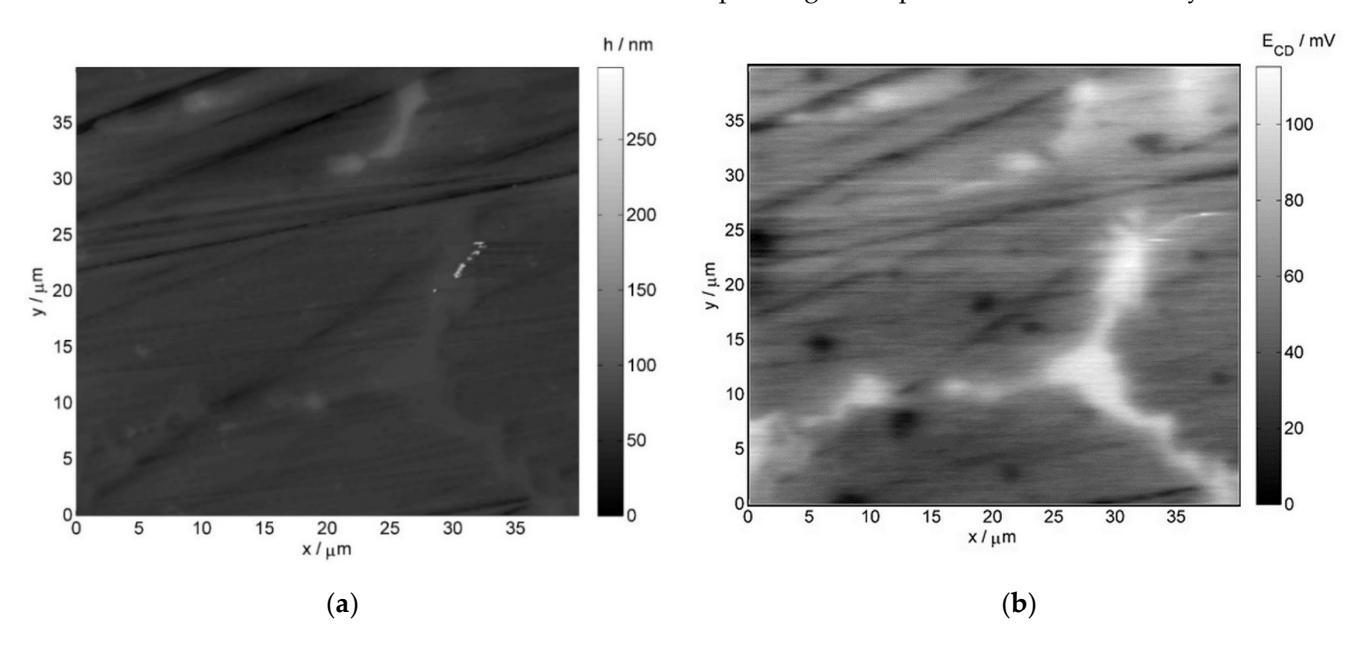
Figure 6. (a) AFM and (b) SKPFM images of the 0.4C-35Cr-45Ni-Nb alloy—non-exposed reference sample's surface.

In case of the non-exposed reference sample, the chromium-rich inclusions (more noble) are present on grain boundaries, which is visible on both the AFM image (brighter elevated regions) and SKPFM image (bright regions indicating higher potential as compared to the matrix)—Figure 6. After the service exposure, niobium-rich phases are clearly resolved on the AFM and SKPFM images (Figure 7). They can be identified as brighter regions on the topographical AFM image, whereas on the SKPFM image, the niobium-rich phases are dark regions due to their lower potential with respect to the matrix. These results are consistent with the EDX measurements presented earlier.

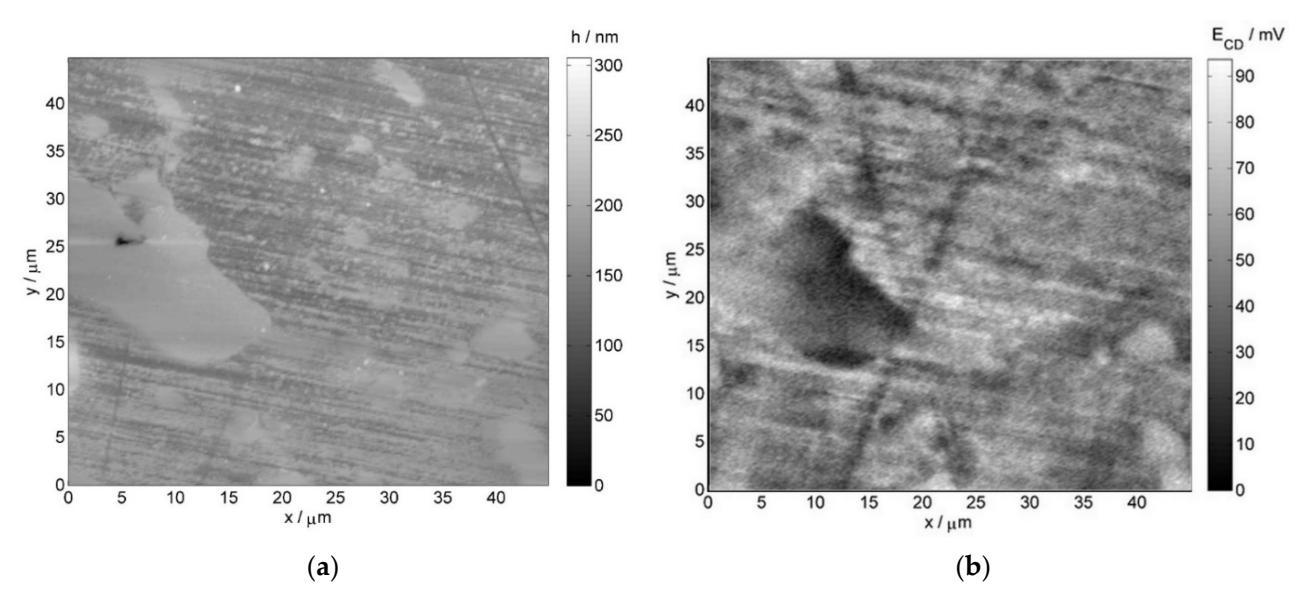
Figure 7. (a) AFM and (b) SKPFM images of the 0.4C-35Cr-45Ni-Nb alloy—service exposed sample's surface.

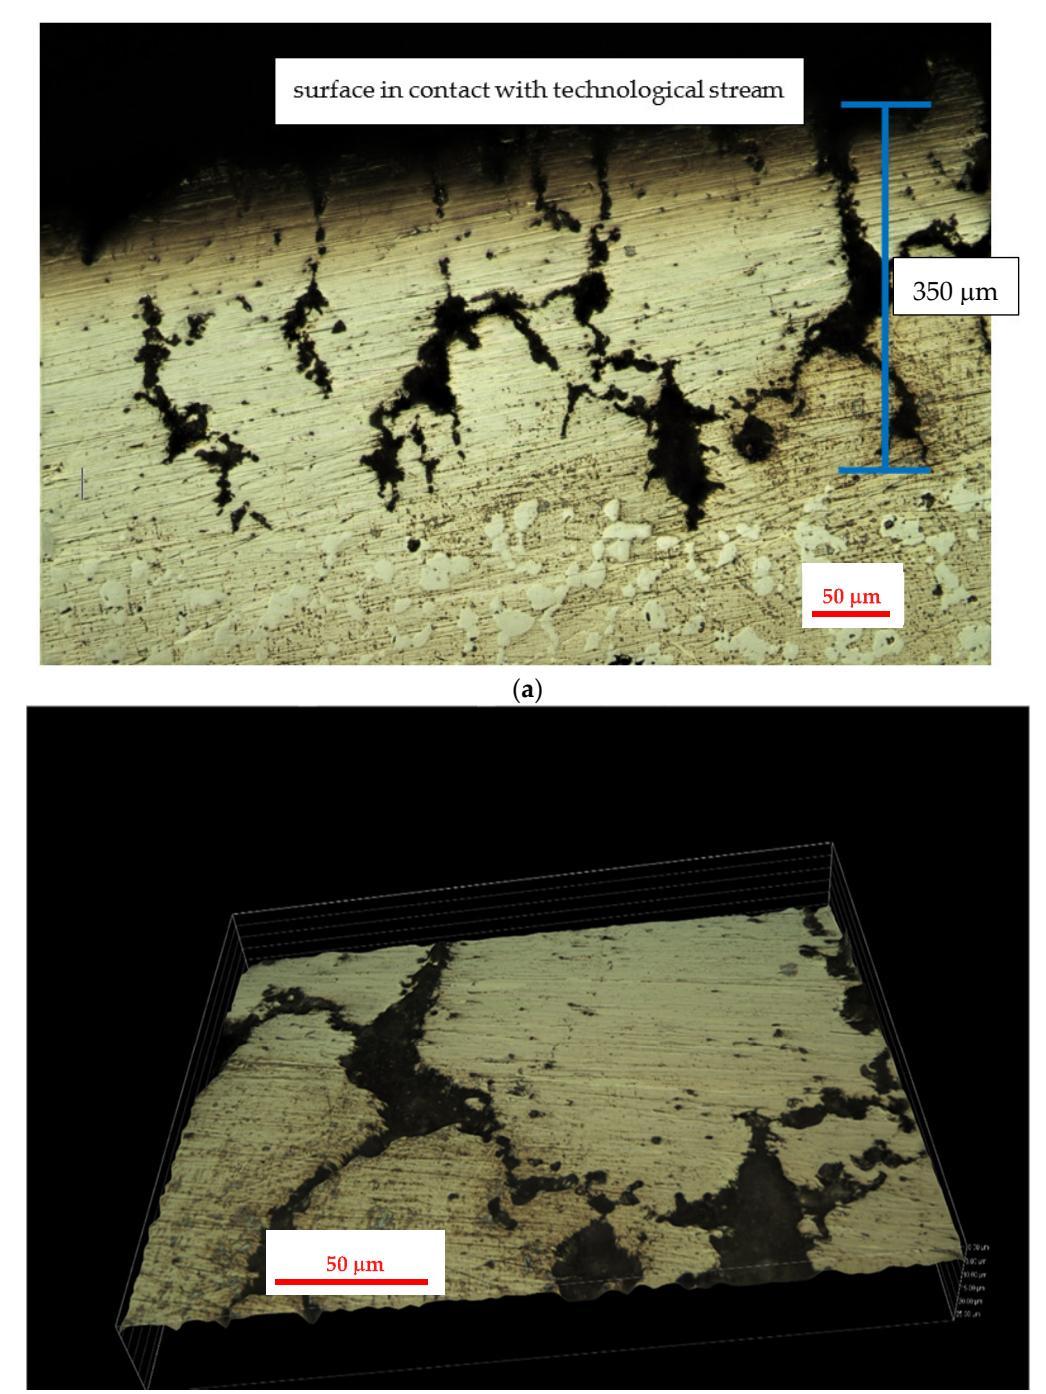
**Figure 8.** Surface images of the 0.4C-35Cr-45Ni-Nb alloy obtained during metallographic investigations of internal part of service exposed coil tube: (a) internal wall neighboring region; (b) magnification of a fragment of the region presented in (a).

The metallographic investigations show high degradation of the alloy structure in the part of the coil tube. This degradation extends ca. 300 µm from the internal wall to the bulk of the specimen. Visible dark structures are characterized by high amount of silicon and lower content of chromium (spot 1—Figure 9) as compared to the matrix. The presence of a narrow region suffering from dechromization process is also reported in some literature sources [2,12]. Moreover, the degraded zone of the alloy is much more carburized due to the presence of coke, which is formed during thermal degradation of cracked hydrocarbon feeds. Upon service conditions, the internal part of coil tubes can be subjected to metal dusting, although no significant corrosion losses were detected [13,14].

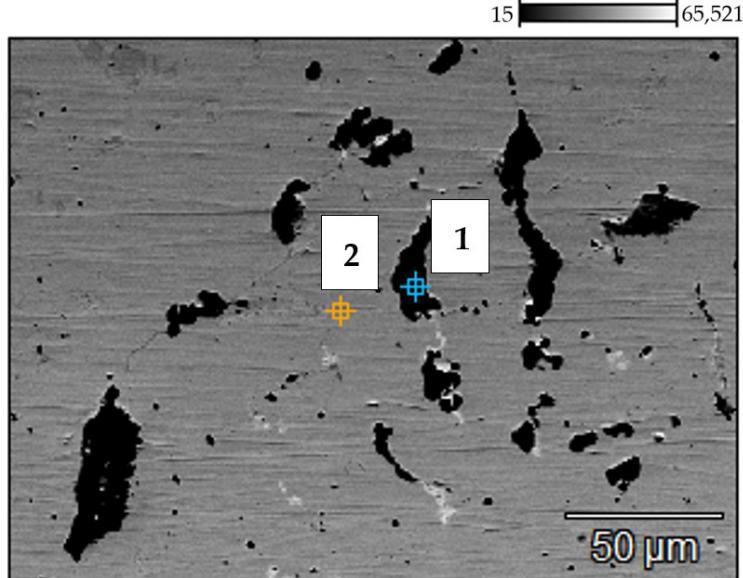
Figure 9. BSE SEM image of the 0.4C-35Cr-45Ni-Nb alloy surface—internal part of the service exposed sample. Numbers indicate the spots of EDX analysis.

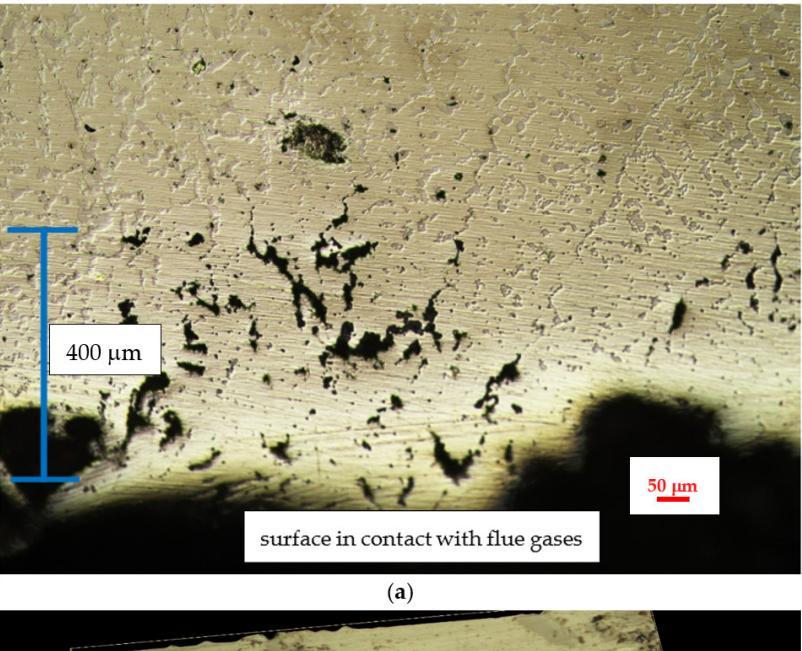
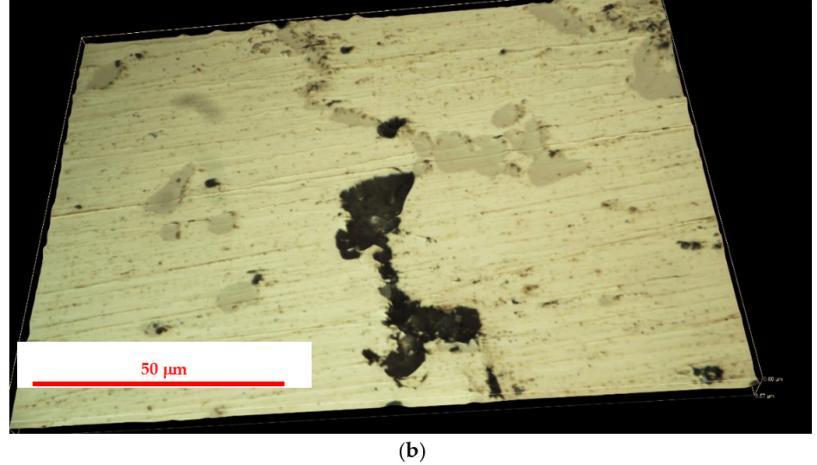
The external part of the coil tube was in contact with the flue gases used for heating of the furnace. In the analyzed case, the fuel consisted of gas hydrocarbons, mainly methane. Oxygen content in the flue gases stream was low, which indicated no risk of the oxidation mechanism [3]. The gas fuel utilized was of high purity, thus eliminating the mechanisms of fuel ash corrosion and flue gas dew point corrosion [3]. High temperature and low content of carbon compounds in the flue gases resulted in decarburization, which is evident on the metallographic images (Figure 10). It occupies a zone of ca. 200  $\mu$ m, which corresponds to the region with a limited number of carbides [11]. The entire zone of significant structural degradation covers 400 µm.

**Figure 10.** Surface images of the 0.4C-35Cr-45Ni-Nb alloy obtained during metallographic investigations of external part of service exposed coil tube: (**a**) external wall neighboring region; (**b**) magnification of a fragment of the region presented in (**a**).

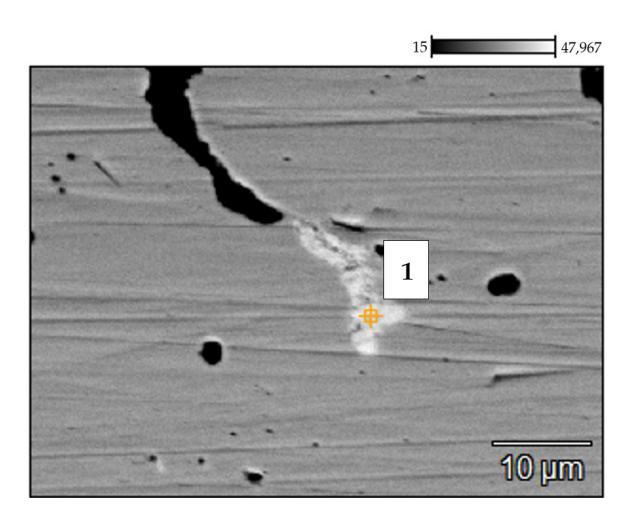
**Figure 11.** BSE SEM image of the 0.4C-35Cr-45Ni-Nb alloy surface—external part of the service exposed sample. The number indicates the spot of the EDX analysis.

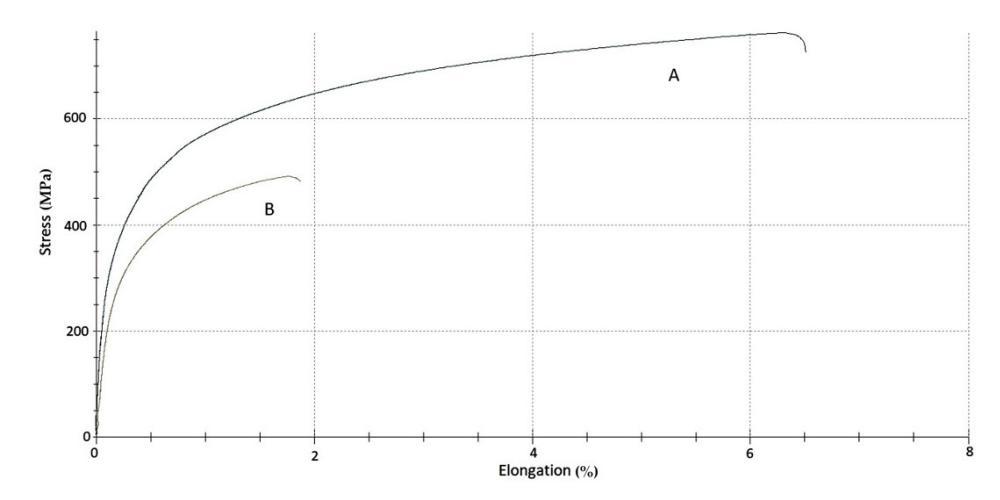
Figure 12. Results of mechanical tests of: (A) non-exposed reference sample; (B) service exposed sample.

The mechanical investigations revealed significant changes of the mechanical properties of the service exposed sample as compared to the reference material. Deterioration of plastic properties of the alloy is evident. The ultimate elongation of the exposed material decreased by more than three times compared to the non-exposed reference specimen. The maximum tensile stress also decreased by ca. 10%. Substantial deterioration of the mechanical properties is probably associated with the process of hydrogen and methane bubbles formation inside the alloy structure due to corrosion processes. Indisputably, it is a dangerous phenomenon (with potential negative influence on impact strength), which calls for more detailed investigation.
