Case Report Influence of Corrosion on Fatigue of the Fastening Bolts

Maciej B. Lachowicz ^{1,2} and Marzena M. Lachowicz ^{1,*}

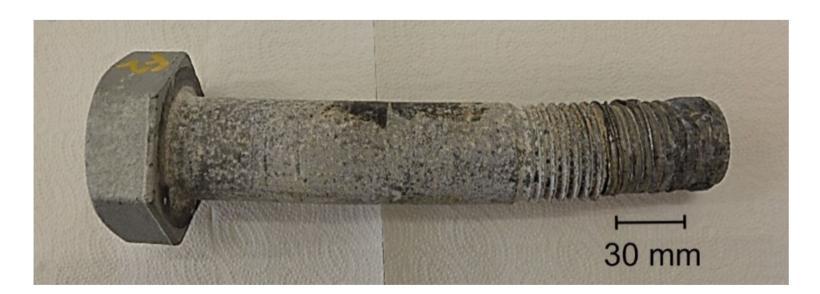
The overall view of the tested S1 bolt is shown in Figure 1. It was characterized with a secondary bend, which resulted in unacceptable shape deviations in the bolt's shank. The arrow of the bend for the bolt was up to 2.3 mm (Figure 2).

Figure 1. General view of the S1 bolt.

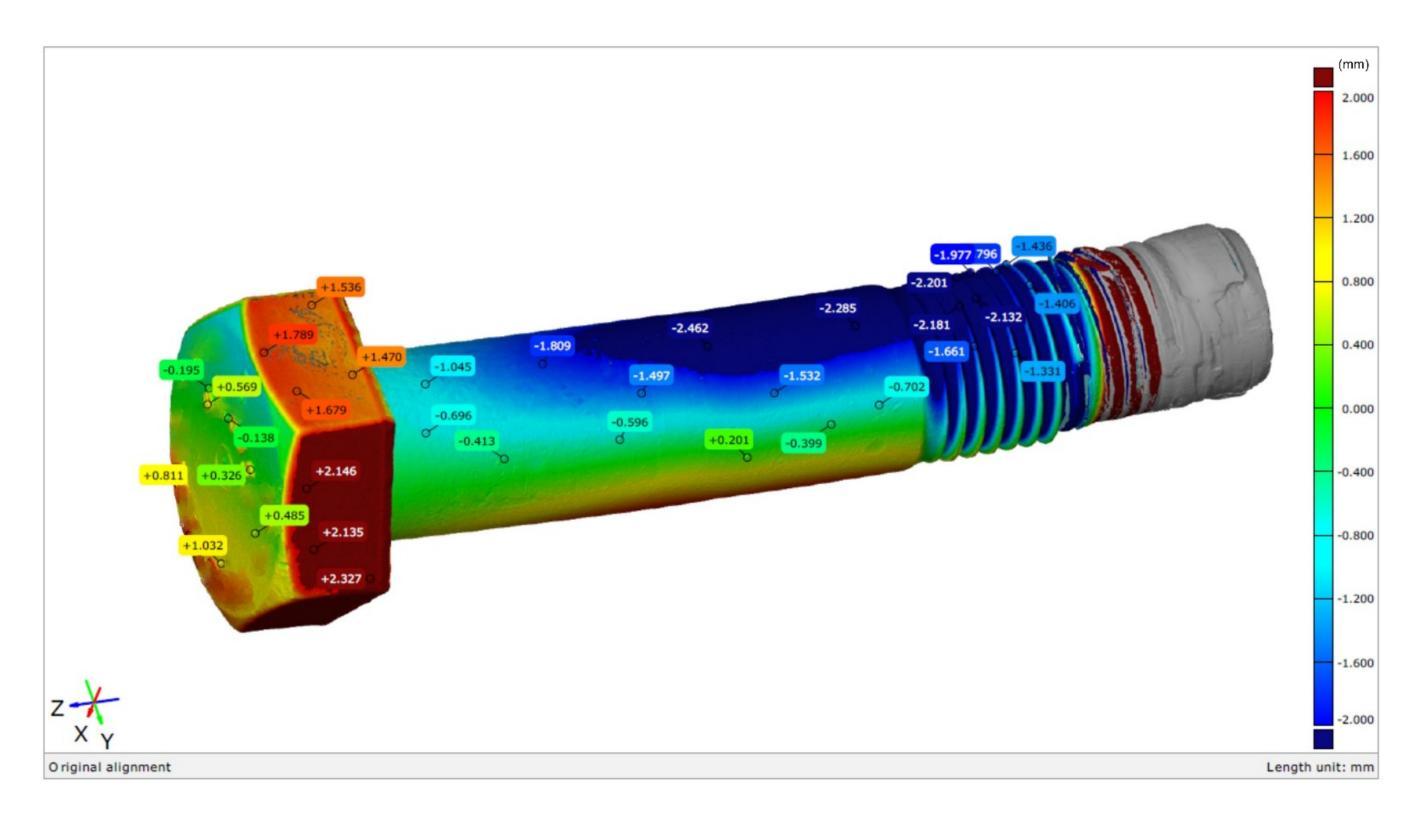
Figure 2. Colored map of deviations for the S1 bolt.

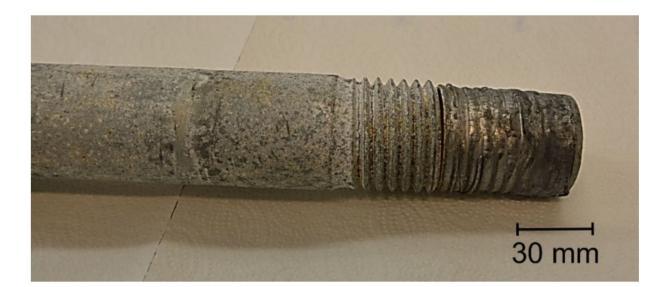
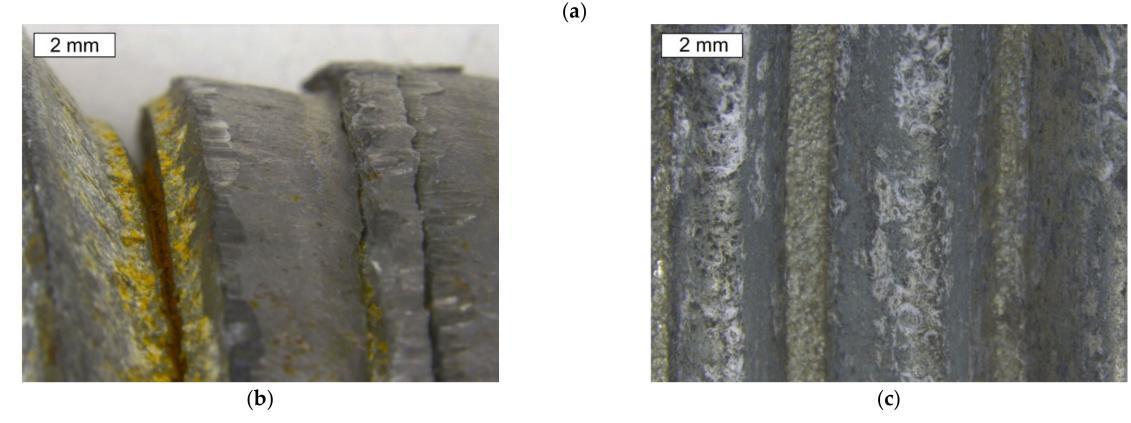
The bolt was deformed during the catastrophe—the fall of the wind turbine tower. The threaded area had strong deformation as a result of the thread shear (Figures 3 and 4a). The bend of the bolt and thread shearing could only have happened when the two connected flanges of the tower began to split during the tilting and falling of the turbine tower. In such a situation, the nut was not uniformly loaded, which led to a concentration of stress. The pressure is then only present at the small surface of the nut, and a complex state of stresses then begin to act and the tensile and shearing forces, as well as bending moment, appear simultaneously. Such a state of stresses is reproduced in the tensile test of bolts at a wedge, which is described in the ISO 898-1 standard. The trial concerns the shearing head of the bolt, however, the same stress state is evoked when the nut is supported by the wedge. In such cases, thread shear in the bolt or in the nut is very common. In the case of the occurrence of only one-axis tension of a bolt, shearing of the thread should never occur. This is due to the fact that the normalised height of the nut has to provide a much better shear strength of the thread and a stronger surface pressure then the tensile strength of the bolt material. Thread shear could also only occur in the case of the lowering of its strength, e.g., as a result of decarburization. However, this phenomenon in the analysed case did not occur, which was not the case in further tests. Fretting damage of the thread was also observed as a consequence of contact stress occurring in the mating flanks (Figure 3c).

The provided bolt in the area of the sheared thread and in the region of the thread that is normally localized below the nut had numerous deep cracks appearing in the thread roots (Figures 3b and 4b, respectively). The thread roots are the construction notches and they concentrate stresses. This means that this bolt has also suffered fatigue failure, as well as crack initiation in the thread roots. The level of stress and the fatigue crack propagation regions were small enough that they did not lead to fatigue destruction. However, the occurrence of many cracks is a symptom of strong fatigue load, possibly as a result of unsteady bolt vibrations. They can act longitudinally, laterally, or in both directions. Due to alternating horizontal loads, lateral vibrations usually lead to the loosening of the bolts. Longitudinal vibrations pose less risk due to pulsating axial loads. It was reported that high strength bolts are susceptible to high stress concentrations at the root of their thread [14,15,25,26], and especially dangerous tensile stresses occur at the first pair of thread roots [26].

Figure 3. Sheared thread of the S1 bolt: (a) General view, (b) Cracks in the sheared thread roots, (c) Fretting damage of the thread.

The tested bolt in the location of where the cracks appeared was covered with many corrosion products of white and brown colour (Figure 3b). White rust, also known as white corrosion, is created as a result of corrosion of the zinc coating. The type of formed products is influenced by environmental conditions. The authors agree that after long-term exposure to atmospheric conditions, occurring in the presence of carbon dioxide and in the absence of industrial pollution, the dominant products of the white corrosion of zinc and its alloys are zinc oxide ZnO, zinc hydroxide $Zn(OH)_2$, and mainly hydrozincite $Zn_5(OH)_6(CO_3)_2$, which is the basic zinc carbonate. When their formation takes place in the presence of chlorine, a simonkolleite with the formula $Zn_5(OH)_8Cl_2 \cdot H_2O$ is also formed [27,28]. The formation of corrosion products may be accompanied by the formation of smithsonite with the formula $ZnCO_3$, or gordaite with the formula $Na_4Zn_4SO_4(OH)_6Cl_2 \cdot H_2O$ [27,29,30]. In the EDX spectrum obtained from white corrosion products, no presence of aggressive ions such as chlorides, which could accelerate the corrosion, was observed (Figure 5). However, it is worth mentioning at this point that other bolts from this wind turbine tower were also tested and the presence of chlorine was observed. In the places of cracks, red corrosion of the steel was also observed, which indicates that the zinc layer in these locations was not protecting the steel against corrosion.

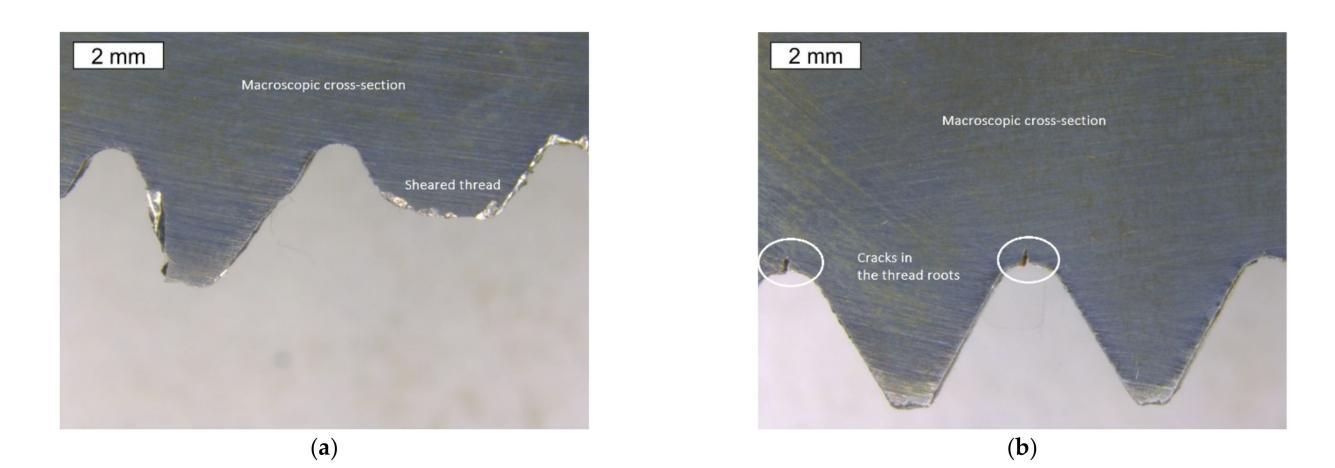
Figure 4. Stereoscopic image of the macro section, which was made at the longitudinal cross-section of the S1 bolt threadinside (**a**) and outside (**b**) of the macroscopic shear area. Visible cracks running along the thread roots.

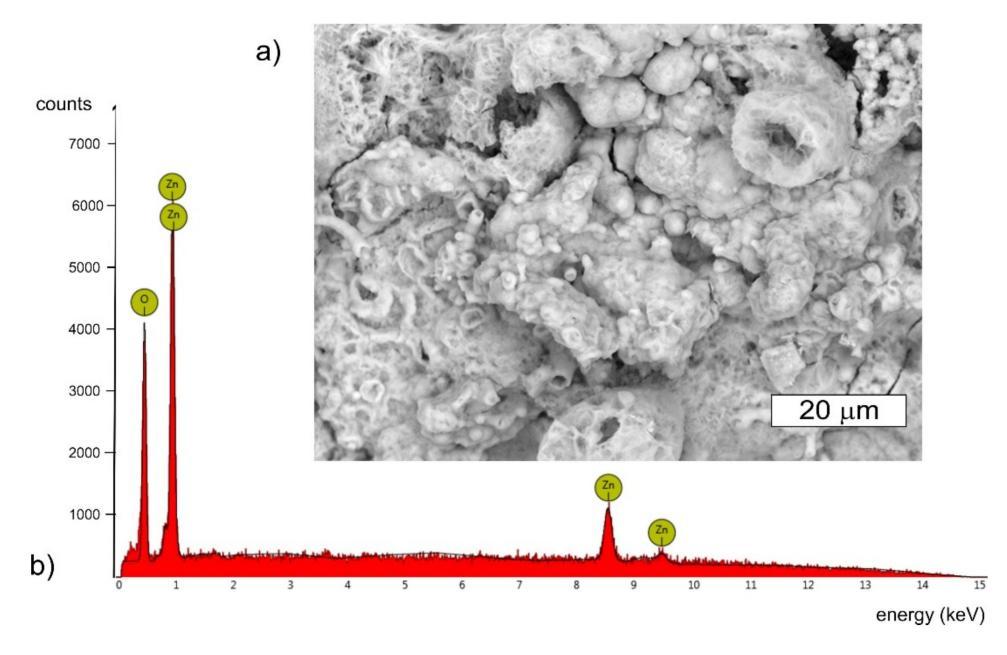
Figure 5. The deposit observed under the S1 bolt head: (a) SEM image, BSD (b) Characteristic X-ray spectrum for the presented area, SEM/EDX.3.2.2. Bolt 2.

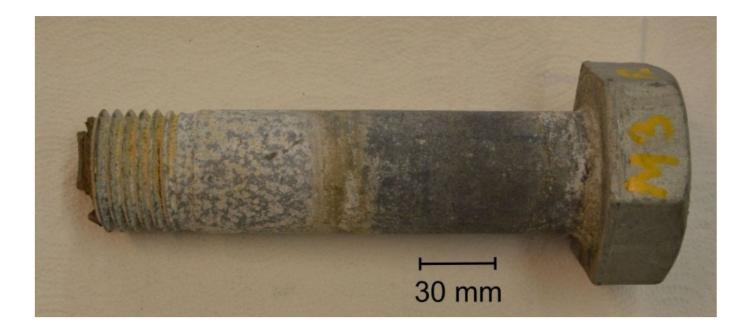
Macroscopically, the surface showed symptoms of strong white corrosion of the zinc layer of the shank and the threaded part of the bolt (Figure 6). In the location of cracks, red corrosion of the steel was also observed. The head of the bolt was free of corrosion symptoms, as was the case with the S1 bolt. The extensive area of white corrosion indicates the long-term stay of the bolt in wet conditions. It should also be noted that in this case the head of the tested bolt did not show symptoms of white corrosion. It was only the area between the bolt head and the nut, which was in contact with the steel flanges of the tower, that showed strong white corrosion. As a result of observing the S2 bolt, the appearance

Figure 6. General view of the S2 bolt's fracture formed in the threaded part.

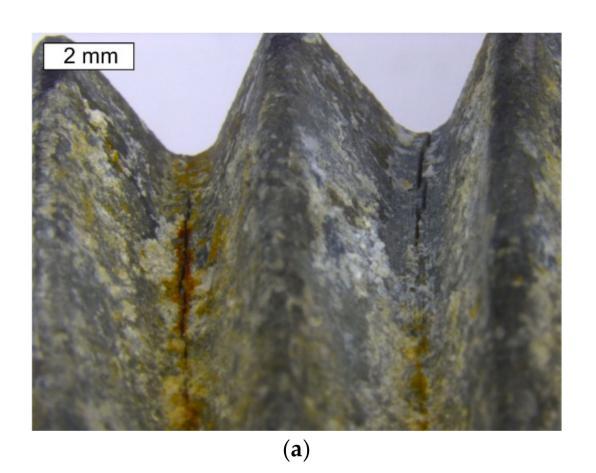
of cracks was seen in the thread roots located in the area under the nut. In the location of cracks, red corrosion of the steel was observed. The condition of the bolt and cracks observed in the thread roots is shown in Figure 7.

Figure 7. Stereoscopic image of the macro section taken at the longitudinal section of the S2 thread. Visible cracks running along the thread roots, as well as white and red corrosion symptoms: (**a**) area 1, (**b**) area 2.

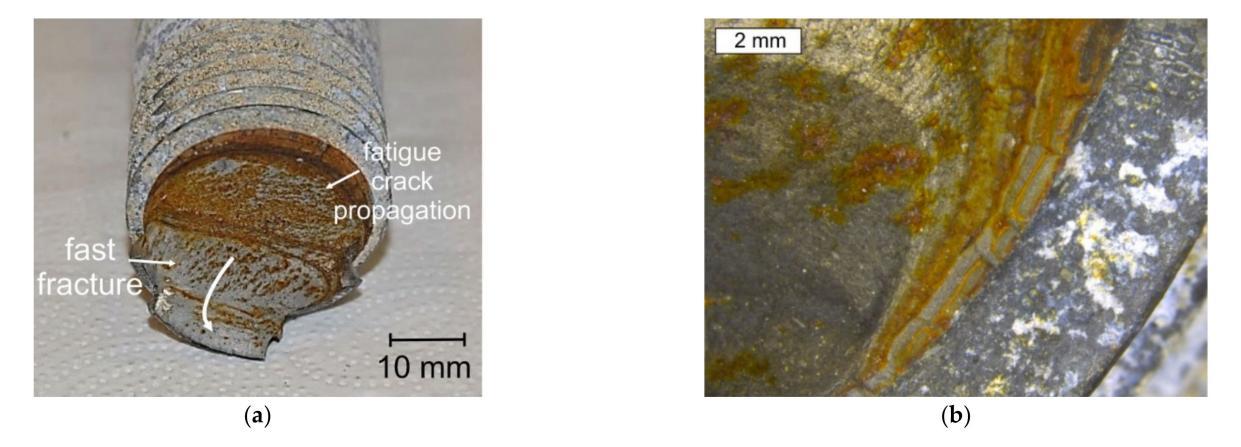
The failure of the bolts was caused by fatigue crack growth in their threaded part. The general view of the fractures reveals a distinct fatigue crack propagation region and a fast fracture region with pronounced beach marks (Figure 8). The fracture differed from that observed by other authors [11] and caused by hydrogen-induced stress corrosion cracking. The fatigue propagation area was located near the extreme circumference of the bolt. The crack initiated at the thread root and was probably caused by the presence of microcracks, as was also observed in the thread roots of all the tested bolts. Two different rates of fracture development in the fatigue crack propagation region can be observed. In the first phase, this zone did not develop fast and the surface corroded. In the second phase, the rate of crack growth increased, and the fatigue crack propagation region shows much lower features of the corrosion. The bolts showed slight deformation in the fast fracture area, which was also a result of the bolts breaking during the crash (shown by the arrow at Figure 8a).

Figure 8. General view (a) and stereoscopic image (b) of the S6 bolt fracture. The elliptic wrapping of the beach marks.

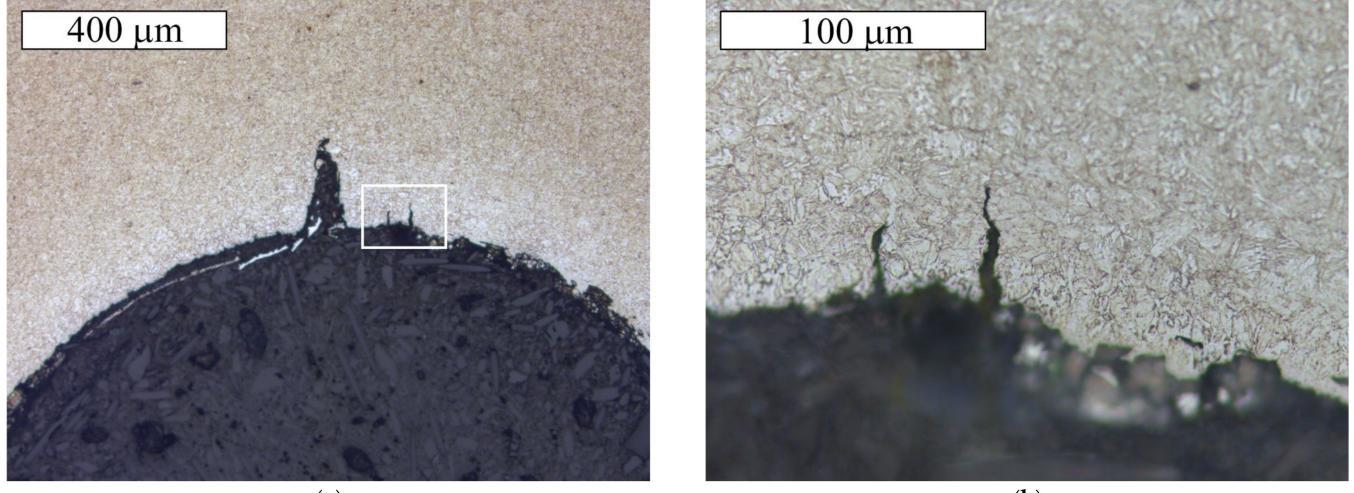
The microscopic observations of the S1 bolt were performed at longitudinal sections of its threaded parts. The observations were conducted in a non-etched and etched state with 2% Nital. Figure 9 presents microscopic images of the cracks observed in the thread roots. In the location of the cracks, no significant decarburisation of the surface was found. Moreover, no irregularities that could possibly influence crack initiation were located. At the base of the microscopic observations, it was found that the maximum allowed value (defined by the ISO 898-1 standard—max. 0.015 mm) of the total decarburization of the tested bolt was not exceeded. The material showed a microstructure of the homogeneous

Figure 9. The longitudinal section of the threaded part of the S1 bolt. (**a**) Visible cracks initiated in the thread root, (**b**) The enlarged area indicated by the frame at the Figure 9a Etched state, Light Microscopy.

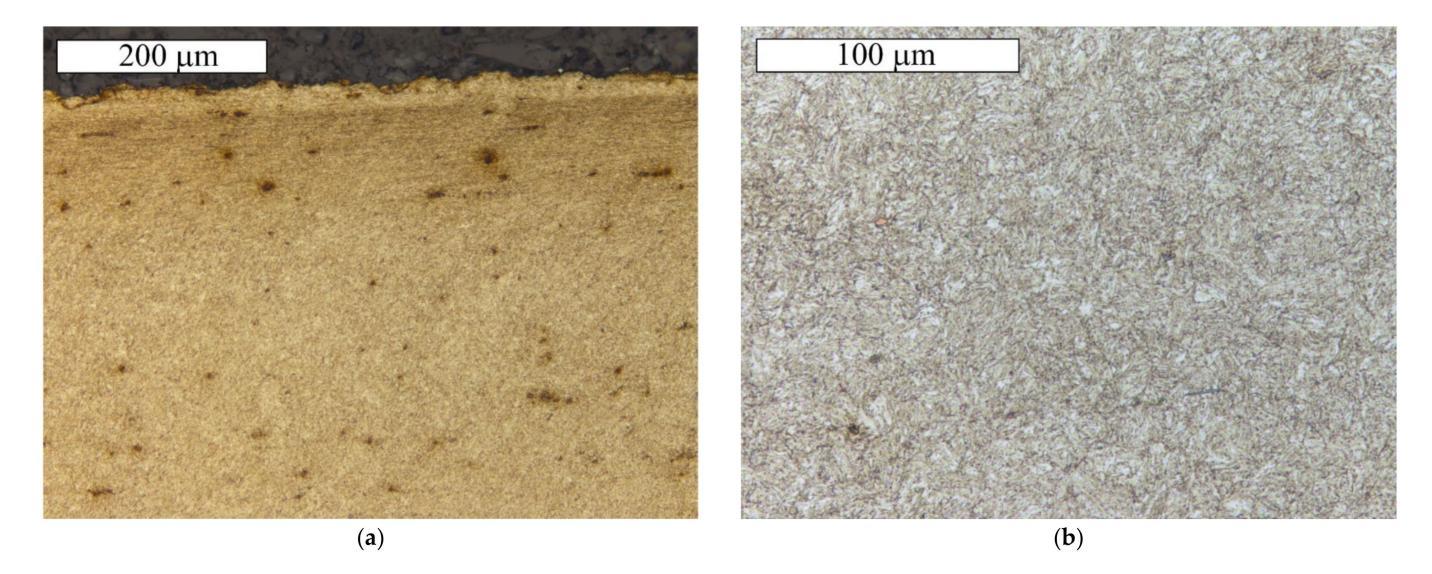
fine-acicular tempered martensite, which is the microstructure typical and proper for quenched and tempered steel parts (Figure 10). Figure 10 presents the microscopic image of the surface section through the threaded part of the S1 bolt in the location where the thread was truncated. The strong plastic deformation of the surface, caused by the action of the shearing force in this location, is visible.

Figure 10. The longitudinal section of the threaded part of the S1 bolt in the surface location: (**a**) Visible martensitic microstructure and a strong plastic deformation of the surface, (**b**) Martensitic microstructure in the core. Etched state, Light Microscopy.

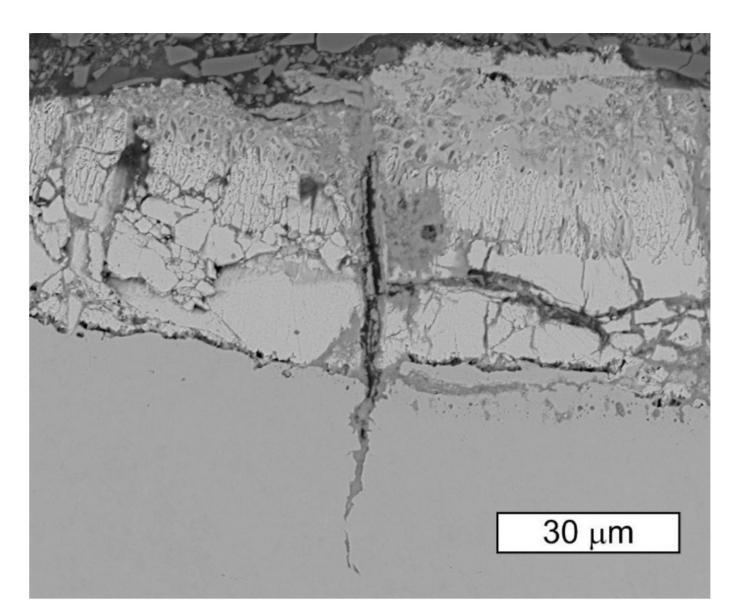
The SEM image of the zinc layer observed in the thread root of the S1 bolt is presented in Figure 11. The image shows the crack in the bolt material beginning at the notch surface. It can be observed that the radial crack of the zinc coating also occurs in the place of the bolt material crack. The crack observed in the steel and the crack observed in the coating run almost along one line and act like their own extensions. The opening of the zinc crack suggests that the initiation of the crack happened on the surface of the layer, and also that the resulting crack running through the zinc coating and the screw material is filled with

corrosion products. The thickness of the zinc coating at the threads, determined using the microscopy method, was about 40 μ m.

Figure 11. SEM image of the longitudinal section of the S1 bolt thread root (BSD). Visible radial cracks of the zinc coating and steel substrate cracks filled with corrosion products.

The course of the crack initiated in the hot-dip zinc coating is determined by its microstructure. Cracks initiate in the area of the most brittle phases, which are the δ and Γ phases, and then propagate to the ζ phase [31–33]. In the case of crack initiation inside the coating, the authors of work [31] did not observe crack propagation to the η phase, which prevents the steel substrate from coming into contact with the corrosive environment. The network of cracks in the area adjacent to the steel substrate may form at the crystallization stage due to the difference in the thermal expansion and elasticity of the steel and the zinc coating [24,34]. The increase in the galvanizing time, leading to the achievement of well-developed hot-dip zinc coatings, promotes the formation of radial cracks [31]. The lead content has also been found to influence the crack rate [35]. This seems to be associated with an increased brittleness of the δ phase in the presence of lead [32]. The number of developing cracks depends on the applied load [24]. The crack development may lead to the exposure of the steel substrate and the lack of cathodic protection of the steel in a corrosive environment. Exposure of the steel surface and zinc corrosion can lead to the absorption of hydrogen.

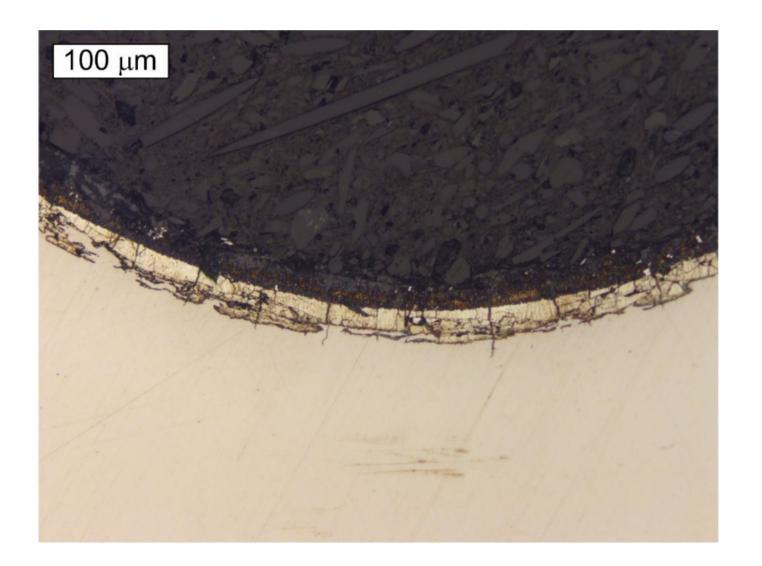
The microscopic observations of the S2 bolt were performed at the longitudinal sections of its threaded parts in non-etched and etched states. Figures 12 and 13 present exemplary cracks that were observed in the S2 bolt's thread root. It is very clear that the fracture initiates in the thread root region. Similarly, as in the case of the cracks observed in the material of the remaining bolts, it can be noted that the cracks occurring in the material of the S2 bolt are accompanied by cracks of the zinc coating in the same direction. It was apparent from an examination of the metallographic specimen that crack-like defects were created in the thread roots by a corrosion cracking mechanism. The cracks started at the surface of the root and ran into the bolt's core.

Figure 12. Microscopic image of a longitudinal section of the S2 bolt. Visible cracks initiating in the thread root. Non-etched state, Light Microscopy.

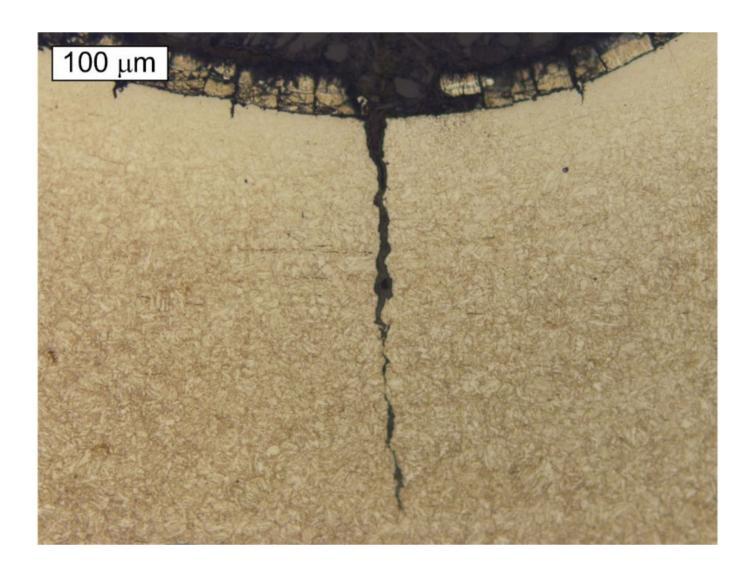
Figure 13. Martensitic microstructure of the longitudinal section of the threaded part of the S2 bolt. Visible cracks initiating in the thread root. Etched state, Light Microscopy.

Similarly, as in the case of the remaining bolts, etching of the S2 bolt material revealed a tempered martensite microstructure, as shown in Figure 13. At the base of the microscopic observations, it was found that the maximum allowed value of the total decarburization of the tested bolt was not exceeded, which is defined by the ISO 898-1 standard (max. 0.015 mm). The requirements concerning the maximum allowable value of decarburization was met by both bolts. Lapping was also observed in the zinc coating, but was not accompanied by cracks.

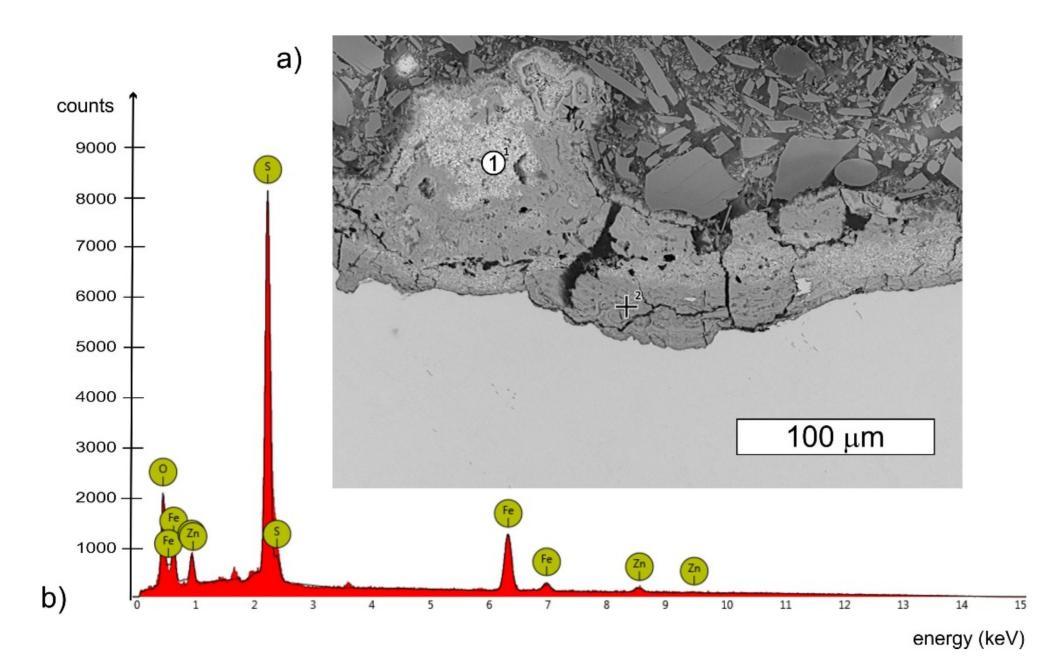
Torsional and tensile stresses are dominant in the bolts. Each bolt can only be stretched to its yield strength, above which it fails. In order to maximize the possibilities of the bolts, i.e., to achieve maximum tension, and thus the maximum clamping force, without damaging them, it is necessary to minimize torsional stresses in order to maximize tensile stress. This is most effectively achieved by applying lubricant to the bolt thread. An additional benefit resulting from this is the obtaining of repeatability in the obtained values of the clamping force. The bolts should be lubricated with the application of a MoS₂-based thread lubricant. The deposits present on the bolts provided for the tests were subjected to analysis that aimed to determine the presence of molybdenum in the deposit. On the basis of the performed microanalyses of the chemical composition of the bolt thread surface, the presence of sulphur was found (Figures 17 and 18).

Figure 17. (**a**) SEM image of the deposit observed on the cross-section of the S1 bolt thread surface, BSD (**b**) Characteristic X-ray spectrum obtained for point 1 presented in Figure 17a, SEM/EDX.

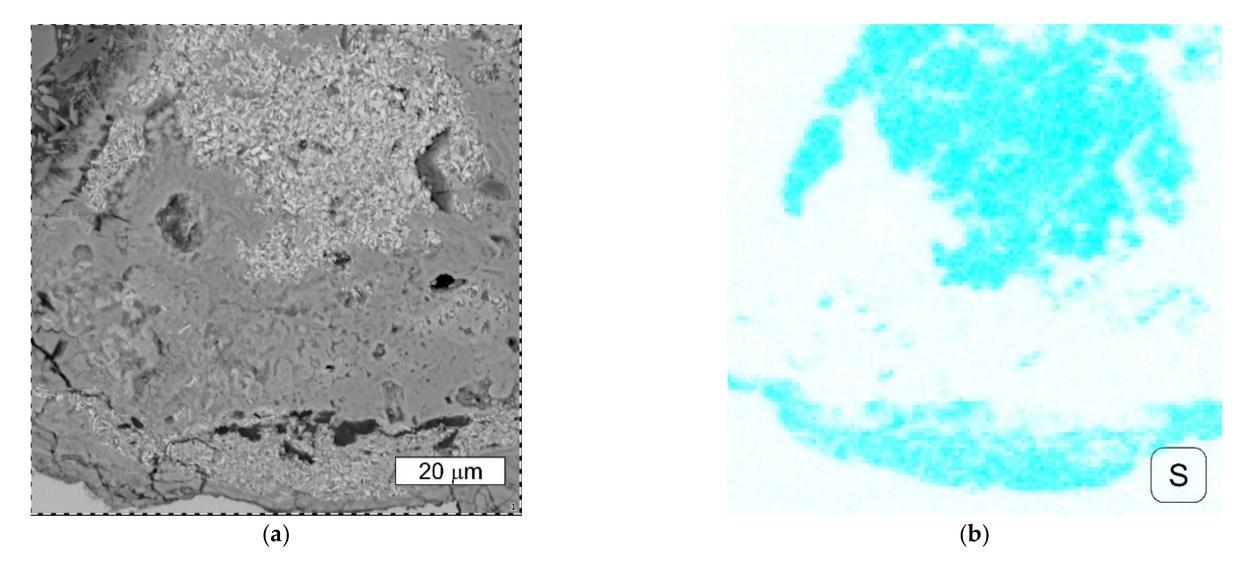
Due to the fact that the overlap in the EDX spectrum between the L series peaks of Mo and the S K α peak was very pronounced at an applied accelerating voltage of 15 kV, the obtained EDX spectra did not give a clear answer as to whether a lubricant containing molybdenum disulphide MoS₂ was used. Therefore, the deposits present at the fasteners were subjected to extraction with hexane. After evaporation of the hexane extracts, the dry remnants were analysed using the atomic absorption spectrometry method with electrothermic atomisation—ETAAS, according to the EN ISO 15586 standard. As a result of the performed analysis, the presence of molybdenum was confirmed at the surfaces of all the samples subjected to the tests. This confirms the presence of MoS₂ molybdenum disulfide, which is a component of grease that lowers friction, on the surface of the fasteners. While the presence of sulfur could be related to surface contamination, the presence of molybdenum is difficult to explain.

Figure 18. (a) SEM image of the deposit observed on the cross-section of the S1 bolt thread surface. An enlarged area from Figure 17a, BSD (b) Distributions of sulphur obtained in the mapping performed at the area presented, SEM/EDX.
