Technical Note

Damage Characteristics and Mechanism of a 2010 Disastrous Groundwater Inrush Occurred at the Luotuoshan Coalmine in Wuhai, Inner Mongolia, China

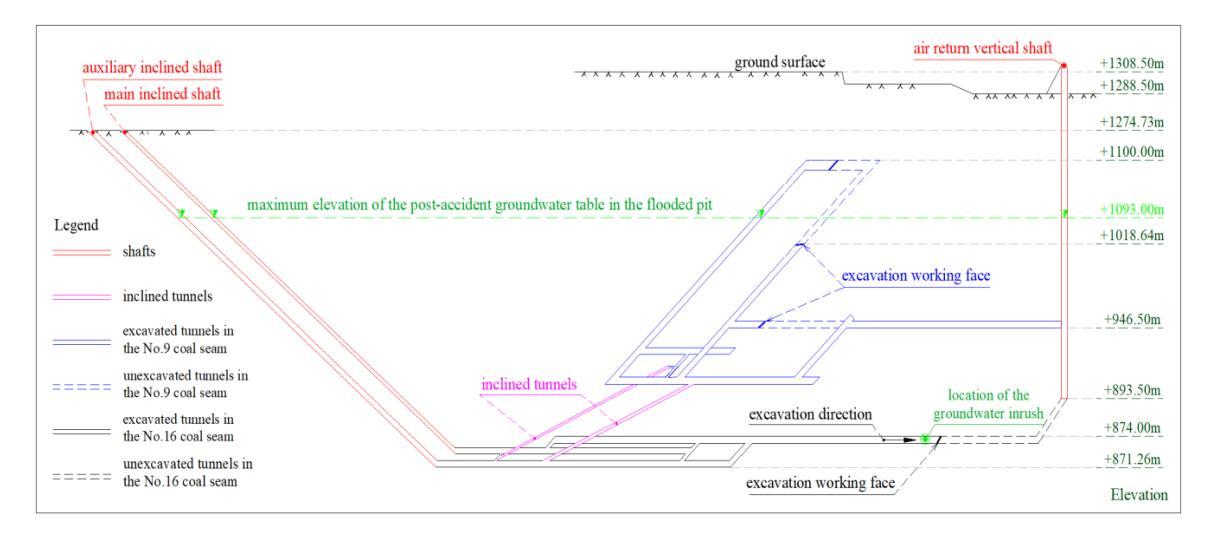
Figure 3. Distribution sketch of the shafts and galleries in the Luotuoshan pit.

Before the date of the groundwater inrush, construction of the main inclined shaft, auxiliary inclined shaft and vertical air return shaft of the coalmine had been completed. Meanwhile, construction of main galleries in the No. 9 zone and the No. 16 coal seam had been completed, too. As shown in Figure 3, at the time of the groundwater inrush, two air return galleries in the No. 9 coal seam and an air return gallery in No. 16 coal seam were under construction.

At 6:10, more jet streams appeared from 5-6 blast holes. The maximum diameter of the water streams was approximate 20 cm. Meanwhile, a small part of the floor heaved 0.1-0.3 m. This part was 10-m long and 1.2-m wide. As shown in Figure 3, it originated from a location where the distance between it and the heading face was approximate 26 m. An obvious fracture appeared at the boundary of the heaved part. The fracture was approximate 10-m long, 4-cm wide and 5-cm deep.

At 24:00, 3 March, the maximum elevation of the accumulated groundwater table in the pit reached +1093.00 m, as Figure 3 illustrates.

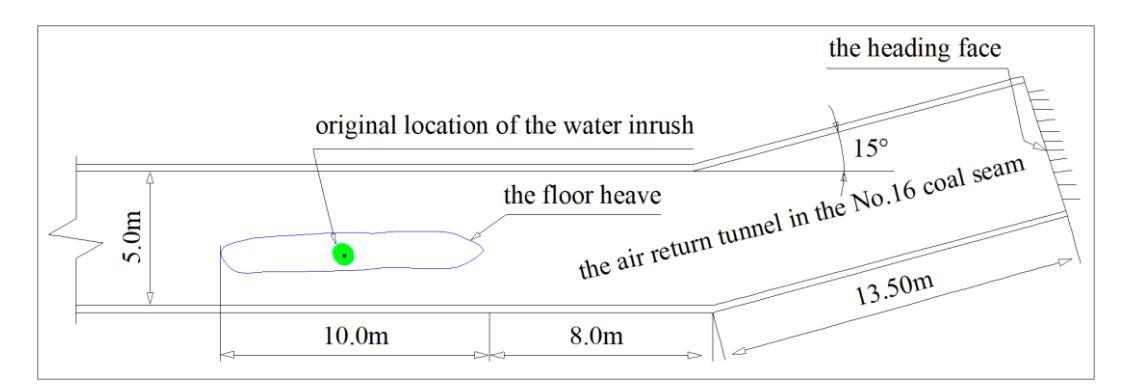
Figure 5. A plane sketch of the origin of the groundwater inrush.

According to recall of some of the miners who escaped from the flooded pit and post-accident site-reconnaissance, the groundwater inrush originated from the floor heave, in the air return gallery in the No. 16 coal seam, as Figure 5 illustrates.

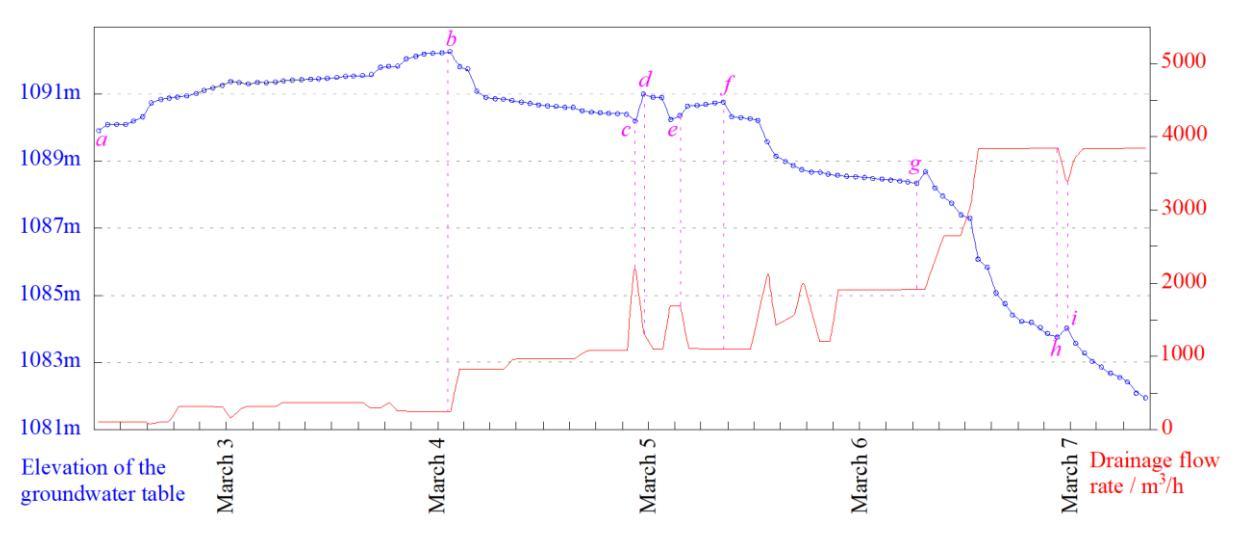
Figure 6. Monitoring records of the groundwater table and the drainage flow rate in the post-accident rescue.

The inburst groundwater is from the Ordovician limestone aquifer, which underlies the No. 16 coal seam. The reasons are as follows: Firstly, according to the hydrochemical test results, the properties of the inburst groundwater are similar to those of the nearby Ordovician karst groundwater, as shown in Table 1. Secondly, based on monitoring records of tables of the accumulated groundwater in the pit and drainage flow rates in the post-accident rescue, as Figure 6 illustrates, variations of the two curves show that the inburst groundwater behaved with obvious characteristics of the Ordovician karst groundwater. This conclusion is supported by the following facts: ① During the initial drainage period, i.e., the *a-b* segment in Figure 6, the groundwater table still increased slowly even if the drainage flow rate remained a certain constant scale. This showed that the groundwater in the pit

was recharged strongly and continuously. The recharge behaved with obvious characteristics of the Ordovician karst groundwater. ② The groundwater table in the pit decreased obviously on increasing of the drainage flow rate. Then the decrease developed slowly because of the increased recharge, i.e., *b-c* and *f-g* segments in Figure 6. It behaved with obvious characteristics of the Ordovician karst groundwater, too. ③ The groundwater table recovered obviously on decreasing of the drainage flow rate, i.e., *c-d*, *e-f* and *h-i* segments in Figure 6. It showed that the groundwater in the pit was recharged strongly and continuously. The recharge behaved with obvious characteristics of the Ordovician karst groundwater, too.

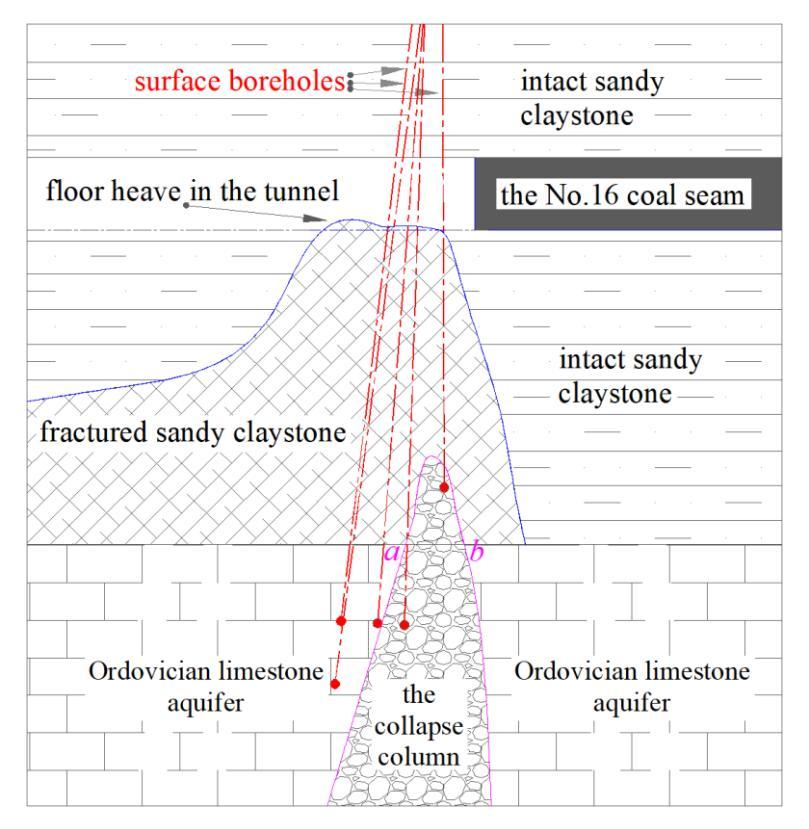
Figure 7. Distribution sketch of the passage of the inburst groundwater.

With respect to the passage, as shown in Figure 7, a water-conductive karst collapse column was uncovered by some boreholes drilled after the site rescue. The collapse column, the gallery excavation and the high-pressure groundwater induced together the passage to form gradually.

Firstly, the vertical distance between the floor of the No. 16 coal seam and the top of the Ordovician limestone was approximate 34 m. However, according to the site tests and theoretical calculations, the safe thickness of the aquiclude was approximate 11.5 m. Therefore, the karst groundwater had no way to touch the floor of the No.16 coal seam under tectonic influence conditions or absent a geological anomaly. Secondly, based on the borehole surveying and the related analysis, as Figure 7 illustrates, excavation of the air-return gallery of the No.16 coal seam triggered the underlain sandy claystone to fracture. Therefore, the floor heave formed gradually. Furthermore, the high-pressure groundwater accumulated in the water-conductive collapse column induced the overlying sandy claystone to fracture, too. The fractured sandy claystone expanded gradually and eventually the water-conductive passage formed. As a result, the high-pressure groundwater in the Ordovician limestone aquifer rushed into the galleries in a large scale and the disastrous accident occured quickly.

According to the drilling surveys, the width of the top of the collapse column, *a-b* segment in Figure 7, was approximately 10 m. As shown in Figure 8, core samples in the collapse column are seriously fractured, poorly sorted and poorly rounded. They present obvious properties of the collapse mass.
