A Comprehensive Investigation on Abnormal Impoundment of Reservoirs—A Case Study of Qionglin Reservoir in Kinmen Island

Yin-Chun Hung 1,*, Tung-Tsan Chen 2, Tsai-Fu Tsai 2 and Hao-Xi Chen 3

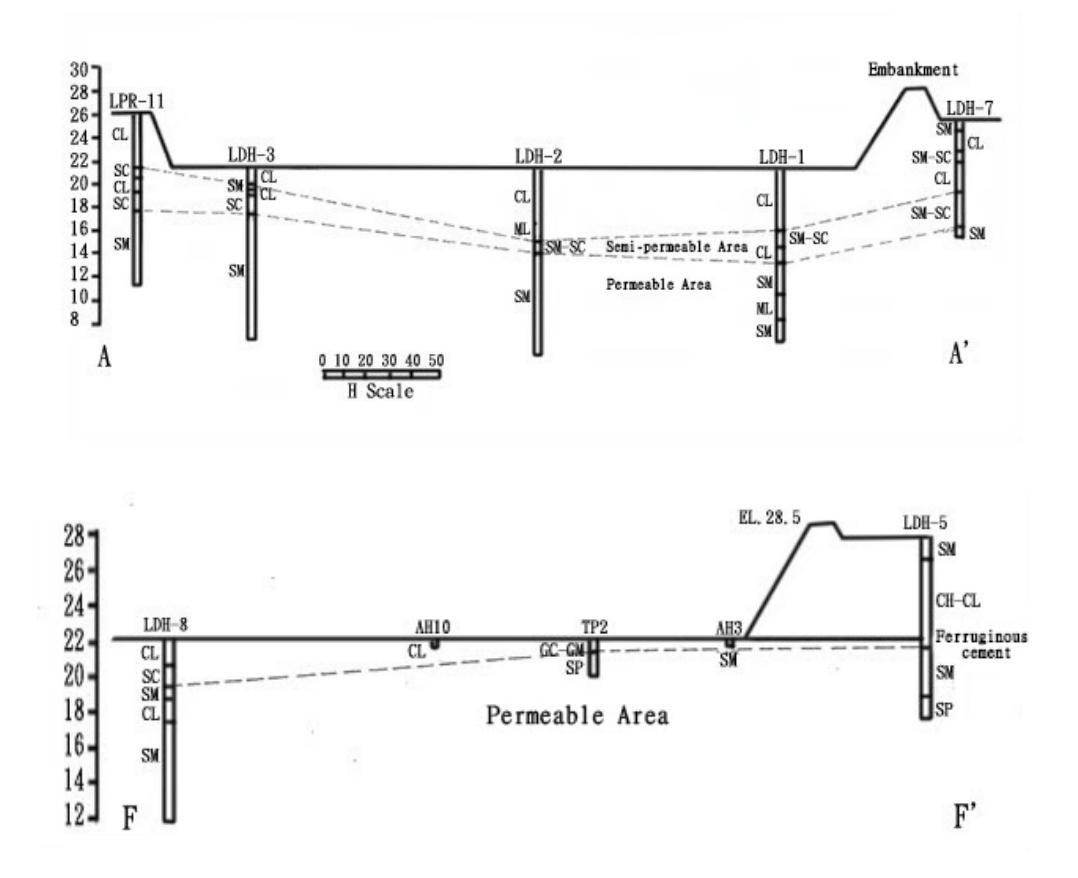
Figure 3. A-A' and F-F' geologic cross-section of the dam of Qionglin Reservoir.

The submerged area of the Qionglin Reservoir dam is placed on the soil foundation (multi-layer, CL). The drilling data in Section 4.3 and Figure 3 show that there is still a thin layer in front of the dam, which may cause leakage. Therefore, this article discusses the leakage analysis of the dam and the leakage analysis of the head difference (hydraulic gradient) caused by the groundwater level:

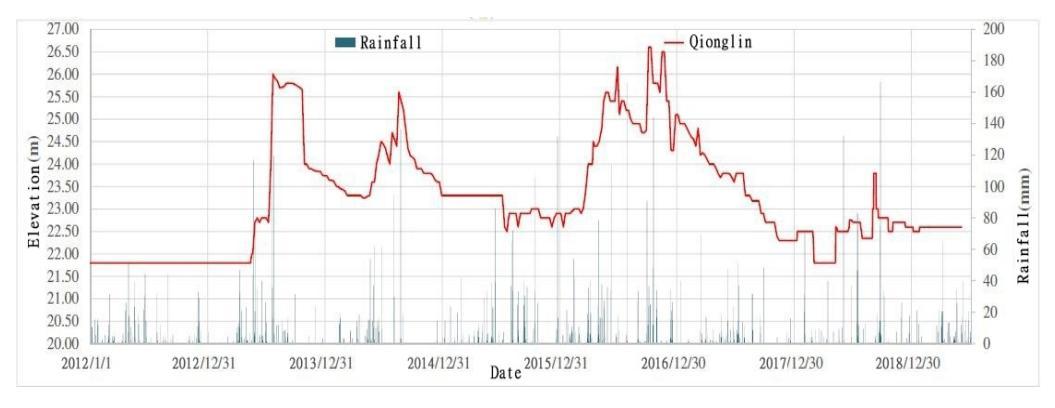
Figure 6. Comparison between water levels and rainfall of Qionglin Reservoir.

Figure 6 is the comparison between water levels and rainfall of Qionglin Reservoir from 19 December 2011 to 4 June 2019. From the observation of the above water level changes, Qionglin Reservoir was at the dead water level before May 2013; its water level changed significantly from May 2013 to 2017 with the rainfall; the water level changes slightly after dropping to the dead water level in March 2018; and the water level was around EL.22.5–23 m, despite the heavy rain in May and August 2018.

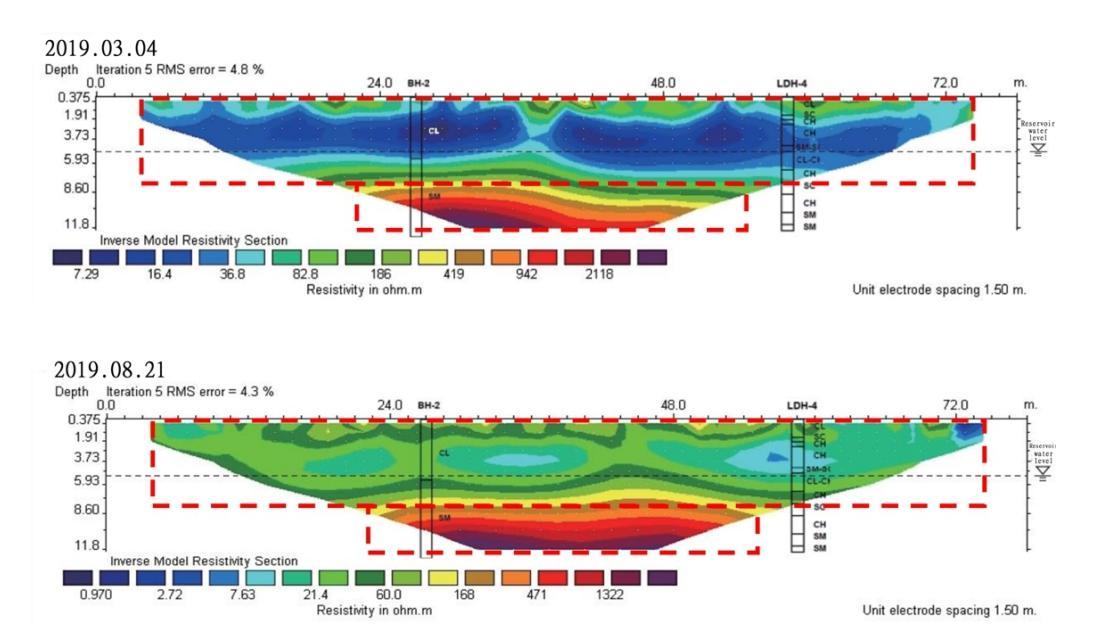
Figure 7. Results of line L1.

The electrical resistivity tomography results of L1 are shown in Figure 7. The resistivity distribution was roughly two-layered, showing a low–high pattern from shallow to deep. In the first layer, the resistivity was relatively low, and the depth was less than 8.6 m; in the second layer, the resistivity was relatively high, and the thickness was about 3 m. The first test was carried out a few days after rain, and it was wet below the surface; therefore, the resistivity was very low, within 6 m below the surface. By comparing the results of the two tests, the overall results tended to be the same with clear distinction under the depth of 6 m, except for the variables caused by rainy days. With the drilling data and the reservoir water level of the day, it could be found that the boundary between the permeable layer and the impermeable layer was the same as the boundary of the earth resistance between the first layer and the second layer.

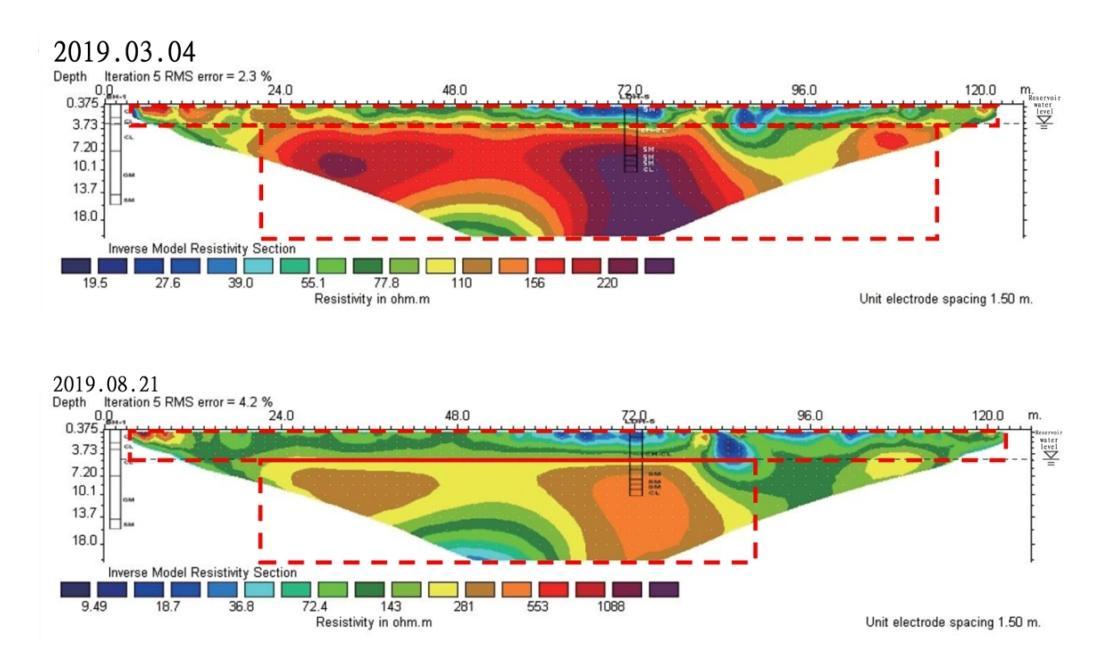
Figure 8. Results of line L2.

The electrical resistivity tomography results of L2 are shown in Figure 8. The resistivity distribution was roughly two-layered, showing a low-high pattern from shallow to deep. In the first layer, the resistivity was relatively low, and the depth was less than 4 m; in the second layer, the resistivity was relatively high, and the thickness was about 15 m. The overall results of the two tests tended to be the same. With the drilling data and the reservoir water level of the day, it could be found that the boundary between the permeable layer and the impermeable layer was the same as the boundary of the resistance between the first layer and the second layer.

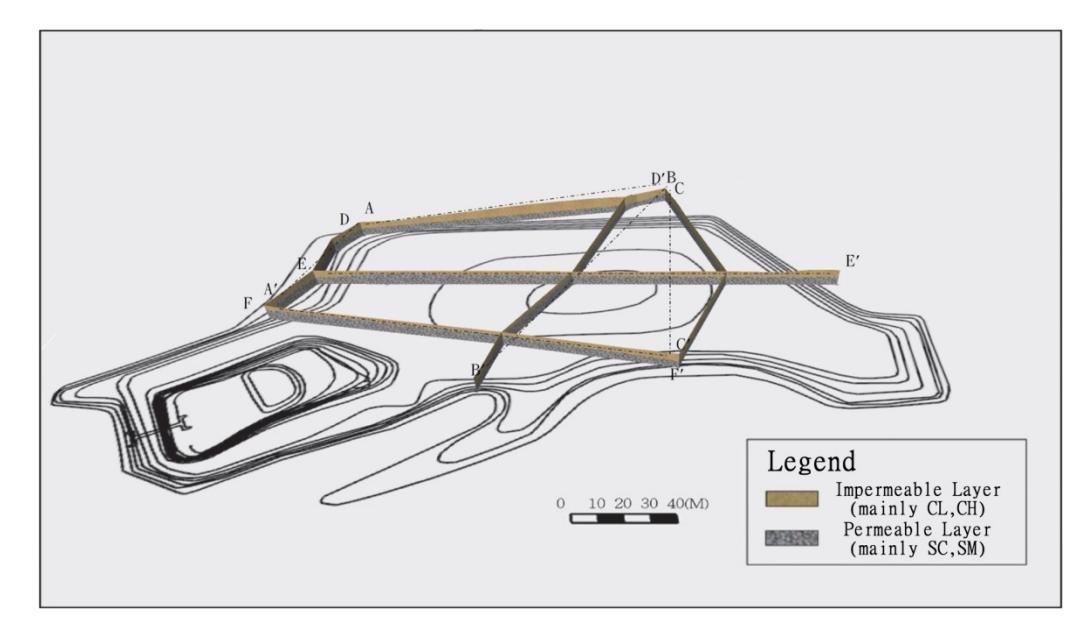
Figure 11. Geological fence diagram.

Based on the data from previous drilling, water permeability tests and test pits and the results of this drilling and water permeability test, the geological fence diagram of Qionglin Reservoir was drawn in this study, as shown in Figure 11. The analysis results are as follows:

- (1) According to the results of the manual test pits, the Relative Compaction (RC) of the dam is 93%, and the Relative Compaction (RC) of the dam bottom is 89–92%, which proves that it did meet the compaction density requirements and effectively reduce the water permeability when the reservoir bottom was backfilled.

- (2) According to the results of the water permeability test, the permeability coefficient of the dam bottom is low, meaning it does not easily leak water.

- (3) The borehole in this water permeability test is located outside the reservoir with a high permeability coefficient between 2.3 × 10⁻⁴cm/sec and 4.3 × 10⁻⁴ cm/sec, indicating good permeability outside the reservoir.

- (10) According to the geological drilling data and geological fence diagram, in the sedimentary layers inside and outside the dam and of the reservoir bottom, their impermeable layers cover their permeable layers. In addition, leakage improvement works have been carried out for the reservoir, and impermeable cloth has been laid throughout the reservoir area. Therefore, it is preliminarily concluded that Qionglin Reservoir shall have no serious leakage.

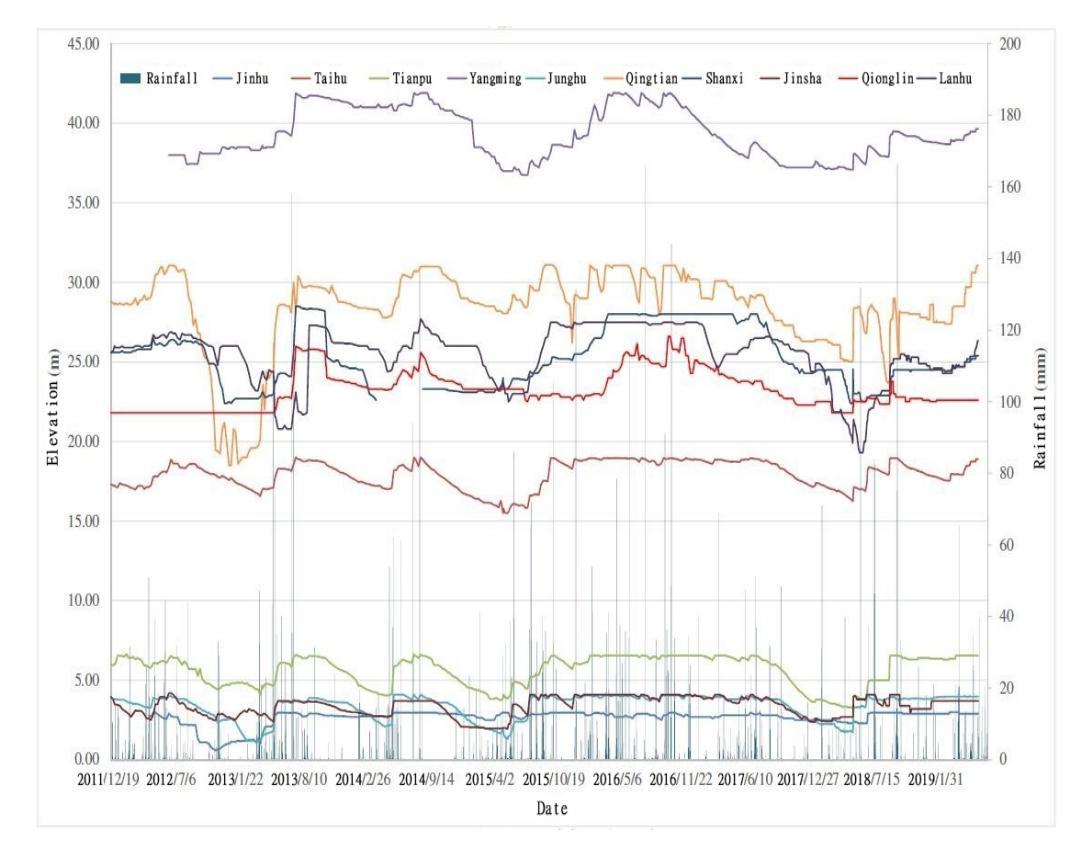
Figure 12. Comparison between water levels and rainfall of 10 reservoirs in Kinmen Island.

Figure 12 is the comparison between water levels and rainfall of 10 Reservoir in Kinmen Island from 19 December 2011 to 4 June 2019. The results showed that there was no abnormal change in the water level of Qionglin Reservoir, and the rate of decline from the high water level was not higher than that of other reservoirs (without considering the water intake from reservoirs). According to the data from the meteorological station of Kinmen County, the monthly evaporation of Kinmen is between 100 and 200 mm depending on the season, and the average daily evaporation is between 3 and 6 mm. Figure 12 showed that, from the end of October 2016 to the beginning of June 2017, the water

level of Qionglin Reservoir steadily declined. After comparing the declining trend with the rainfall and evaporation, it was proved that the declining trend of reservoir water level is within a reasonable range. Based on the analysis of the above reservoir water level changes, Qionglin Reservoir should have no serious leakage.

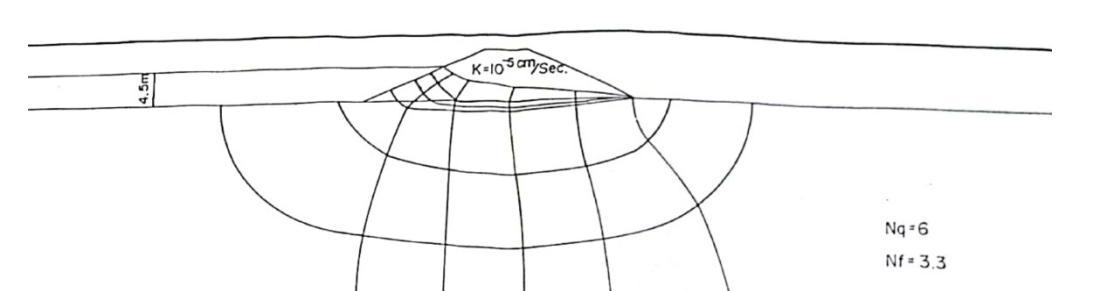
Figure 13. Seepage flow net diagram of dam and dam foundation of Qionglin Reservoir.

Case 1: Analysis of dam leakage: when the reservoir water level is full (EL = 26.5m), leakage will occur due to the hydraulic gradient, and at this time, the groundwater level will raise and maintain at the bottom of the reservoir (EL = 21.5m).

The leakage analysis of the dam is as follows: the basic assumptions are as follows, and the flow net is shown in Figure 13.

- (1) The permeability coefficient of the reservoir bottom and the dam $K = 1 \times 10^{-5}$ cm/s.
- (2) The permeable layer at the bottom of the reservoir is assumed to be 30 m deep.
- (3) The dam leakage analysis width is 400 m.
- (4) Where I = hydraulic gradient, A = grid area, Nf= number of flow channel, Nq= number of potential drop, h= the difference between upstream and downstream heads, L= Seepage path length.

$Q = 400 \times 2.475 \times 10-6 \times 86,400 \times 365 = 3.1 \times 104 \text{ m}^3/\text{year} = 31,000 \text{ m}^3/\text{year}$

From the above calculation, it can be seen that when Qionglin Reservoir is full all year round, the annual leakage of the dam is 31,000 m³/year. However, when there is a small amount of water in the reservoir all the year round, leakage occurs due to the hydraulic gradient of groundwater, the annual leakage is 22,700 m³/year in the bottom of the reservoir. Although all the leakage is not large, the reservoir management unit must pay attention to this problem, such as by implementing the leakage prevention improvement project at the bottom of the reservoir.
