# **CT** Scans of Asbestos Cement Pipes as a Reference for Condition Assessment of Water Mains

Karel van Laarhoven 1,\*, Jip van Steen 1, Frank van der Hulst 2 and Hector Hernandez Delgadillo 2

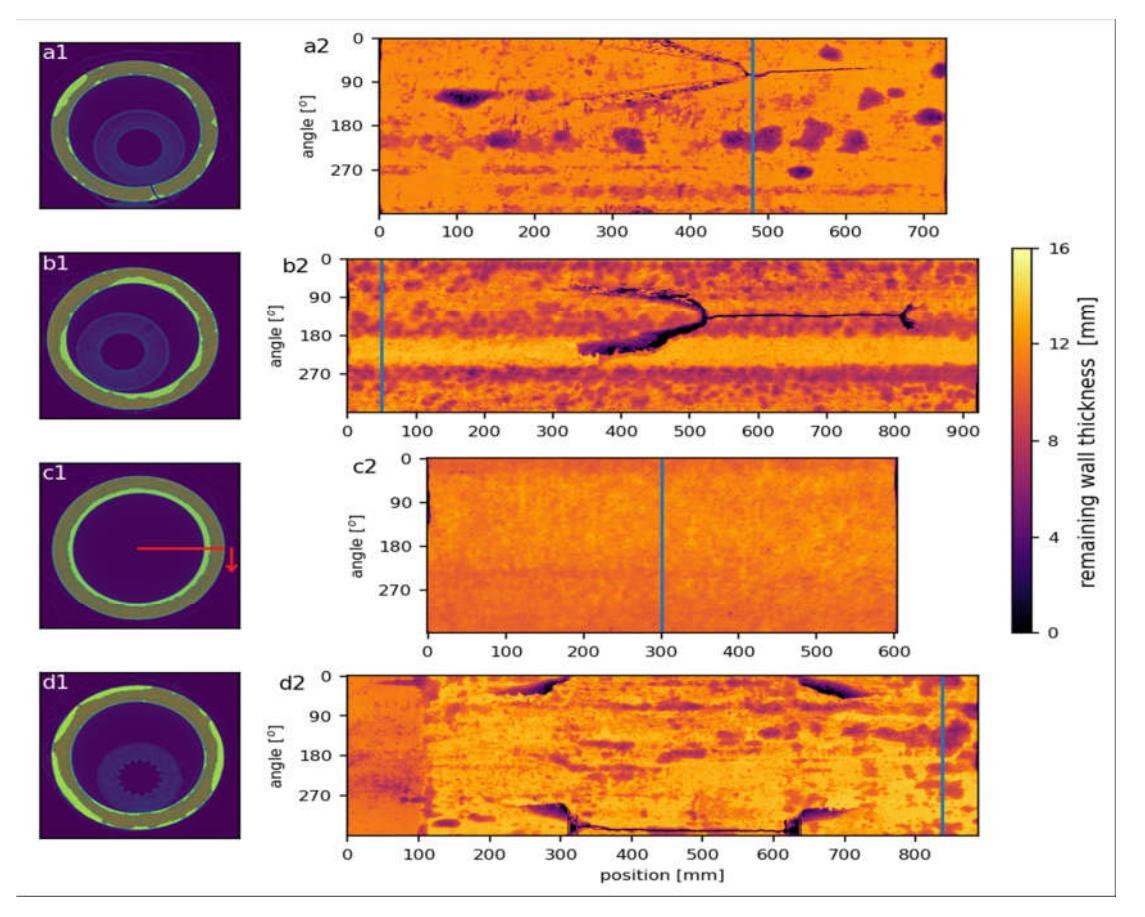
The remaining wall thickness of the pipe in Figure 2a displays a spotty pattern across the pipe surface that corresponds to many localized areas of external degradation. In Figure 2b, internal and external degradation are drawn out in thin bands across the surface. The pipe in Figure 2c displays a far more even landscape, which corresponds to the homogeneous, internal degradation across the pipe wall that is considered to be typical for leaching AC pipes [10]. Figure 2d again shows a somewhat spotty, inhomogeneous pattern, with degradation clearly being more pronounced at certain angles around the pipe's longitudinal axis.

**Figure 2.** Four examples of degradation patterns of AC pipes as measured with CT. The ID's of the pipes in Table 1 are 103679 (**a**), 168218 (**b**), Blerick4 (**c**), and D161290 (**d**). The cross-sections (**a1–d1**) are the CT slices at the locations marked with the blue lines in the corresponding height maps of the pipes (**a2–d2**). The height maps indicate the remaining wall

Presumably, the localized external degradation in Figure 2a–d stems from contact with un-homogeneously distributed aggressive soil components around the pipes while they were in use. The inhomogeneous nature of the internal degradation in Figure 2a,b is more remarkable, however, since the leaching of calcium hydroxide from AC pipes into the drinking water is usually understood to be a diffusion controlled process that occurs homogeneously across the pipe surface [10], as was the case for the pipes like the one in Figure 2c. Research on the chemical (and possibly the microbiological) microclimate of the inner pipe wall in relation to local deterioration is needed to further explain this discrepancy. This would also require research on possible factors that lead to such local differences, such as fault production or installation, damage due to pressure surges, or water compositions that lead to inhomogeneous precipitation across the pipe wall or that support colonial microbial growth. Obtaining the historical operational data of water utilities required to study this may prove a challenge in itself.

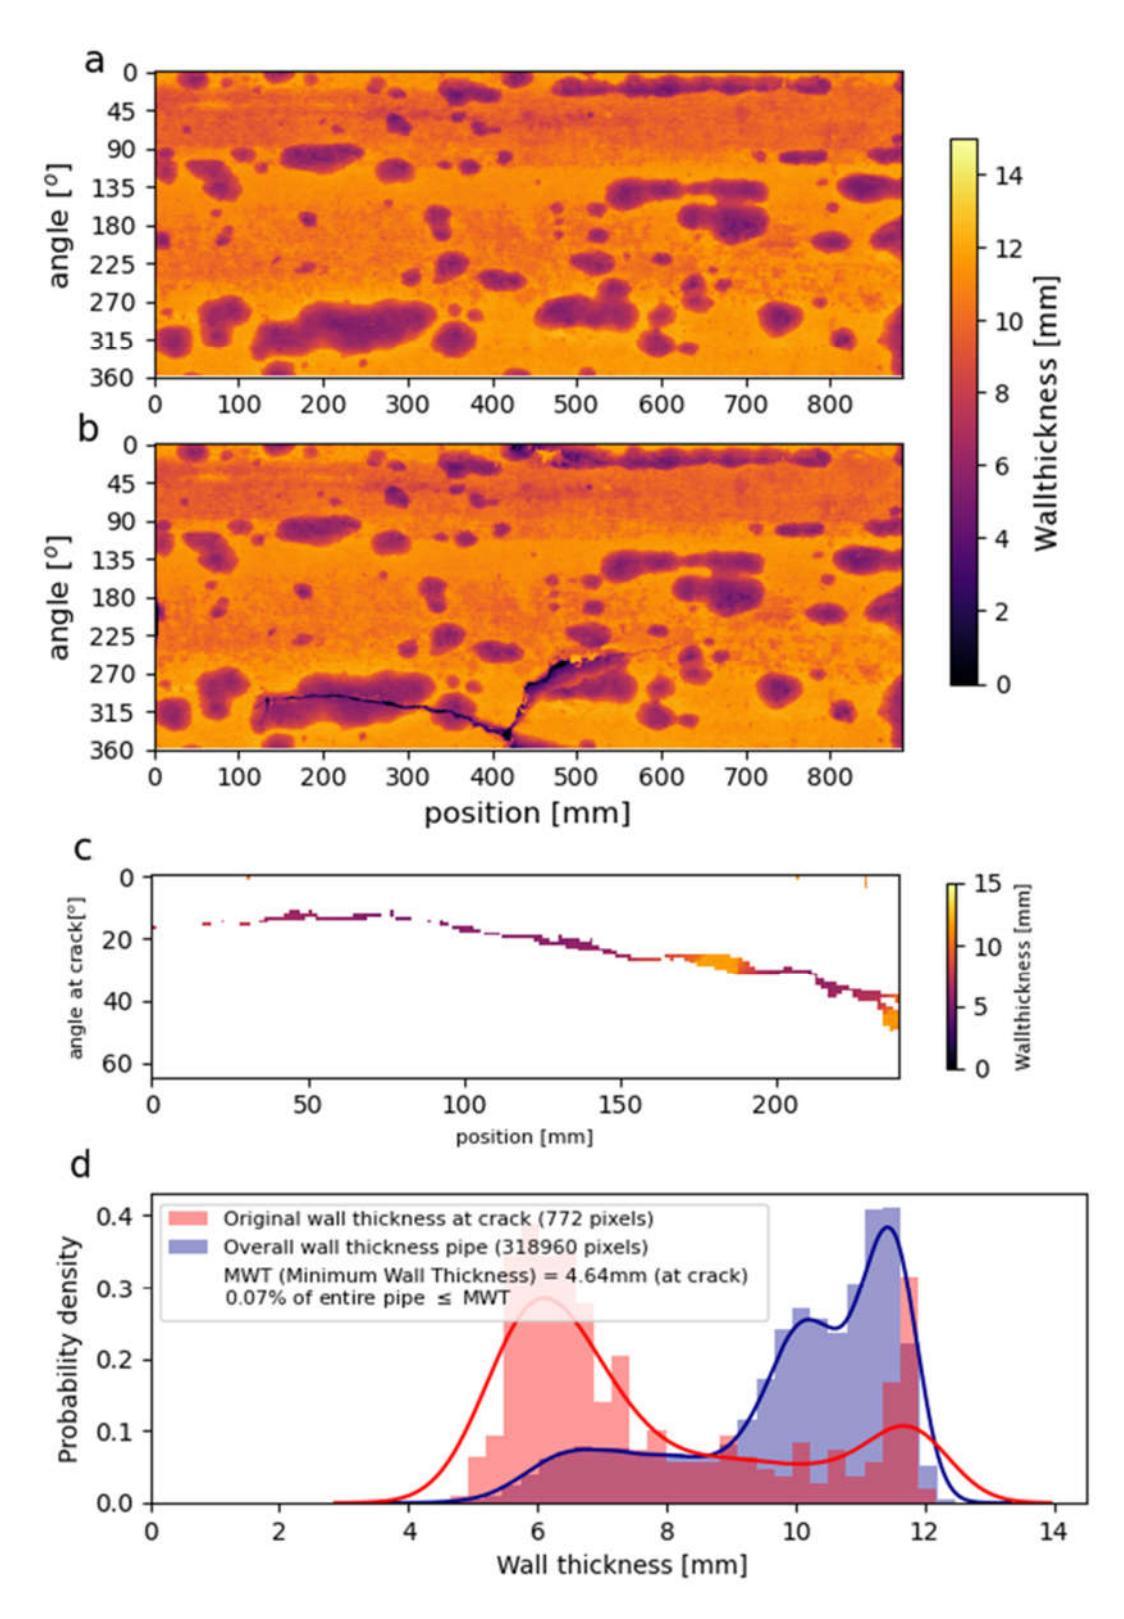
Figure 3 shows an example of how this was approached for pipe 177598: the location of the crack that resulted from the strength tests was obtained from the scans that were taken after the tests (Figure 3b). Subsequently, that information was combined with the scans that were taken prior to the strength tests (Figure 3a) to determine the original remaining wall thickness along the trajectory of the crack (Figure 3c). Since the crack's exact point of initiation could not be obtained from the CT scans, the part of the crack between forks was taken to be the first part of the crack, which formed directly after initiation. The distribution of remaining wall thicknesses along this part was compared to the distribution of the remaining wall thicknesses across the complete pipe wall (Figure 3d). In this particular case, indeed, one of the lowest values for the remaining wall thicknesses was found on the crack, and the wall thicknesses along the crack were clearly lower than those that were present elsewhere on the pipe, although there was a clear overlap in distributions as well. The minimum wall thickness on the crack belonged to the 0.07% lowest anywhere on the pipe.

This exercise was carried out for 10 pipes (see Table 2, the IDs marked with an asterisk) that failed during the strength tests. In 8 out of 10 cases, the minimum wall thickness on the crack belonged to the 1% smallest wall thicknesses anywhere on the pipe, like the example of Figure 3. In 2 out of 10 cases, at least 8% of the pipe wall had lower remaining wall thicknesses than anywhere on the crack, so that a clear connection between the location of the crack and the points of lowest wall thickness was not obvious. The fact that, in 80% of the studied cases, the crack included the 1% most degraded spots indicated that local spots of inhomogeneous degradation indeed influenced failure behavior, although the 10 cases studied here cannot provide a statistically representative basis for that conclusion.

**Figure 3.** Approach for investigating an influence of local degradation on cracking. (**a**) The CT scan of pipe 177598 prior to the strength test. (**b**) The CT scan of the cracked pipe after the strength tests. (**c**) The remaining wall thicknesses in the first scan on the location of the crack in the second scan. (**d**) Normalized histograms of the distribution of wall thicknesses along the crack (red) and across the whole pipe (blue).

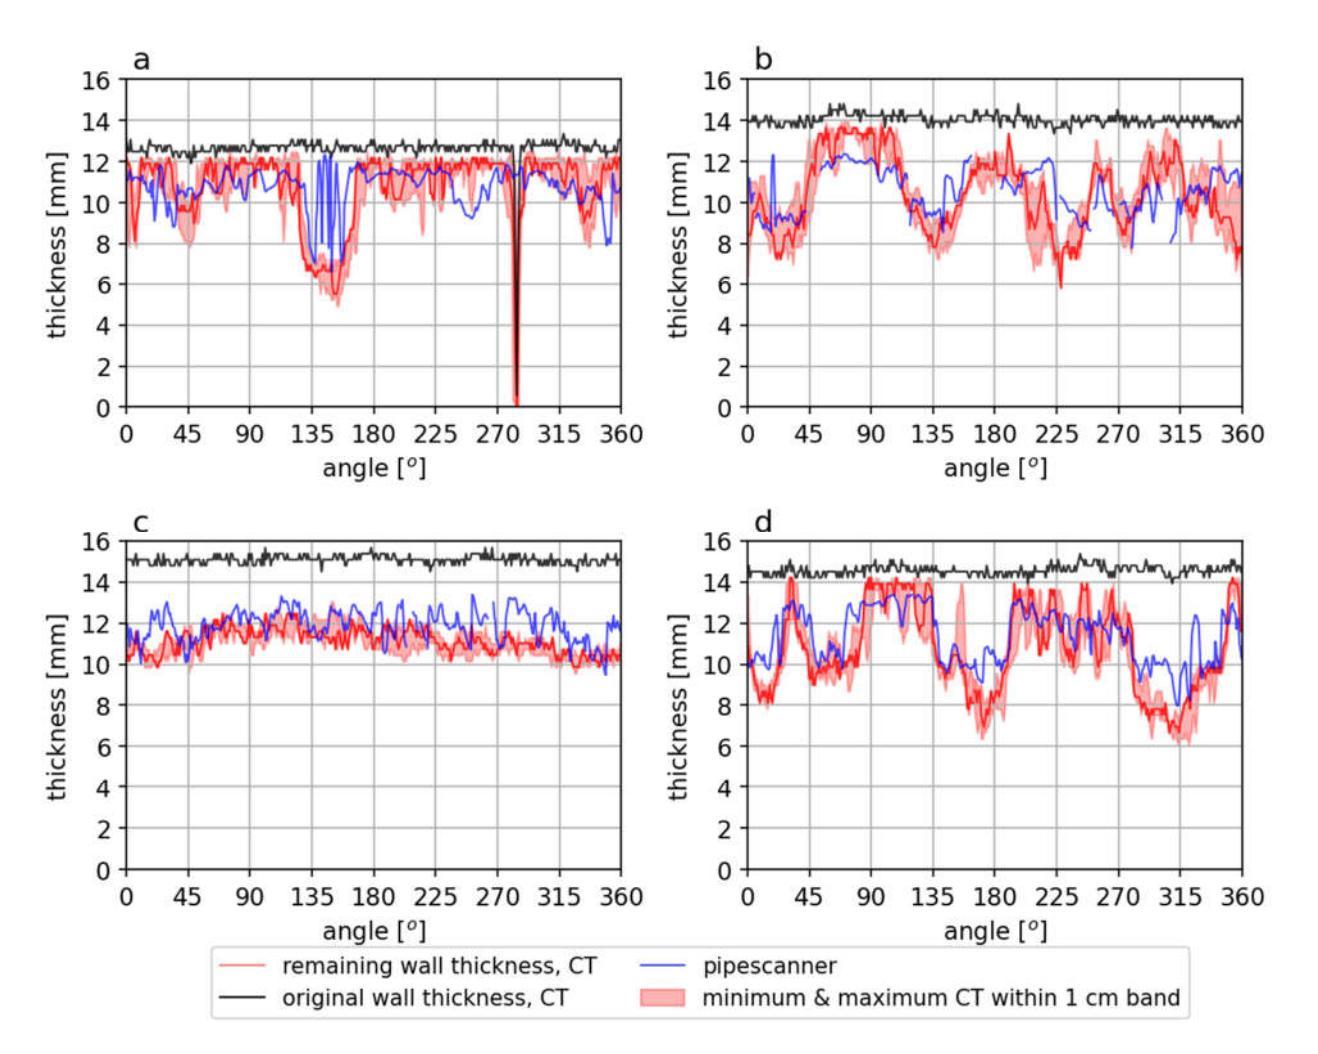
Overall, the ultrasound profiles matched the CT profiles quite well in terms of shape and order of magnitude. There were offsets in the order of a few mm at some locations, such as Figure 4a around 135°, Figure 4b around 90°, and Figure 4d around 90°.

**Figure 4.** Comparison of CT (red) and ultrasound (blue) measurements of the remaining wall thicknesses of the four crosssections of degraded pipes shown in Figure 2 (the lettering (**a**–**d**) corresponds to pipes with the same letters in Figure 2). The black lines represent the original wall thickness (comprising degraded and undegraded material) as determined from the CT scans.
