Supplementary Materials

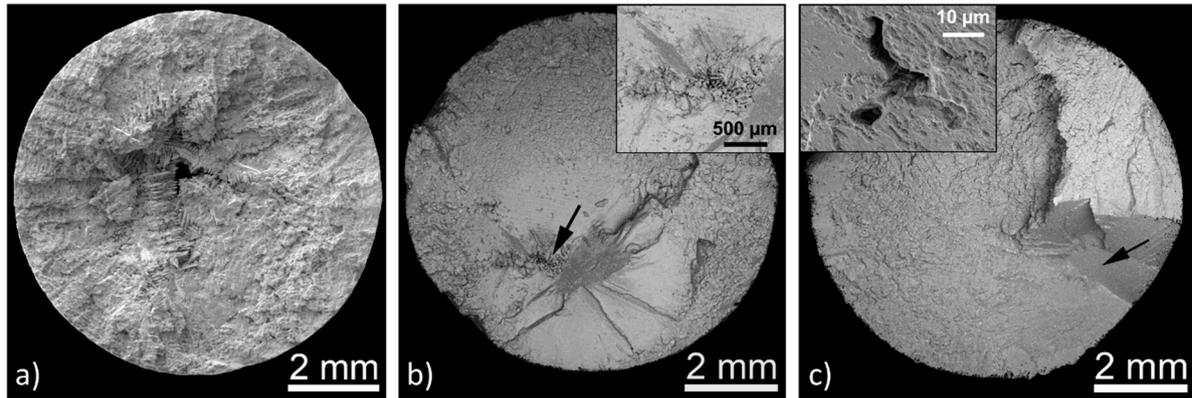
Figure S2. Fractographs of (a) TF specimens without HIP, (b) TF specimen with HIP and (c) BF specimen.

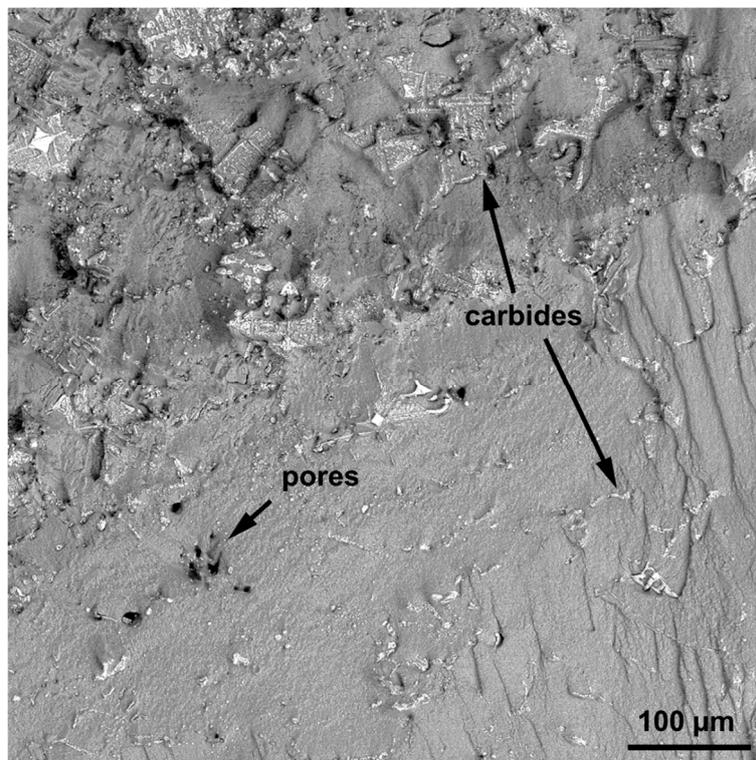
Figure S3. Backscattered electron micrograph of the fracture surface showing the presence of carbides and gas pores, favourable sites for the fatigue crack propagation.
