A Study on the Failure of AISI 304 Stainless Steel Tubes in a Gas Heater Unit

Abbas Bahrami ¹ and Peyman Taheri ^{2,*}

Abstract: This paper investigates a failure in convection section tubes of a gas heater unit in a petrochemical plant. Tubes are made of AISI 304 stainless steel. The failure is reported after 5 years of service at working temperature 500 °C. The failure is in the form of circumferential cracks in the vicinity of the weld. Various characterization techniques, including optical and electron microscopes as well as energy-dispersive X-ray spectroscopy (EDS), were used to study the failure. Results showed that that the damage has initiated in the heat affected zone (HAZ) area parallel to the weld/base metal interface. Cracks have propagated alongside grain boundaries, resulting in an intergranular fracture. The main cause of failure was concluded to be attributable to the grain boundary sensitization and intergranular grain boundary attack due to improper welding and long time exposure of tubes to high temperature. Possible mitigation strategies to minimize similar failures will be discussed.

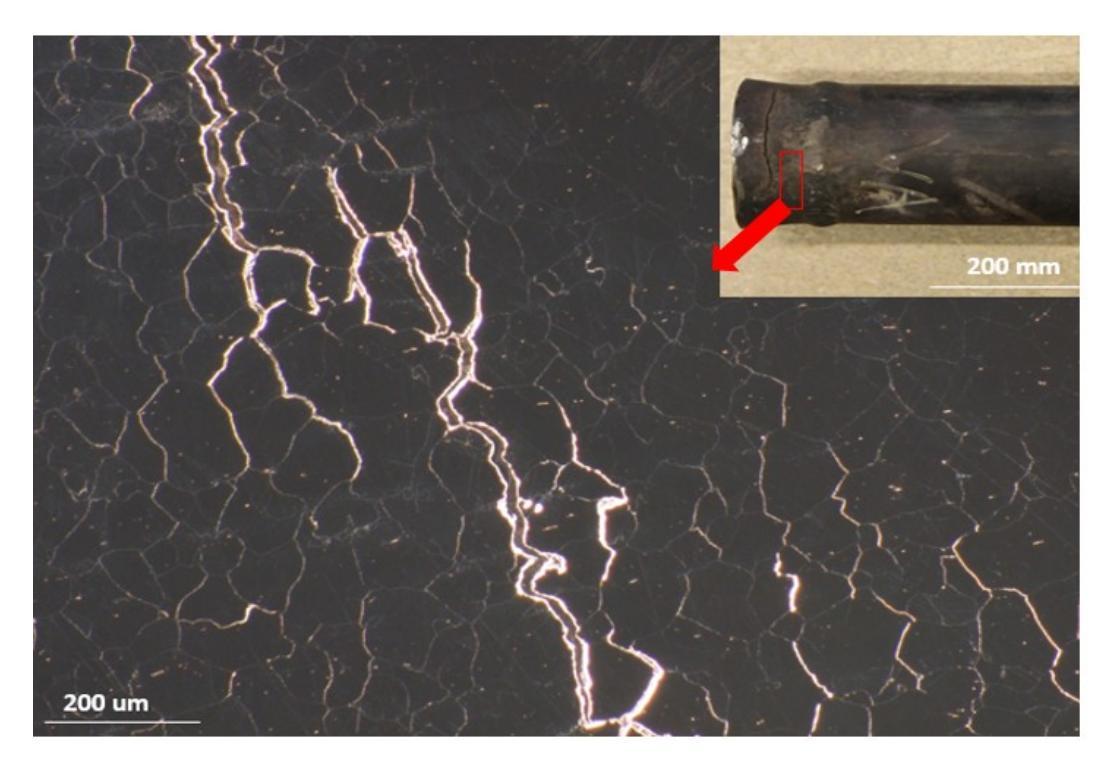
Figure 1 shows an example of a failed tube together with stereomicroscopic image of crack. As can be seen, the crack has propagated circumferentially parallel to the welding line. The crack has propagated in HAZ area in the vicinity of the weld. stereomicroscopic image shows that the crack has propagated alongside grain boundaries. There is no defect in the form of crack or cavities inside the weld, inferring that the weld itself has a perfect quality. In some areas there are some deposits on the surface. Other than these mentioned features, there is hardly any other abnormality in the form of bulging, thinning, or localized deformation in any form. The fact that there is no bulging or localized deformation infers that creep is not a major issue.

Figure 1. Macro and stereomicroscopic images of failed specimen.

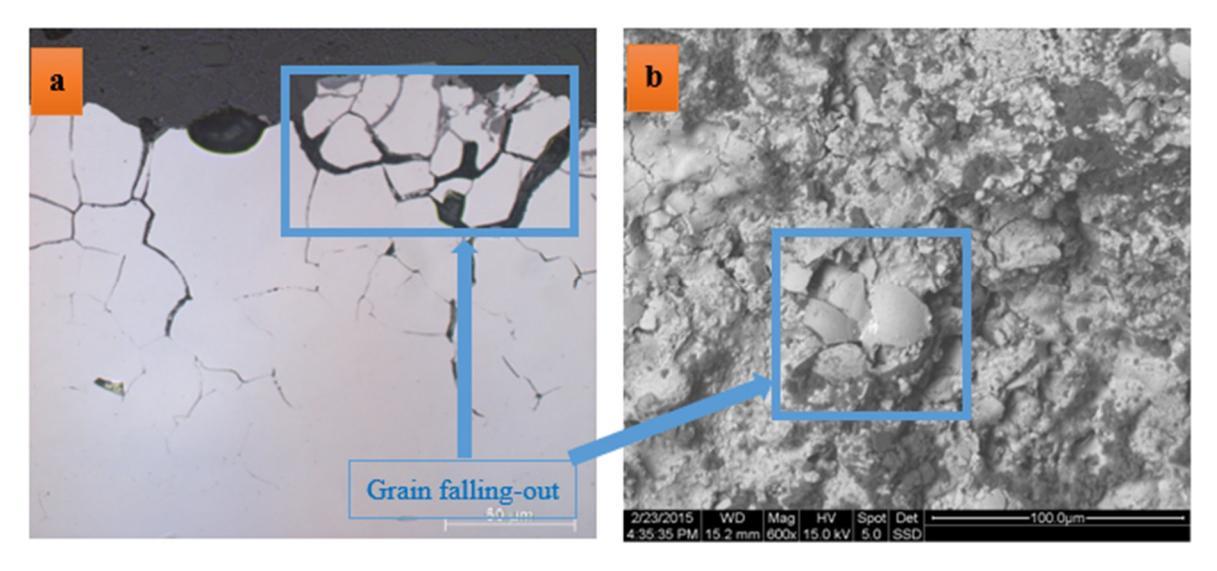
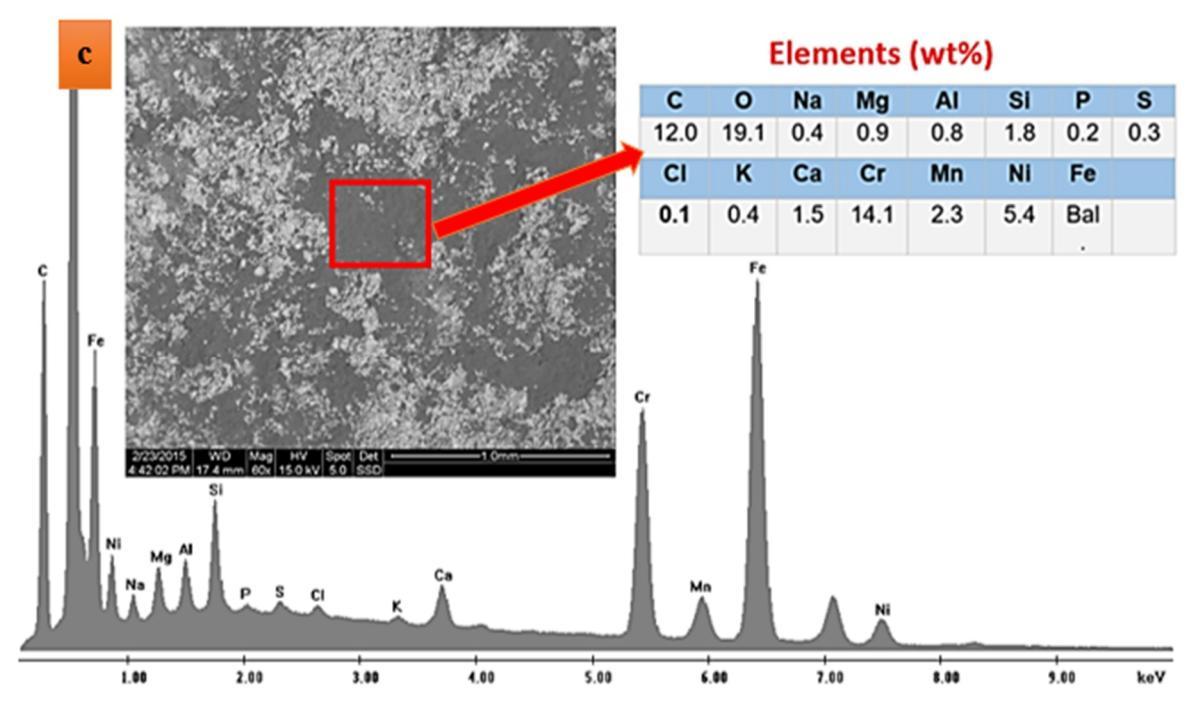
Figure 2 shows grain structure and deposits on the surface of the tube near the damaged area. Two main features are noteworthy to mention. The first noticeable observation is the so-called "grain falling-out" phenomenon (see Figure 2a). It appears that grain boundaries at the surface are heavily oxidized, resulting in the weakening of grain boundary and detachment of a whole grain from the surface. This is also confirmed by the SEM image (Figure 2b). It is also noticeable that some areas on the surface are covered a black deposit. The EDS analysis of these deposits are given in Figure 2c, showing that elements like C, Cl, Mg, Na, and Ca are present in the composition of these deposits. Given that the outer surface of the tube is the fire-side, one can conclude that these deposits are typical fly ashes, coming from the fuel. In this case fly ash corrosion appears to have a significant attribution to the observed failure. Fly ash is a residue generated due to coal combustion and contains fine particles. In this case ash is brought to the system via flue gas. The composition of fly ash depends on the coal and the combustion condition. In most cases, fly ash contains ferric oxide, aluminum oxide, silicon dioxide, and calcium oxide [18]. Fly ash particles are normally collected by filter bags and/or electrostatic filter. Yet, there is a chance that very small residues are not captured by filters. These residues are then precipitated on the outer surface of the tube. Fly ash residues can accelerate surface corrosions. Elements like Ca and Na can diffuse into grain boundaries, resulting in the weakening of grain boundaries and ultimately grain detachment on the surface. Needless to mention that elements like Cl can also severely corrode stainless steels.

Figure 2. (a) Optical microscope image of grain falling-out at the surface, (b) SEM image of grain falling-out at the surface, and (c) SEM/energy-dispersive X-ray spectroscopy (EDS) analyses of deposits on the surface.

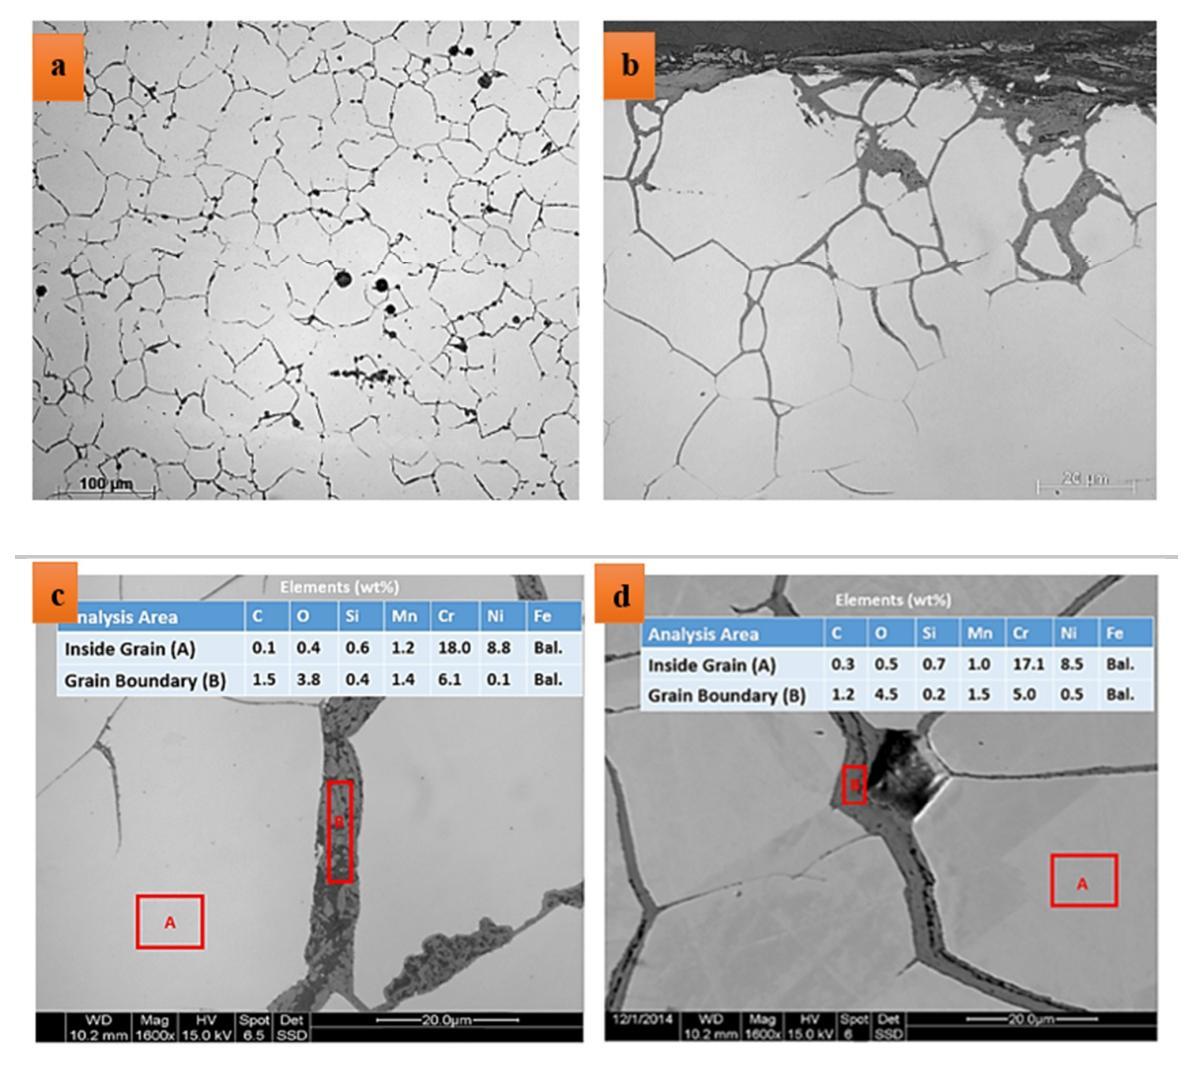
Figure 3 shows optical microscope and SEM images of HAZ structure in the as-polished condition. Figure 3a,b show that grain boundaries are mostly covered with a rather thick black phase layer. Figure 3c,d depict that the thickness of the grain boundary phase layer can be as high as 10 µm. The grain boundary phase appears to be rather brittle. This is clearly seen in Figure 3c in which the grain boundary phase is broken. The EDS analyses of grain boundary, given in Figure 3c,d, show that the grain boundary phase is rich in oxygen, carbon, and chromium. It appears that grain boundaries are sensitized and are heavily oxidized. Grain boundary sensitization takes place when chromium carbide precipitates at grain boundaries. Chromium carbide precipitation at grain boundary creates a chromium-depleted zone in the vicinity of sensitized grain boundaries. Given that chromium is the major element when it comes to the corrosion resistance in stainless steels, this narrow chromium-depleted region adjacent to the grain boundaries makes grain boundaries preferential corrosion spots. A continuous network of carbides on grain boundaries and intergranular corrosion makes grain boundaries weak and brittle. Cracks can therefore more easily propagate alongside sensitized grain boundaries. Sensitization of grain boundaries of austenitic stainless steels takes place in temperature range 510 to 780 °C [19]. Any thermal exposure into this temperature range during welding or service could potentially result in the sensitization of grain boundaries in stainless steels. The temperature and time required to cause sensitization and intergranular corrosion depends on the chemistry of the alloy, and more specifically on the carbon content of the alloy. Obviously, the higher the carbon content of the alloy, the higher is the risk of sensitization. For this reason, low carbon stainless steel grades such as AISI 304L and AISI 316L alloys are known to have an excellent resistance against sensitization during welding. In higher alloyed stainless steels such as alloys AISI 904L, grain boundary susceptibility to sensitization is also essentially not a concern [19]. In this case, the observed sensitization has possibly its root in the welding practice. The service temperature is on the lower side of the sensitization temperature range and service exposure has possibly not the major contribution to the sensitization. If sensitization was due to the service exposure, one should have seen sensitization in the base metal as well, which obviously is not the case.

Figure 3. Optical microscope images of grain structure in the heat affected zone (HAZ) area of failed specimens; (**a**,**b**) an overall view, and (**c**,**d**) SEM/EDS analyses of grain boundary phase and inside grains.

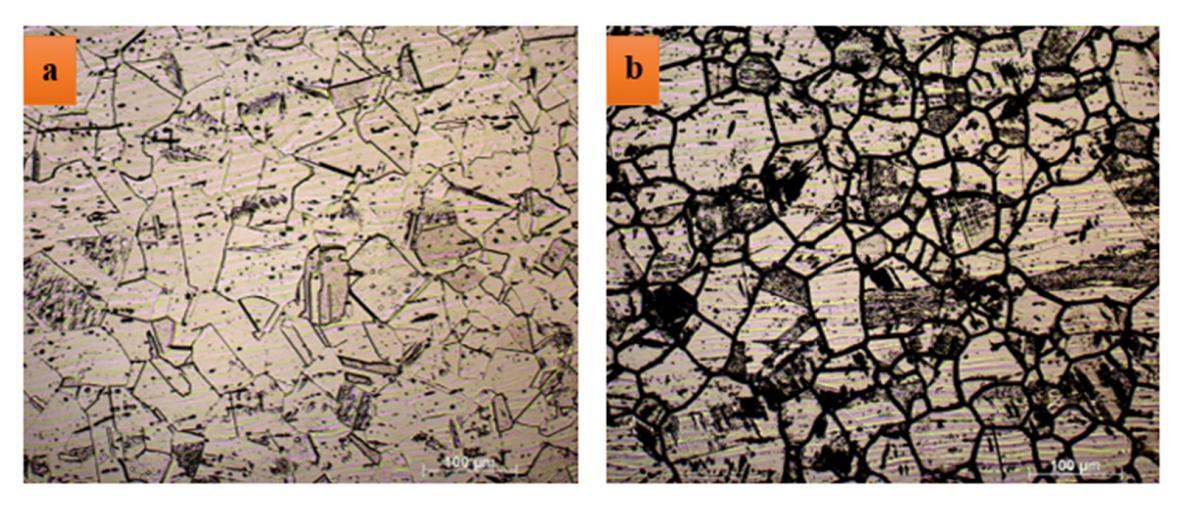
The formation of the latter etch structure is an indication of grain boundary sensitization. Figure 4 shows the etch structure of AISI 304 stainless steel in the base metal (Figure 4a) and in the HAZ (Figure 4b). A clear difference is observed between these structures. While the former is a typical step

structure, the latter is a clear ditch structure, inferring that HAZ has become severely sensitized during welding and service exposure.

Figure 4. Optical microscope images of grain structure in (**a**) base metal and (**b**) HAZ area of failed specimen, etched according to standard ASTM A262, Practice A.

- Carbon content has a very decisive influence on the susceptibility of grain boundaries. Superior resistance to grain boundary susceptibility can be achieved by reducing the carbon content values less than 0.03 wt%. It is highly recommended to use AISI 304L or other low-carbon stainless steel grades instead of AISI 304.

- Stabilizing elements like Nb and Ti can also enhance the resistance to sensitization. These elements
 form stable carbides at high temperature. This way less carbon is available for the formation
 of chromium carbides at grain boundaries. Commonly used stabilized austenitic stainless steel
 grades are AISI 321 and AISI 347. Replacement of currently used AISI 304 alloy with stabilized
 grades is also highly recommended.
