Article Investigation of Corrosion Effects on Collapse of Truss Structures

Zeynep Fırat Alemdar *^{,†} and Fatih Alemdar [†]

Department of Civil Engineering, Yıldız Technical University, Istanbul 34220, Turkey

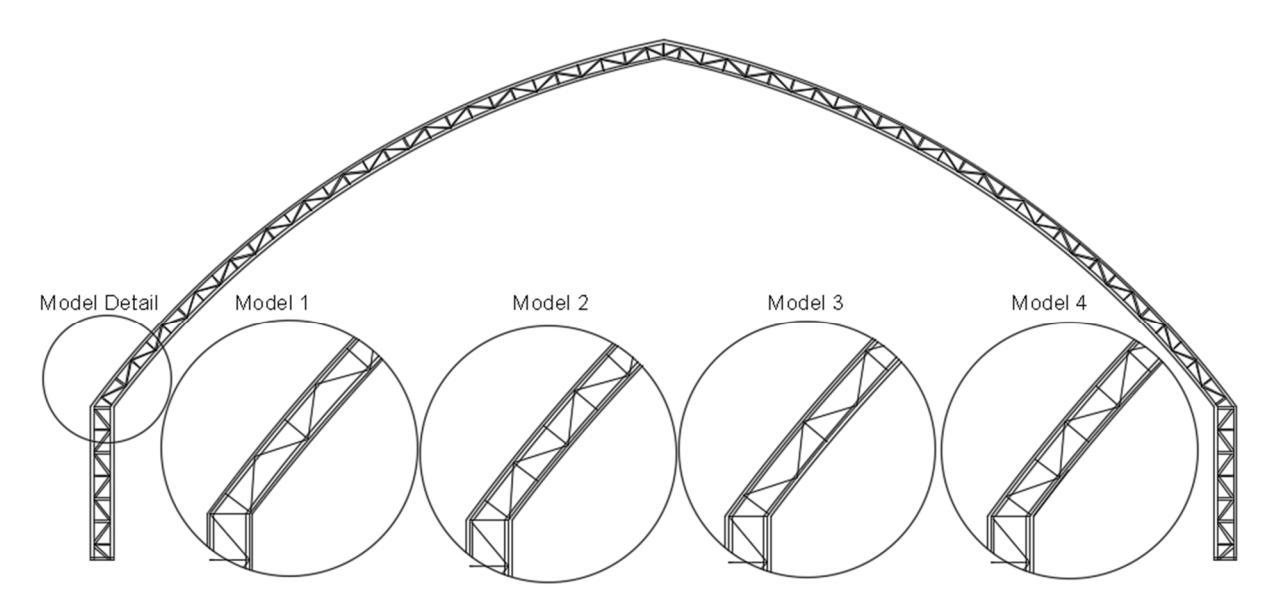
In the on-site examinations, it was observed that the purlins were joined to the rafter systems as well as to each other via fillet welding. The weld sizes were determined as the minimum for each profile based on the thicknesses of the profiles. There were some differences in the configurations of the diagonal and vertical elements used in the rafter systems in one structure, as shown in Figure 2. Numerical simulations were defined individually to consider the differences in the rafters.

Figure 2. Different configurations of the rafter systems.

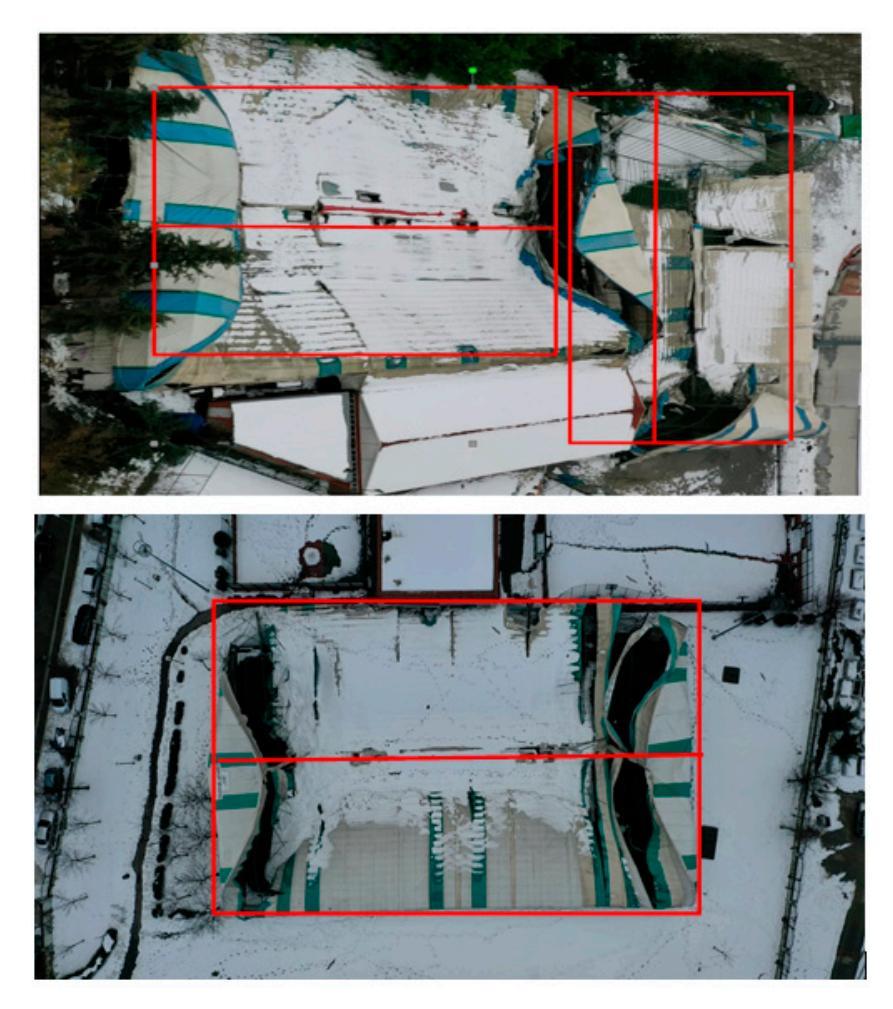
Damage to the primary load-bearing components may result in a partial or total collapse of the structure. The top views of the collapsed structures are given in Figure 3 on the day of the collapse. The observed damage modes were identified during visual inspections, and the reasons for the damage are discussed below.

Figure 3. Top views of the collapsed structures.

Looking at the photographs of the systems after collapse in Figure 3, it is seen that the roof ridge lines were approximately in the middle of the system. Thus, it is thought that was no disruption to the symmetry in the system at the time of collapse.

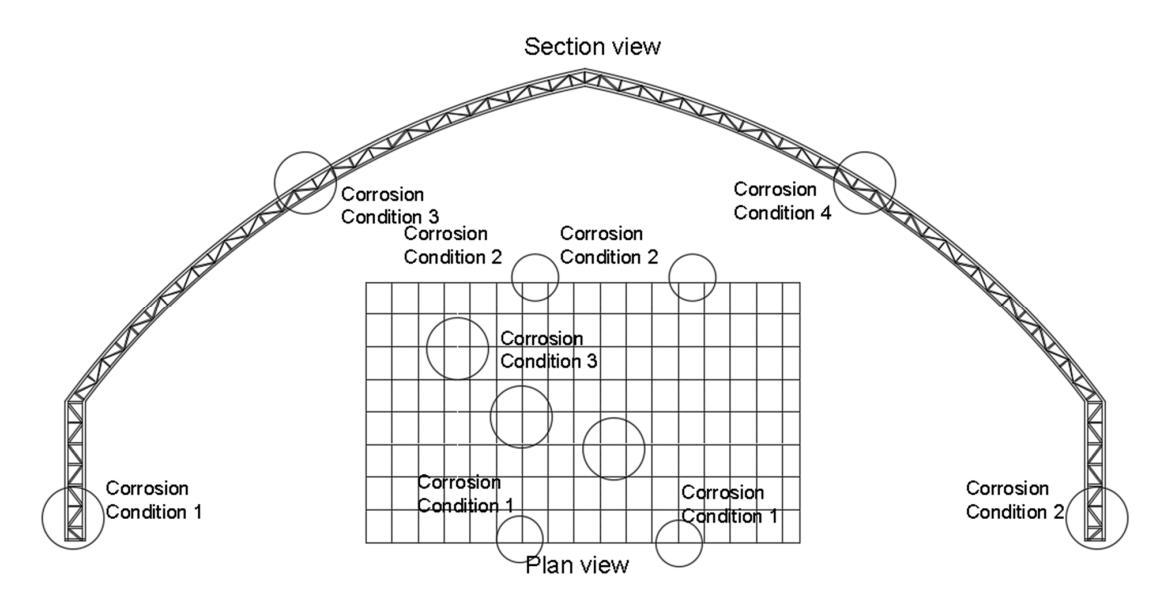
The regions exposed to corrosion are approximately illustrated according to the field observations in the section and plan views of the structures in Figure 4. The welding method and workmanship of the purlin connections were not very good, and some of the profiles were broken from the welds after the collapse, as shown in Figure 5. Moreover, corrosion problems were noticed at the purlin connections to the roof system in Figure 5. These conditions made the roof system more prone to collapse. The connections should be resistant to bending and displacement under service loads because the capacity of the connections should be more than or at least as much as the load-carrying capacity of the purlin profiles, according to the relevant standards.

Figure 4. Corrosion conditions of the structures.

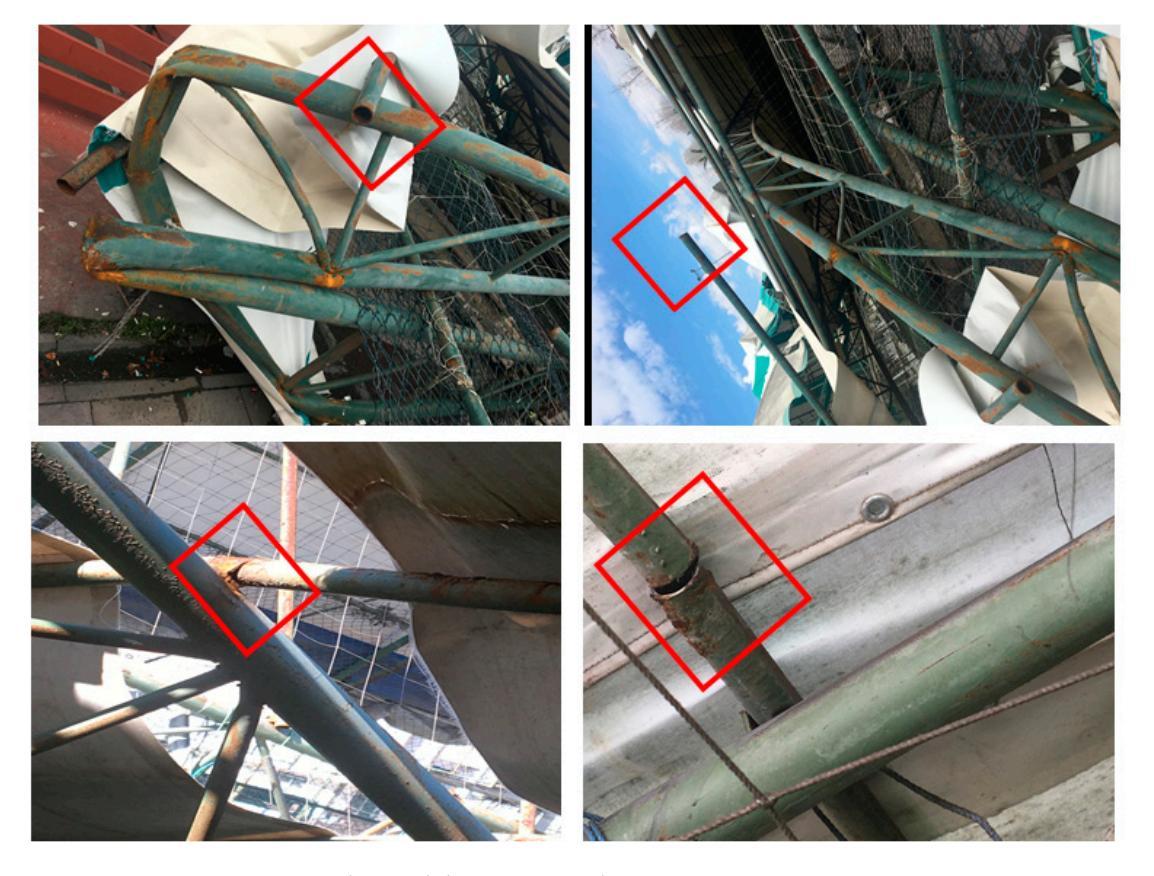
Figure 5. Observed damage on purlin connections.

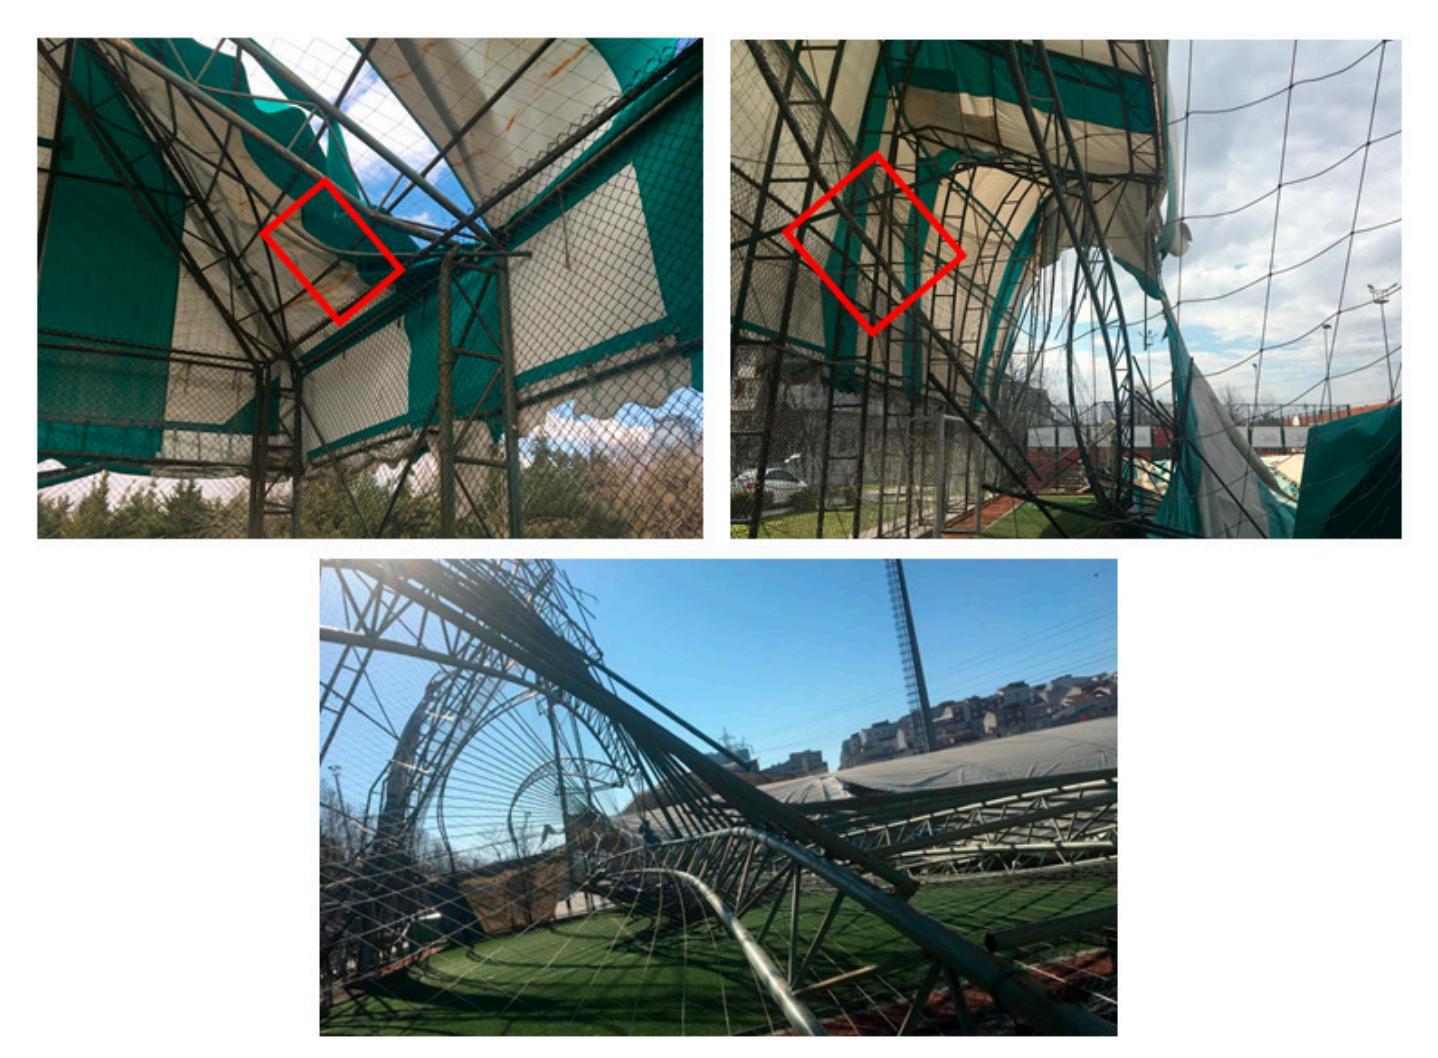
Roof and façade wind stability braces were examined in situ and are presented in Figure 6. It was observed that the braces failed due to inadequate welding and excessive vertical deflections. This indicates that the capacities of the brace members and their connections to the truss columns and the roof rafters were not enough to carry their service loads.

Figure 6. Roof and façade wind stability braces.

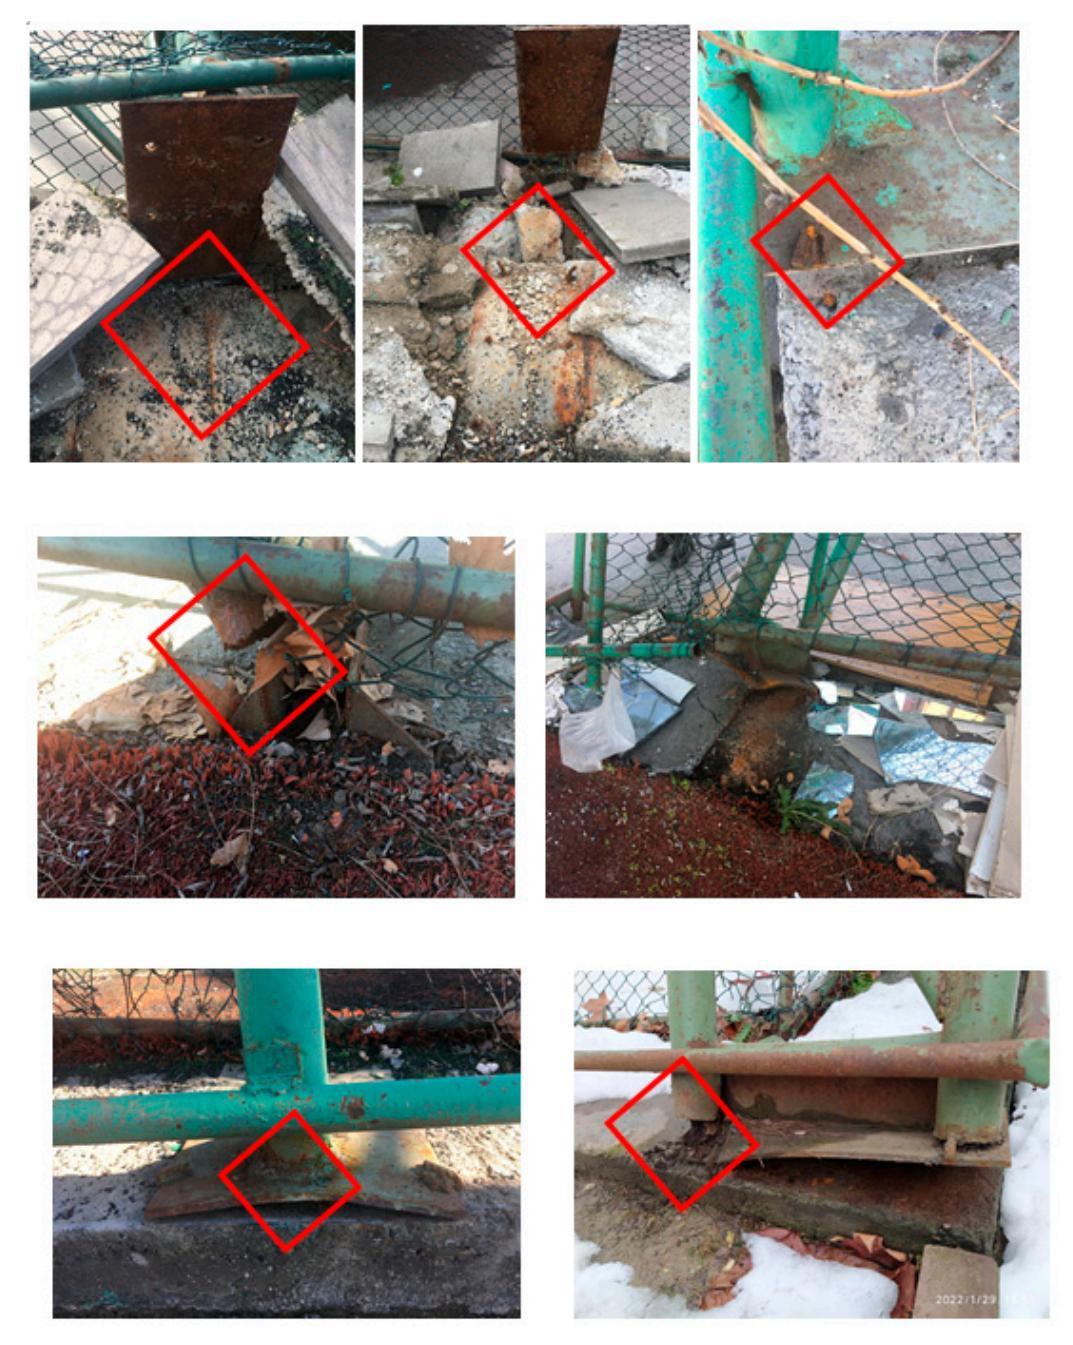
The deficiencies in the connections of the column support plates to the reinforced concrete foundation were observed and are shown in Figure 7. In the on-site investigations, it was observed that reinforcing steel bars were used instead of anchor rods to connect the support plates to the foundation, and the number of bars was even less than the value required for the design of the connections. The cross-sectional loss occurred on the steel bars as well as on the truss column members due to corrosion (Figure 7). In addition, the excessive upward displacement of the support plates resulted in the failure of the truss columns.

Figure 7. Failure of the column support plates.

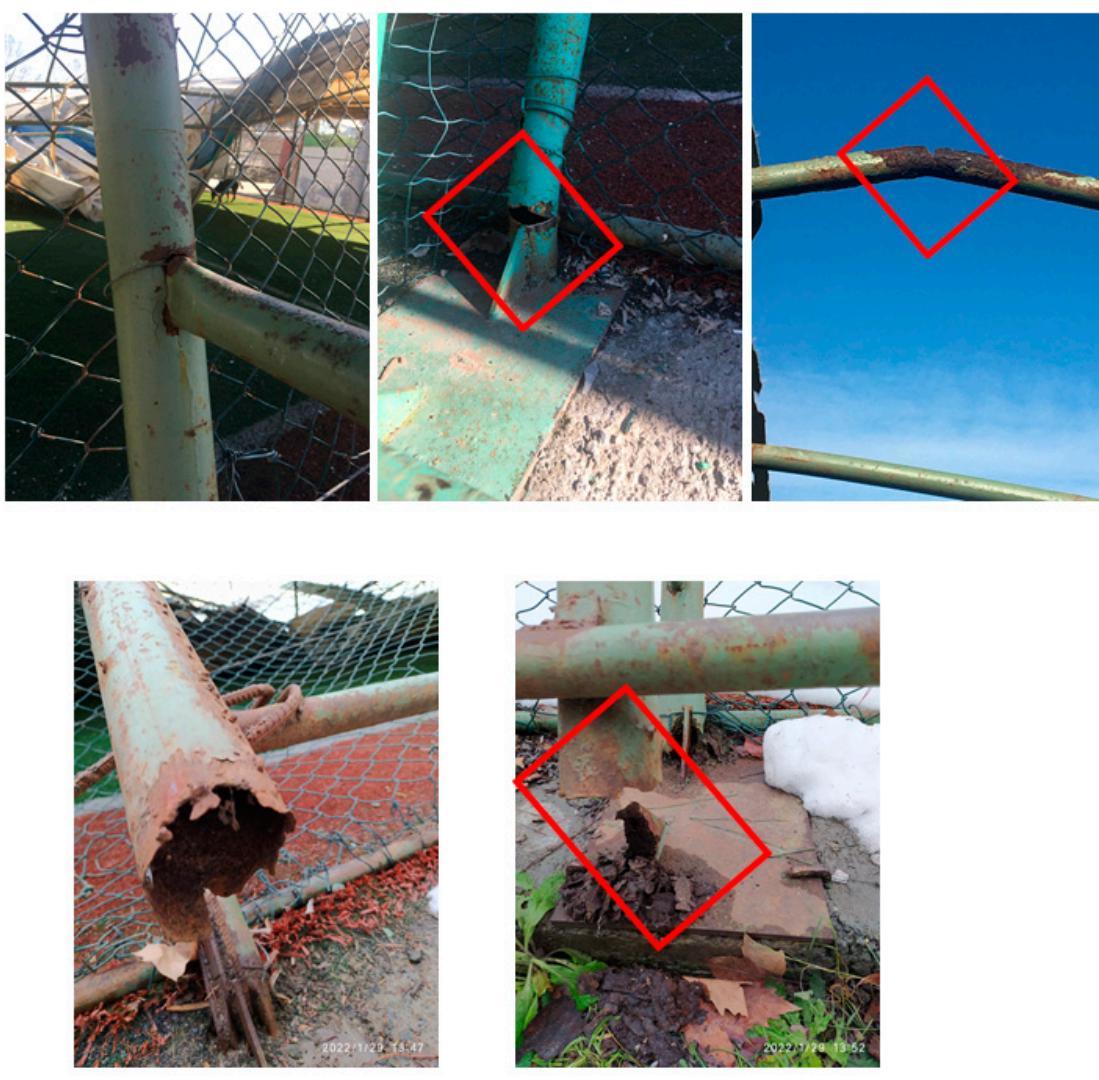
Looking at the photographs in Figures 5 and 7, high levels of corrosion were detected in the member cross-sections and the connections. These corrosion levels led to the loss of almost entire cross-section areas in some regions of the structures, as shown in Figure 8. The truss column members failed due to excessive corrosion in the support connections. The steel structures should have been built according to the NACE International Standards [25] to prevent or control corrosion problems, and holes should have been drilled to drain the water in the sections, thereby reducing the exposure time of these structural elements to water and the corrosion levels of the sections. The thicknesses of the profiles in the collapsed structures were designed as equal to or thicker than 2.5 mm; thus, it is supposed that the profiles should not have any stability problems. However, the stability of the structural members and their connections were affected by the high levels of corrosion and improper erections.

Figure 8. Corrosion damage to structural members.

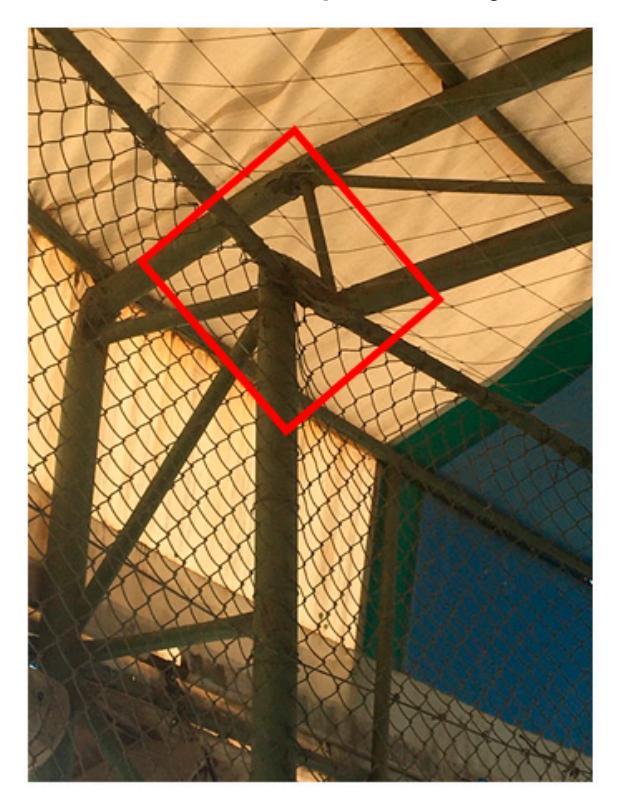
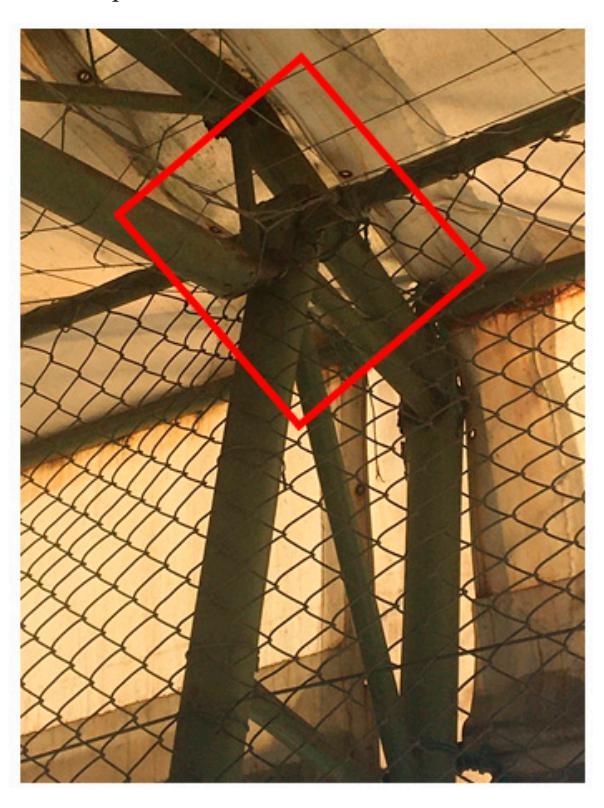
Figure 12. Observed damage at the end of rafter system in Model 4.

Von–Mises stress distributions were obtained for the different rafter models. The comparisons of the analysis results were made for the rafter system on the second axis because it was subjected to full snow loading. Although the Von–Mises stress values formed in different rafter systems with four simple supports did not reach the yield strength of the steel material, the stresses exceeded the yield capacity in some members of the rafter system in all FE models with three and two supports, as shown in Figure 14. It was observed that the stress values were similar for different rafter systems with the same number of supports (Table 2). High stress concentrations were found along the bottom chord members of the rafter at the connection region to the column profiles (Figure 14). This situation was also observed in the collapsed structures, as shown in Figure 12.
