Article Up-Floating Destruction and Reinforcement Measures of Damaged Basement Based on the Bending Moment and Deformation Analysis

Abstract: Based on the up-floating incident of the basement in a high-rise residential building, the finite element (FE) model of the up-floating destruction region is established to investigate the damage mechanism. The stress states and the deformations of the basement structure are obtained under complex loads including water buoyancy forces, vehicle loads and construction loads. To assess the extent of damage, a novel damage indicator is defined based on two levels: the cracking bending moments and the yield bending moment. The first-level cracking bending moment, second-level cracking bending moment and the yield bending moment can be determined using the section stratification method. By comparing the maximum bending moment of the component with its corresponding cracking moment, one can determine whether the cracks have occurred and assess their severity. Meanwhile, the antifloating failure model is constructed to analyze the mechanism of the up-floating destruction. Finally, a detailed reinforcement treatment plan of 'decompression first and t

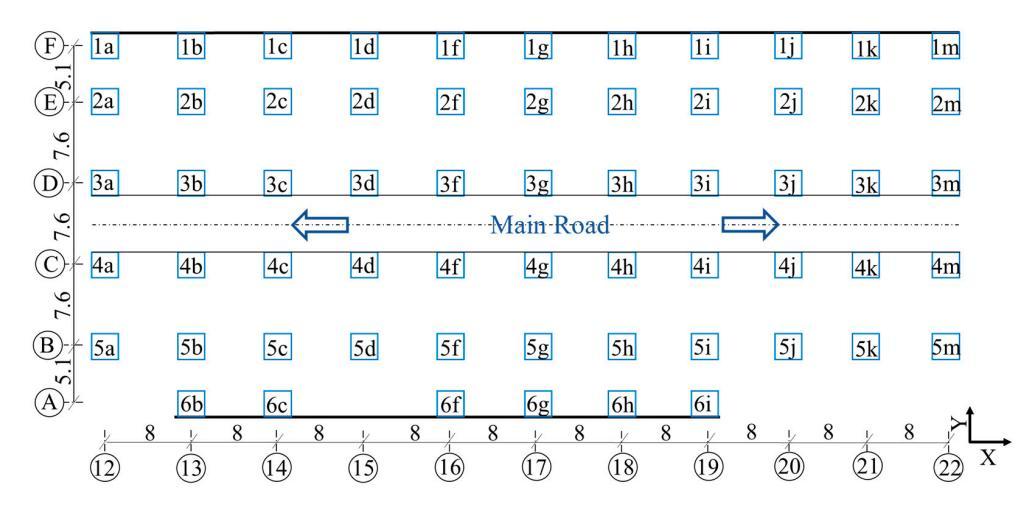
Figure 1. The destruction area in the basement: blue square means the initial intact column. 1a indicates the number of the column. According to architectural drawing codes, A denotes the A-axis along the X-axis, and 12 represents the 12-axis along the Y-axis. The unit of the distance is meter (m). Blue arrows are the directions of main road.

According to the on-site inspection, a significant number of reinforced concrete walls and columns in the basement exhibit cracks, primarily concentrated within Axes 12–22 and Axes A-F as depicted in Figure 2. At the onset of the cracking, only a limited number of fissures appear on the walls and columns with minimal degrees of severity. As cracks progress, their quantity increases while damage intensifies. After further development, the number of cracks increases and their severity worsens. The cracks mainly take a horizontal form and penetrate partially through the cross-section of the column. Additionally, a few cracks exhibit the full-sectional penetration. Based on the severity of the damage, these cracks can be categorized into four levels (Levels A, B, C and D) with the increasing degrees of cracking as illustrated in Figure 3. Between Axis 14 and Axis 22, a total of 47 columns displayed significant cracks. Among them, Level C cracks were observed in 20 columns. The columns on Axis 12 and Axis 13 do not exhibit any observed cracks. The majority of cracks are between Level B and Level C, situated at the bottom and top of the columns and oriented towards adjacent high-rise buildings. Columns located in close proximity to high-rise residential buildings, such as those on Axes B, C, E and F, display more severe degrees of cracking when compared to those on Axis D. Some cracks with a diagonal upward orientation of 45° appear at the intersections between the columns situated on the outer sidewalls and the beams of the top slab. These cracks have progressed to damage of Level D, with widths exceeding 2 mm and lengths in excess of 1 m for certain columns.

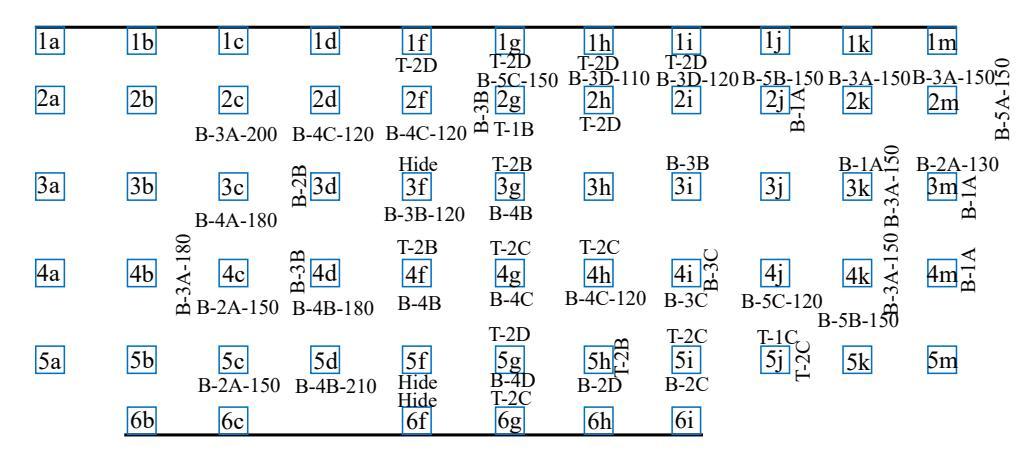
Figure 2. The cracks at the damaged columns: B-3A-200 indicates three cracks of Level A with a distance of 200 mm at the column bottom. T-2D denotes two cracks of Level D at the column top.

In Table 4, it is observed that the maximum bending moments at the top and bottom of the columns are 49.42 kN·m and 33.71 kN·m, respectively, when the vehicle loads act on the travel lane of the roof plate between Axis 18 and Axis 19 in the Y-direction. Neither of these values has yet reached their corresponding Stage 1 cracking moment, indicating no generation of cracks. However, it can be inferred that vehicle loads have a greater impact on the bending moment at the column top than at the column bottom. From Table 5, it can be observed that the bending moment at the top of the 3g column exceeds its Stage 1 cracking moment under the vehicle loads between Axis C and Axis D in the X-direction. The Level B cracks occur at the top of the 3g column, which is referenced as T-2B on 3g column in

Figure 2. Specifically, the bending moment is measured at 59.69 kN·m while the Stage 1 cracking moment is only 57.16 kN·m. Consequently, small cracks may appear at the top of this column but no cracks are visible at its bottom. Similarly, for the 5g column, its bending moment reaches up to 78.93 kN·m which represents approximately 93% of its corresponding Stage 1 cracking moment (84.77 kN·m). The initiation of cracks will occur at the top of the 5g column (T-2D on 5g column). It is evident that all other bending moment values are inferior to their corresponding Stage 1 cracking moments, thus resulting in cracks at these positions along the columns.

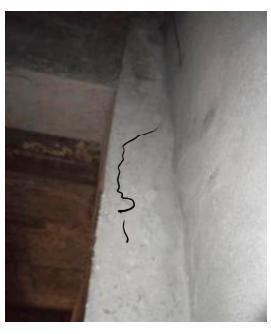
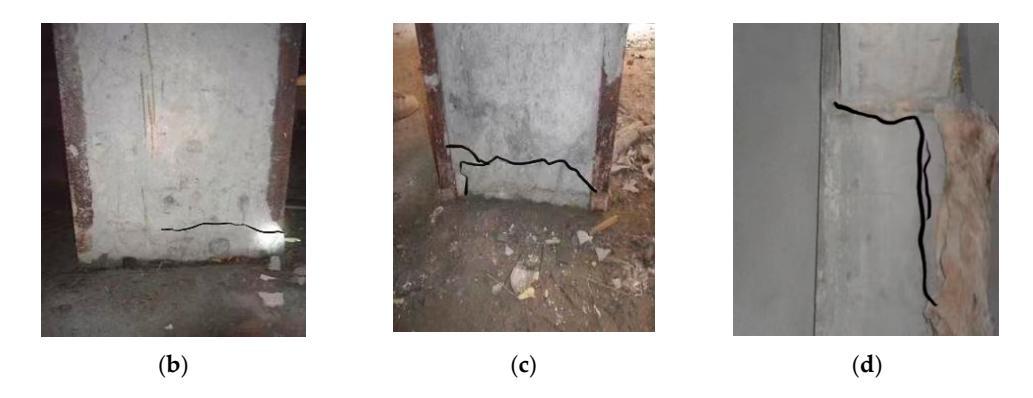
Figure 3. Four levels of cracks, namely A, B, C and D, based on the degrees of cracking. (**a**) Level A: The minuscule vertical fissures located at the center of the column. (**b**) Level B: The minute horizontal fissures that traverse the partial cross-section of the column bottom. (**c**) Level C: The horizontal cracks that traverse the entire cross-section of the column bottom. (**d**) Level D: The horizontal and vertical cracks that traverse the entire cross-section of the column top.

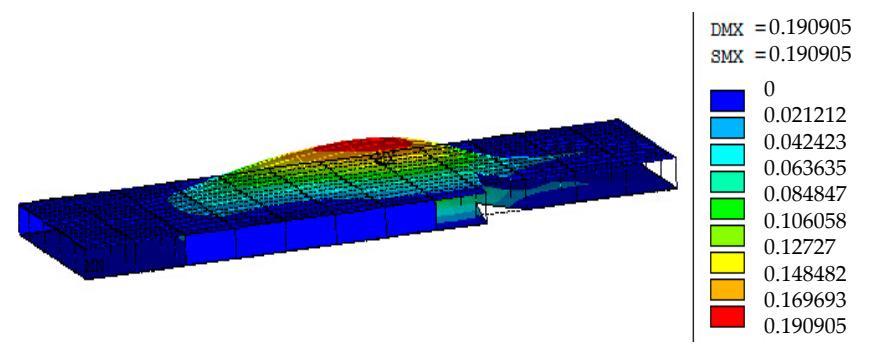
Under these various load cases, the maximum uplift deformation of the basement can be obtained from Figure 9. It is evident from Figure 9 that the maximum uplift deformation of the basement is 0.191 m, which closely approximates the actual maximum uplift deformation of 0.194 m observed in situ. To further validate the effectiveness of the antifloating failure model, we have selected 30 damaged columns (including 2a to 2k, 3a to 3k and 4a to 4k) at Axis C to Axis E and compared their upward uplift displacements with actual measured values. The results are presented in Figure 10. As shown in Figure 10, the simulated uplift deformation values of the basement floor from the FE model are highly consistent with actual measurements. Based on Figure 10, it is evident that the modeled uplift deformation of the basement floor exhibits a high level of agreement with actual measured values, with maximum errors falling within 14%.

Figure 9. The uplift deformation of the basement (m).

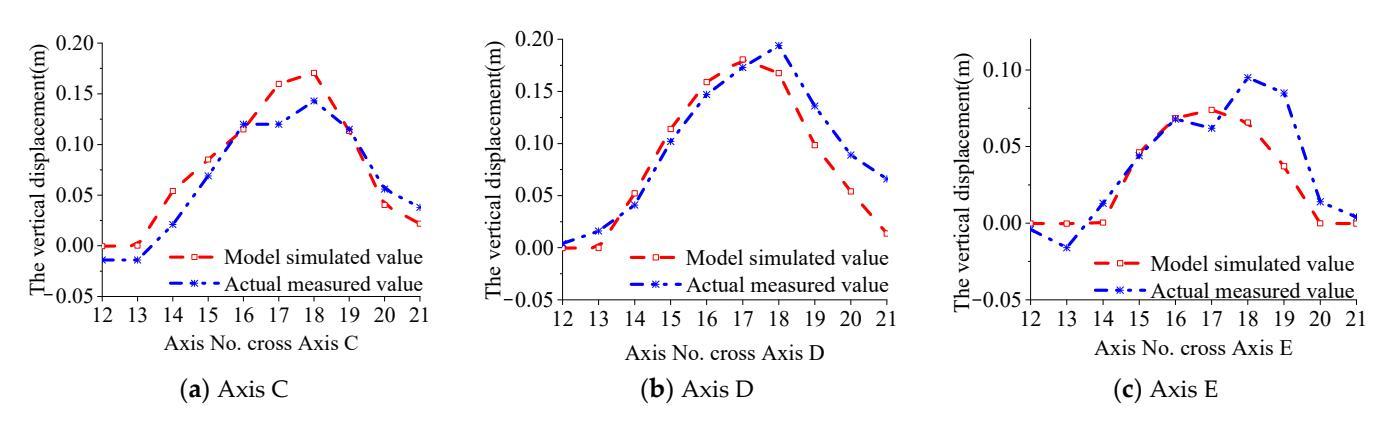
Figure 10. The vertical displacement of the 30 damaged columns on the basement floor.

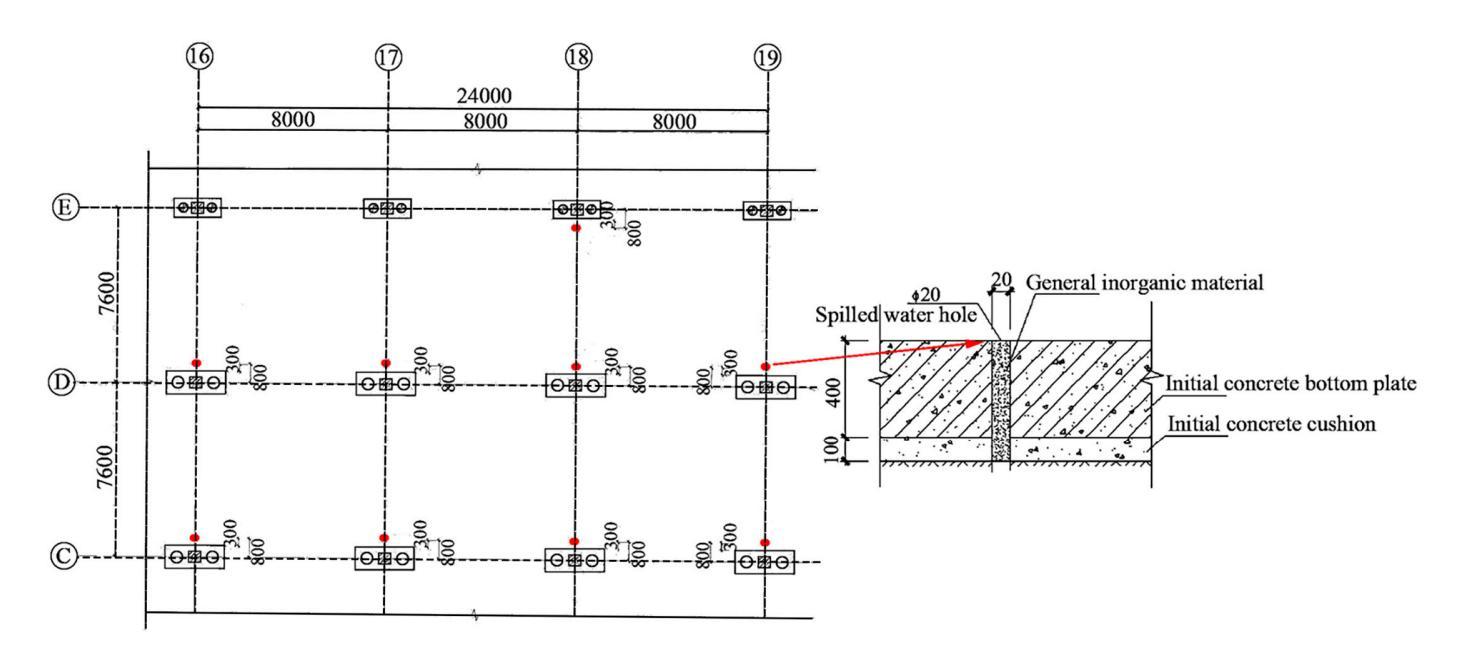
Figure 14. Pressure relief holes.

- (1) Reposition the water spillage holes in close proximity to the damaged columns [39]. The dimensions and locations of the designated water spillage holes are depicted in Figure 14. As shown in the figure, nine circular apertures with a diameter of 20 mm have been drilled and marked as red circles. These holes serve to alleviate the uplifting effect of water buoyancy on the basement floor by facilitating groundwater discharge. During the decompression period, it is necessary to regularly monitor the settlement of the bottom slab. Once the original groundwater has been released through the spillage holes, a sump pump should be used to drain any remaining open water and prevent backflow into the spillage holes.

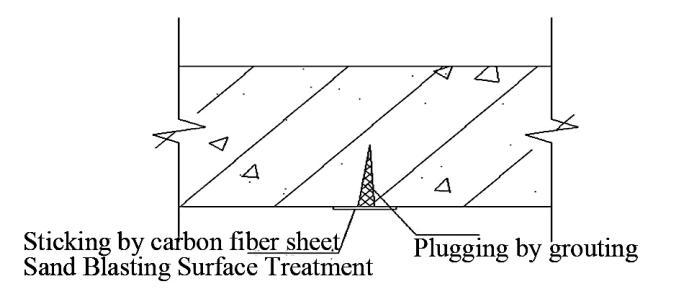
Figure 15. Crack sealing and reinforcement.

- (2) Plug the cracks in the components. Cracks in the columns, beams, slabs and walls require grouting treatment [40]. After sealing the cracks with grout, the carbon fiber sheets are utilized to reinforce the top slab surface as depicted in Figure 15.

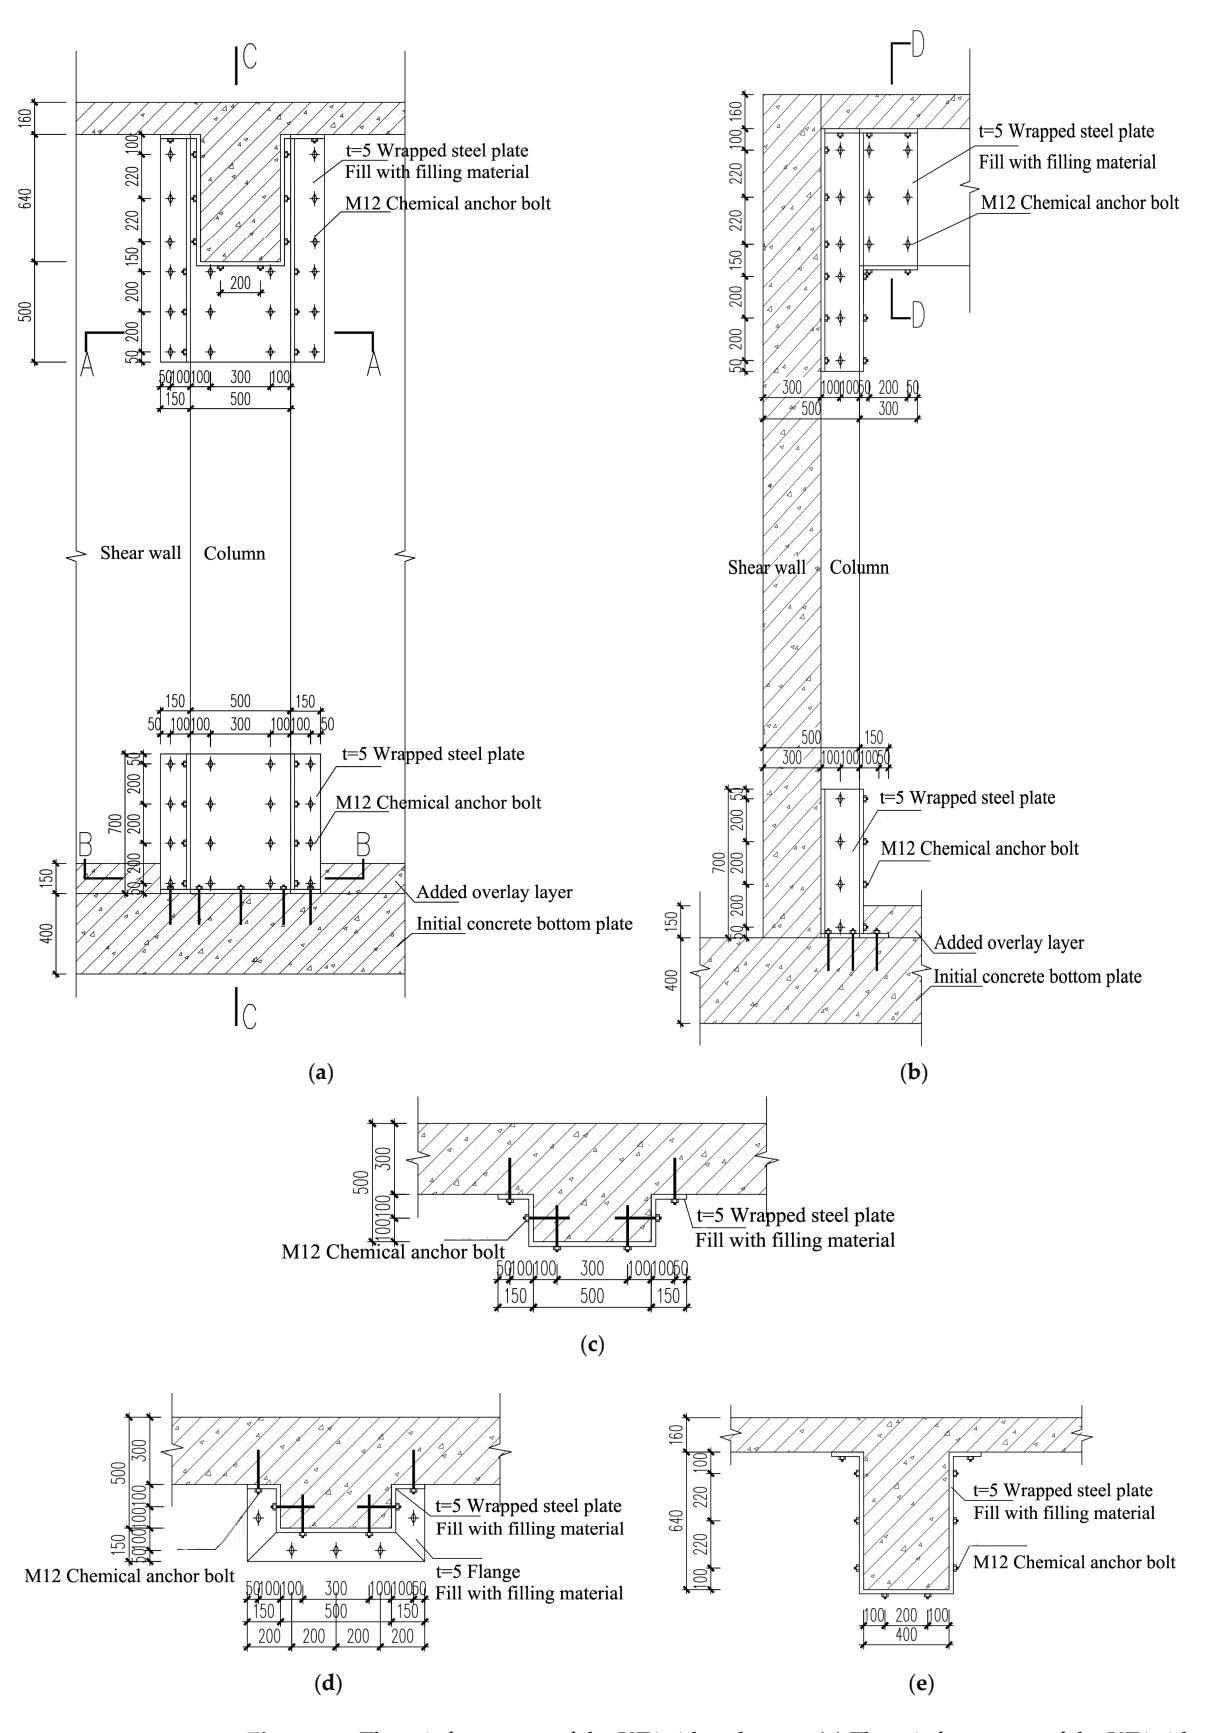
Figure 16. The reinforcement of the KZ1 side columns. (**a**) The reinforcement of the KZ1 side columns. (**b**) Cross profile of C-C. (**c**) Cross profile of A-A. (**d**) Cross profile of B-B. (**e**) Cross profile of D-D.

- (3) Reinforce the damaged columns with the U-shaped steel [41]. The U-shaped steel reinforcement measures for the side columns (KZ1) and main columns (KZ2) are

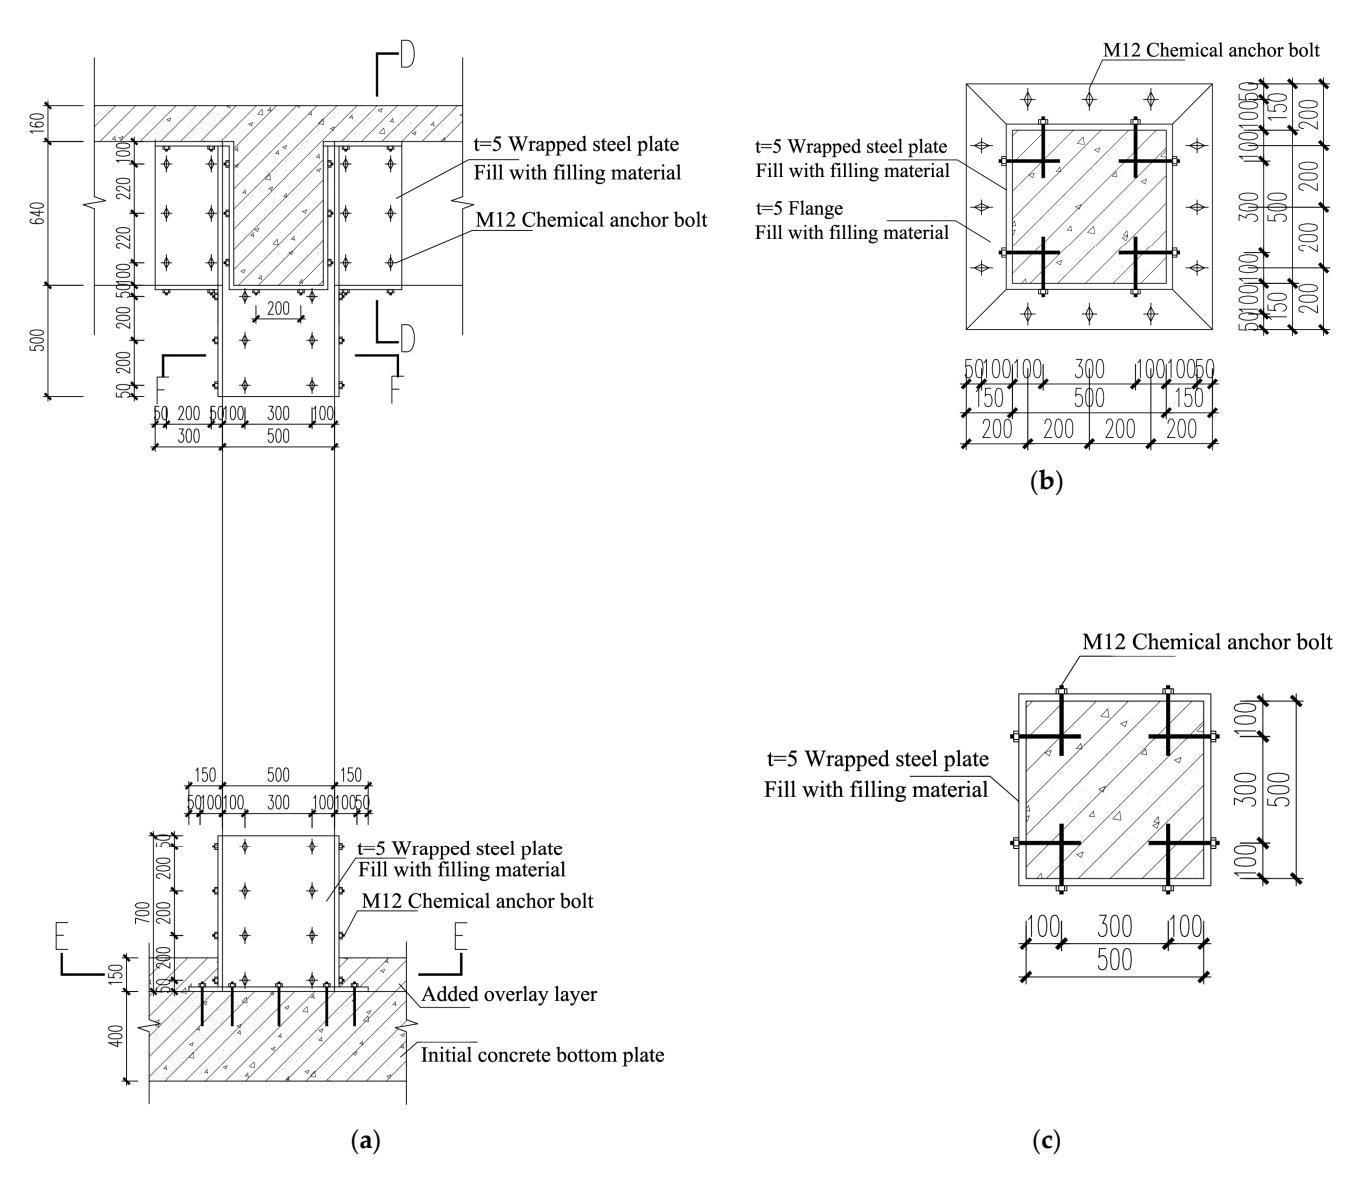
Figure 17. The reinforcement of the KZ2 columns. (a) The reinforcement of the KZ2 columns. (b) Cross profile of E-E. (c) Cross profile of F-F.

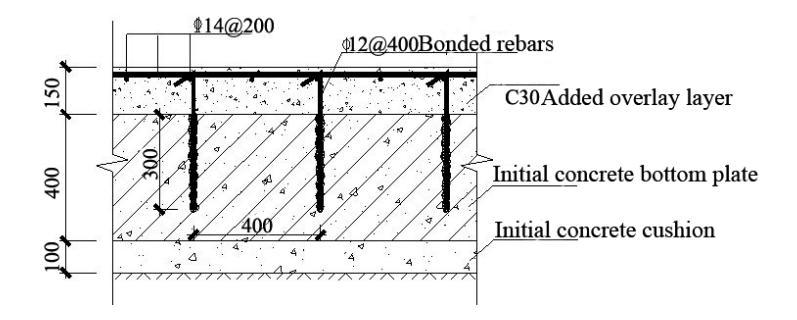
Figure 18. Reinforcement of the bottom slab.

- (4) Thicken both the bottom and top slabs. The basement's bottom slab is filled with 150 mm thick concrete, which is connected to the original concrete using embedded steel bars as shown in Figure 18. After adding the overlay layer, to maintain the original design strength, it is necessary to incorporate a steel mesh into the laminated layer that matches or exceeds the size and spacing of steels in the original surface layer. The top slab is covered with casing soils that are 800 mm thick. According to structural FE calculation in Figures 11–13, these covered loads and the dead loads can meet the requirements of antifloating bearing capacity in the code [37]. Once the cover of the casing soils on the roof plate is fully installed, the spillage holes can be sealed.
