# Article Analysis of Truck Tractor Tire Damage in the Context of the Study of Road Accident Causes

Kazimierz Drozd<sup>1</sup>, Sławomir Tarkowski<sup>1</sup>, Jacek Caban<sup>1,\*</sup>, Aleksander Nieoczym<sup>1</sup>, Jan Vrábel<sup>2</sup>, and Zbigniew Krzysiak<sup>3</sup>

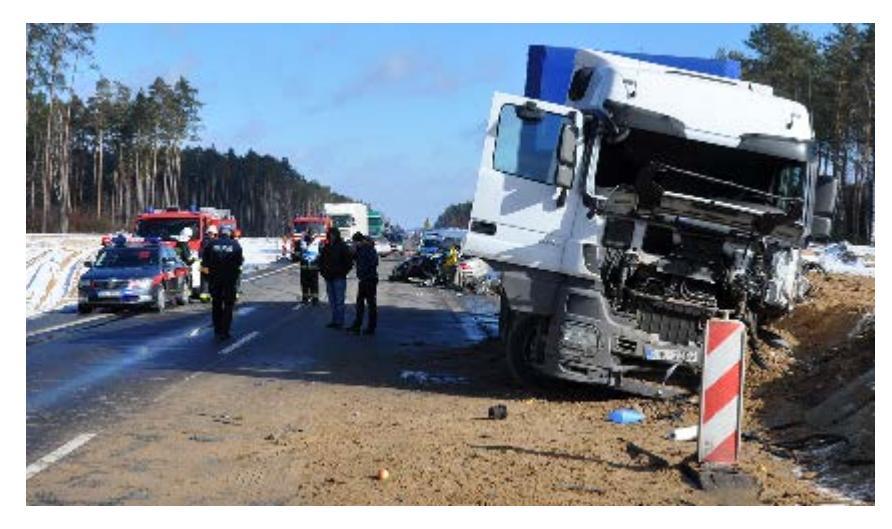
Taking into account the location of the tire friction marks on the road as well as the post-accident location of the vehicles, it was found that before the accident, a lorry truck drove into the opposite lane, on which two passenger cars were driving successively. The truck then drove into a not-very-deep ditch and stopped on an adjacent slope (Figure 1).

**Figure 1.** Photo of the area of the accident site. Lorry truck in the foreground, and cars in the background center.

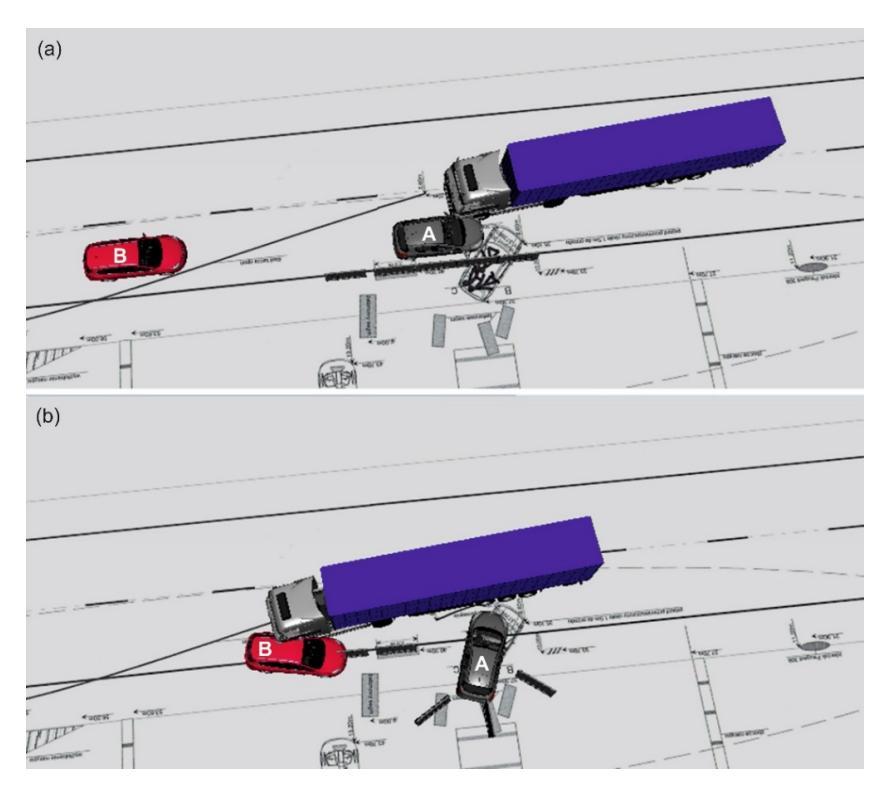
The analysis of the scratch marks documented on passenger cars made it possible to state with high probability that the Truck came into contact with Car A (first) and only later with Car B. As a result of the collision, the passenger cars rotated around vertical axes; at the same time, the rear part of Car A could be lifted up, hitting concrete segments on the roadside; Figure 2.

**Figure 2.** Location of vehicles at various stages of the accident, at the moment of (**a**) crash between Car A and Truck tractor; (**b**) collision between Car B and Truck tractor.

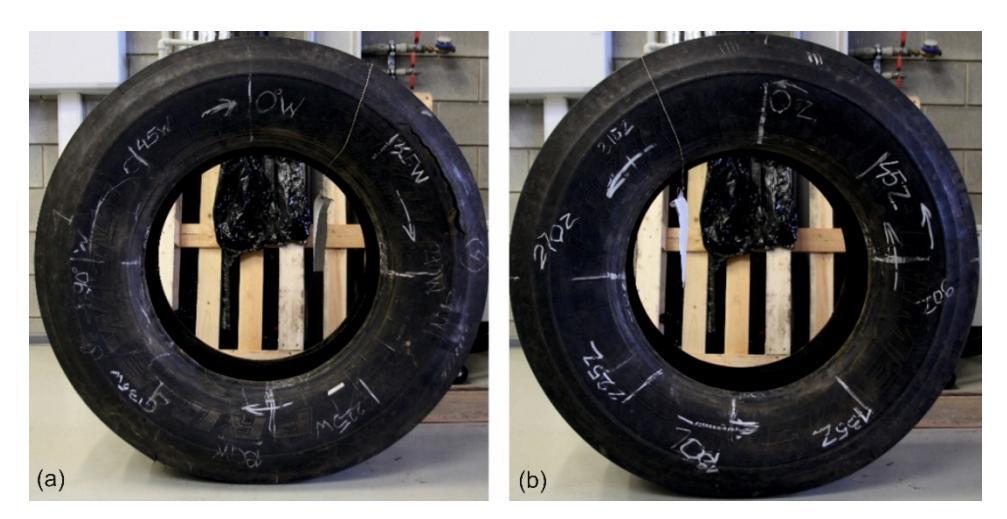
During the inspection of the damaged tire, chalk markings were applied to its side surface (Figure 4), by means of which the circumference was divided into fragments, marking them using the approximate values of the angular degrees:  $0^{\circ}$ ,  $90^{\circ}$ ,  $270^{\circ}$ ,  $360^{\circ}$ . Additionally, the direction of rotation of the tire while driving is marked with an arrow. The applied signs mean the Z-outer side and the W-inner side. The terms inside and outside of a tire correspond to the way it is mounted on the rim and positioned in relation to the direction of movement of the truck tractor.

Figure 4. Tire markings applied during the tests: (a) inner side of the tire; (b) outer side.

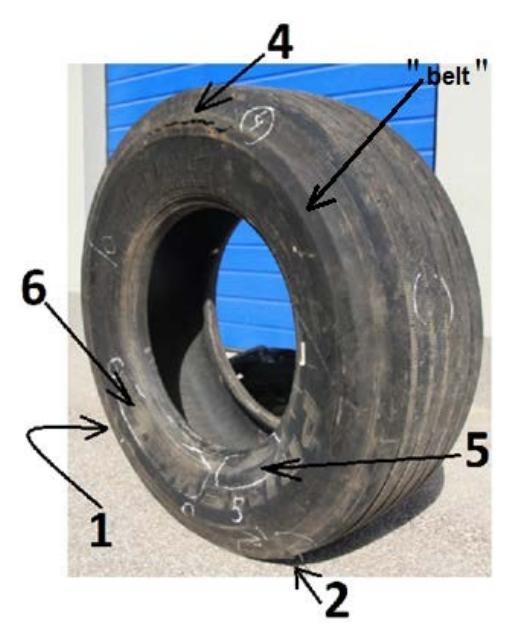
- A crack on the side of the tire, approximately 300 mm long (marked with number 4 in Figure 5), located along the angular length of 270 ÷ 315° W on the part of the tire named "belt";

- Irregular sidewall abrasions on the "belt" on both sides of the tire around the entire circumference;
- Scratches on the side of the tire close to the bead (marked with numbers 5 and 6 in Figures 5 and 6) at the angular length of 70 ÷ 180° W;

Figure 5. View of the inside of the tire of the left front wheel of a truck tractor.

The presence of corrosion of the steel cord at the fracture site (which has been proven before the accident) allows the conclusion that in this place (marking 4, Figure 5), the tire sidewall was weakened. This fact cannot be interpreted as the cause of an impact fracture but only as a necessary condition for such a fracture to occur at all. It cannot be ruled out that with such a weakening of the tire structure, its breakage may have occurred while driving. The surfaces of the wire fractures (Figure 14b,d) are rough and intercrystallite. There was also observed small necking at the sectional area. However, in the steel of pearlitic structure, there is an expected visible cup or cone shape of the material deformation. Due to the lack of occurrence of these breakthrough features, it can be concluded that the damage to the wires took place at a relatively high speed or that the damage was caused by the presence of intercrystallite corrosion. Non-destructive tests to control the occurrence of this type of corrosion are practically not carried out even for elements to which there is unlimited access. In the case of a cord placed as reinforcement in the tire material, it is not possible to conduct direct corrosion tests at all. Even small cracks in the tire carcass can cause the penetration of moisture by capillary action and the development of corrosion of the steel cord, which can lead to its significant weakening and, at the same time, an increase in the temperature of the tire material in the area of corrosion.

Subsequent tests concerned the formation of irregular sidewall abrasions on the socalled belt on both sides of the tire (Figure 5). A thesis was formulated which assumed the appearance of abrasions as a result of operation with too low air pressure in the tires. In order to confirm the probability of this thesis, the key test was to examine how the sides of the tire pressed to the surface by the wheel rim deform.

The utilitarian conclusion from work is that it is suggested to withdraw tires with cracks on the side surface from service. Progressive degradation of this surface may cause penetration of moisture and aggressive agents (road maintenance agents in winter) and cause corrosion of steel wires. In addition, testing of wire samples from each series of deliveries should be introduced in production plants. This would eliminate the material with initiated corrosion directed to the production line. This procedure would increase production costs, but it would clearly increase the quality of the product and the safety of operation in road traffic.

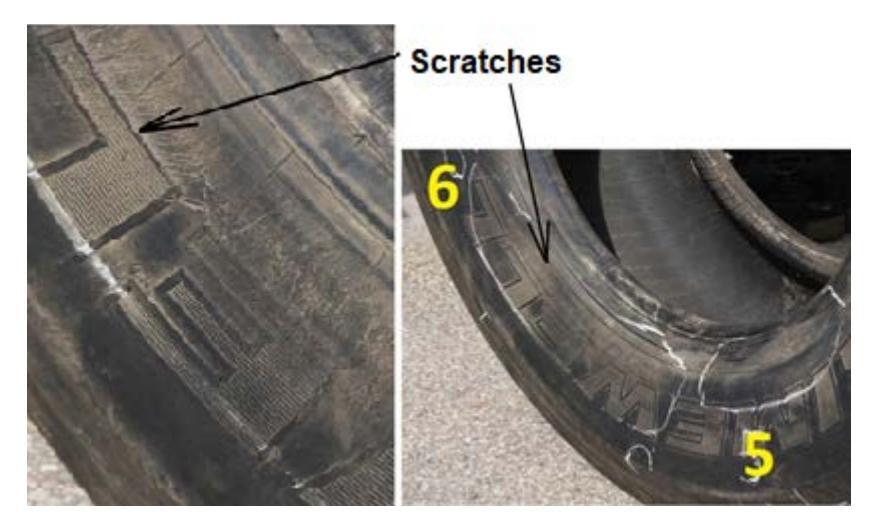
Figure 6. Scratches on the inner side of the tire (near the bead).

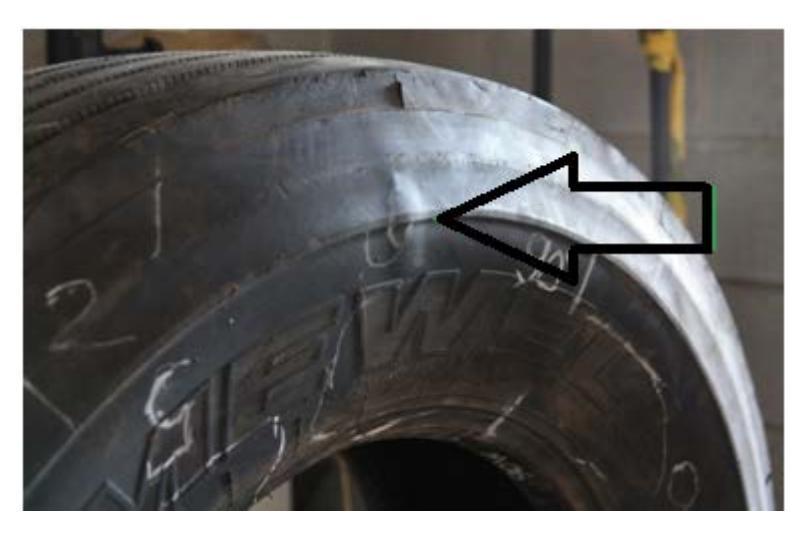
- Local deformation of the side resulted from damage to the cord (Figure 7), which was at the 110° W site.
- Inspection of the tire tread allowed us to identify the following characteristics:

Figure 7. Local deformation of the sidewall on the inner side (indicated by an arrow).

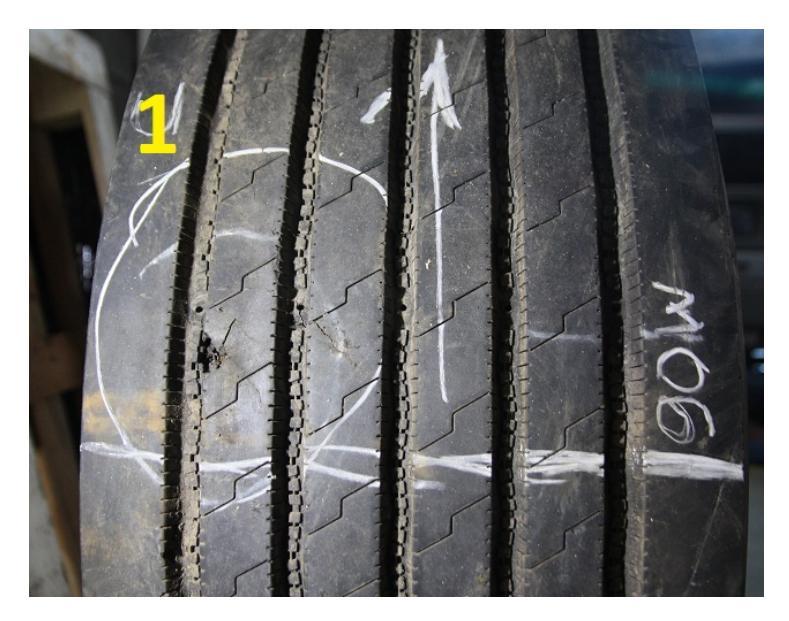
- Local loss of material on the tread face with the exposed cord (marked with the number 1 in Figure 8), which was in the place marked with 90° Z;
- Tearing of the tread face (marked with number 2 in Figure 9), located in the place marked 140° W;

Figure 8. Local loss of tire material on the forehead of the tread on its outer side.

Relating the location of the damage to the wheel rim on its outer side to the damage to the tire, it was found that the local material loss on the tread face (Figure 8) was on a plane perpendicular to the side of the wheel and passing through the place of maximum deformation of the rim edge. The deformation of the wheel rim on its outer side can be explained as a result of a collision with Car A with which the wheel first came into contact or as a result of the wheel contacting with deformed parts of the truck's shell, e.g., cab steps, which were deformed and disintegrated as a result of successive impacts to the vehicle.

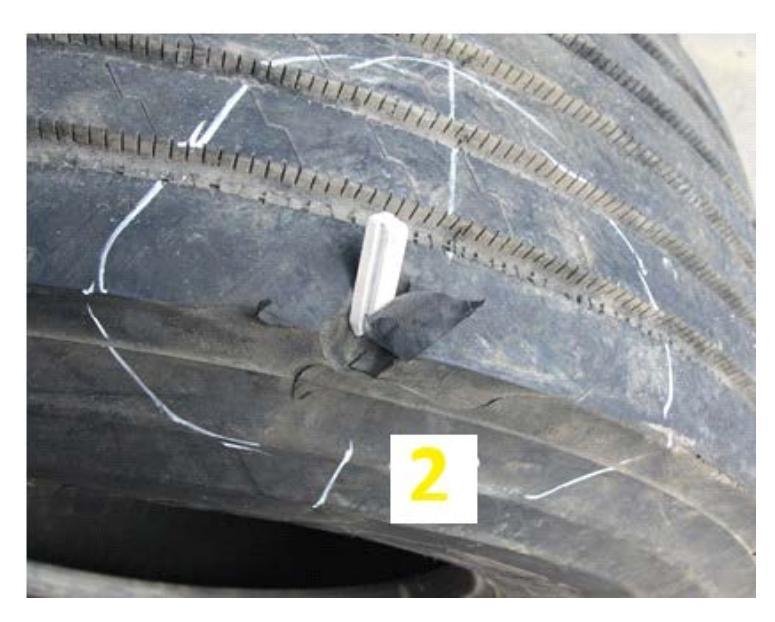
Figure 9. Tear in the tread face and a hole in the place where the white chalk is placed.

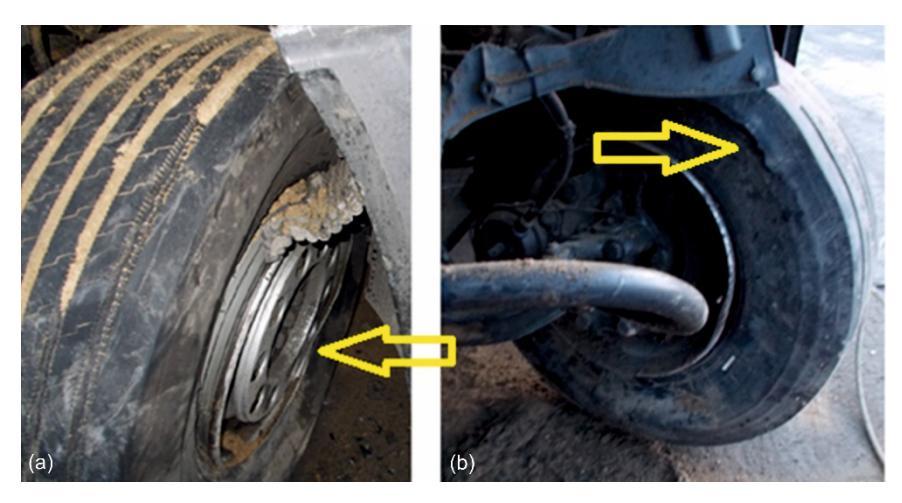
Damage in the form of deformed edges was found on both sides of the wheel rim, while the extent of deformation on the outer side was greater than on the inner side. The deformation of the rim on the outer side was (during the post-accident inspection) on the side opposite to the crack in the tire sidewall; Figure 10.

It was assumed that the point of application of the force resulting from an impact is at the point of maximum deformation of the rim. This point is, therefore, on the opposite side of the circumference and on the opposite side of the wheel, where the tire sidewall fracture (which was found on the inside) was identified.

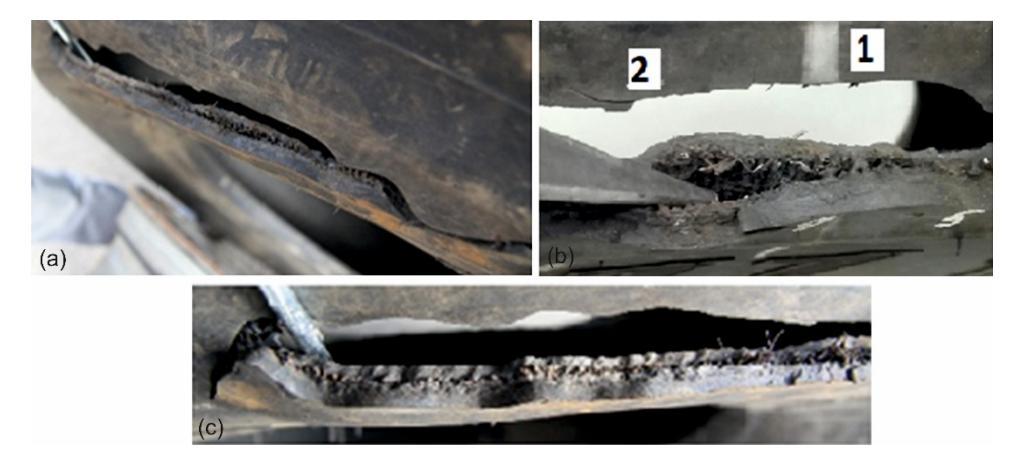
Detailed studies of the area of the rupture of the tire sidewall and the wires forming the steel cord were carried out. The crack (marking 4 in Figure 5), approximately 300 mm long, had an approximately rectilinear path in the central part and a sinusoidal course at both ends (Figure 12a). If the rupture of the tire was caused by a sharp edge, the period and amplitude of the sine wave would be greater and greater. In the case under study, however, initially (from the edge), the period is small, and the amplitude is large. Then the period is very large, and the amplitude is small (almost straight). The other end of the burst is an almost symmetrical reflection of the first. Sometimes the cut starts only by scratching the surface of the tire, which is not present here. It can, therefore, be concluded that the tire is unlikely to undergo a mechanical cut initiated from the outside.

Figure 12. View of the crack in the sidewall of the tire.

In its central part, on both sides of the cord, the layers of the material were separated: in the zone located below the fracture line closer to the flange, the delamination depth (in the "deepest" part) was about 20 mm (Figure 12b), above the fracture line-delaminated about 5 mm. The surface of the rubber was smooth with visible grains (Figure 12b). In the areas near both ends of the cracks, local losses of rubber and cord were visible in the form of "faults" of the material, forming lines in a direction close to perpendicular to the side of the tire (Figure 12c). On the surface of the fracture of the rubber, no traces of any cause of the fracture were working "from the outside".

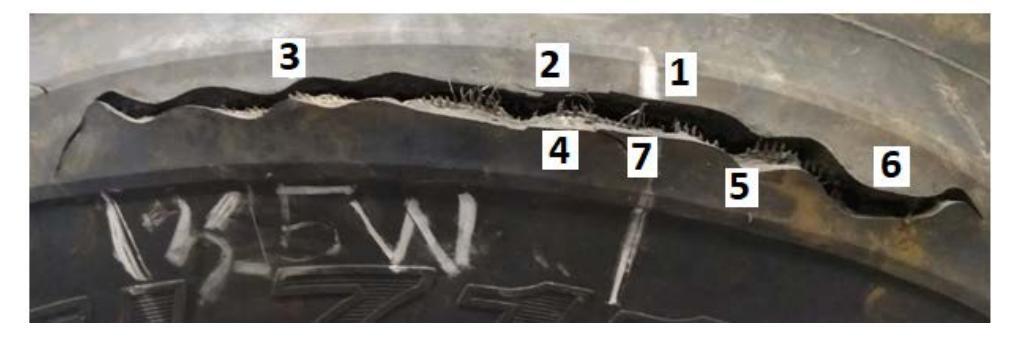
Steel cord samples were taken from places in the area of the tire sidewall fracture. The place of sampling and the method of their determination are shown in Figure 13. The samples marked as "1", "2", "4" and "7" were taken from the central fracture zone. The samples marked "3", "5" and "6" were taken from the part above the fracture line from

zones where the fracture was already sinusoidal. Samples "1", "2", "4" were located in the zone where the tire material coatings were delaminated (separated from the cord coating). In the area where the delamination depth was the greatest (about 20 mm) below the fracture line, the sample designated "7" was taken. This sample was cut approximately 10 mm below the edge of the sidewall fracture.

Figure 13. Places of sampling and method of marking samples.

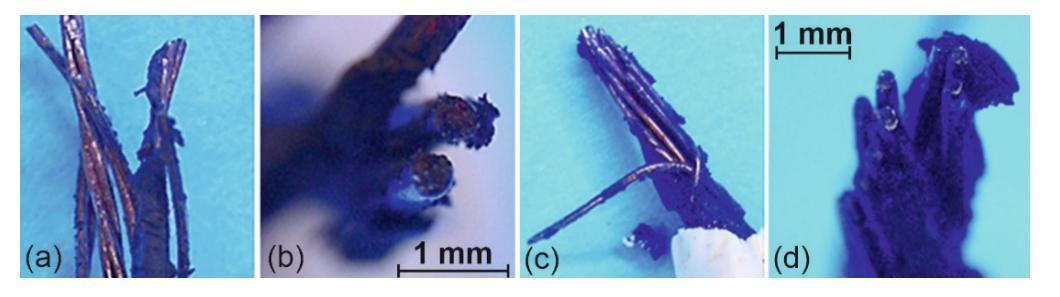
The wire fragments forming the steel cord were subjected to macroscopic examination using the NIKON SMZ 1500 stereoscopic microscope. Figure 14 shows the view of selected steel wires under the microscope (wire fractures and their side surfaces). The cord consisted of a strand of nin steel wires, each 0.35 mm in diameter. There were corrosion changes on each of the analyzed samples, which proves that the wires were in contact with moisture.

Figure 14. View of selected steel wires: (a,b)—sample 3; (c,d)—sample 5.

The observation of several fractures shows that there were no corrosion changes, but contamination is visible (Figure 14c,d, sample number 5). It should also be stated that the corrosion (on the breakthroughs and on the side part of the wires), visible in Figure 14a,b, occurred unevenly and with varying intensity. Assuming the homogeneity of the cord material and comparable corrosion incubation time, it can be concluded that the surfaces with visible corrosion traces of a higher degree of advancement were exposed to aggressive factors for a longer time than the fragments on which the wear level was lower during the test (Figure 14). It is also important that under the rubber cladding (covering the bundle of wires) in sample "7", in the part below the fracture line, corrosion traces of steel wires were also observed. This fragment was located in an "insulated" area sheltered during the tire storage as evidence and was not exposed to external factors, as was the case with "exposed" wire fragments. This clearly indicates that before the accident, there were corrosion centers on the wires of the steel cord, which weakened the tire structure (Figure 14). On the cross-section of the wires, no traces were noticed that would indicate interference of a sharp metal element with the tire.

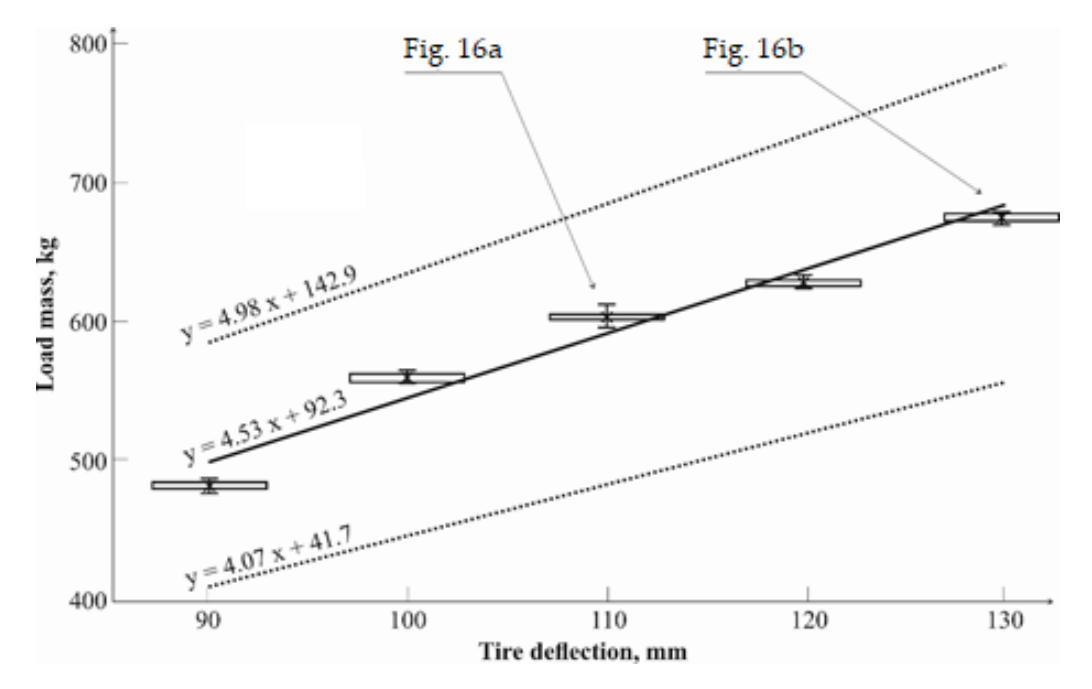
During the analysis of the successive stages of loading the tire, it was noticed that the side of the tire was deforming in the place where the "belt" was located (Figure 5). The static deflection of the tire profile, loaded with a mass of 603 kg, was equal to 250-140 = 110 mm. The results of deflection vs. load of the tire tests are shown in Figure 15. For a sample size of 20, in five levels of tire deformation, a regression function was found as well as a 95% confidence interval for the regression equations. These parameters were determined in accordance with the rules applicable in scientific works [56,57]. The method of deformation of the profile (and "belt") with a mass of 603 kg is shown in Figure 16a. With such deflection, the side of the non-rotating tire did not touch the ground surface. The static deflection of the tire profile, loaded with a mass of 676 kg, was equal to 250-120 = 130 mm. The method of deformation of the profile (and the "belt" of the tire), when loaded with a mass of 676 kg, is shown in Figure 16b.

**Figure 15.** Results of testing load mass for particular deformation of tire up to contact of the "belt" with ground.

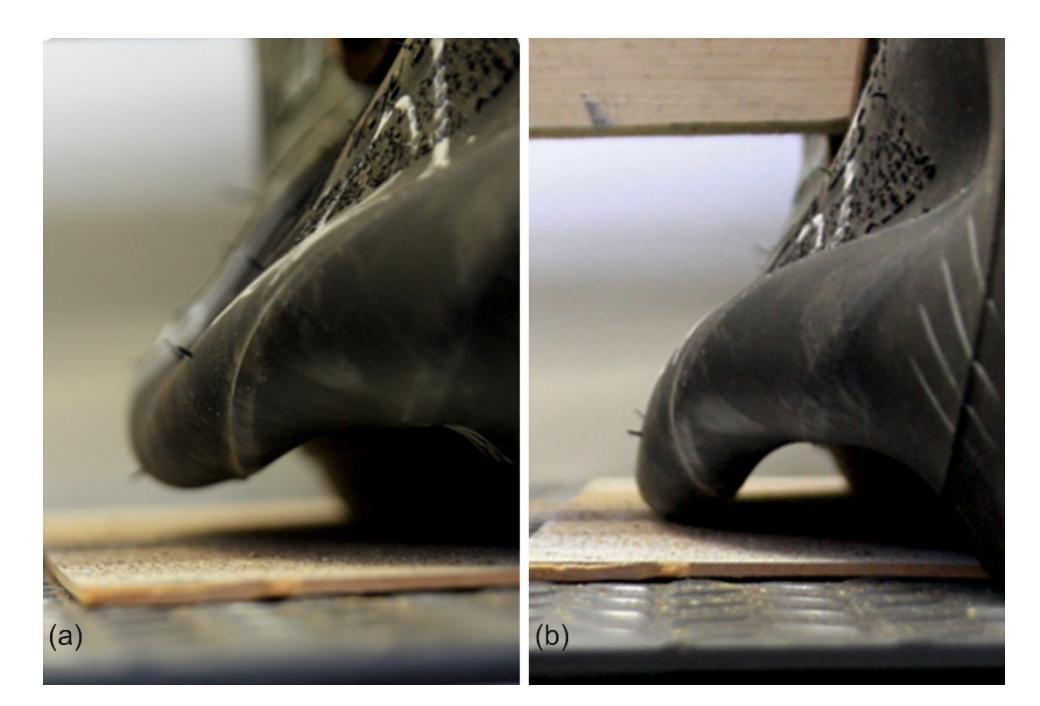
Figure 16. Profile deformation under a load of (a) 603 kg; (b) 676 kg.

The way the profile deformed during the static load test indicates that the "belt" on the sidewall of the tire was not making contact with the road surface. In this context, it should be considered unlikely that the scratches on the side of the tire ("belt") were related to the long-term operation of the tire with a lower tire pressure value. In such a case, the abrasions would be below the "belt" and would be uniform.
