Article Debris Management in Turkey Provinces Affected by the 6 February 2023 Earthquakes: Challenges during Recovery and Potential Health and Environmental Risks

Spyridon Mavroulis ^{1,*}, Maria Mavrouli ², Emmanuel Vassilakis ³, Ioannis Argyropoulos ¹, Panayotis Carydis ⁴ and Efthymis Lekkas ^{1,5}

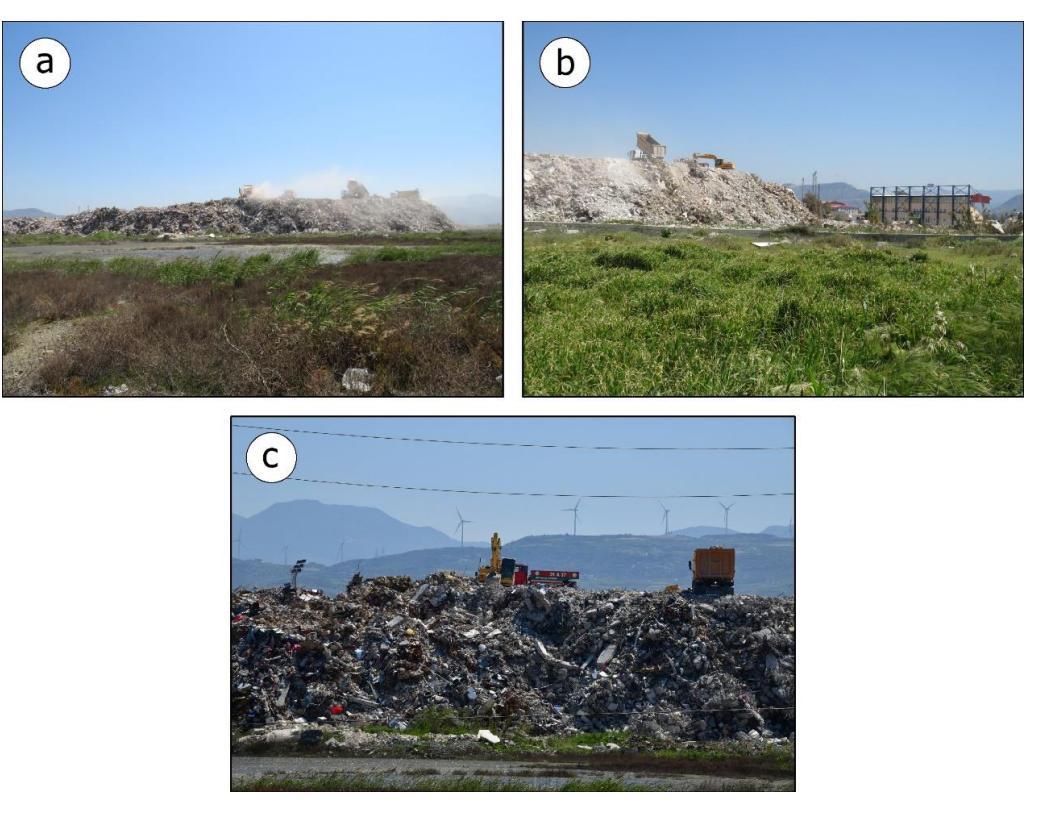
This disposal site is located just 20 m southwest of the above field, 30 m from the coastal road, and 150 m from the coastline (Figure 4). During our field survey in the southernmost end of the earthquake-affected area in early May 2023, we found that due to the continuous dumping of debris from the earthquake at this location, a wide and high pile had been formed (Figure 5a). It was higher than the adjacent stand of the stadium (Figure 5b), while it also occupied a large part of the marshy area west of the field (Figure 5a,c).

Figure 5. Views of the Samandağ disposal site. Dust clouds were constantly formed (**a**,**b**) due to the limited prevention measures applied during treatment. (**b**) The pile was formed very close to a stadium where a tented camp had been set up. (**c**) Several types of debris in the pile reveal no sorting at all and cover a large part of the coastal swamp west of the stadium.

A characteristic of the earthquake debris management at this site was the constant arrival of trucks and the dumping of the debris at the top and side of the debris pile without any other intermediate treatment for sorting materials. Particularly on the slopes of this debris pile, the presence of various materials was evident, for example, concrete, steel reinforcement bars, household waste, white appliances, soil material, etc. (Figure 5c). This mixture of materials makes this assemblage very dangerous for water bodies and the local population. Due to the mixing of many materials of different types and origins from different and distant areas, soil, seeds, or other materials containing non-native species may be unintentionally introduced into the local environment and then dominate and disturb the native flora and fauna with chain reactions and expansions up to the local human population.

This indiscriminate dumping of earthquake debris endangers both surface and underground water bodies in the area. Marshes and rivers formed in the surrounding area will be degraded immediately by surface water contamination by rubble, chemicals, and hazardous material of the earthquake debris and by subsequent water quality degradation that will make the water unsafe for human consumption and the aquatic life with high potential for long-term effects.

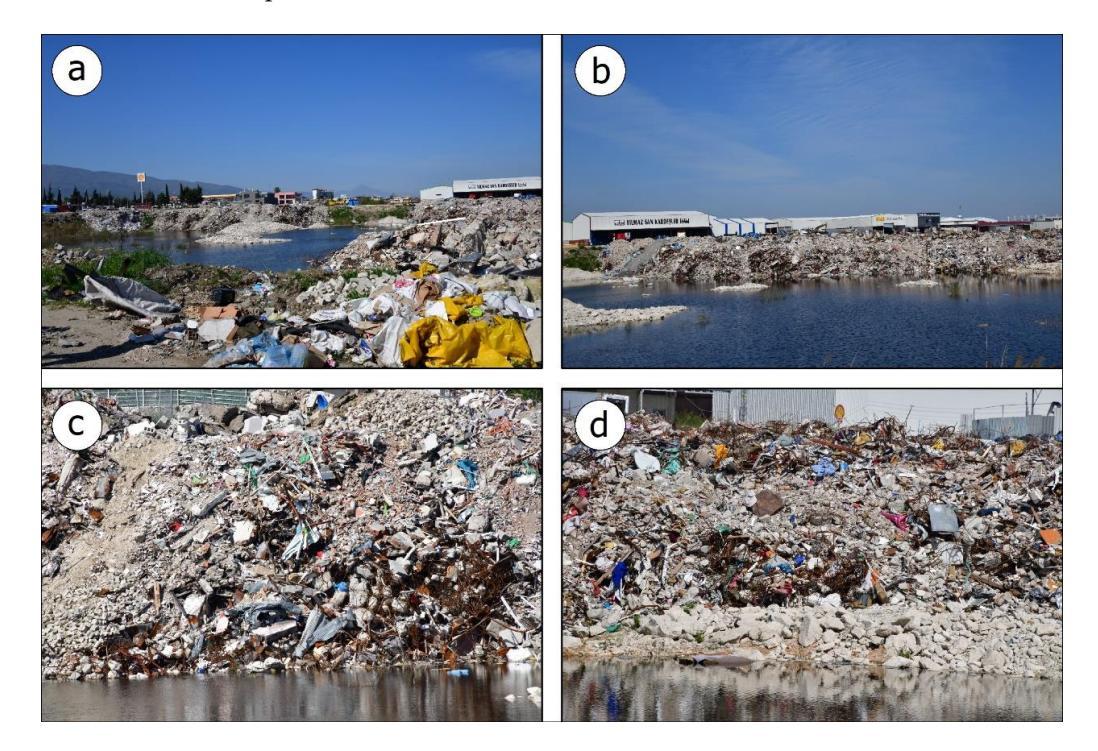
This disposal site was filled with water and covered with rubble in its northern and eastern parts (Figure 7). Characteristic of this area was the constant arrival of trucks loaded with rubble that were dumped near the edges of the pile, and pushed with heavy machinery into the water. This process resulted in the continuous formation of dust clouds.

Figure 7. Typical views of the unsorted earthquake debris dumped in the Antakya site on 4 April 2023. (**a**,**b**) The area was entirely covered by water before debris dumping forming a small water body very close to a stream flowing to the Orontes River. During recovery, the site has been selected for disposal of unsorted earthquake debris (**c**,**d**). The chaotic mixture contained mainly concrete and steel reinforcement bars from collapsed and demolished buildings as well as various damaged construction materials and related equipment.

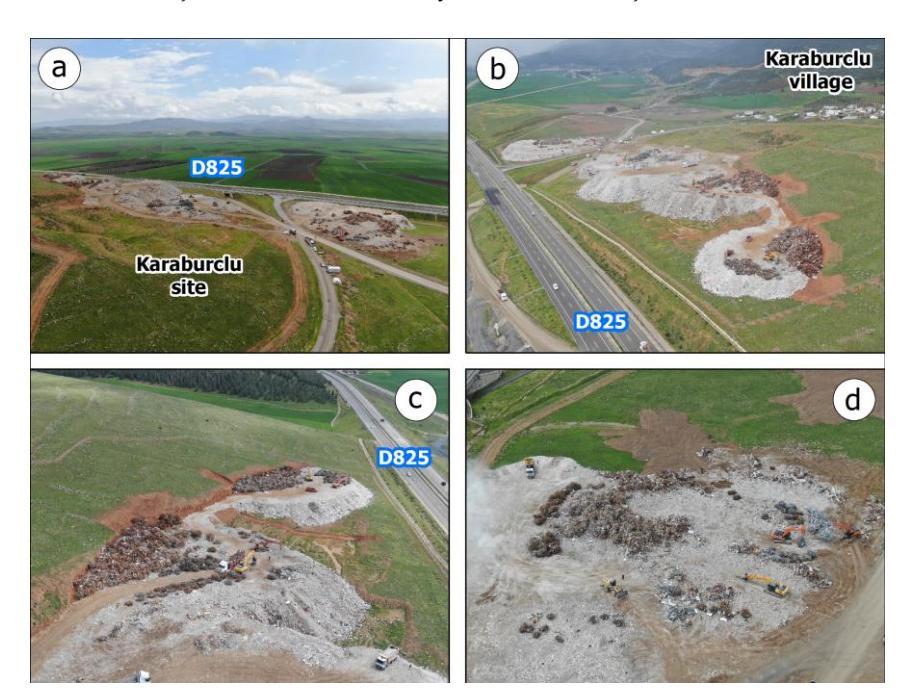
During our field survey in the Nurdağı area on 5 April 2023, we found that debris processing including crushing of concrete and sorting of steel reinforcement bars was taking place (Figure 9b–d). This treatment was conducted with heavy machinery including crushers, hydraulic excavators, loaders, and heavy trucks. The steel bars were turned into balls that were piled up in the western part of the site towards the settlement (Figure 9b–d). The crushing of debris resulted in the creation of dust clouds at various stages of its processing from the very first phase of debris deposition on the site until its final compaction by loaders and rollers. Due to the fact that these activities continued all day with no

interruption, there was a constant dust accumulation not only over the disposal site but also on the adjacent road and mainly towards the adjacent Karaburçlu settlement.

Figure 9. Characteristic drone views of the Karaburçlu earthquake debris disposal site during a post-event field survey conducted by the authors in the earthquake-affected area on 5 April 2023. (a) Drone view from west to east with the D825 state road passing east of the site. (b) Drone view from north to south with Karaburçlu village located at a small distance of about 100 m from the eastern boundary of the site. Dust was constantly present due to the crushing of concrete during debris treatment not only over the site but also in the wider area including the settlement. (c,d) The debris treatment in the Karaburçlu disposal site included concrete crushing and sorting of the steel. Steel balls were observed in the eastern part of the site (c,d).

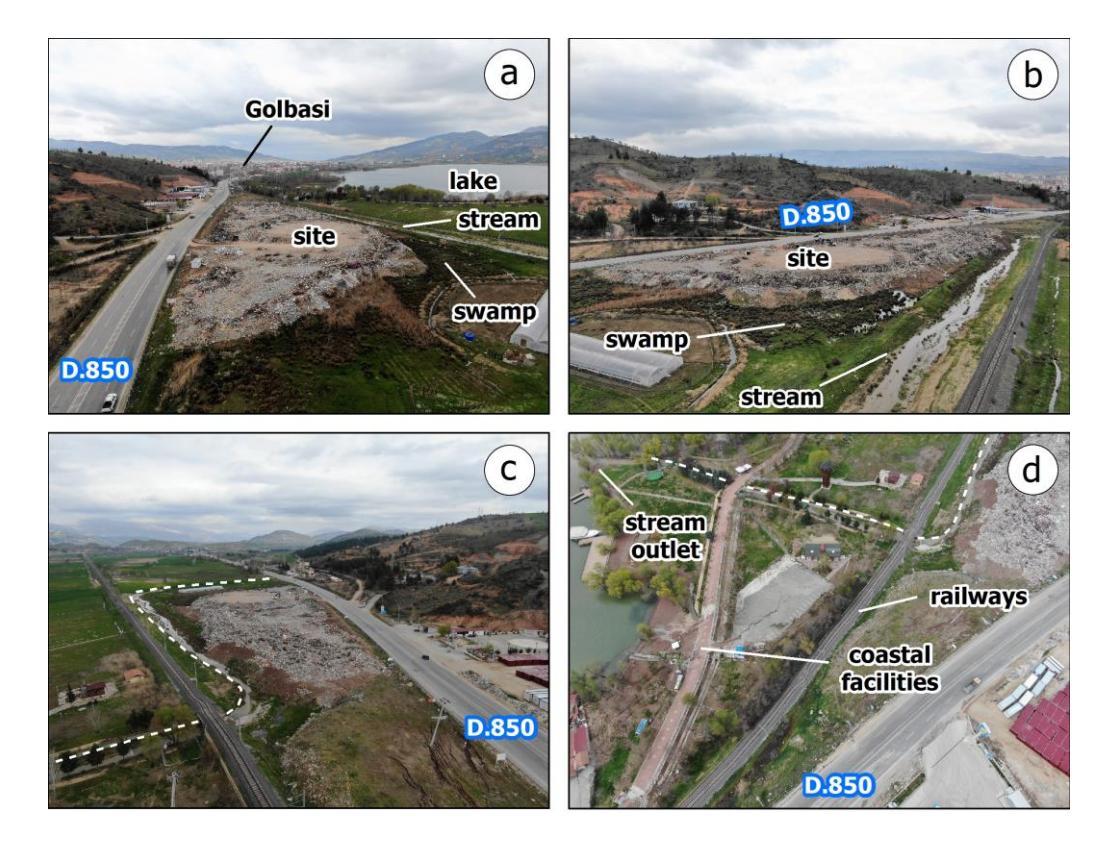
During our field survey in the area on 2 April 2023, it was in full operation. Among other activities, the steel reinforcement bars were separated from the concrete, as shown by various steel balls on the site, and the creation of a debris pile with a perimeter of approximately 650 m, and an area of 0.02 km² (Figure 11a,b).

Figure 11. Characteristic drone views of the Gölbaşı disposal site on 2 April 2023. (a) View from north to south. The Gölbaşı town is located south of the site. The site has been set up next to the D.850 state road and at a former swamp area (b), very close to the lake. Furthermore, a stream flows at a small distance from the site into the lake (white dotted line) (c,d).

The above characteristics of the surrounding area and the debris management reveal that the site is not suitable for debris disposal due to its establishment too close to residential areas where a large part of the population lives and works, agricultural land for crops, which were partially covered by debris and surface water bodies (streams and artificial irrigation channels). Furthermore, the constant arrival and departure of trucks and operation of heavy machinery at the debris disposal site without any measure for the reduction of the generated dust severely limit the suitability of this earthquake debris disposal site.

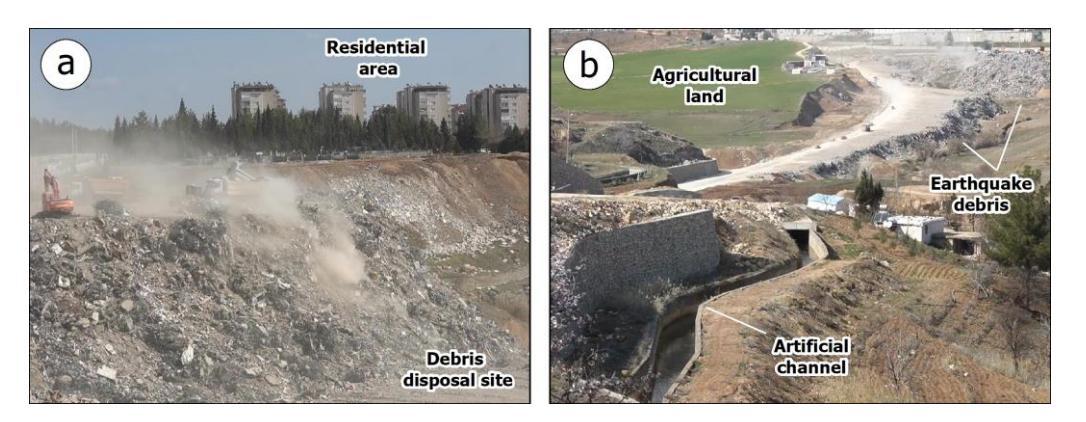
Figure 13. Characteristic views of the earthquake debris management in Adiyaman disposal site. (a) The formation of dust clouds was constant during debris treatment at the site. The applied protection measures against dust-containing asbestos fibers were limited. (b) The debris disposal site was set up close to water bodies including a stream and an artificial channel.

Furthermore, it can lead to increased erosion and further deposition and sedimentation. Debris, if not managed properly, can block drainage routes and increase erosion. In addition, sedimentation and deposition of materials in streams, artificial canals, and other water bodies can harm aquatic life, degrade water quality, and damage ecosystems both upstream and downstream of the site.

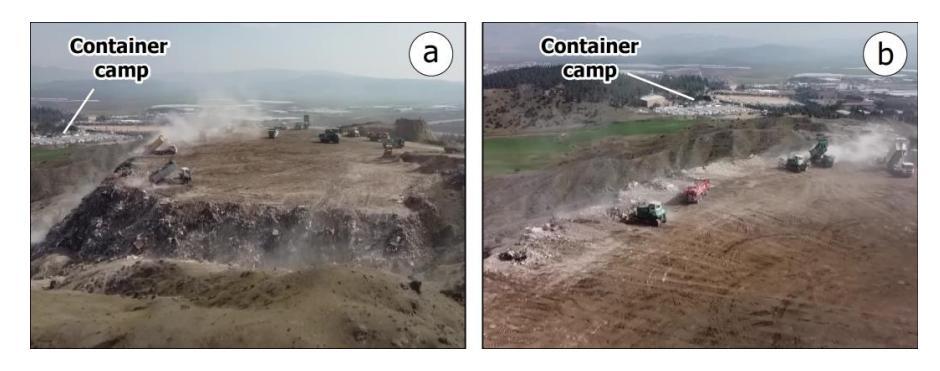
During our field survey in early April to this area we found that the site was receiving a large number of trucks depositing debris, and the number of heavy machinery processing the debris at the site was also large (Figure 15). The dumping of debris was occurring at such a rate that the wetting of the debris with water during treatment was not adequate (Figure 15). As a result of these deficiencies in the implementation of preventive measures, dust clouds were created, which not only remained over the site for a long period of time but also spread to surrounding residential areas (Figure 15) including all the above-mentioned facilities for managing the effects of the earthquake disaster.

This site, which is one of the largest that have been established in the area, may have an impact on the health of residents, especially of the earthquake-affected people accommodated in the adjacent camp, and the balance of the natural environment. Many of these adverse effects have already been mentioned and analyzed in detail in the previous sections.

Figure 15. Characteristic views of the Kahramanmaras disposal site. The formation of dust clouds has the potential to affect not only the workers and volunteers on the site, but also people living in nearby container camps (**a**,**b**) for the accommodation of the earthquake-affected and homeless people among other residential areas around the site.
