Article Contribution of High Mechanical Fatigue to Gas Turbine Blade Lifetime during Steady-State Operation

Sung Yong Chang ^{1,2} and Ki-Yong Oh ^{3,*}

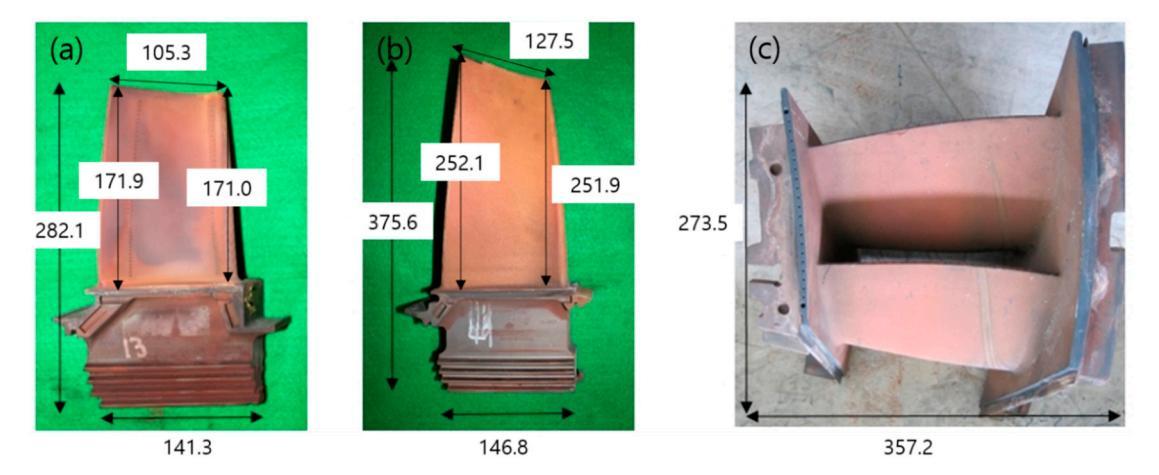
Figure 1. Service-exposed hot gas pass components (HGPCs): (**a**) first-stage blade, (**b**) second-stage blade, and (**c**) second-stage vane (unit: mm).

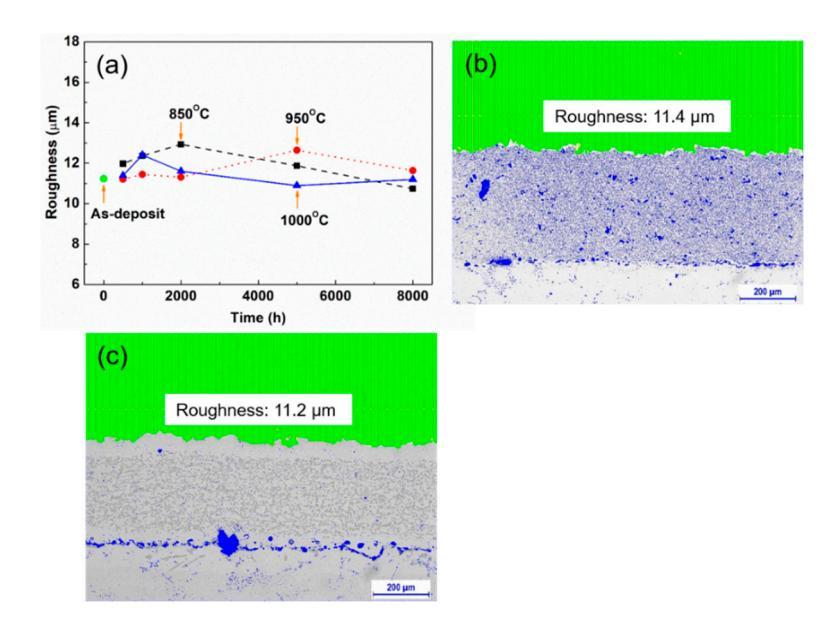
In Figure 3a, the roughness does not indicate any trends with isothermal heat exposure, suggesting that the isothermal heat treatment does not contribute to the rumpling and ratcheting that result in the fatigue failure of the bond coat. Specifically, an image of the bond coat surface exposed to 8000 h of heat treatment (Figure 3c) is not significantly different from that exposed to 500 h of heat treatment

(Figure 3b) at a constant temperature of 1000 °C; the roughness values on the surface between TBC and the bond coat are 11.2 and 11.4 μ m, respectively. It can be deduced that the isothermal heat exposure of the blades and vanes only contributes to the degradation caused by creep. In particular, the thermally grown oxide, which is caused by the degradation due to isothermal heat exposure, is negligible in Figure 3b because the coupon specimen is only exposed for 500 h. In contrast, the thickness of thermally grown oxide is 55.3 μ m when the coupon specimen is exposed for 8000 h, as shown in Figure 3c. The thickness of the thermally grown oxide is averaged 10 times, and its standard deviation is 9.0 μ m. Note that fatigue, which mainly causes coating failure, is of interest in this study. Hence, thermally grown oxide representing the evolution of creep is not analyzed in detail in this study. It can be deduced that the EOH calculated by Equation (1) is reasonable if HGPCs operate only under a constant operating temperature during a steady-state operation.

Figure 3. (a) The evolution of roughness on the surface between a TBC and bond coating for a variety of isothermal heat exposures and the post-processed optical microscope images representing a slight variation in the roughness on the surface between the TBC and bond coating exposed to (b) 500 h and (c) 8000 h at a constant temperature of 1000 $^{\circ}$ C.

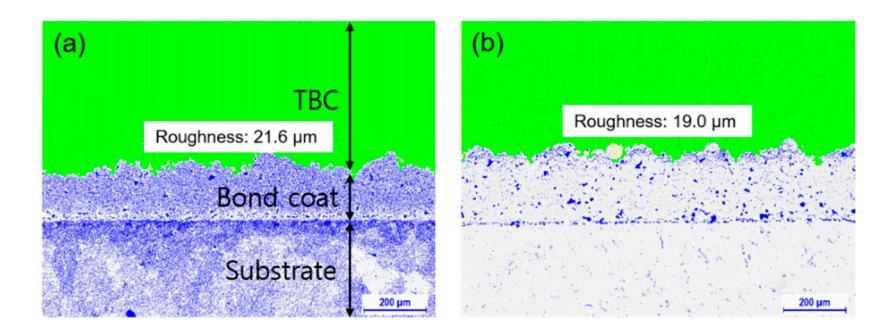
Figure 5 clearly shows an increase in the roughness for service-exposed blades and vanes due to fatigue. Figure 5a shows an image of the first-stage blade (sample 1 in Table 1), whereas Figure 5b shows an image of the second-stage blade (sample 4 in Table 1). The surfaces of the bond coats

are rougher than those subjected to an isothermal heat treatment (Figure 3b,c) at 21.6 and 19.0 μ m, suggesting again that roughness is a sensitive metric for evaluating the evolution of fatigue.

Figure 5. Post-processed optical microscope images of the bond coat surface representing a significant increase in the surface roughness compared to the fresh state (Figure 3b): (**a**) First-stage blade (sample 1 in Table 1) and (**b**) second-stage blade (sample 4 in Table 1).
