Article Surface Mechanical Effects of Wildfires on Rocks in Climbing Areas

Keywords: wildfires; rock weathering; hazards; risk perception; rock hardness; ultrasound pulse velocity; sport climbing

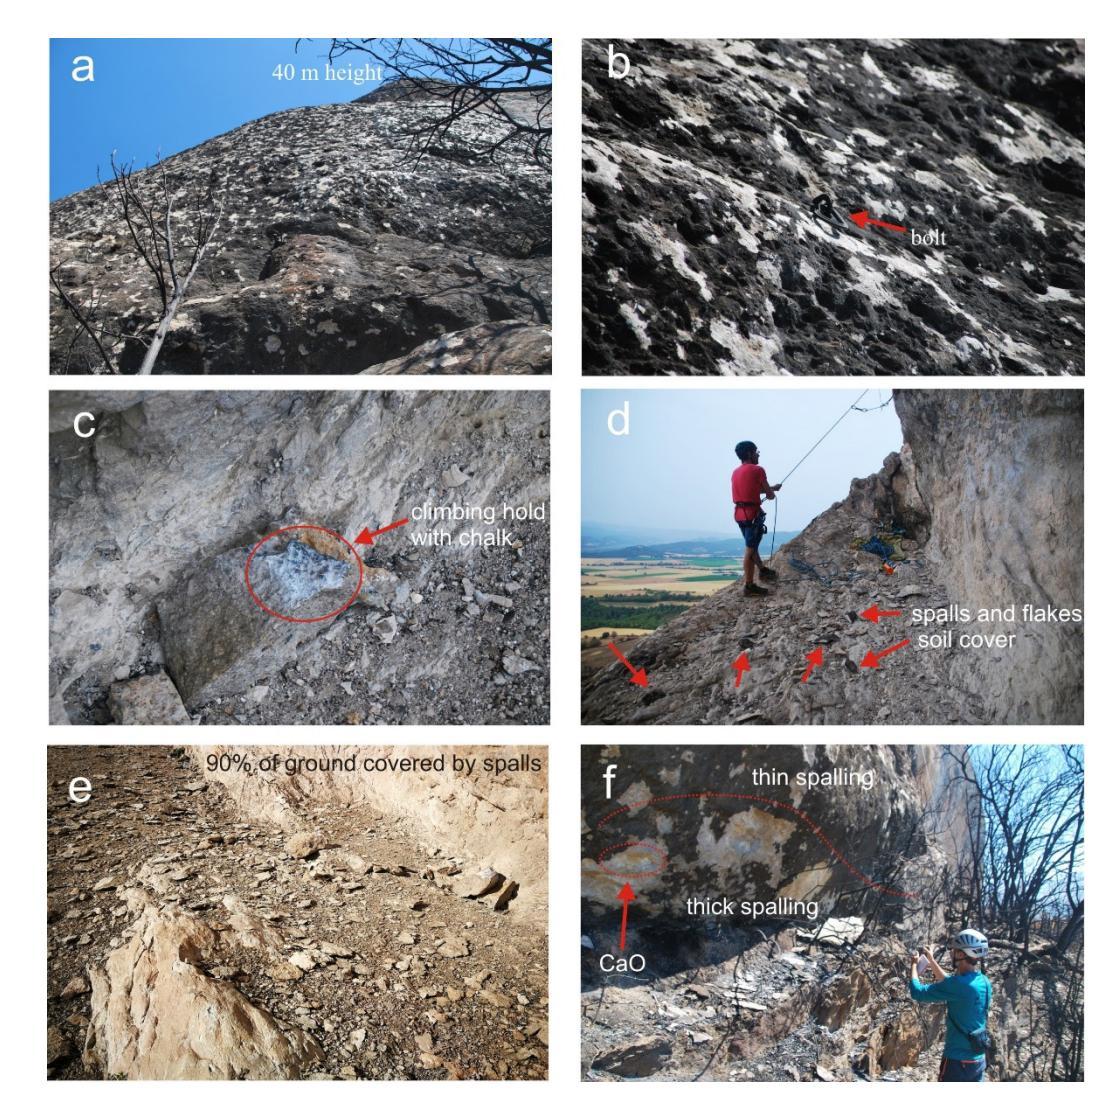
Figure 7. Visible rock surface decay features in Oliana as a result of the fire: (**a**) flaking and spalling on the left side of the climbing crag; (**b**) extensive flaking affecting an anchor; (**c**) large rockfall from a climbing route (notice that the rock still preserves the climbing chalk); (**d**) climbing area covered by spalled flakes; (**e**) ground of climbing area is 90% covered by spalls (photograph: Toni Mas); (**f**) limit of thick and thin spalling due to prolonged heat in the lower part provided by adjacent burned bushes.

The wildfire effect observed on the climbing wall is the fall-out of thin slabs, arranged as great patches of metric size in some sectors of the wall. Spall scars show clean and fresh areas, easily observable and different from the dark burned areas without detached slabs. The thickness of the spalling oscillates between 2 and 20 mm, with 5 mm on average (Table 3). The spall size ranges from 5×10^{-3} to more than 0.5 m^2 . The lower part of the climbing wall has been affected by the wildfire, where it is impossible to identify the spall sizes. The effect of the wildfire is lower in the upper part of the climbing routes (Table 4).

Regarding the size of the detached spalls by wildfire in the Oliana climbing wall, we measured blocks of 1.8 m long, 0.15 m thick, and about 2 m² in area. These fractured blocks are more abundant close to the ground, although they can be observed up to 3 m high in the wall. Moreover, previous fractures and weakness planes could favor the breaking of these blocks. In the most affected areas, spalls covering 90% of the soil were observed (Figure 7e).

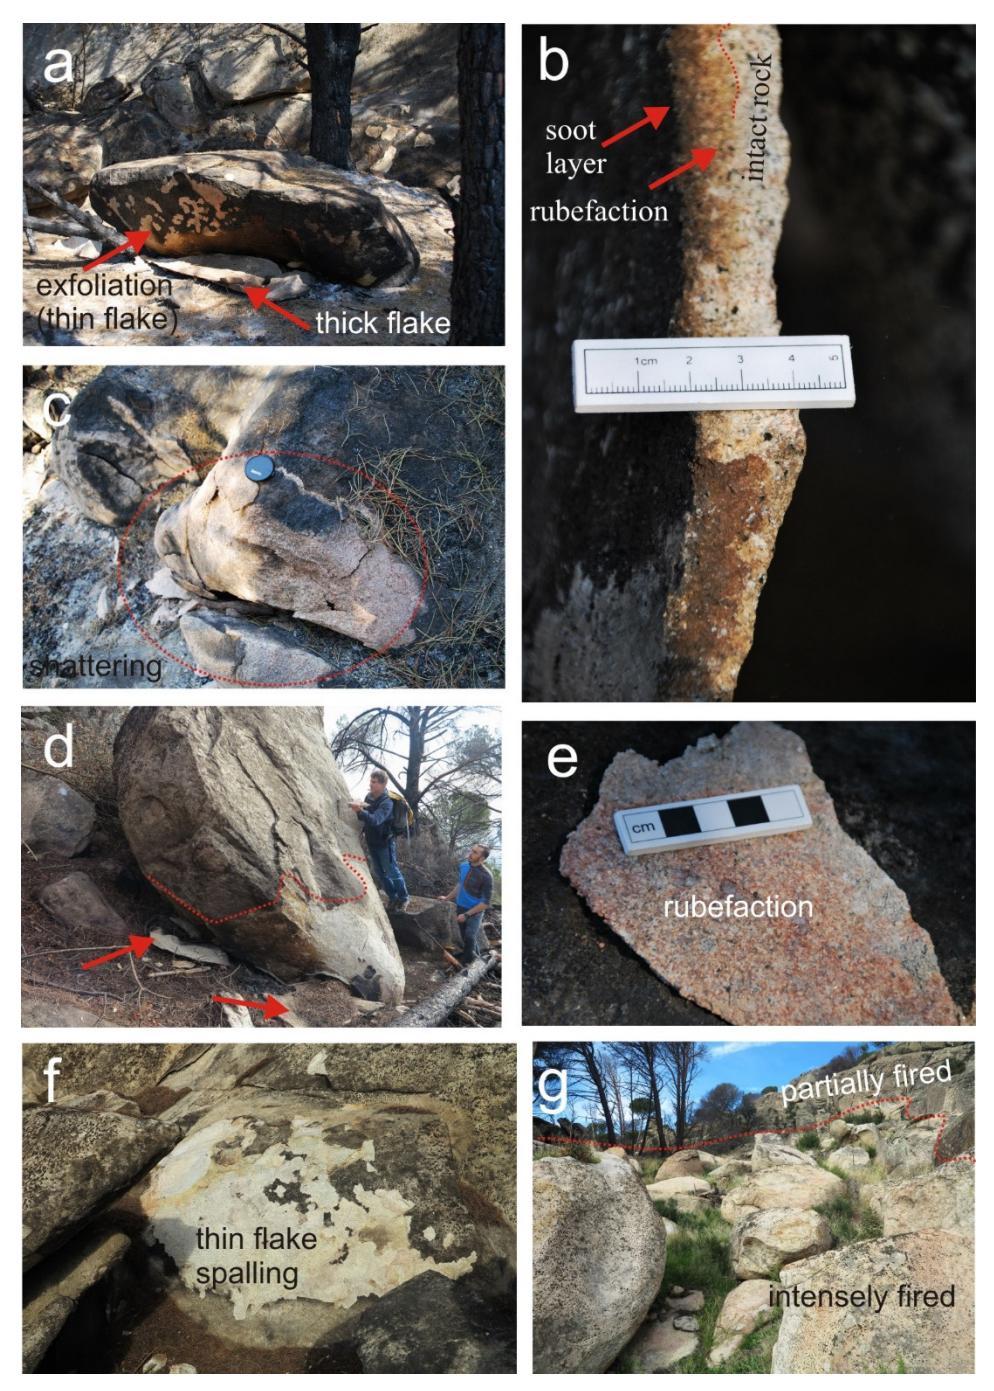
Another important effect of the wildfire is the formation of cracks in granite blocks (Figure 8), constituting a risk for climbing. These cracks can reach 1.5 m long and 1 m deep from the bottom of the granite rock. Subsets of subparallel fractures appear in areas where the wildfire reached the maximum temperature. Reddening is the result of thermal oxidation from around 300 °C, while spalling and cracking may be due to thermal shock during either the fire or its extinction. Surface temperatures above α to β quartz transition (573 °C) increase the chance of granular disaggregation instead of spalling [1,5,7].

Figure 8. Visible rock surface decay features in the Cadalso de los Vidrios site as a result of the fire: (a) flaking of blackened surface and thick spalling at the bottom part of a boulder, possibly generated by thermal shock during aerial firefighting; (b) spall showing the surface black soot layer penetrating and clogging the fire-induced surface cracks, an intermediate thermally reddened portion, and seemingly unaffected rock; (c) completely shattered boulder as a consequence of intense thermal shock; (d) boulder showing a 1 m thick shattered portion at the bottom and spalling at the top, possibly due to prolonged heating caused by the burning of an adjacent log that appears to be completely burned; (e) reddened spall due to thermal oxidation of iron-rich micas; (f) boulder with extensive detached scaling and spalling, where a new "fresh" surface appears in the detached areas; (g) the clearer "fresh" surface formed after spalling is more abundant in areas that were totally covered by fire. Blackened surfaces of soot deposits appear in the area only partially affected by fire.

In Cadalso, the most intense damage, expressed as severe reddening and spalling, appears in boulders on the ground surrounded by vegetation, especially logs, in line with the findings of [46] and a densely burned forest mass (Figure 8). These boulders have been subject to prolonged high-temperature wood combustion [47]. The distribution and thickness of the detached spalling is consistent with data presented by previous research in other areas [46]. Analogously, the most intense damage in the climbing walls also appears in the first few meters, close to the ground. In this area, the rock has completely lost its original surface due to the spalling detachment, displaying, therefore, a new "fresh" surface. This explains the apparent contradiction of having higher values of UPV and SH (which would mean a less mechanically damaged rock) in the area affected by the highest temperature.

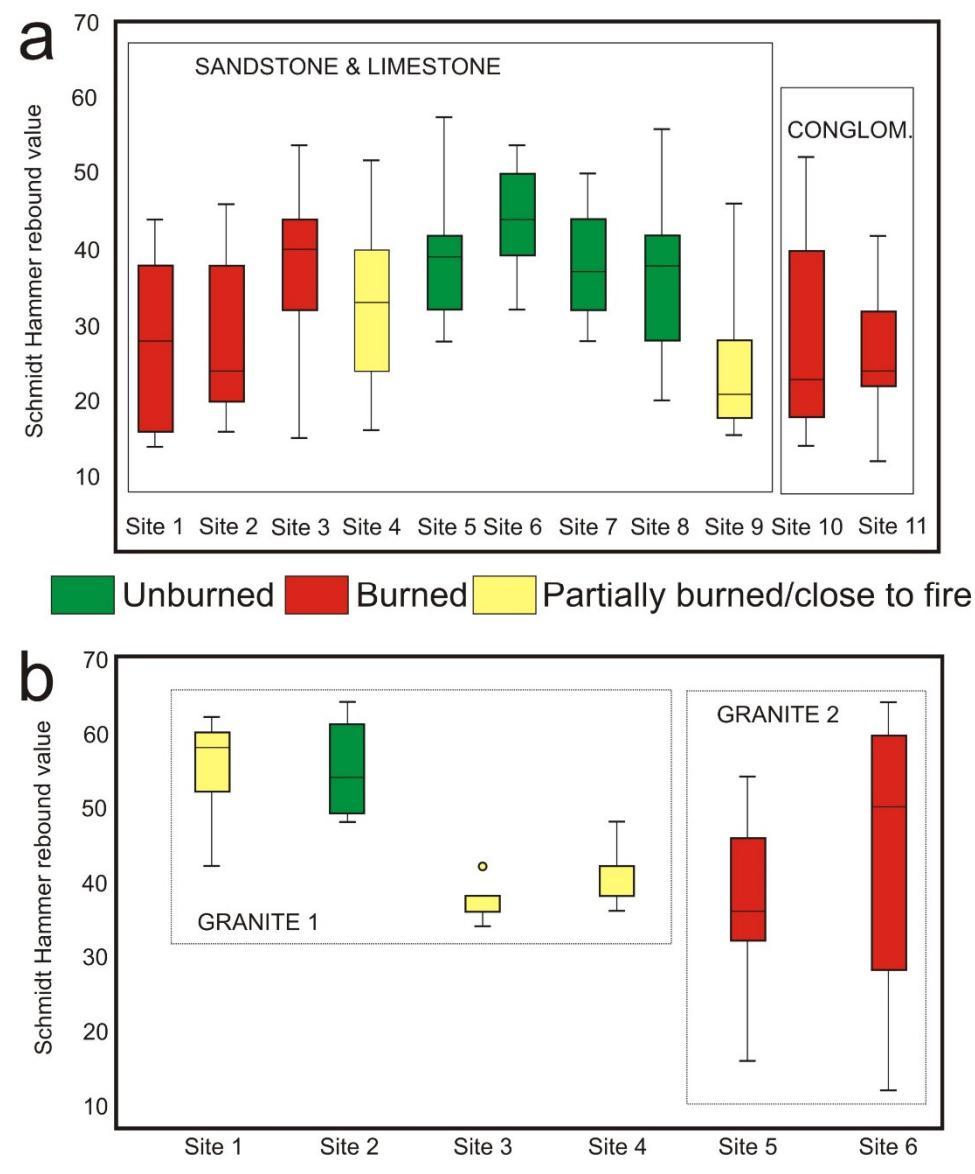
The Schmidt Hammer (SH) rebound numbers from the random grid at the bottom of both climbing areas show a clear relationship between the decrease in the rebound value and the observed mechanical damage features. The results from Oliana reinforce the idea of the increase in mechanical damage in the burned areas (Figure 9a) and also an increase in variability. The latter could be related to higher SH values measured in spalled areas in contrast with lower values in damaged areas not spalled during the fieldwork measurements.

Figure 9. Schmidt Hammer (SH) values of the two studied areas: (**a**) Oliana with a clear variation of rebound values between sites visibly affected and non-affected by fire; (**b**) Cadalso de los Vidrios with two different granites along the various crags.

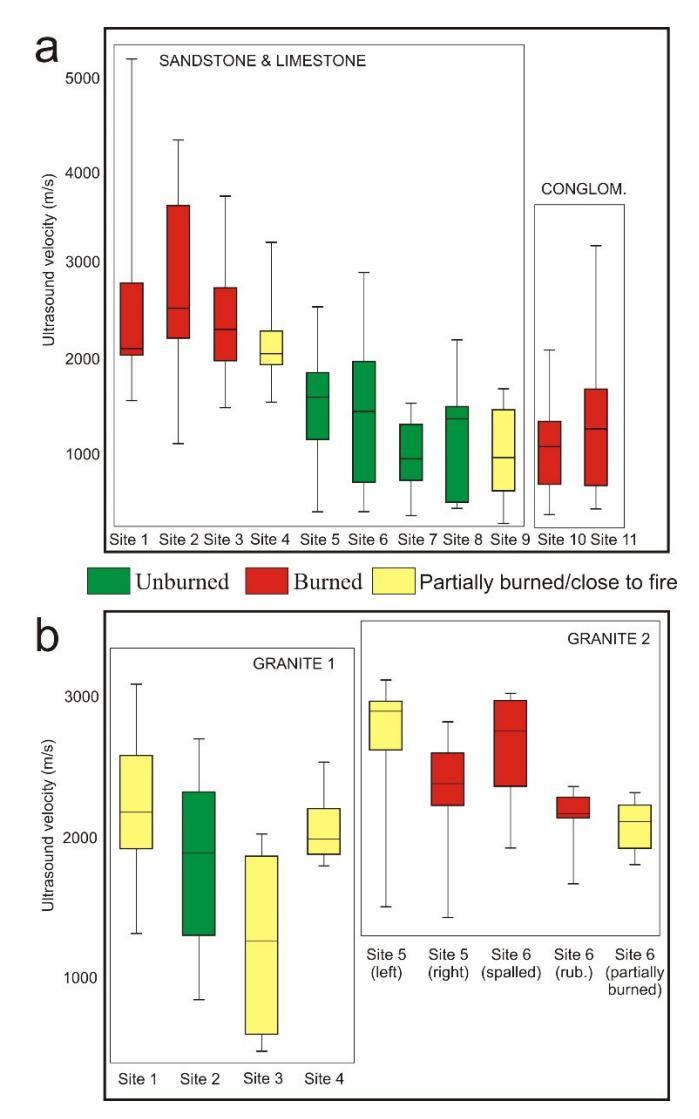
Figure 10 shows the UPV values for the random grid measurements obtained at the bottom of both climbing sites. Figure 10a shows the results displayed as a boxplot for the different climbing routes in the Oliana area. They are similar along the main wall, with the higher average values on the left side, which corresponds to the area with more visible effects caused by the fire, particularly blackened, soot-covered surfaces.

Figure 10. Ultrasound pulse velocity of the two studied areas: (a) Oliana across the entire climbing wall; (b) Cadalso de los Vidrios with two different granites along the various crags.

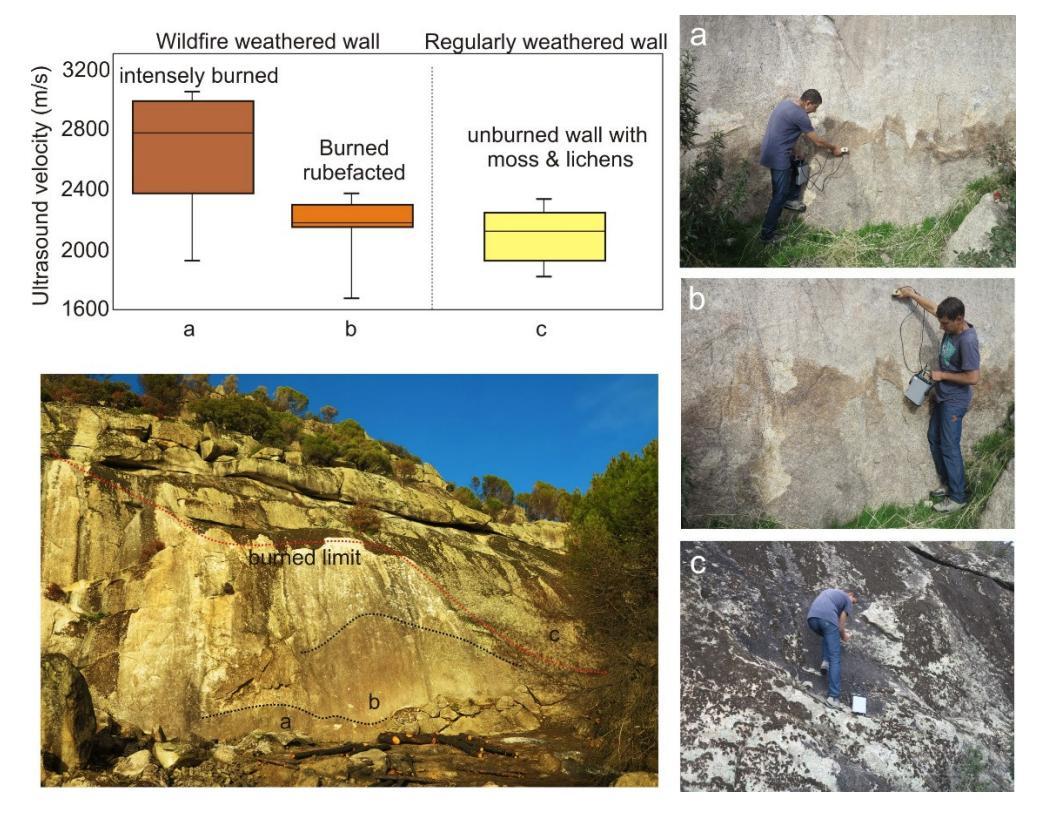
Figure 11. Detailed UPV values in the Cadalso de los Vidrios climbing wall along two areas with different degrees of fire damage: (**a**,**b**) wildfire weathering. (**a**) Intensely burned area with a soot deposit and detached spalling at the bottom part of the wall; (**b**) reddened area, which occurs above one meter in height; (**c**) area on the right side of the wall with preserved lichens and moss, indicating that it was not affected by the fire.

The boxplot display of UPV in Figure 11 does not show highly relevant differences between "fresh" (Zone a) and reddened (Zone b) areas with 61.8 % probability of significant differences between data sets for a t-Student two-tailed test. UPV shows a significant increase in Zone c because of the combination of two effects generated by fire: detachment of spalling, which reveals new surfaces that were not affected by cracking during the fire event, and pore clogging due to the penetration of soot and fumes within the surface cracks.

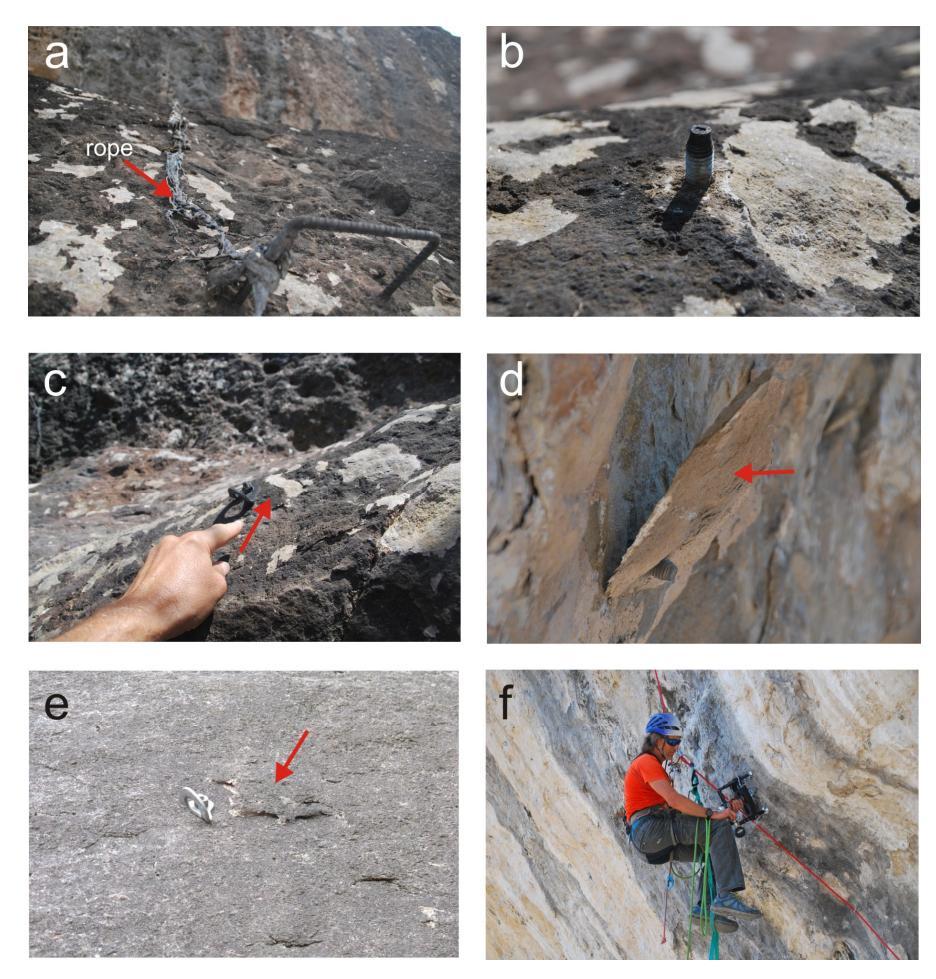
Figure 14. Impacts on climbing anchors: (**a**) remains of climbing ropes and iron stairs in Oliana; (**b**–**d**) spalling on anchors in Oliana; (**e**) exfoliation in Cadalso de los Vidrios near a bolt anchor; (**f**) anchor test in the "La Dura Dura" route.

The iconic climbing area of Oliana was affected in a different way. The left side of the wall has experienced dramatic changes by spalling, rockfalls, and shattering (Figure 7). All routes on the left side have been destroyed by fire, even up to the highest part (~40 m). The vertical hot currents caused a sudden thermal shock. Conversely, the central part of the wall—the place where the most iconic routes are located—was protected from the fire. The right side of the wall was also damaged (Figure 14a). Spalling not only affects the wall, but also several anchors lost a few centimeters of rock cover (Figure 14b–d). Surprisingly, the anchor test (Figure 14f) showed a good condition of all protections.
