Soil Erosion and Land Degradation on Trail Systems in Mountainous Areas: Two Case Studies from South-East Brazil

Luana Rangel 1,*, Maria do Carmo Jorge 1, Antonio Guerra 1 and Michael Fullen 2

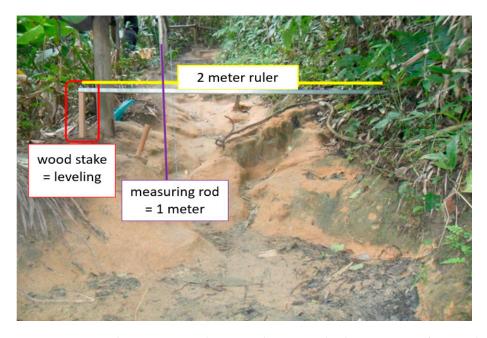
Figure 3. Measuring soil microtopography using the erosion bridge on *Caixa D'Aço* pool trails. Photo: L. Rangel (2016).

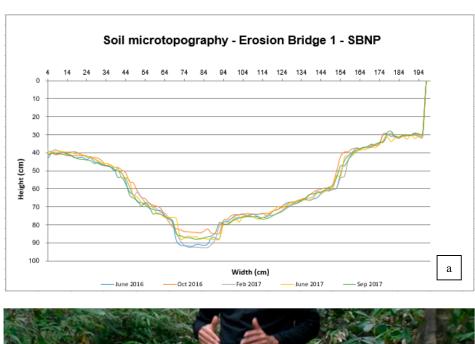
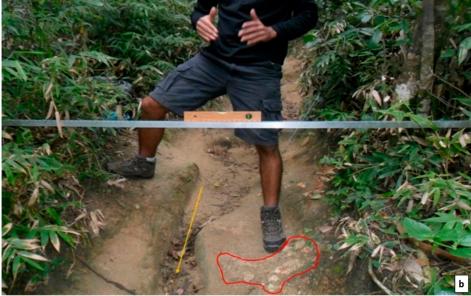
In the first erosion bridge measurements (EB1) there was a notable rill (depth 16 cm, width \sim 21 cm). Between October 2016–September 2017 the rill incised by a further \leq 10 cm and some C horizon soils were exhumed (Figure 5).

Figure 5. (a) Soil microtopographic analysis between June 2016 and September 2017 on EB1. (b) The yellow arrow indicates a rill containing accumulated litter. The red highlight indicates the onset of the exposure of the C horizon. Photo: L. Rangel (2017).

On the SBNP trails (EB1), the quantity of material deposited within rills can be associated with litter accumulation, which varies according to the production and decomposition cycle of the organic material and the rainfall regime [13]. Soil erosion probably occurred due to a combination of intense rainfall, local steep slopes and the erodible sandy texture.

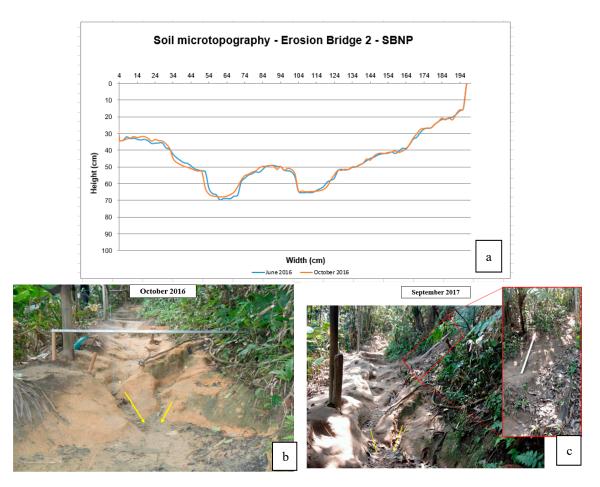
Figure 6 shows two rills on EB2, one \sim 20 cm deep and 24 cm wide and another \sim 13 cm deep and 28 cm wide. The estimated soil loss due to erosion on EB2 was 0.28 m² in June 2019 and 0.29 m² in October 2019. On EB2, between January and February 2017, a small landslide occurred on the upper slope of the trail, which became a shortcut for walkers.

Figure 6. (a) Soil microtopographic analysis between June 2016 and October 2016 on EB2. (b) The yellow arrows indicate rills with litter accumulation in October 2016. (c) Landslide (detail in red) in September 2017. Photos: L. Rangel (2016 and 2017).

On EB2 it was only possible to conduct two monitoring sessions, since in February 2017 one of the cuttings that served as a levelling base was removed by a landslide that occurred in the upper slope of the trail and the other was eroded as a result of this slippage. These processes are associated with the high local rainfall amounts. Between 1 January–3 February 2017 (the dates of the surveys), rainfall at Paraty Weather Station was 485 mm. During 3-h on 10 January 2017 ~101 mm of rain fell [44].

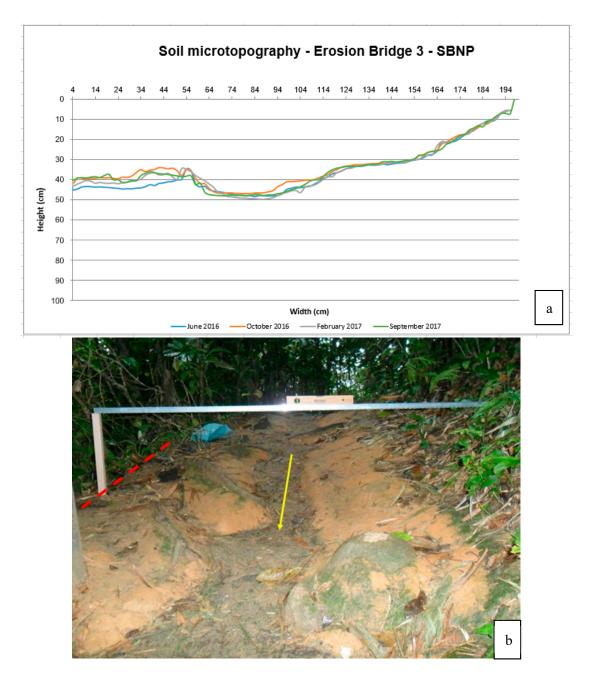
Analysing data from the third erosion bridge survey (EB3), it is possible to identify a rill partially infilled with leaf litter. Between October 2016–September 2017 the rill incised by a further \leq 5 cm (Figure 7). On EB4, between October 2016–February 2017, the rill incised a further \leq 12 cm. The effects of trampling and runoff are evident in the formation of three rills (Figure 8).

Figure 7. (a) Soil microtopographic analysis between June 2016 and September 2017 on EB3. (b) The yellow arrow indicates a rill with litter accumulation and the red line indicates erosion on the edge of the trail. Photo: L. Rangel (2017).

In EB3, the rill (\sim 50 cm wide, \sim 15 cm deep) shows the preferential path of runoff and visitors, who further compact the soil by trampling. On EB4, the presence of three rills may be associated with steep microslopes.

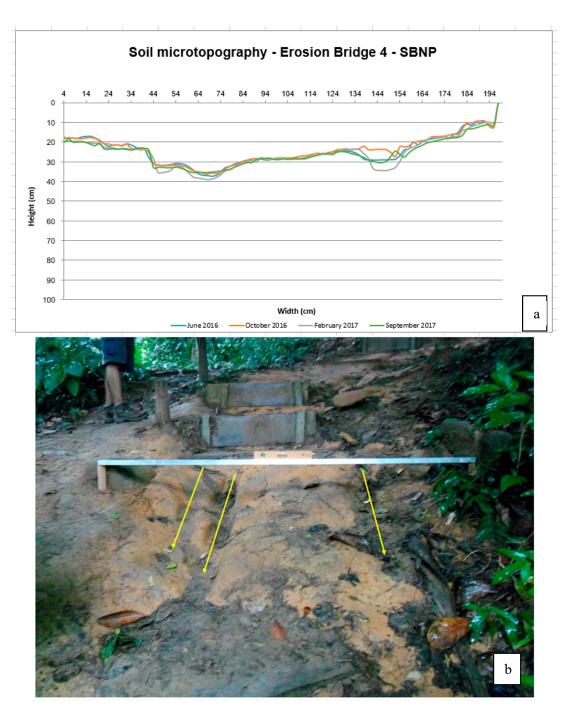
Figure 8. (a) Soil microtopographic analysis between June 2016 and September 2017 on EB4. (b) The yellow arrows indicate rills partially infilled by plant litter. Photo L. Rangel (2017).
