# An Integrated Framework for Image Acquisition, Processing, and Analysis Procedures for Automated Damage Evaluation of Concrete Surfaces

**Abstract:** Concrete surface cracks serve as early indicators of potential structural threats. Visual inspection, a commonly used and versatile concrete condition assessment technique, is employed to assess concrete degradation by observing signs of damage on the surface level. However, the method tends to be qualitative and needs to be more comprehensive in providing accurate information regarding the extent of damage and its evolution, notwithstanding its time-consuming and environment-sensitive nature. As such, the integration of image analysis techniques with artificial intelligence (AI) has been increasingly proven efficient as a tool to capture damage signs on concrete surfaces. However, to improve the performance of automated crack detection, it is imperative to intensively train a machine learning model, and questions remain regarding the required image quality and image collection methodology needed to ensure the model's accuracy and reliability in damage quantitative analysis. This study aims to establish a procedure for image acquis

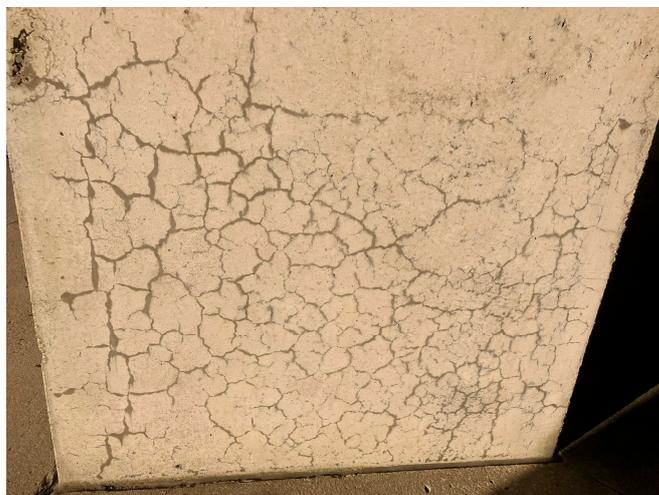
**Figure 1.** Concrete column affected by the alkali-silica reaction (ASR) presenting a map cracking pattern.

an initial step in evaluating the overall condition of the concrete structure [3]. Currently, the evaluation of concrete elements affected by the ASR starts with the visual inspection process, aimed at qualitatively examining signs of deterioration on the surface.

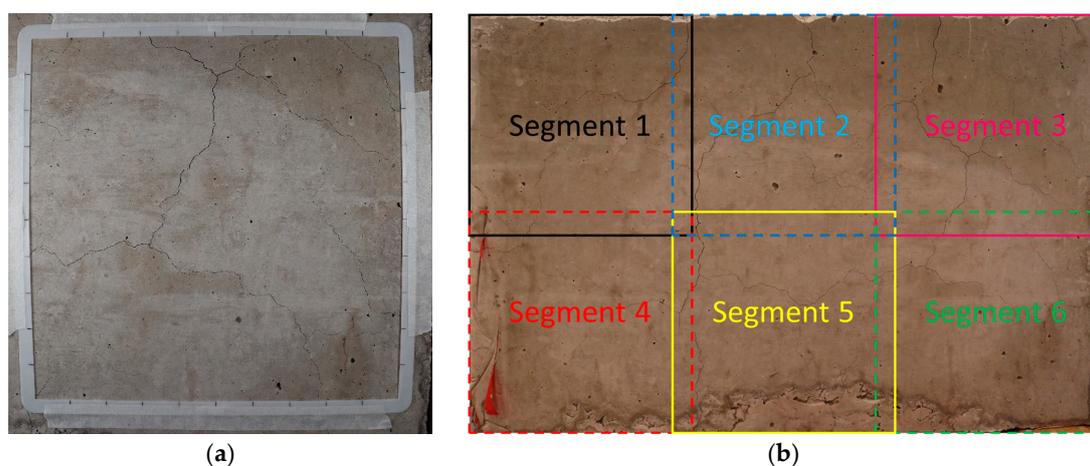
**Figure 2.** (a) A typical cracking index layout on a concrete surface using a 3D-printed reference grid representing one block surface segment and (b) a segmented concrete block surface.

As shown in Figure 2a, each CI reference grid should contain a measurable amount of cracking. These grids serve as visual reference points for quantifying and documenting the extent of cracking in the concrete structure. To measure the width of cracks on the surface of the investigated element, a magnifying lens with a plastic crack comparator card is required for precision. Each line drawn on the surface should be divided by 10 intervals as reference points and to tabulate the crack amount and width in 10 steps for each side. Figure 2a illustrates a 25 cm by 25 cm 3D-printed reference frame used in this study since the full grid size exceeded the block surface. Figure 2b illustrates the ROIs where the concrete block surfaces were divided into 6 segments, and some overlap is noted due to the limited size of the surface.

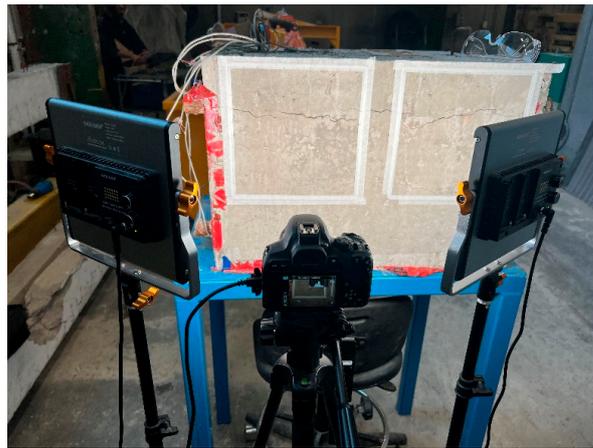
**Figure 3.** Image acquisition setup, including a digital single-lens reflex (DSLR) camera, LED light panels, and objective concrete elements with the reference frame attached.

It is worth mentioning that the concrete blocks were lifted onto a table to allow for a comfortable working height, thus minimizing human error. The lights were placed on either side of the camera, and the camera was brought close to the surface of the concrete block until only the reference frame was brought into the field of view. The procedure will ensure that each image captured by the camera captures the ROI with the maximum quality, where the minimum crack width as per the comparator card is visible in the images. Furthermore, many images may exhibit perspective distortion, which occurs when the camera's imaging frame is not parallel to the target plane during photography, leading to a trapezoidal shape instead of maintaining the intended square shape, as depicted in Figure 4. To address perspective distortion, a 3:2 frame was used to aid in adjusting the camera's shooting angle and position. Detailed instructions on how to address the perspective are further illustrated in the following step-by-step procedure for image acquisition.

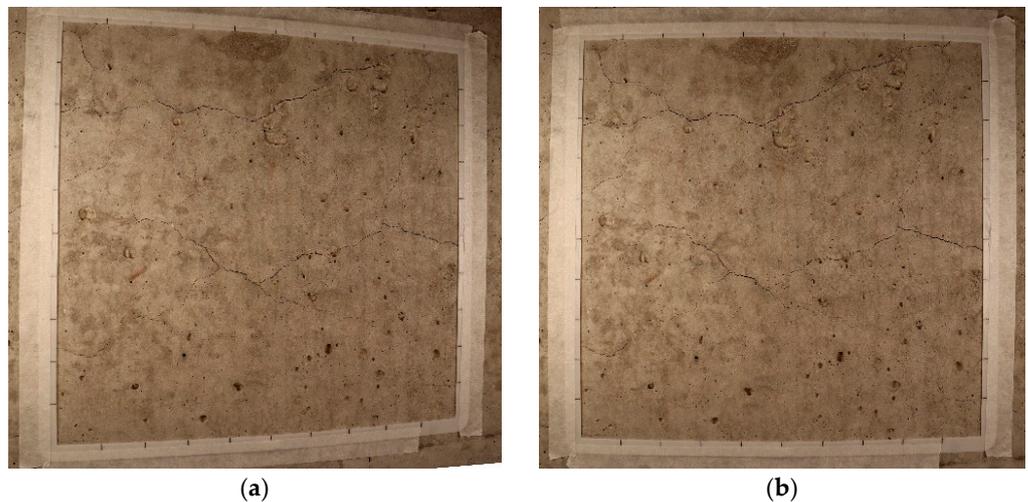
**Figure 4.** (a) Image with perspective distortion, (b) image after perspective correction. The image (a) has wider left side boarder than right side border, resulting in scale inconsistency for the whole image.

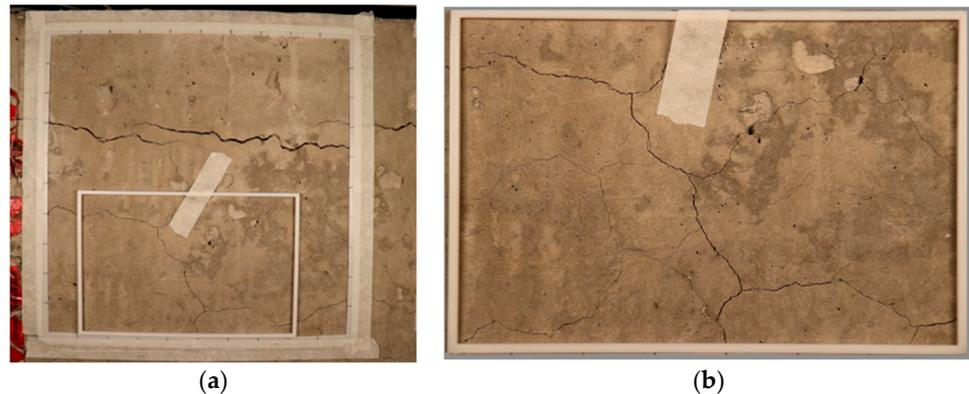
**Figure 5.** (a) A perspective frame affixed at the lower part of the reference frame and (b) the perspective frame in the full field of view after zooming in.

5. Perspective adjustment: The camera lens' zoom ring was adjusted to view the perspective frame (as shown in Figure 5). The height and shooting angle were tuned to guarantee that all four corners of the frame fit within the camera's view. After the

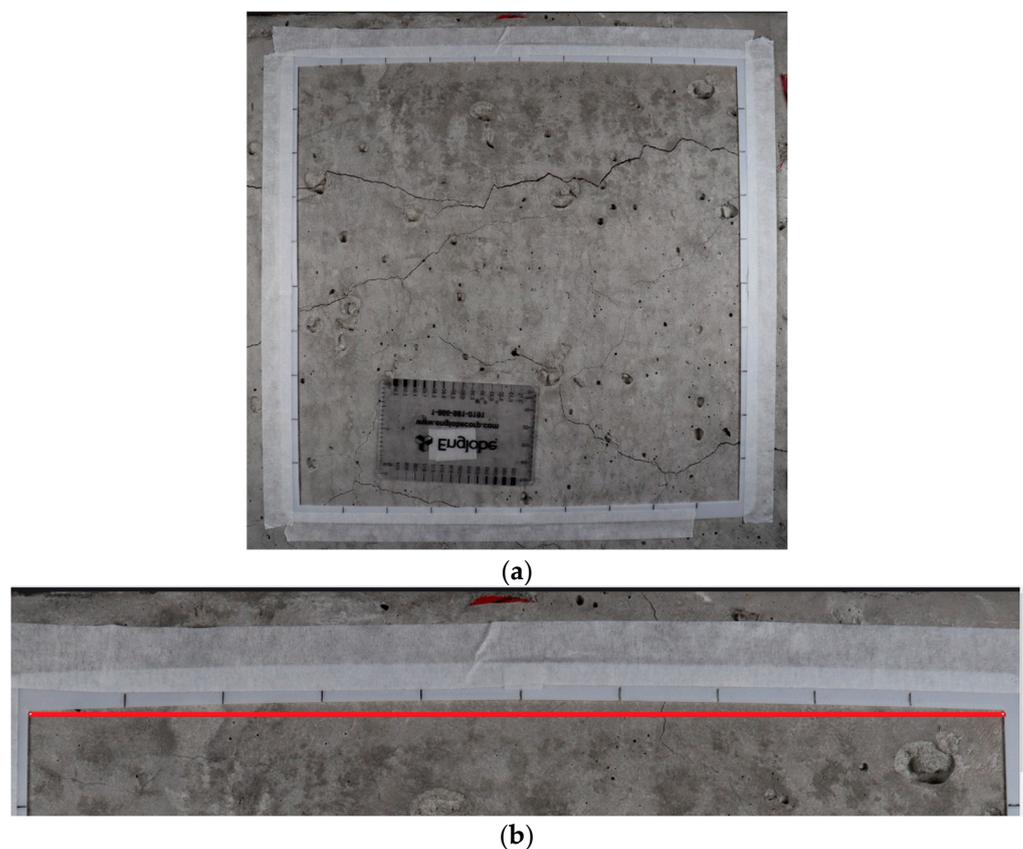
**Figure 6.** Barrel distortion that appears near the edge of the frame that caused the image to have outward distortion curves: (a) shows the full image and (b) shows the upper edge with the outward distortion curve showing deflection from a straight line drawn in red.

Once the distortion parameters are applied to the images, the previously displaced pixels within the image will be restored to their original positions. The precision of the “undistortion” process is influenced by the quantity of calibration images captured with the specific camera. The camera matrix and distortion coefficients obtained from the calibration can be stored using write functions in NumPy [38], allowing them to be readily accessed for future applications.

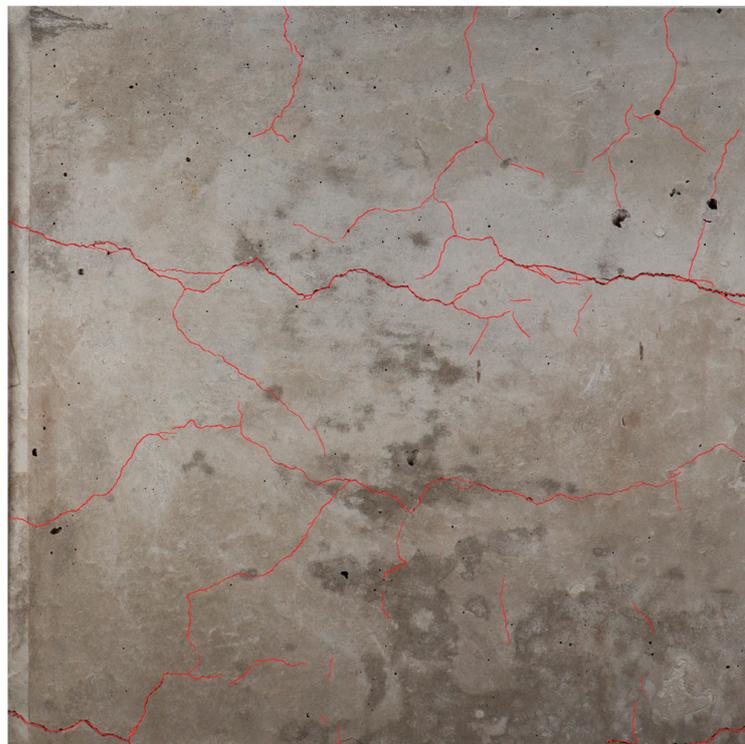
**Figure 7.** A traced image with its mask layer. The red lines represent the annotations that were manually traced.

The mask layer was then extracted, converted to an 8-bit image, and analyzed to determine the total number of traced pixels using the Particle Analyze function.

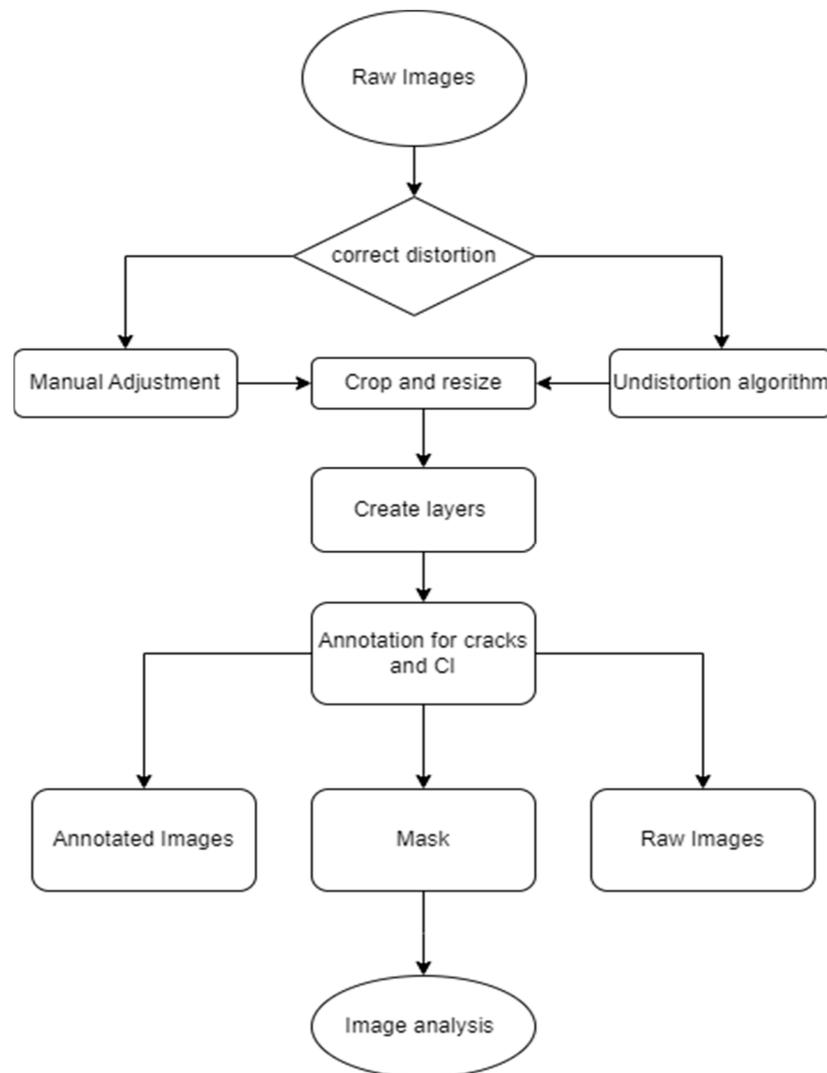
**Figure 8.** Image processing flowchart.

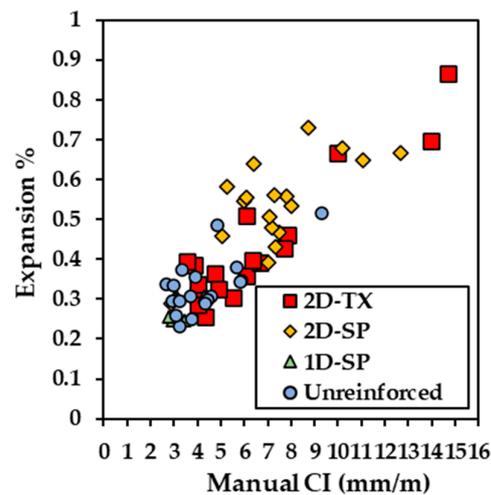
**Figure 9.** Calculated expansion level vs. average CI of two operators for 66 square segments.

The cracking index (CI) outcomes for seven concrete blocks were manually recorded by two operators and calculated as per Equation (1). Figure 9 illustrates the measured expansion as a function of CI, which exhibits an overlap between different types of blocks, yet some clustering is observed. The calculated expansion (Equation (2)) of 2D-TX blocks (reinforced in two directions and made with reactive Texas sand) can spread between 0.25% and 0.86%, and the CI can range from 0.35 mm/m to 14.50 mm/m. Furthermore, 2D-SP blocks (reinforced in two directions and made with reactive Springhill coarse aggregate) have a narrower range of expansion compared to 2D-TX blocks, but the CI can vary from 5.25 mm/m to 12.56 mm/m when the expansion level is around 0.65%. In contrast, the unreinforced type of block has a more concentrated CI value (2.9 mm/m to 5.9 mm/m) and expansion level (0.23% to 0.50%). Moreover, the 1D-SP blocks (reinforced in one direction and made with reactive Springhill coarse aggregate) show the narrowest ranges between 2 and 5 mm/m for expansions of 0.25–0.33%. Overall, a good correlation was found at a  $R^2$  value of 0.72.

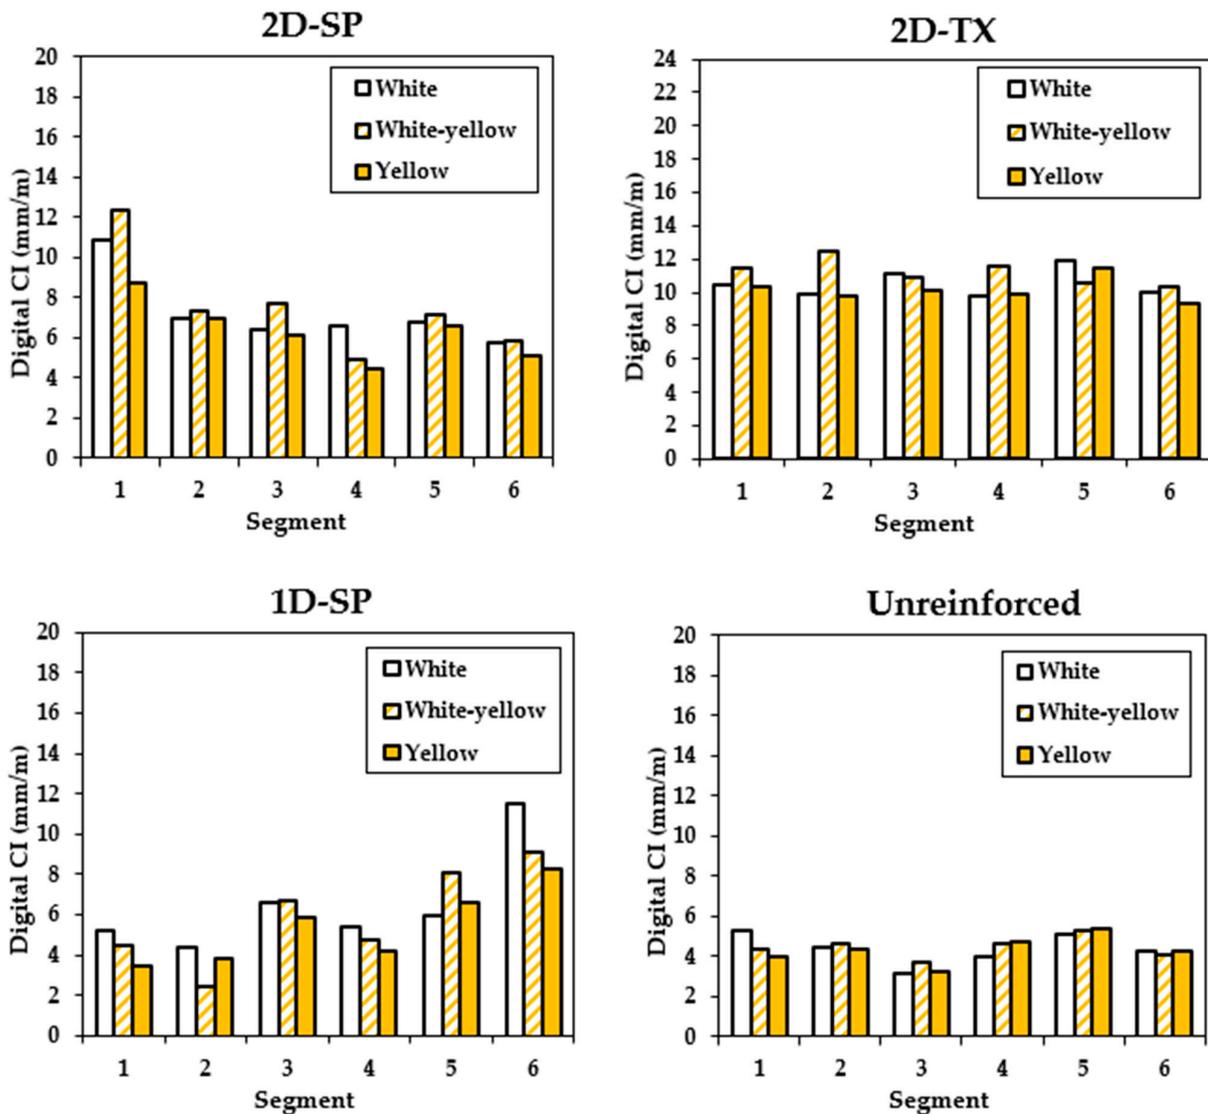
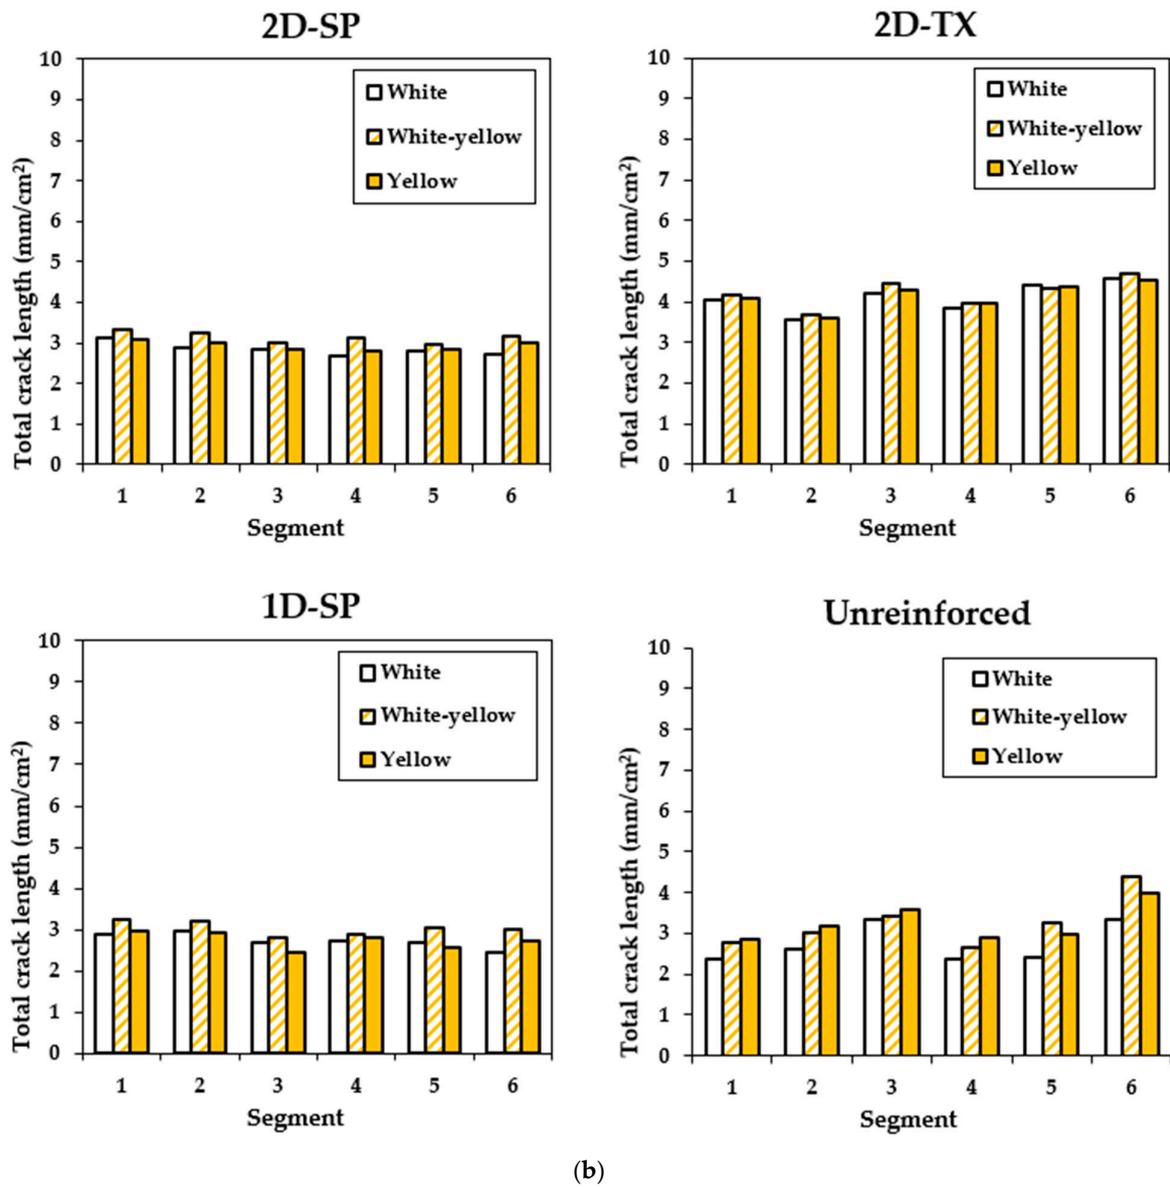
**Figure 10.** Comparison for 3 light conditions among 24 image segments from 4 types of blocks using (a) cracking index (mm/m) and (b) total crack length (mm/cm<sup>2</sup>). White bars = cold light (white—5600 K); striped white and yellow bars = daylight (white/yellow—4800 K); and solid yellow bars = warm light (yellow—3200 K).

A comparative analysis of CI and the novel measurement of total crack length (TCL—length over area, mm/cm<sup>2</sup>) results was conducted over 72 digitized images under three distinct lighting conditions, including warm light (yellow—3200 K), daylight (white/yellow—4800 K), and cold light (white—5600 K), as depicted in Figure 10. Four out of the 7 blocks were selected for this portion of the study, representing various components with different reinforcement settings: unconfined, reinforced in one direction (1D-SP), reinforced in two directions with reactive coarse Springhill aggregate (2D-SP), or reactive Texas fine aggregate (2D-TX). A similarity in the results can be observed for each light condition, where overlapping results are observed, yet the overall trend is conserved. The highest CI value is captured with daylight (white/yellow) at 12.4 mm/m. The corresponding CI value for cold (white) light is 10.9 mm/m, and that for warm (yellow) light is 8.8 mm/m Figure 10a). Meanwhile, the largest difference can be observed with a CI value of 3.6 mm/m. As for the TCL, similar trends are observed, where the results are comparable to CI yet smaller variations are obtained from the TCL (Figure 10b).

Due to the varied extent of damage in the concrete blocks, the CI results range from 3.9 mm/m to 12.4 mm/m, reflecting some degree of variance within the group. However, ANOVA analysis (Table 3a) across the four different types of blocks under various lighting conditions indicates that varying lighting conditions does not significantly affect the CI results obtained from image analysis. Statistically, Table 3 presents a  $p$ -value exceeding the significance threshold of 0.05, indicating insufficient evidence to reject the null hypothesis (i.e., no significant difference in results among different lighting conditions). This conclusion is further supported by the fact that none of the “F values” exceed its corresponding “F-critical” value. Similar findings apply to the TCL image analysis results (Table 3b). TCL values range from 2.6 mm/cm<sup>2</sup> to 4.7 mm/cm<sup>2</sup>. ANOVA analysis reveals a  $p$ -value higher than the significance level of 0.05, and the tabulated F value is below the F-critical value, reinforcing the absence of significant differences among the three sets of light condition results.

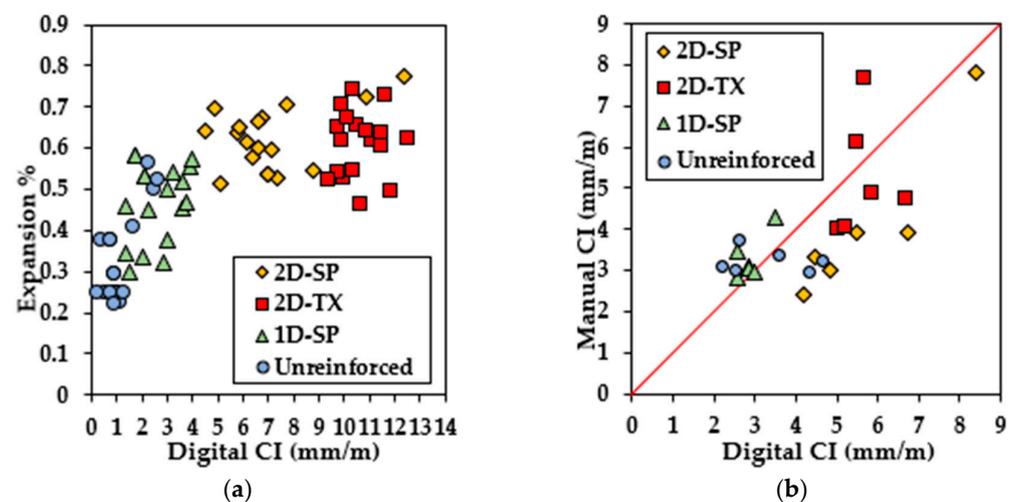
Figure 11. (a) Digital CI vs. calculated expansion level. (b) Manual CI vs. digital CI where datapoints are illustrated along the red 1:1 line.

The digital image-based analysis is a different approach to collecting the measurement of cracks using pixel-wise annotations on images. Figure 11 illustrates the digital CI results from four selected blocks (one from each configuration as previously mentioned). Compared with the manual CI results, digital CI represents a more distinctive CI and expansion level for different types of blocks. CI values for unreinforced blocks ranged from 0.25 mm/m to 2.50 mm/m, with a calculated expansion level ranging from 0.22% to 0.55%. Both types of blocks reinforced in 2 directions (2D) exhibit more severe damage, and their expansion level similarly ranges from 0.50% to 0.78%. Interestingly, the digital CI results for the two types of 2D blocks show a significant difference (ranging from 6.3 mm/m to 11 mm/m for 2D-SP blocks and from 9.38 mm/m to 12.5 mm/m for 2D-TX blocks). Interestingly, more prominent clustering is observed using the digital CI when compared to the CI performed manually as observed in Figure 11a. Digitizing the CI was found to be effective as observed in Figure 11b where datapoints cluster along the 1:1 line.

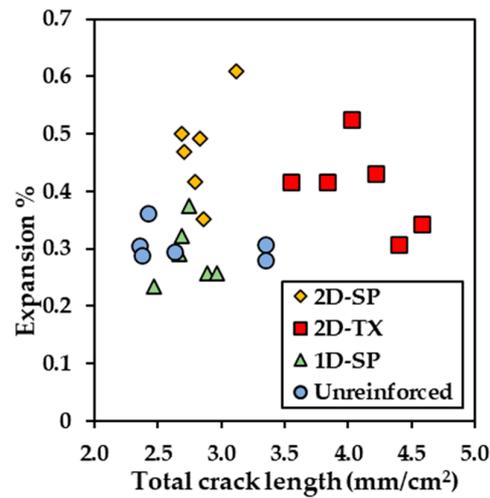
Figure 12. Calculated expansion level against the total crack length (TCL) value.

The total crack length (TCL) was measured through image analysis and calculated using a unit in  $\text{mm}/\text{cm}^2$ . Figure 12 illustrates the calculated expansion from the digitally recorded crack widths as a function of the TCL over 24 segments under artificial light in daylight conditions (4800 K). The data points exhibit a broad distribution while generally clustering into distinct groups. The TCL values within all types of blocks range widely, ranging from  $2.3 \text{ mm}/\text{cm}^2$  to  $4.6 \text{ mm}/\text{cm}^2$ . Notably, Block B5 (i.e., unreinforced, SP) displays the most modest expansion level (0.23–0.37%, computed based on CI values derived from image analysis) among the four types of blocks.

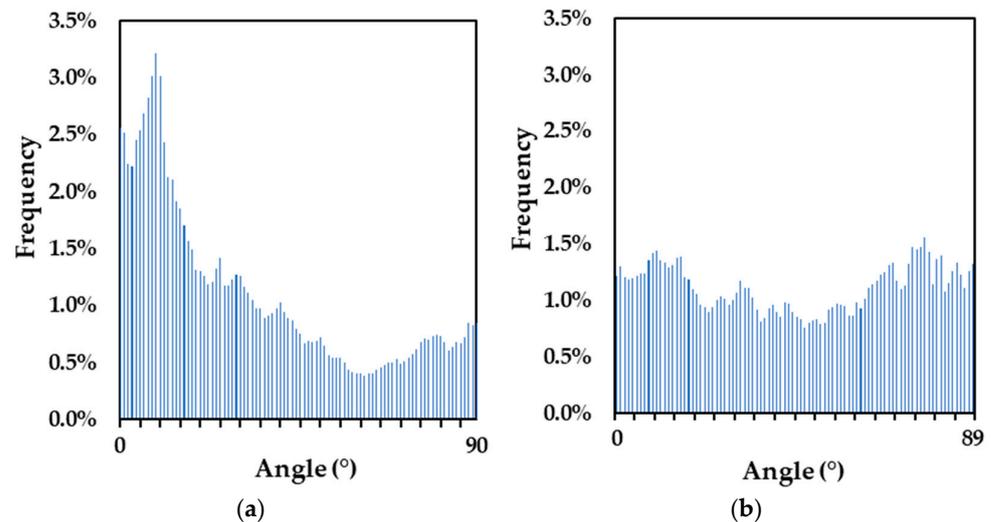
Figure 13. Histograms of crack orientation angle from one square segment of (a) a reinforced and (b) unreinforced block.

Through image analysis, the crack orientation can be obtained as an output that can be further illustrated using histograms to depict the most frequently observed crack directions. Figure 13 presents the histograms for a reinforced block and an unreinforced block. The distribution in the reinforced block histogram (Figure 13a) shows a preference for the 0-degree region (horizontal) and a lesser tendency towards the 90-degree region (vertical). This suggests that more cracks are oriented horizontally rather than vertically. In contrast, the unreinforced block exhibits an orientation angle that does not concentrate in any range of direction (Figure 13b). Table 4 presents the results for all blocks where the 2D reinforced blocks show average orientation angles of 35.37 and 33.12 degrees. These values are slightly less than that of the 1D reinforced block at 38.20 degrees followed by the unreinforced block at 45.46 degrees.

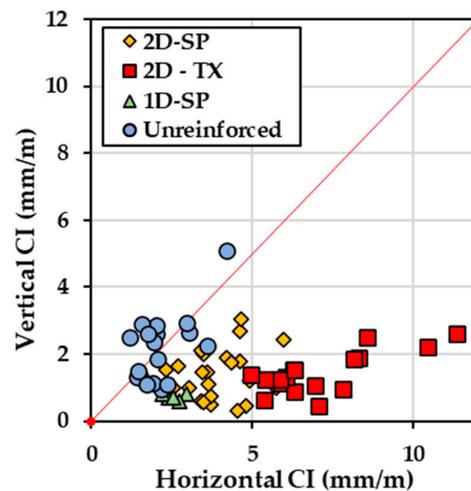
**Figure 14.** Plot of CI measurement collection for vertical vs. horizontal measurements in mm/m manually collected from 7 blocks with marker shape differentiated by concrete reinforcement configuration: (1) reinforced in two directions (2D) with reactive coarse (SP—blue square) or fine (TX—green square) aggregate, reinforced in one direction (1D) with SP coarse aggregate (triangle), and unreinforced with SP coarse aggregate (circle). Values are shown along the 1:1 red line.

Considering the apparent observable crack directionality, the CI was divided into two directions to capture horizontal cracking and vertical cracking. Figure 14 presents the average directional CI results from both operators plotted along a 1:1 line; this plot indicates that cracking is more significant in the horizontal direction. Note that the x-axis represents the crack CI measurement from cracks aligned in the horizontal direction, and vice versa.

By evaluating the data clusters where different types of blocks were grouped to assess the impact of reinforcement on crack patterns, it can be observed that all data points from blocks without reinforcement cluster closely around the 1:1 line, with the highest CI value of 4.20 mm/m for vertical cracking and 5.10 mm/m for horizontal cracking. This suggests that their horizontal CI values closely align with their vertical CI values since these blocks can expand in all directions without restraint. In contrast, all reinforced blocks exhibit CI values in horizontal cracks that are much greater than those in vertical cracks. The block is reinforced in one direction and has an average CI value of 2.43 mm/m for horizontal cracking and 0.81 mm/m for vertical cracking, which are lower than the value observed for blocks reinforced in 2 directions in both vertical and horizontal cracking directions. For blocks reinforced in 2 directions, 2D-SP has an average CI of 3.86 mm/m for horizontal cracking and 1.39 mm/m for vertical cracking, while 2D-TX has an even larger crack width open with values of 7.458 mm/m for horizontal and 1.439 mm/m for vertical cracking directions.

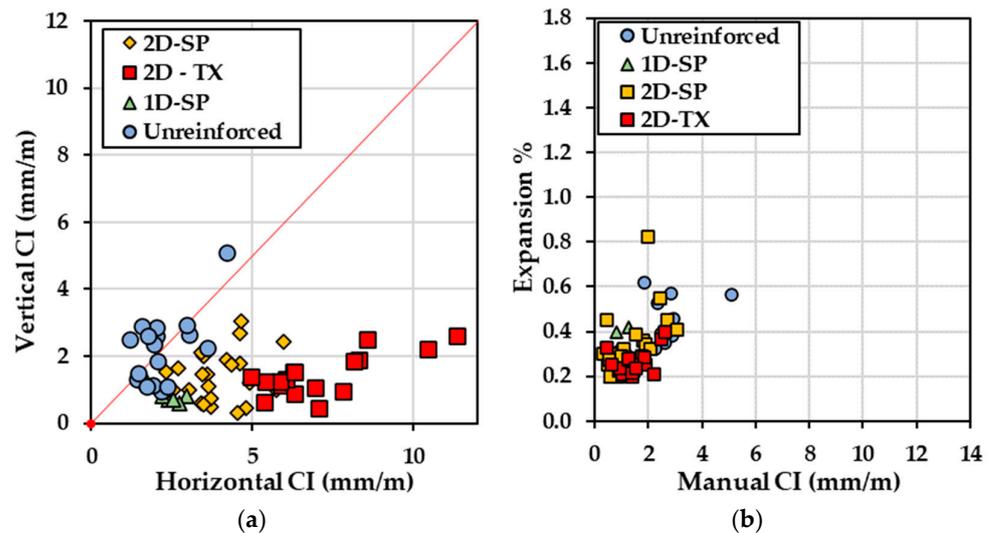
**Figure 15.** (a) Calculated expansion level vs. average CI result from manual measurements collected from 7 blocks with marker shape differentiated based on concrete reinforcement settings: circle—unreinforced, SP; triangle—1D-P; square—2D-SP; diamond—2D-TX. (b) Calculated expansion level vs. average CI result from manual measurements.

Figure 15 displays the expansion level calculated using Equation (2) against the CI value for horizontal and vertical cracking directions, separately. Based on 132 observations, it is evident that the calculated expansion levels as measured based on the horizontal cracking direction exhibit a larger mean range of expansion (0.2% to 1.6%) compared to the vertical cracking direction (0.2% to 0.8%), especially for reinforced concrete blocks. It is apparent that both CI and expansion values plotted for 1D-SP, 2D-TX, and 2D-SP types of blocks are notably higher than those for unreinforced blocks (Figure 15a). In contrast, when measuring cracks in the vertical direction (Figure 15b), the values tend to cluster within a certain range for each block. This observation reveals that the presence of reinforcement has no effect and leads to increased crack openings and expansion along the reinforced direction. Corroborating the existing literature [8,14,33], the expansion measurements performed on various surfaces of the reinforced blocks revealed that the propagation of induced expansion transfers from reinforced directions to directions with lower or no reinforcement and results in more expansion in the direction with the least amount of reinforcement (perpendicular to the main reinforcing bars). This observation suggests that ASR-induced expansion occurred to a greater degree in the direction where the reinforced blocks faced less or no restraint. For instance, 2D-SP blocks were formed by reactive coarse aggregate (Springhill-SP) and non-reactive natural sand, with reinforcement in the transverse and longitudinal direction. The average result for 2D-SP blocks exhibited an average horizontal CI of 4.05 mm/m compared to a vertical CI of 1.45 mm/m. This disparity indicates that the average expansion in the horizontal direction (0.38%) was constrained, leading to a more pronounced expansion in the vertical direction (0.83%) that experienced no restraints.

Clustering in Figure 15 shows that the calculated expansion as a function CI for horizontal cracking is more distinct when compared to that observed in Figure 9 (i.e., undivided CI). Likewise, through the cracking orientation analysis, preferential cracking directions are observed with respect to the reinforcements. Therefore, in cases of reinforced concrete presenting cracking directionality, quantifying the cracking orientation may help to refine models used to calculate the expansion from the CI.

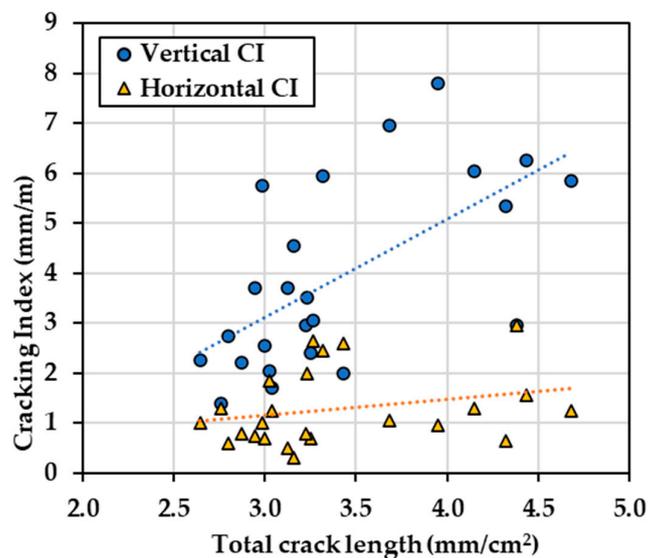
**Figure 16.** Cracking index (CI) as a function of total crack length (TCL). The dashed lines represent the trendlines.

A new metric was considered to quantify the intensity of cracking similar to the total crack length (TCL), which considers the length of cracks (in one dimension) over an area (2 dimensions). The TCL alone cannot measure crack directionality; therefore, it was compared against the vertical and horizontal CIs, as illustrated in Figure 16. By comparing the slope of the trendline, the TCL may not be able to represent a good correlation with either the vertical or horizontal CI value. As the TCL increases, the value of CI between the two directions shows a significant difference, indicating the TCL may not be capable of representing the damage extent in either direction. Moreover, the correlations show an *R*<sup>2</sup> of 0.39 for horizontal cracking and 0.06 for vertical cracking, which is considered a poor correlation.

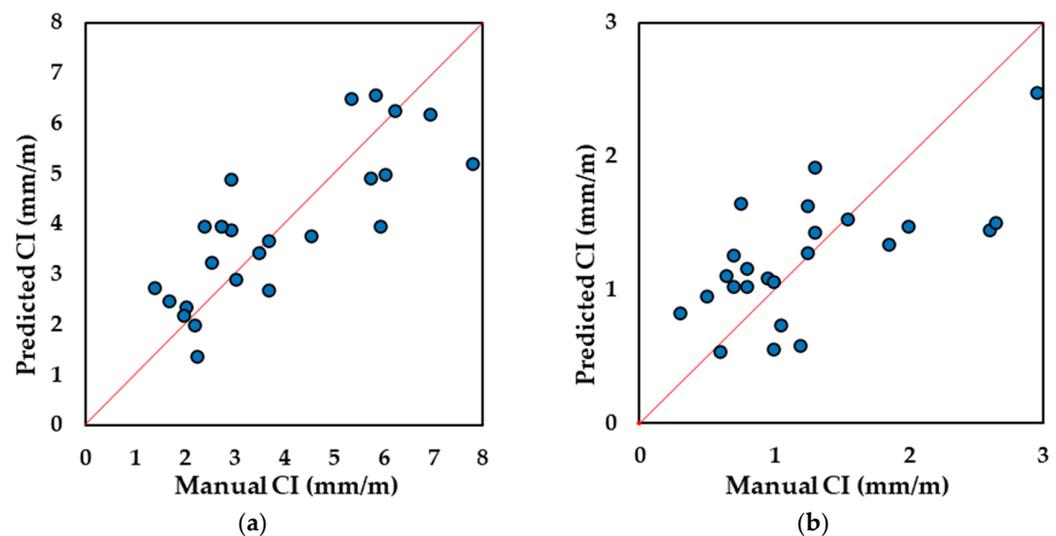
**Figure 17.** CI values predicted using the CD-orientation model in the (a) horizontal and (b) vertical directions.

The two plots presented in Figure 17 compare the predicted CI results vs. manual CI in both directions to better determine the regression performance visually. The performance of the regression model can be assessed through residual analysis, as depicted in Figure 18. The residual values range from  $-2.0$  mm/m to  $+2.3$  mm/m for the vertical direction and from  $-1.0$  mm/m to  $+1.0$  mm/m for the horizontal direction, and a trend of heteroscedasticity is not observed. Notably, the histograms of the residual values in both directions closely approximate a normal distribution. This suggests that the prediction model (Equations (3) and (4)) has good regression with ground truth values.

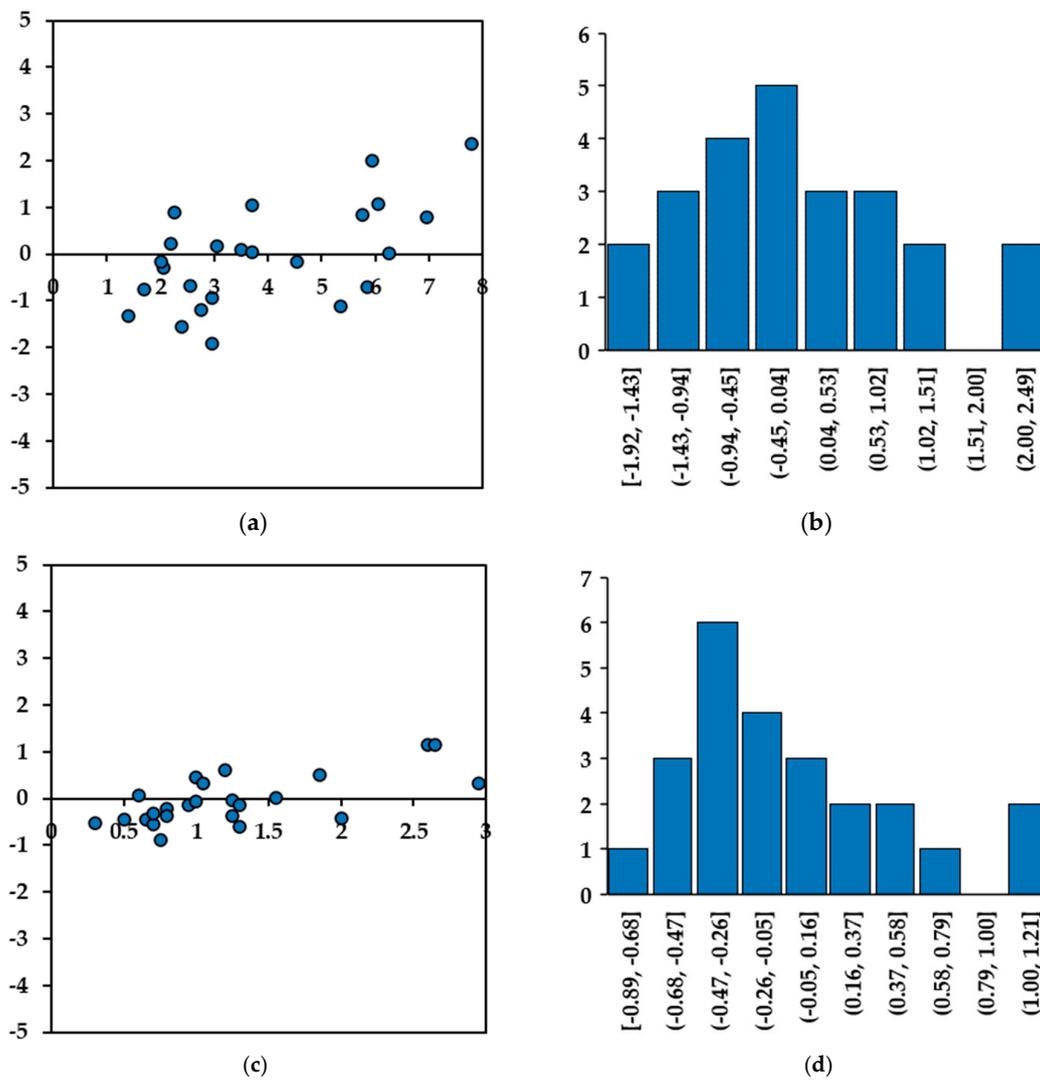
**Figure 18.** Residual analysis for CI prediction using CD and crack orientation: (a) horizontal residual plot, (b) horizontal residual histogram, (c) vertical residual plot, and (d) vertical residual histogram.

The CI, CD, and crack orientation angle represent three distinct parameters that do not exhibit a direct relationship. Nevertheless, when considering CD and crack orientation collectively, they can jointly characterize crack behavior in terms of distribution and quantity. Their combined analysis can reasonably describe the cracking intensity in their respective directions, akin to the role CI plays. Additional findings presented in Table 7 provide compelling evidence to assess the model's predictive capability. Based on the results of paired  $t$ -tests, the predictive outcomes of CI closely align with manual CI results of horizontal cracking, yielding an average  $p$ -value of 0.96 and a correlation coefficient of 0.82. These results suggest that there is no significant difference between the predicted and observed values. Similarly, in the vertical direction, the  $p$ -value is 0.90 with a correlation coefficient of 0.79, supporting a similar conclusion of a positive result.
