Article

Data-Driven Assessment of the Impact of Hurricanes Ian and Nicole: Natural and Armored Dunes in the Aftermath of Hurricanes on Florida's Central East Coast

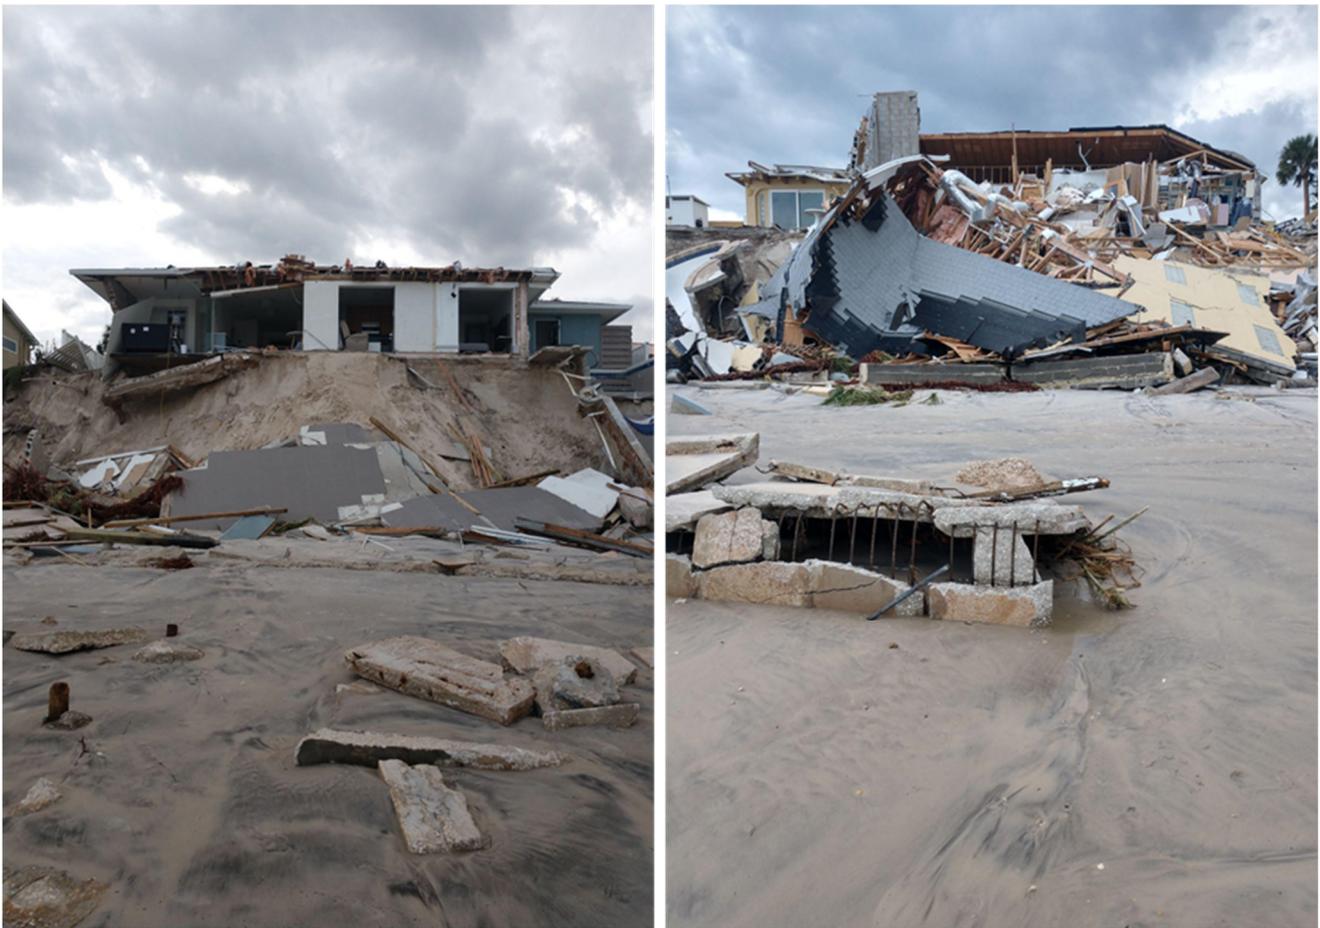
Figure 2. Photos of some of the severe instances of dune erosion and property destruction in the study area. The photos were taken shortly after Hurricane Nicole on 11 November 2022, in the Wilbur-by-the-Sea area (near Ponce Inlet) at approximately 29.126N, 80.954W (courtesy of Daniel Burow).

In particular, Volusia County faced severe erosion following the back-to-back strikes of Hurricanes Ian and Nicole, occurring six weeks apart. A damage assessment conducted by the Volusia County Property Appraiser’s Office estimated the total to be approximately USD 500 million. Dozens of beachfront condominiums, hotels, and single-family homes were declared unsafe after Hurricane Nicole, with many already damaged by Hurricane Ian [25]. The changing coastal dynamics, particularly the scarping observed at higher elevations, reflect the significant alterations in the landscape due to the consecutive hurricanes (Figure 2).

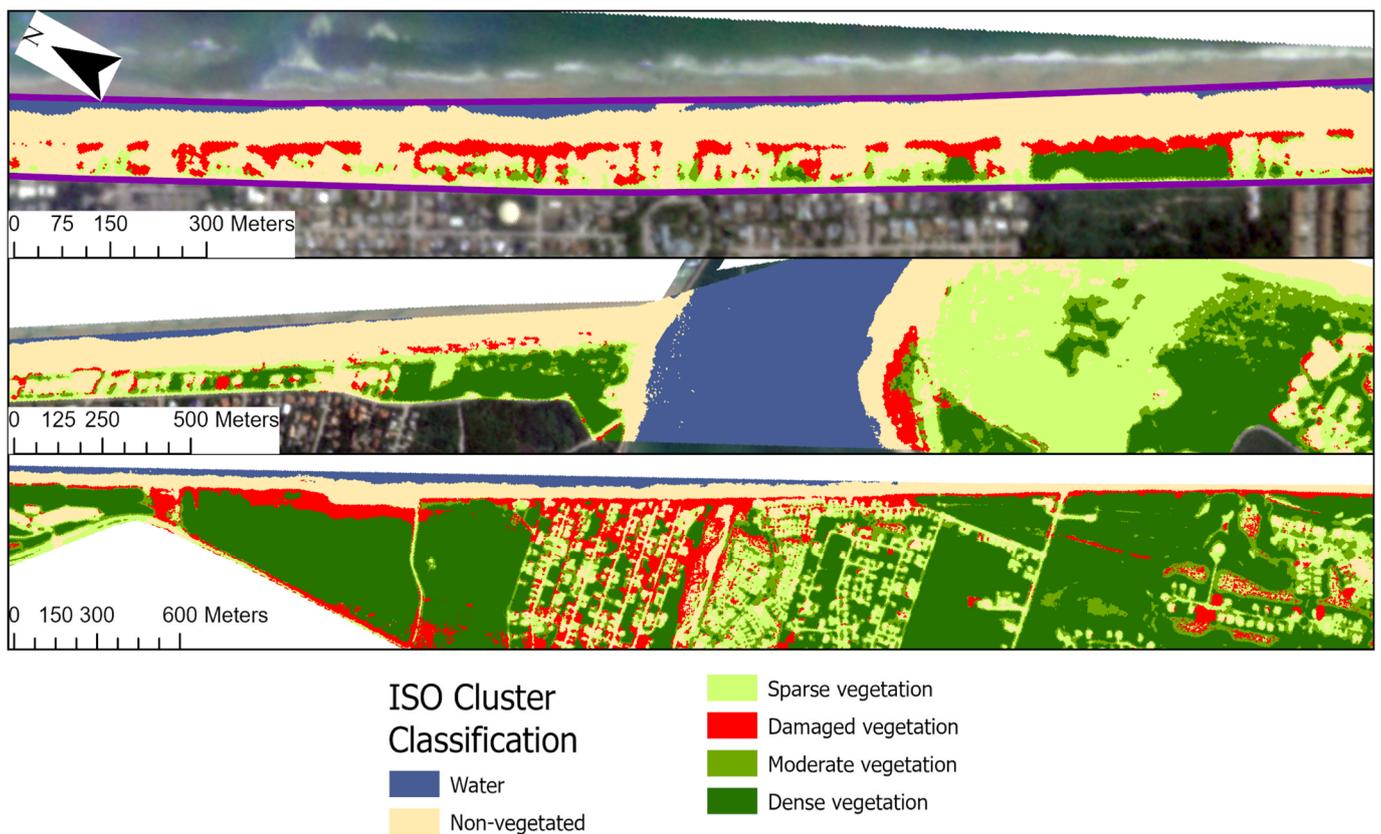
Figure 8. Cluster classifications of pixels in three regions of interest in the study area: Wilbur Beach (top), Ponce Inlet (middle), and the Washington Oaks State Park region near Palm Coast (bottom). Background Planet imagery obtained in December 2021.

The six clusters derived from temporal patterns in NDVIs from December 2021 to December 2023 are shown in Table 3 and Figures 7 and 8. Clusters are ordered numerically from unvegetated (Cluster 1) to heavily vegetated (Cluster 6). Table 3 also shows the land cover composition from NLCD 2021.
