Article

Operational Modal Analysis, Model Update and Fragility Curves Estimation, through Truncated Incremental Dynamic Analysis, of a Masonry Belfry

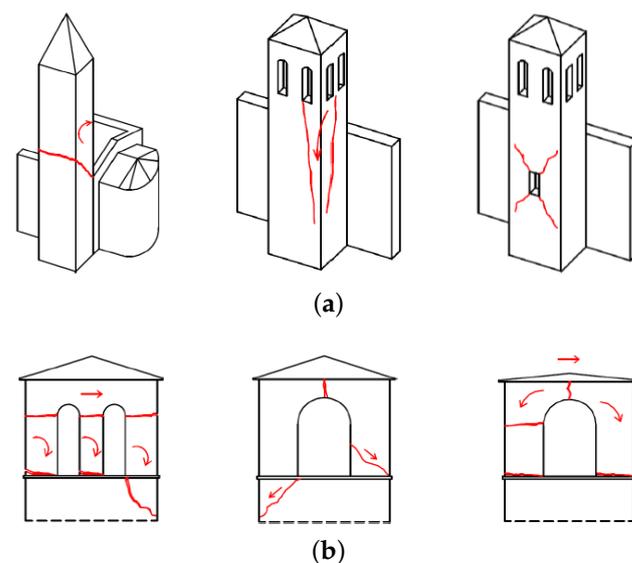
Figure 1. Collapse mechanisms: (a) tower stem; (b) tower top [16].

Field observations, after seismic events, reveal similar damage mechanisms, despite the uniqueness of each construction. The Italian Guidelines for Cultural Built Heritage [16] list the recurrent damage patterns for cultural buildings, driven by collapse mechanisms of different structural parts, named macro-elements, with independent behaviour [17,18], including MTs. Their recurring scenario consists of extended cracks, out-of-plane overturning and local collapse, see Figure 1.

The damage patterns occurs differently in the stem, Figure 1a, and at the top of the tower, Figure 1b.

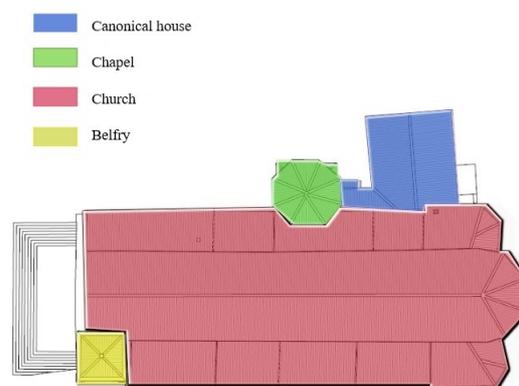
Figure 3. Plan of the building: the colors highlight the position of the structural elements.

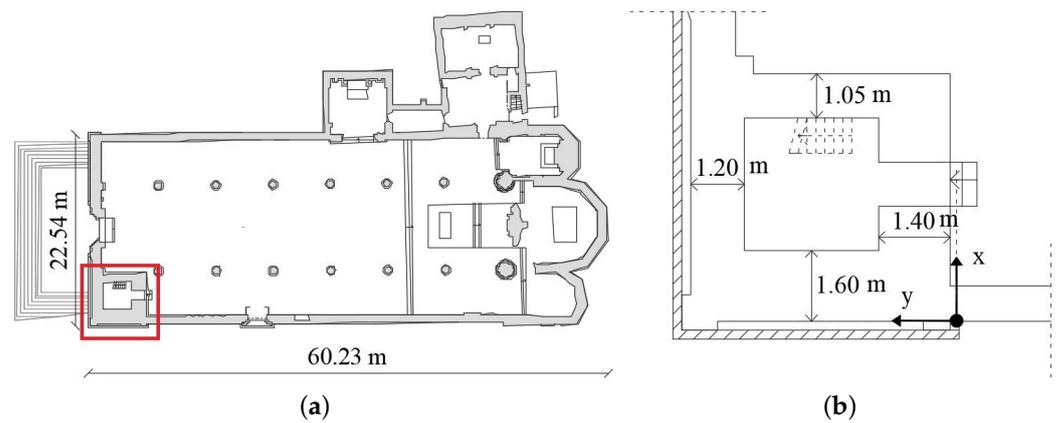
Figure 6. (a) Plan of the church: the red rectangle indicates the belfry; (b) Cross-section of the masonry tower.

Currently, the building exhibits the main features of medieval architecture. The church has a 60.23 m by 22.54 m rectangular plan, Figure 6. The interior consists of three naves: the length of the central nave is two times the length of the lateral ones.

The thickness of the belfry wall is not constant. It changes in correspondence with each wall: 1.05, 1.20, 1.40 and 1.60 m, Figure 6b. The belfry was erected using rubble stone masonry with lime mortar, see Figure 8a. A different type of masonry constitutes the lateral walls, with semi-regular ashlar units, shown in Figure 8b, the so-called “Apparecchio Aquilano”.

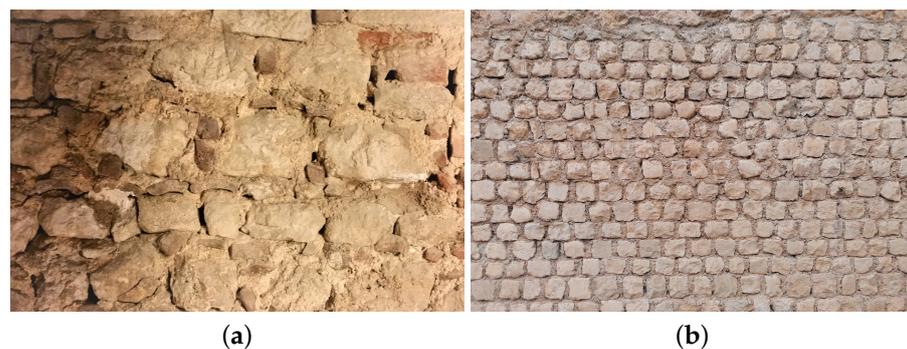
Figure 8. Texture of the masonry, after the restoration of the belfry (a) and of the nave wall (b).

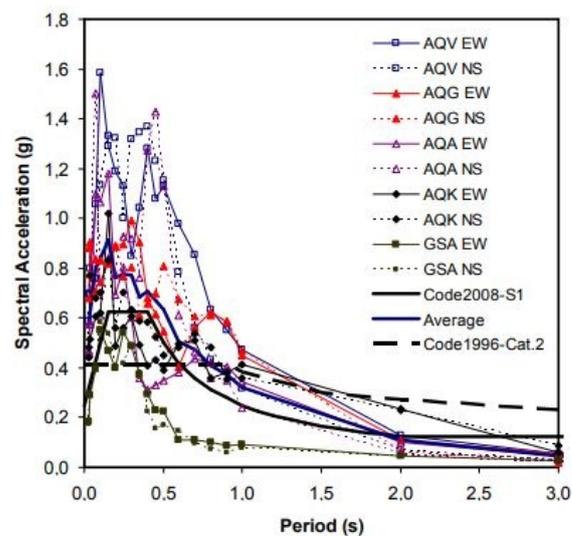
Figure 11. Response spectra of the records from 5 stations for damping and comparison with Normative code design spectrum [38].

On 6 April 2009, at 3.32 a.m., an earthquake with $M_w = 6.3$ struck L’Aquila and the central Apennines. The epicentre was located 10 km west of L’Aquila and 95 km east of Rome. The earthquake originated from the motion of a normal fault in the North-South direction [37]. The main-shock was the third earthquake event by intensity, occurred in Italy since 1972, after the Friuli event, recorded in 1976 with $M_w = 6.4$, and the Irpinia event, recorded in 1980 with $M_w = 6.9$. The response spectral acceleration of the records of the earthquake is reported in Figure 11.

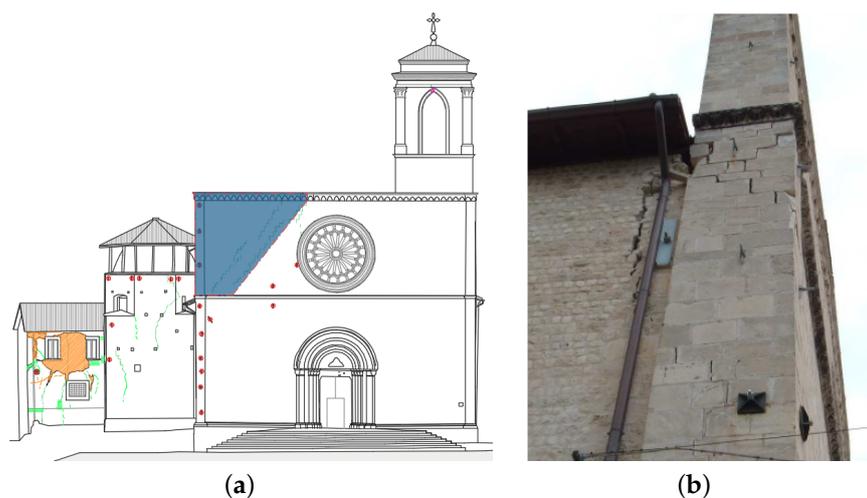
Figure 12. (a) Observed collapse mechanisms of the St.Silvestro facade; (b) External view of the cracks, taken by Fine Art Authority.

The 2009 earthquake highlighted the vulnerabilities of the complex. The most compromised parts were the facade and the belfry. The facade suffered damage, originated from the asymmetrical structural configuration, due to the presence of the belfry on the right side. The gable showed incipient overturning in the unrestrained side, indicated in blue in Figure 12a. The upper part of the facade, on the left side, is free of constraints and was prone to overturning. Nevertheless, the presence of a few retaining ties avoided the collapse, see Figure 12b.

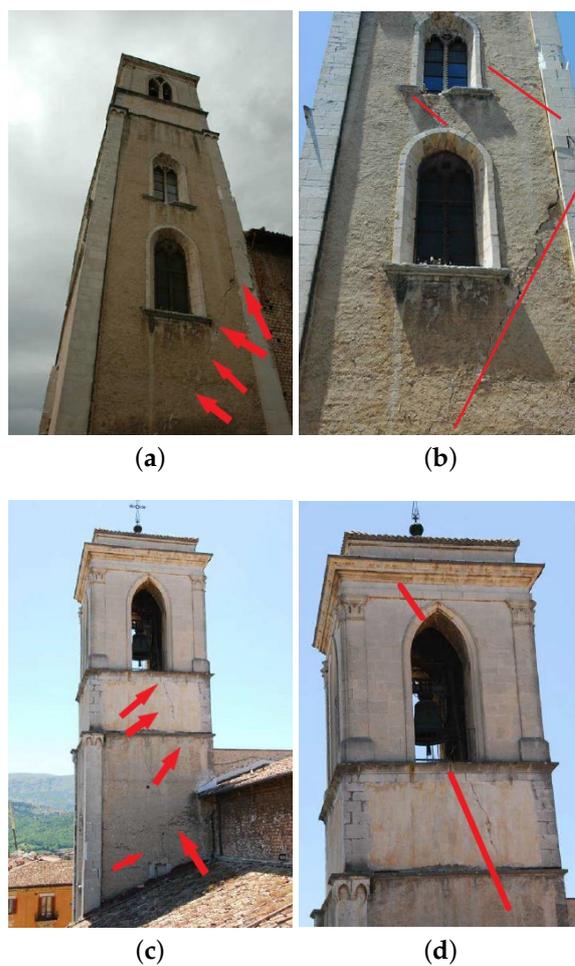
Figure 13. Views of the St.Silvestro belfry after the 2009 earthquakes: red lines and arrows points out the damage pattern (taken by Fine Art Authority): (a,b) cracks pattern along the stem of the belfry; (c,d) cracks pattern along the stem of the bell cell.

The bell tower exhibited extended cracks originated from diverse overturning mechanisms which can be recognised from the direct observation of the damage pattern, see Figure 13.

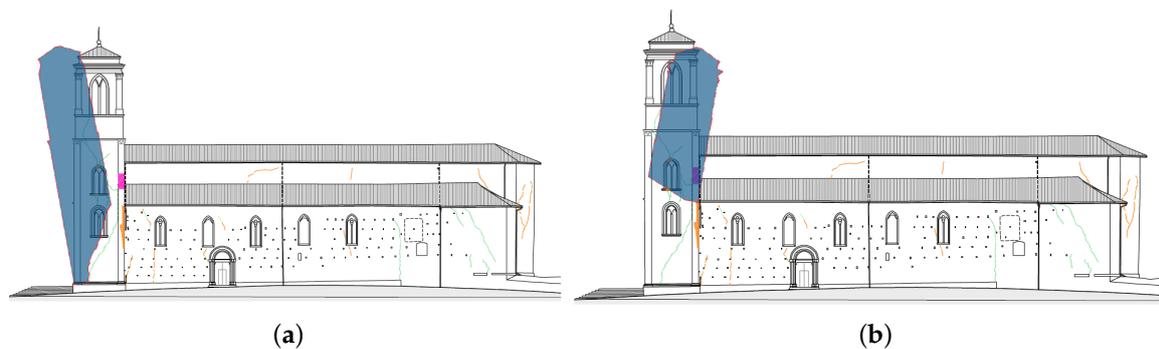
Figure 14. Observed collapse mechanism of the St. Silvestro belfry: (a) The first overturning; (b) The second overturning.

The first mechanism affected the entire belfry, which pivoted around a cylindrical hinge located at the base, depicted in Figure 14a. The second mechanism involved the upper part of the belfry, which pivoted around a cylindrical hinge at 10.20 m, as pictured in Figure 14b.

Both mechanisms caused severe diagonal cracks. The lack of connections among different structural parts gave rise to local mechanisms also in other components of the monumental complex.

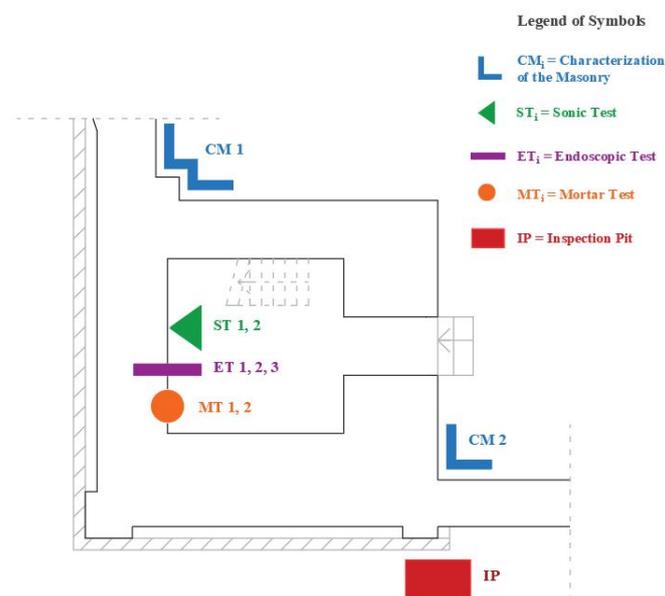
Figure 15. Plan of the diagnostic tests on the belfry.

After the 2009 earthquake, the Fine Art Authority carried out a non-destructive testing campaign to enhance structural knowledge. Regarding the belfry, Figure 15 illustrates the locations of the tests.

The endoscopy technique manifested the arrangement of the masonry units inside the wall, in three different locations: 2.5 m (Endoscopic Test ET1), 8.5 m (Endoscopic Test ET2) and 14.5 m (Endoscopic Test ET3), measured from the floor of the belfry. Masonry consists of irregular units, in local stone, arranged with mortar heterogeneously. According to the results of the three chemical-physical analysis (Chemical-Physical Analysis CPA1, CPA2, CPA3, in the points illustrated in Figure 15), the mortar composition consists of calcareous aggregate, with a negligible silica fraction, and a hydraulic binder, with a small aerial fraction. The sonic investigation technique allowed a more deep characterization of

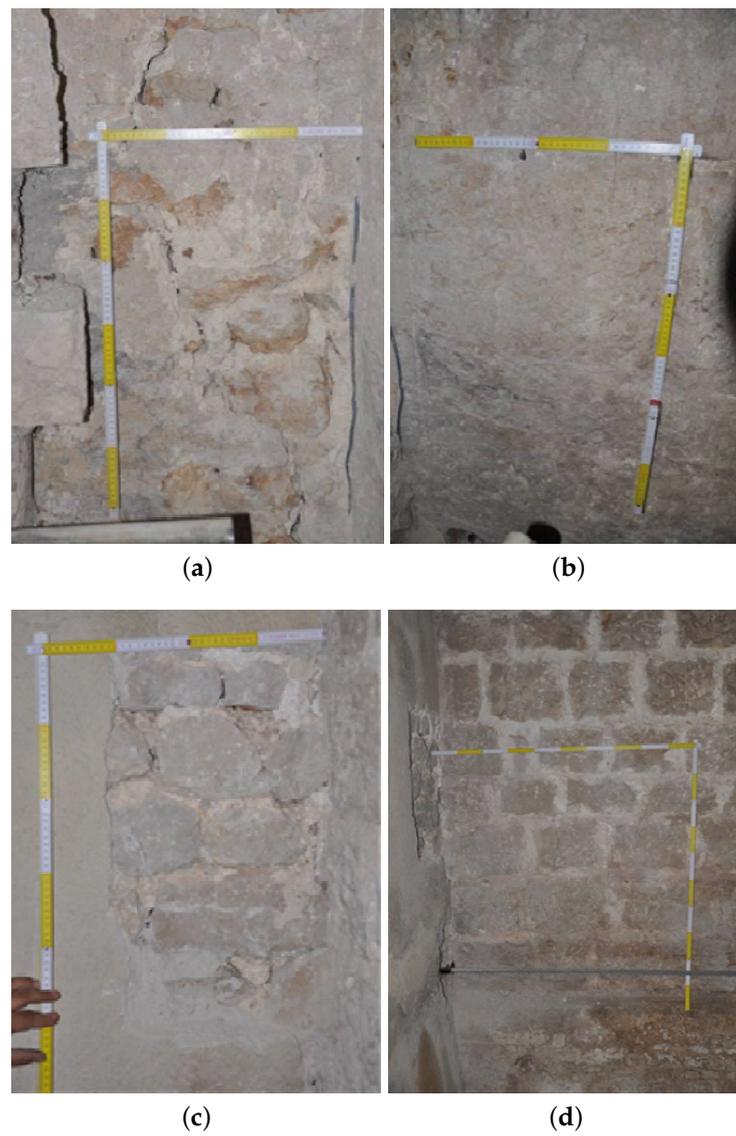
Figure 16. Characterization of the masonry surveys: (a,b) views of the first test, CS1; (c,d) views of the second test, CS2, taken by Fine Art Authority.

Two visual inspections, called CS1 and CS2, are carried out to characterize the connection between different structural parts. The investigations highlighted the lack of the connection between the belfry and the adjacent building: the photos Figure 16a,b show the different textures of the facade and the belfry wall (CS1), Figure 16c,d the nave wall and the belfry wall (CS2).

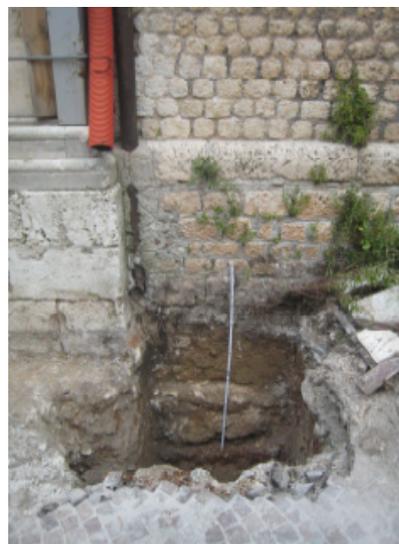
Figure 17. Photo of the inspection Pit, IP, near the foundation of the belfry, taken by Fine Art Authority.

An inspection pit IP, see Figure 17, investigated the foundation of the belfry: it consists of squared unit stones, nearly 0.6 m high.

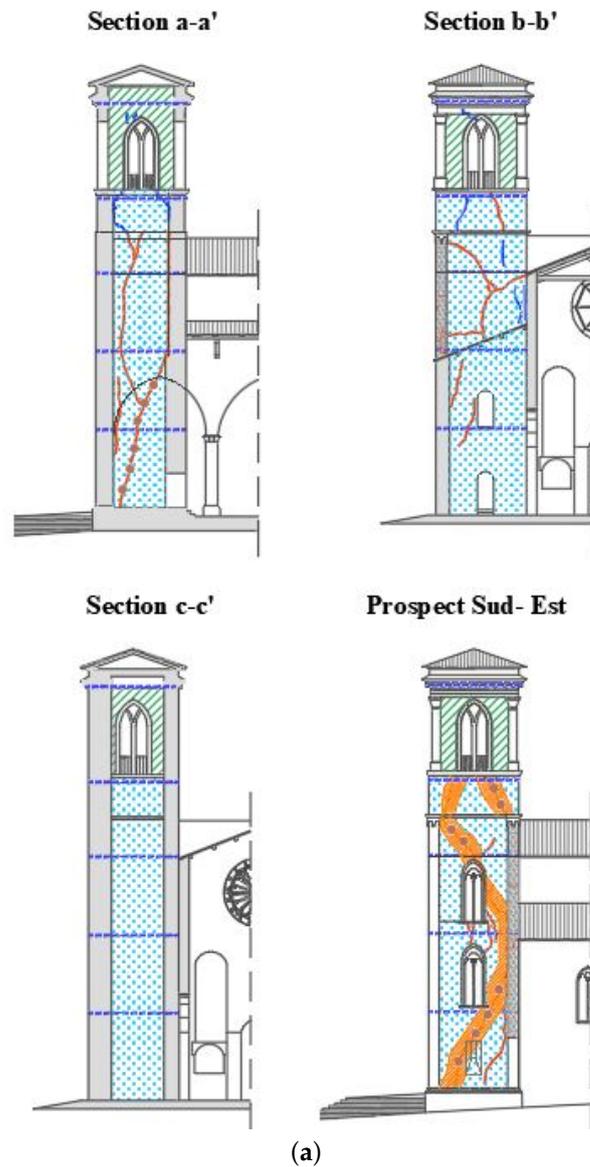
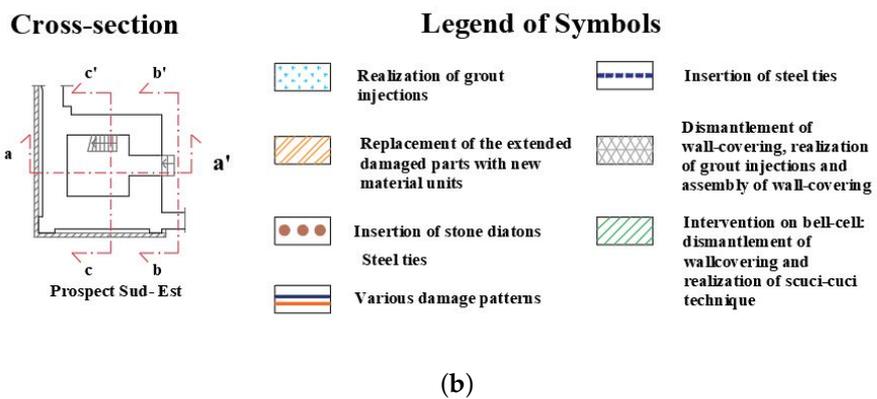
Figure 18. Restoration of the St.Silvestro belfry: (a) Representation of the restoration measure; (b) Cross-section and legend.

The rehabilitation interventions attempted to increase the overall structural response by preventing local collapse mechanisms. Specifically, the belfry was repaired differently, depending on the severity of the damage. The use of mortar injections allowed the repair of the more superficial cracks. The parts with extensive damage were replaced with new bricks. Stone diatons reinforced the wider cracks, by connecting the rupture surfaces, and improved the friction resistance among the masonry units. Expectedly, the reinforcement enhanced the global structural behaviour of the tower, primarily due to the contribution of the steel rods which connected the walls between each other. Furthermore, the grout injections improved the overall mechanical performance of the masonry. The brief descriptions of the interventions on the belfry are depicted in Figure 18.

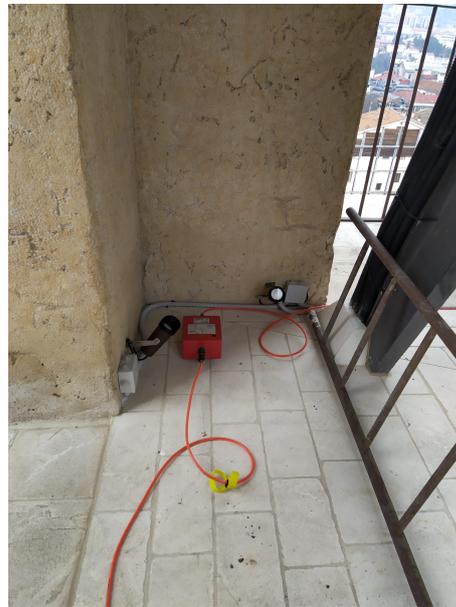
Figure 19. Accelerometer placed on the top of the bell tower, at the height of 22.03 m.

A set of 10 Force-Balance mono-axial accelerometers (SARA Instruments SA10) was used, see Figure 19. The accelerometers are characterized by a dynamic range higher than 165 dB in the frequency interval 0.1–20 Hz and a 5 V/g sensitivity. The authors used two measurements chains for the acquisition system, each one driven by a master recorder unit, synchronized by a GPS sensor.

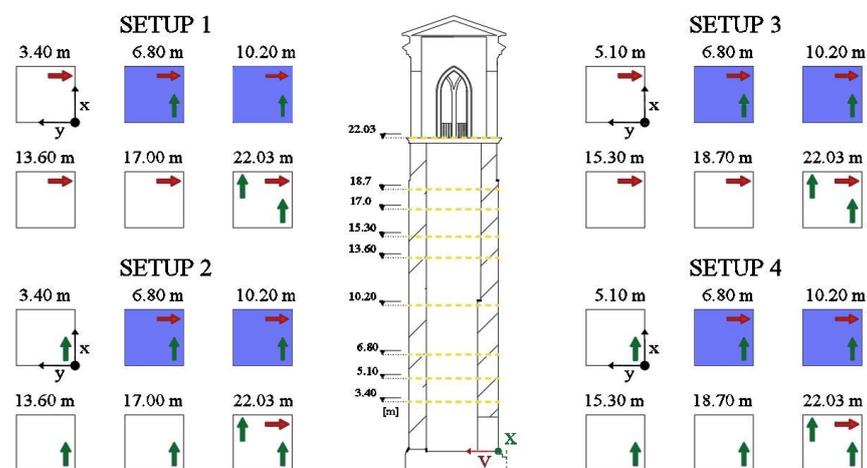
Figure 20. Illustration of the four experimental setups with the measuring directions: the sections filled in blue indicate the accelerometers with the same disposition for each setup.

Figure 20 shows the four setups used during the test: the disposition of the measurement axes of the accelerometers is indicated by arrows, green and red, respectively for the X and Y directions. In the current setups, the position of two accelerometers remained fixed (at the height of 6.80 m and 10.20 m), providing a reference location in the two orthogonal directions. Their position is highlighted in blue in Figure 20. The remaining eight accelerometers were located in the other levels, as represented in Figure 20, changing the disposition of the measurement axis. The features of the belfry and the impracticality of installing devices to support the accelerometers led to the chosen measurement points.

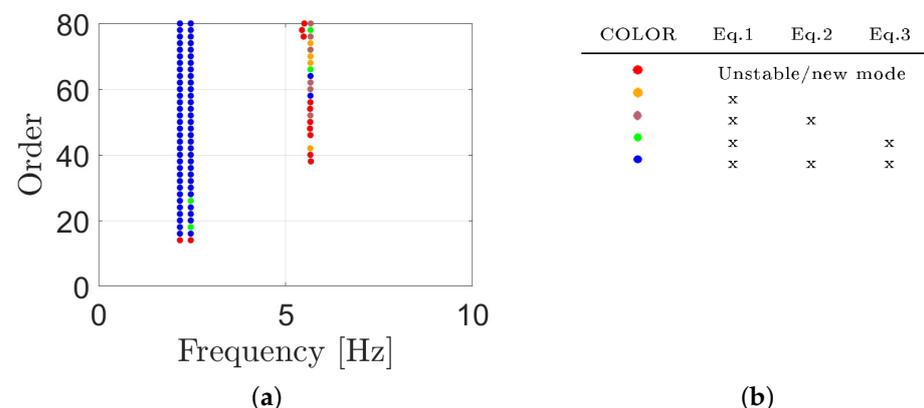
Figure 21. (a) Stabilization diagram obtained from SSI-cov analysis; (b) Legend of the colors.

Unfortunately, the ambient excitation did not sufficiently excite the upper modes: the complex is located in a traffic-free zone, leading to a low ambient excitation level. Only two modes, described in Table 2, arose clearly from the stabilization diagram, which is reported in Figure 21a. The experimental results were quite satisfactory: the Modal Phase Collinearity values, MPC, were equal to 0.91 and 0.86, respectively.

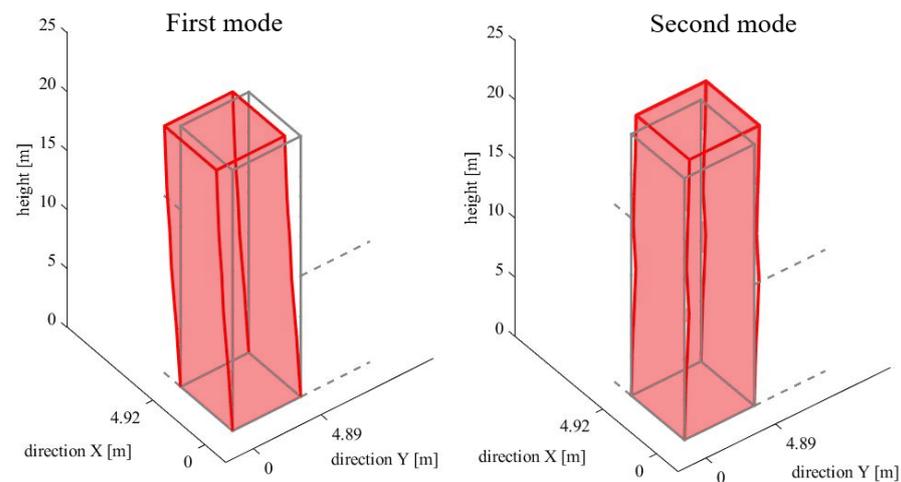
Figure 22. Experimental mode shapes.

The modes are translational in two orthogonal directions, see Figure 22.

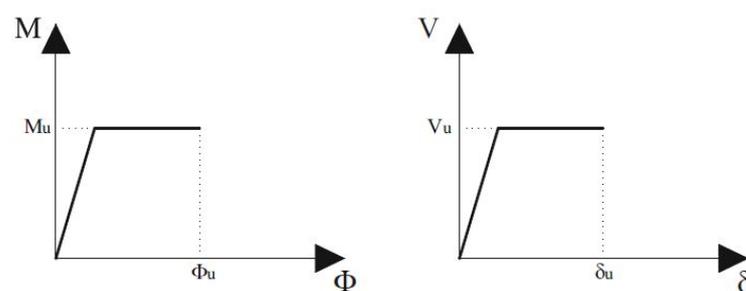
Figure 23. Plastic hinge law for masonry elements.

Numerical analyses were carried out to assess the dynamic response of the belfry. Specifically, the authors developed a Finite Element (FE) model, using an equivalent frame model, implemented in SAP2000, a software package user-friendly interface widely used for seismic analysis. The experimental results pointed out a global behaviour of the belfry, justifying the development a global model. The Finite Element model, based on a simplified modelling approach, ensures good results for global analysis of masonry structures in the nonlinear field [45,46], allowing also to reduce the computational costs of nonlinear analyses. The chosen approach consists in modelling each masonry wall with an equivalent frame, connected each other by rigid links. The reliability of this modelling approach was investigated by several scholars, also in the case of historical structures [47–49]. The nonlinear mechanical behaviour descends from a so-called lumped plasticity approach [50]. The walls are modeled as elasto-plastic with two rocking hinges, located at the ends of each frame, and a shear hinge, located at the mid-height. The masonry elements may exhibit in-plane failure for bending-rocking and shear sliding mechanisms: the constitutive law is represented in Figure 23.

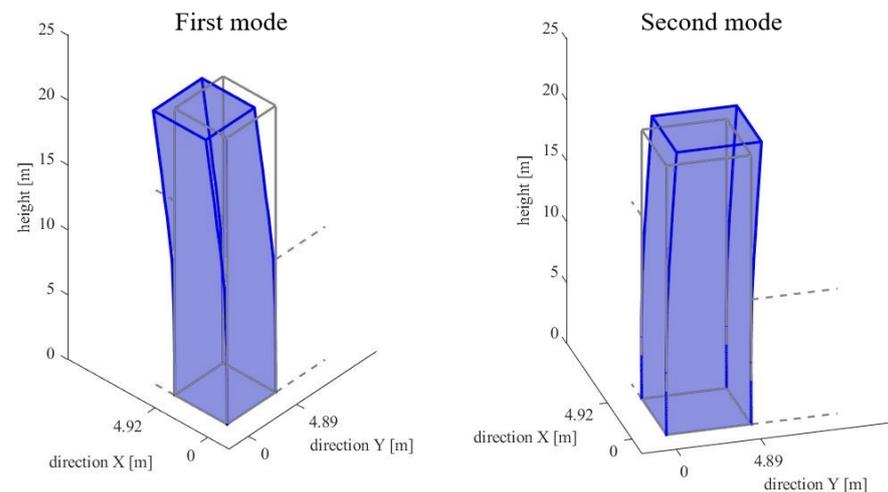
Figure 24. Numerical shapes after the model updating.

Figure 24 illustrates the translational modes revealed by the numerical analysis after the model updating.

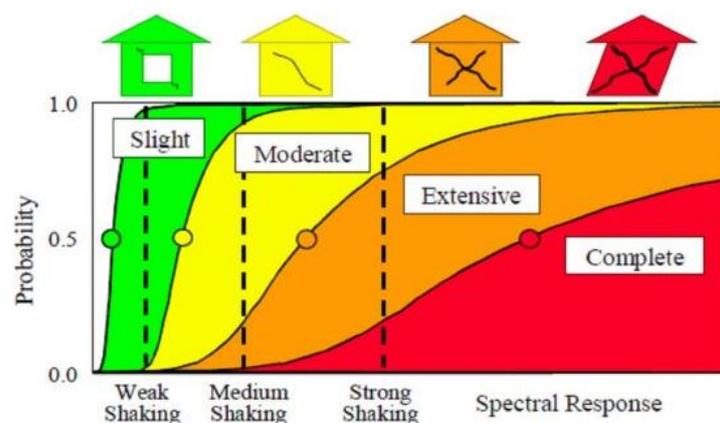
Figure 26. Example of a fragility functions, as reported in FEMA.

A fragility function (Figure 26) specifies the probability of collapse of a structure, or the probability to attain other limit states of interest, depending upon a certain ground motion Intensity Measure IM [56], which, in this paper, is the Peak Ground Acceleration PGA. For a given set of ground motion and dynamic structural analysis results, the occurrence or non occurrence of collapse is defined by the exceed of a given displacement.

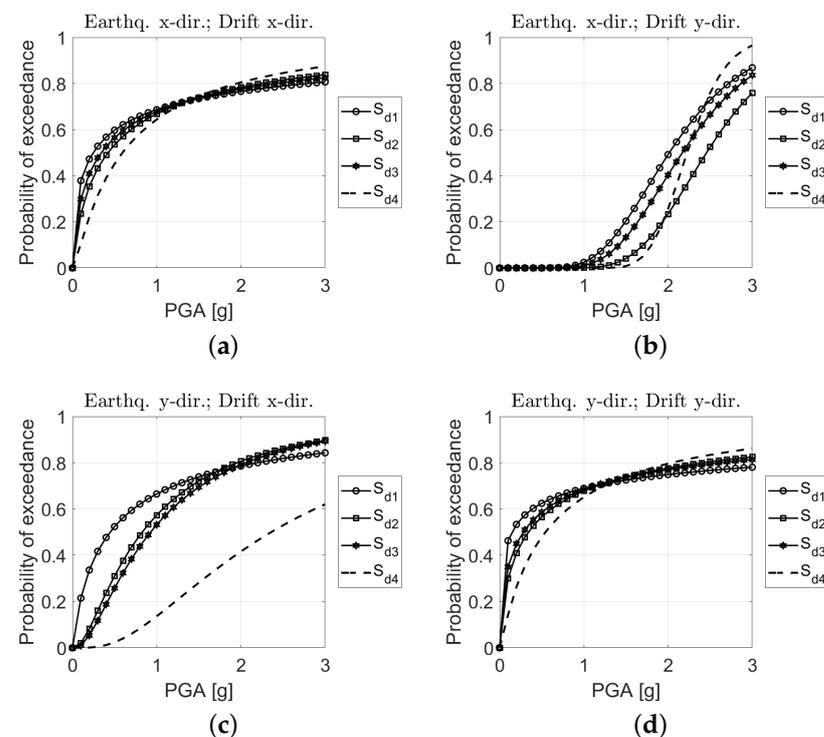
Figure 27. Fragility curves of the masonry tower based on numerical results: (a) Earthquake in X direction, drift in X direction; (b) Earthquake in X direction, drift in Y direction; (c) Earthquake in Y direction, drift in X direction; (d) Earthquake in Y direction, drift in Y direction.

Figure 27 shows the fragility curves obtained from the above procedure. The X-direction is more vulnerable than the Y-direction. The earthquake action yields significant drifts in each direction of application, see Figure 27a,b. Conversely, the drifts are negligible in the perpendicular direction and give lower failure probabilities, see Figure 27c,d. As already discussed, the restoration works not affected the walls homogeneously, leading to different mechanical parameters of the masonry of the wall in the two directions. Moreover, the openings are different in terms of position and size in the two directions, influencing the in-plane capacity of the walls. Conclusively, the horizontal restraint offered by the surrounding building is not the same for the facade and nave wall. This evidence lead to the difference of collapse probabilities in the two directions.
