# Experimental Study on the Performance of Glass/Basalt Fiber Reinforced Concrete Unidirectional Plate under Impact Load

**Abstract:** Fiber-reinforced composite materials have emerged as essential solutions for addressing the durability challenges of traditional reinforced concrete, owing to their lightweight nature, high strength, ease of construction, superior tensile capacity, robust corrosion resistance, and excellent electromagnetic insulation properties. This paper delves into the influence of loading rate and fiber bar type on the mechanical characteristics of concrete one-way plates through impact experiments on such plates fitted with glass/basalt fiber bars at varying drop weight heights. The test results reveal a direct correlation between increasing loading rates and escalating damage in fiber-reinforced concrete one-way plates, reflected in the progressive rise in peak deflection and residual displacement at the mid-span of the specimens. Notably, when subjected to higher impact loads, glass fiber-reinforced concrete specimens exhibit amplified deformation and intricate crack formations, consequently diminishing the overall deformation resistance of the plate. Furthe

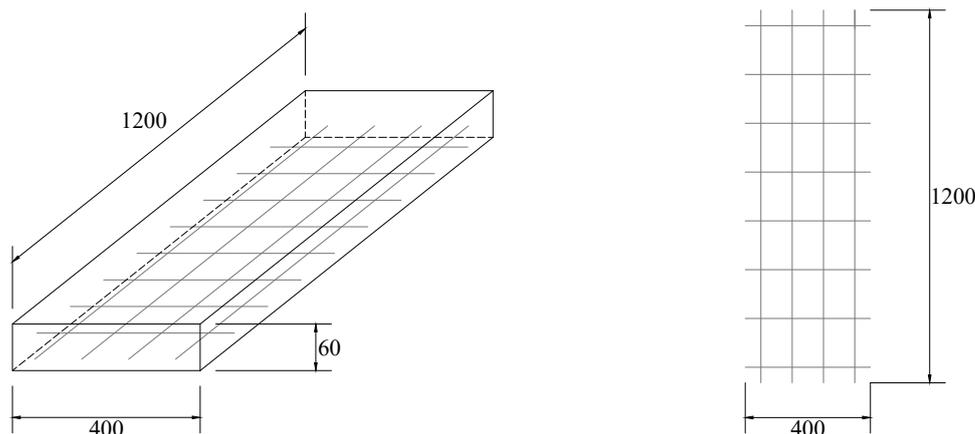
**Figure 1.** One-way plate dimensions and reinforcement diagram.

The specimens were categorized into two height groups, each consisting of three specimens, for impact testing. Glass and basalt fiber-reinforced specimens were subjected to impact testing at heights of 0.25 m, 0.5 m, and 1 m, aimed at assessing the performance of fiber-reinforced concrete under impact loads and elucidating the mechanical response of glass and basalt fiber reinforcements under varying conditions. This study investigated the failure mode and dynamic response characteristics of fiber-reinforced concrete one-way plates under falling weight impact loads, focusing on two key variables: the material of the tensile longitudinal bars and the height of the impact. Detailed parameters of the specimens can be found in Table 2.

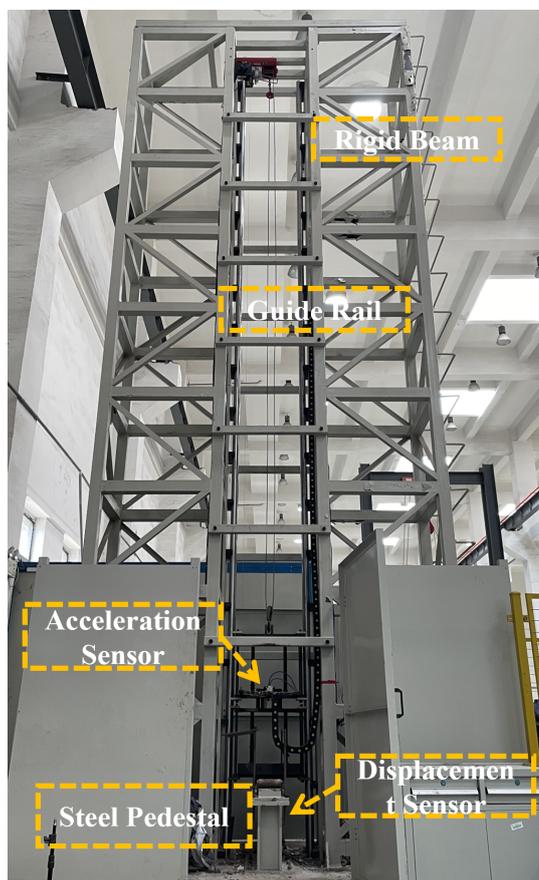
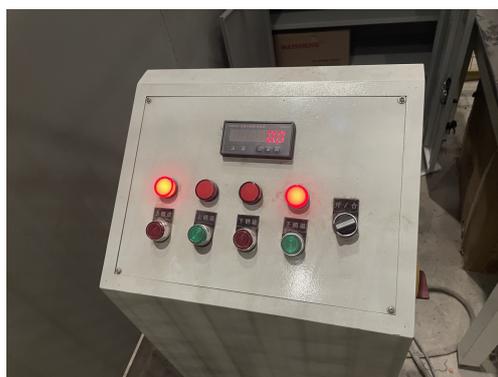
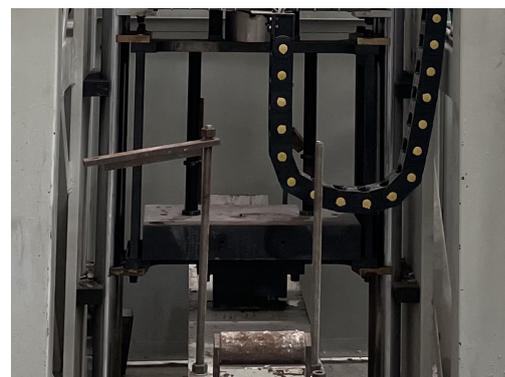
(a) Drop weight impact test loading device

(b) Hammer head control and lifting device

(c) Adjustable weighted drop weight

**Figure 2.** Drop weight impact test device.

The impact test was conducted using a drop weight impact testing machine, comprising essential components such as rigid beams, guide rails, release mechanisms, drop

weights, hammer head control and lifting devices, as well as steel pedestals. The hammer head's maximum release height is 7.5 m, and its weight can be adjusted from 50 kg to 300 kg. This machine utilizes an electromagnet release system, activated by a button on the hammer head control and lifting device, as depicted in Figure 2. For the experiments detailed in this section, a 100 kg hammer head was used to apply a concentrated load at the mid-span of the beam body.

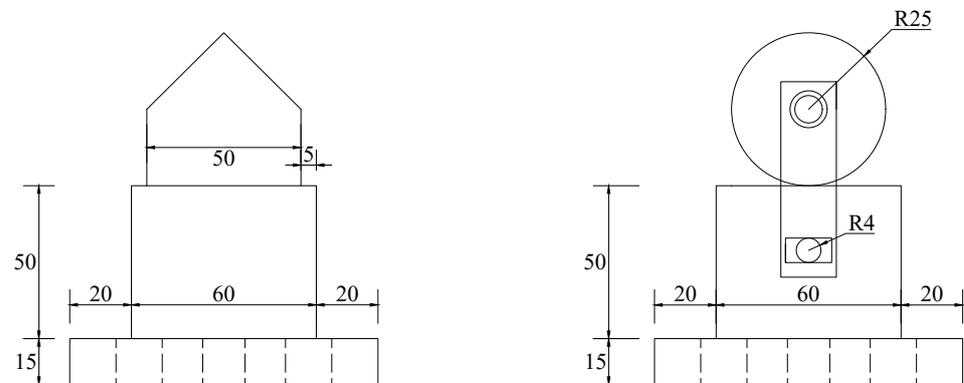
**Figure 3.** Bearing details.

The beam support is composed of a knife-edge support and a roller support. It adopts a two-section simply supported support. The detailed diagram of the support is shown in Figure 3. After the fiber-reinforced one-way plate is erected on the support, adjust the position of the plate so that the mid-span of the plate is parallel to the rigid base. Use a

pressure beam device composed of nuts and two rods to fix both ends of the plate on the support to prevent. During the impact of the falling weight, the specimen bounces off the support, causing test errors.

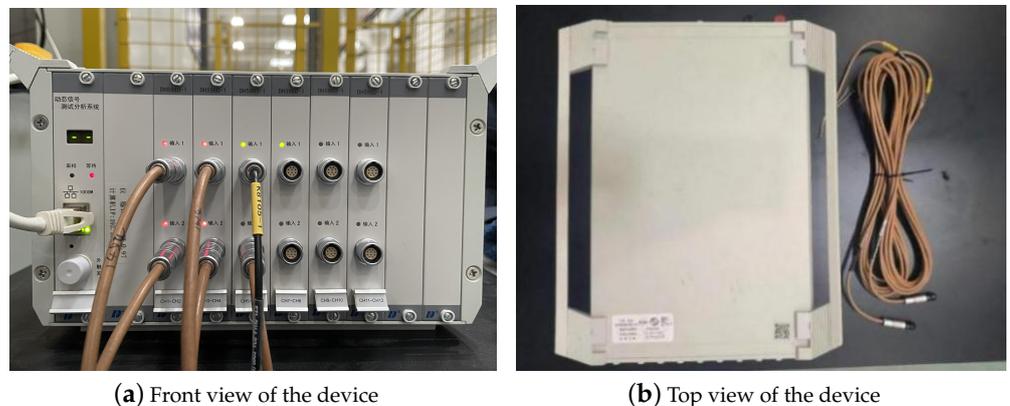
**Figure 4.** Hyperdynamic signal testing and analysis system.

The impact test data was gathered using the ultra-dynamic signal test analysis system DH-5960 manufactured by Jiangsu Donghua Testing Technology Co., Ltd., Jingjiang, China. This multi-channel system can simultaneously capture acceleration, displacement, strain, and other relevant data. The acquisition equipment setup is depicted in Figure 4, showcasing a sampling frequency of 100 kHz for this experiment. Specifically, four channels were dedicated to measuring plate and plate side strains, five channels for acceleration readings, and six channels for mid-span deflection of the specimen beam. Uniform sampling frequencies were applied across all channels.

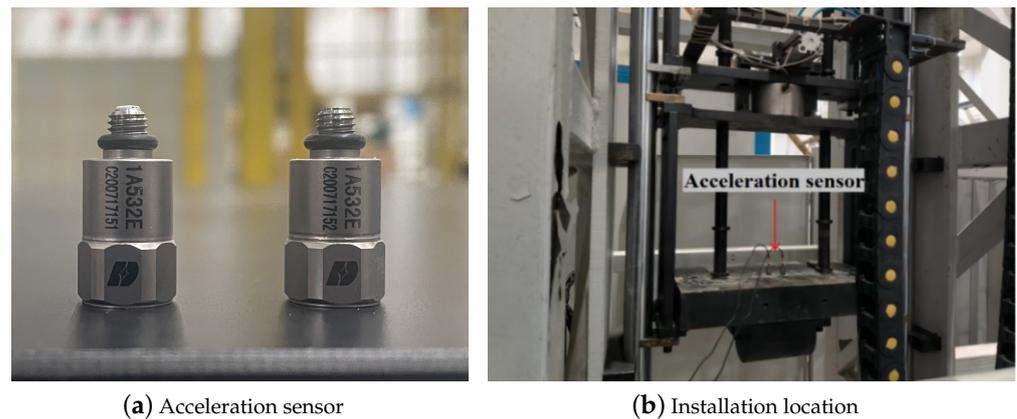
**Figure 5.** Acceleration sensor.

Acceleration data is obtained through an IEPE piezoelectric acceleration sensor, model 1A532E, manufactured by Jiangsu Donghua Testing Technology Co., Ltd., capable of measuring within the range of  $\pm 10,000$  g. Positioned at the center of the hammer head, the sensor gasket is affixed using epoxy resin glue. Once the glue cures, the sensor can be properly oriented and secured. The installation of the acceleration sensor is depicted in Figure 5.

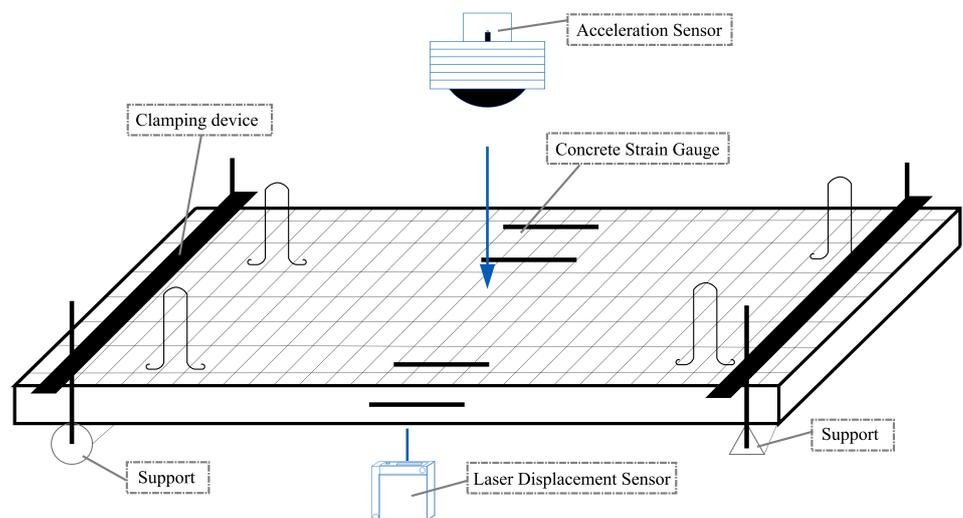
**Figure 6.** Sensor layout diagram.

The primary data gathered in the drop weight impact test encompass the acceleration of the hammer head, the mid-span deflection of the test plate, and the concrete strain on both the plate and its side. Figure 6 illustrates the schematic layout of each sensor. Acceleration is monitored using acceleration sensors, while mid-span deflection is assessed through laser displacement sensors. The entire dataset is captured and processed by the ultra-dynamic signal testing and analysis system.

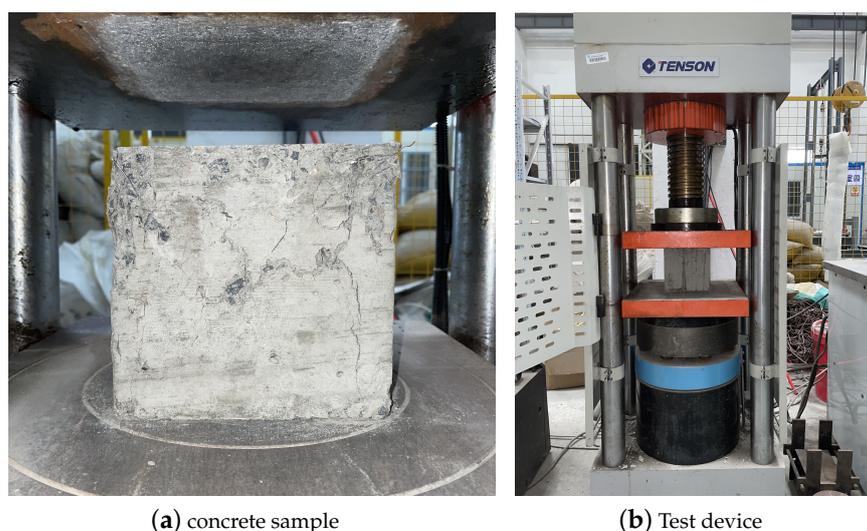
Figure 7. Concrete compressive strength test.

To investigate the material's mechanical properties thoroughly, this study conducted tests on the cubic compressive strength and axial compressive strength of concrete test blocks. Concrete beams were cast for each working condition, and three sides with a length of 150 mm were simultaneously prepared. The cube test blocks were cured for 28 days following the standard procedure. Testing was performed using an electronic universal pressure testing machine from Jinan Tianchen Testing Machine Manufacturing Co., Ltd. (Jinan, China), with consideration given to ensuring test accuracy by averaging the results, as depicted in Figure 7. Three test blocks of each age were tested and the average value was taken and 0.76 times the concrete cube compressive strength value was taken as the concrete axial compressive strength. The test results are shown in Table 3.

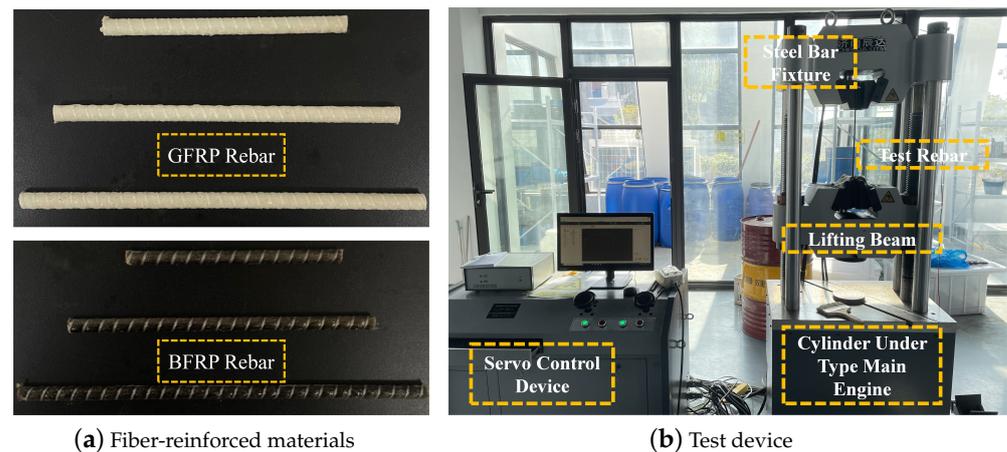
**Figure 8.** Tensile test of fiber-reinforced materials.

Glass fiber rebar and basalt fiber rebar are fabricated using glass fiber or basalt fiber as reinforced material, coupled with high-performance resin and high-strength fiber through a pultrusion process. In comparison to traditional steel rebar, they exhibit superior tensile properties, are lightweight, high-strength, corrosion-resistant [21,31], easy to cut, and non-magnetic. The tensile tests were conducted using the WAW – 600D microcomputer-controlled electro-hydraulic servo hydraulic universal testing machine from Jinan Chenda Testing Machine Manufacturing Co., Ltd. (Jinan, China), resulting in measured tensile strengths of 896 MPa for glass fiber bars and 883 MPa for basalt fiber bars. The tensile test of the fiber-reinforced material is depicted in Figure 8, with the mechanical property test outcomes detailed in Table 4.

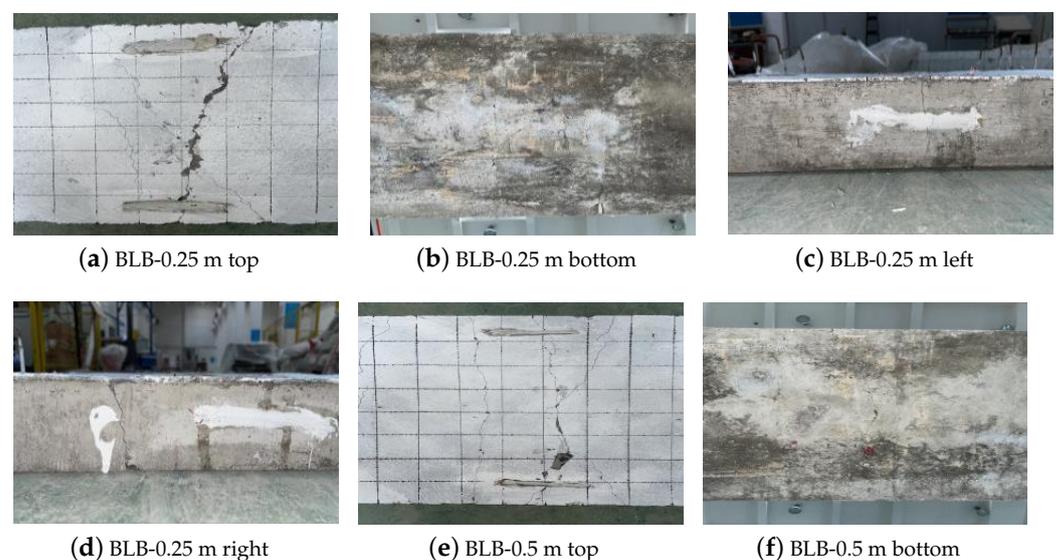
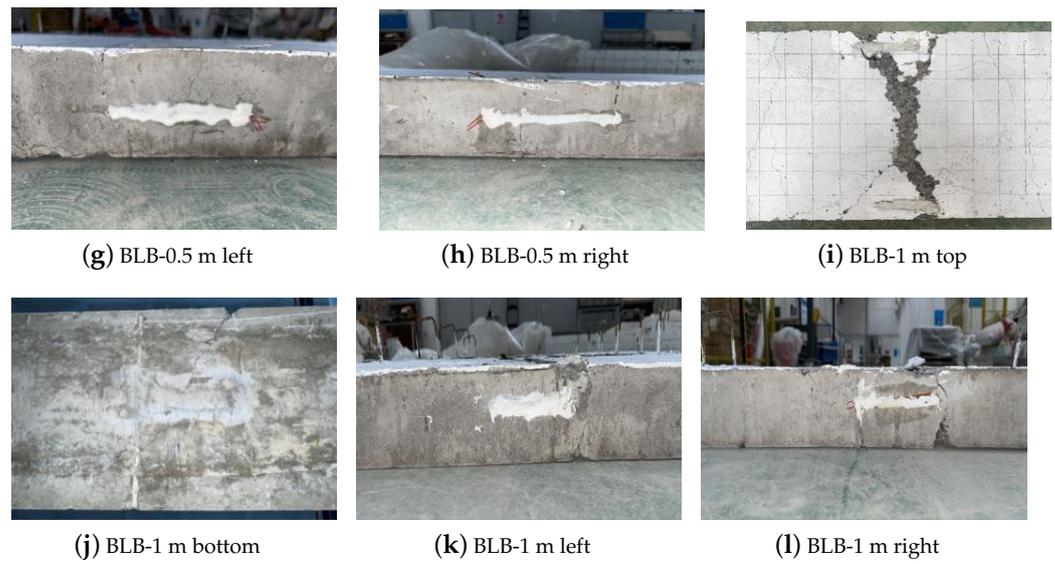
**Figure 9.** Failure pattern of glass fiber-reinforced concrete one-way plate.

The experimental findings in this paper delineate the damage characteristics of the test specimens. During the impact test, all six fiber-reinforced concrete one-way plates exhibited bending damage, with failure patterns detailed in Figures 9 and 10. When utilizing the same type of fiber reinforcement, the degree of damage to the one-way plates gradually increased as the height of the falling weight escalated. Notably, at drop heights of 0.25 m and 0.5 m, the glass/basalt fiber bar specimens exhibited slight damage, with relatively narrow cracks along the mid-span and sides of the plates and only a few perpendicular tiny cracks on the surface at the mid-span impact zone. However, at a drop height of 1 m, the damage level significantly intensified, manifesting in pronounced bending of the plates, concrete breakage, cracks, and fracture of fiber bars in the tension zone at the plate bottom.

Distinct failure modes emerged for glass and basalt fiber-reinforced plates under identical impact conditions. When subjected to a 1 m falling weight, the glass fiber-reinforced plate displayed cracks parallel to the long-side reinforcement, forming intricate networks of multiple fine cracks. In contrast, the basalt fiber-reinforced plate exhibited less prominent and fewer edge reinforcement direction cracks, yet wider perpendicular through cracks on the plate surface.

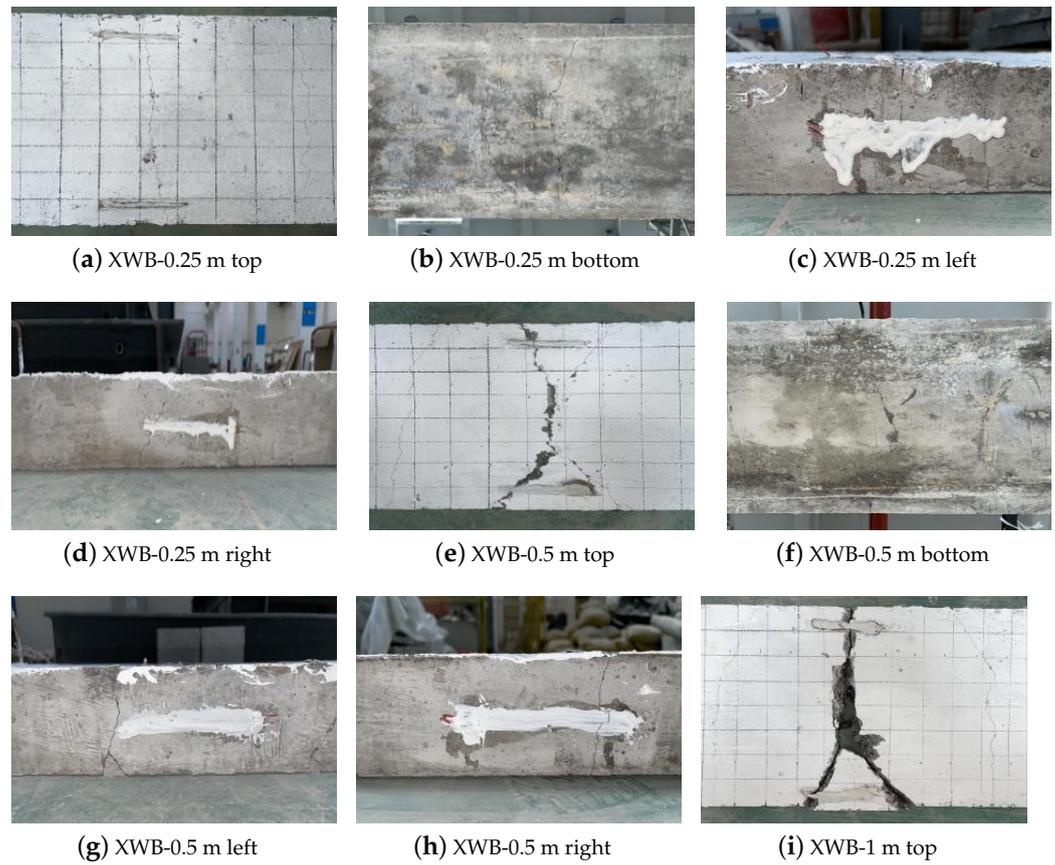
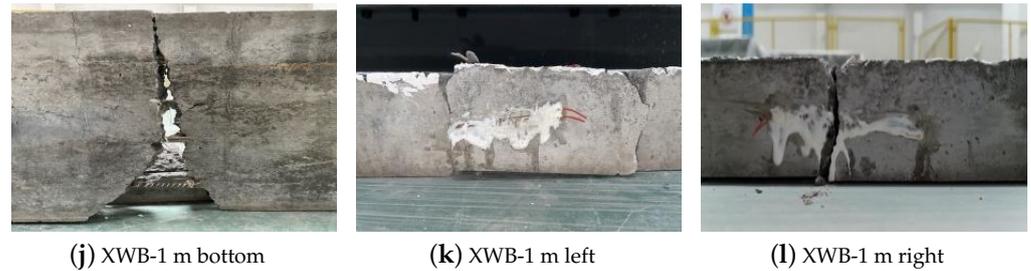
**Figure 10.** Failure pattern of basalt fiber-reinforced concrete one-way plate.

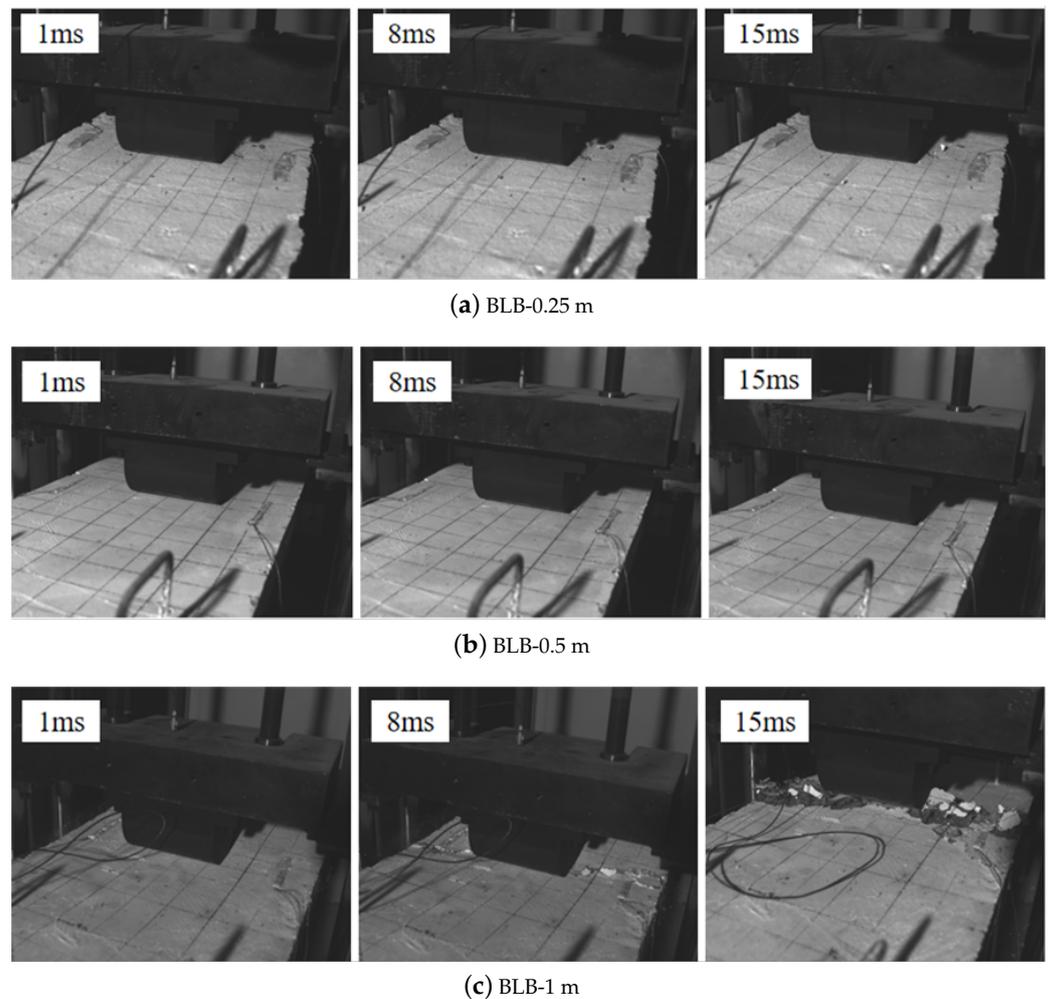
**Figure 11.** Failure process of glass fiber-reinforced concrete one-way plate.

The inherent characteristics of fiber bars, including poor shear resistance, limited elastic modulus, and absence of a clear yield point, contribute to the one-way plate's brittle failure behavior under impact loading. To comprehensively document the impact process, a high-speed camera was employed to capture key test phases, as depicted in Figures 11 and 12.

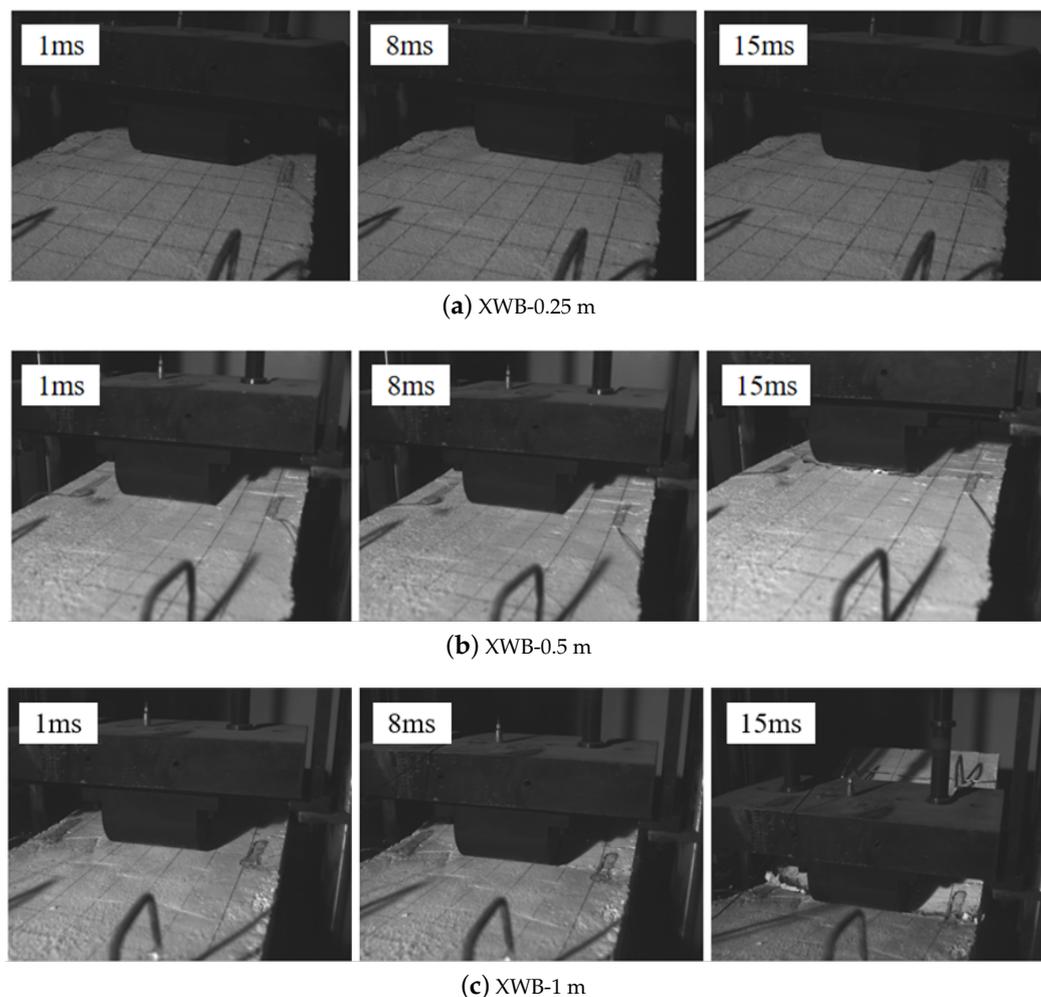
**Figure 12.** Failure process of basalt fiber-reinforced concrete one-way plate.

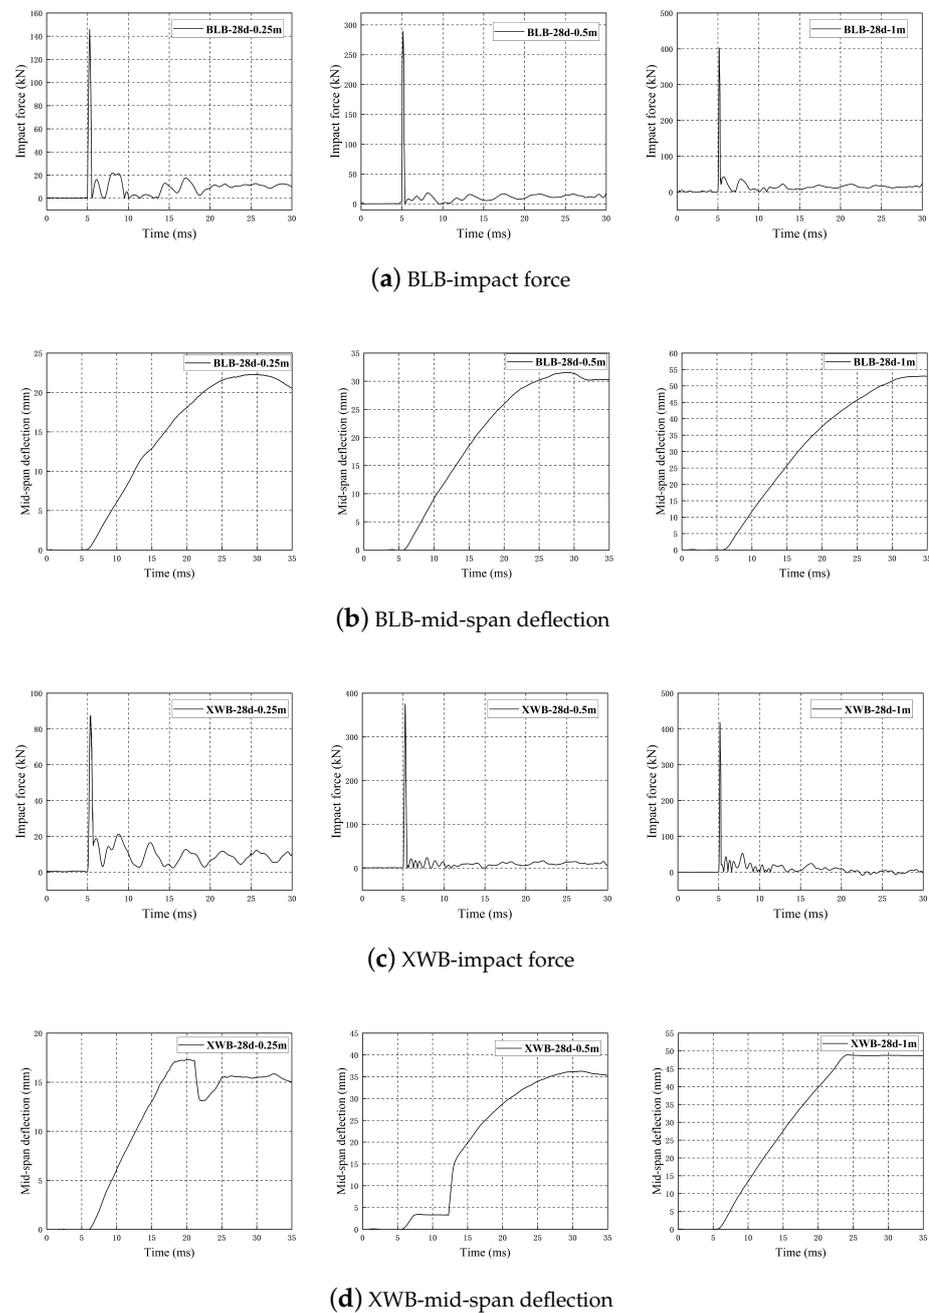
**Figure 13.** Impact force and mid-span deflection time history curves.

correcting any invalid distortion or instrument error values. Processed impact force and mid-span deflection time history curves are presented in Figure 13.

The impact test results of glass/basalt fiber-reinforced concrete one-way plates at various drop heights are detailed in Table 5. The analysis of the mid-span deflection time history curve and impact test outcomes reveals a direct relationship between the increase in drop weight impact height and the corresponding rise in mid-span deflection—a positive correlation exists between these variables. In general, glass fiber-reinforced concrete one-way plates exhibit superior impact deformation capabilities compared to basalt fiber-reinforced counterparts, as indicated by slightly greater mid-span deflection values. Moreover, the peak impact force demonstrates a positive correlation with the speed of the falling weight; an escalation in impact speed leads to a proportional increase in peak impact force. Notably, between drop heights of 0.25 m and 0.5 m, a distinct rebound

process is observable. However, at a height of 1 m, the fiber-reinforced concrete one-way plate undergoes concrete cracking in the compression zone and longitudinal reinforcement rupture in the tension zone, halting any rebound.

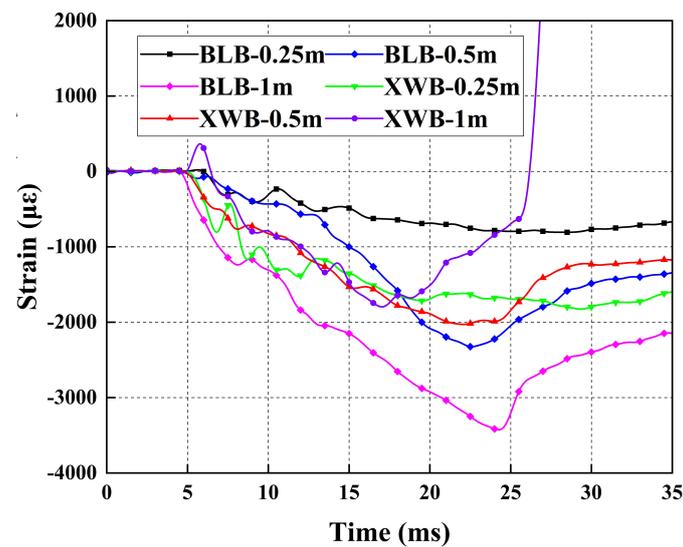
(a) Plate strain time history curve

As depicted in Figure 14a, all hybrid strain gauges on each one-way plate experience compression under impact loads, with strain values rising as the drop weight height increases. For drop heights of 0.25 m and 0.5 m, the strain in the one-way plate during low-speed impacts is generally lower. The increased height and speed of the falling weight under impact loading cause a corresponding rise in the concrete strain rate. The experimental findings corroborate this trend. Evaluation of strain values across different fiber-reinforced concrete one-way plates reveals higher strain levels in glass fiber-reinforced plates compared to basalt fiber-reinforced ones, indicating superior impact performance of glass fiber bars over basalt fiber bars.

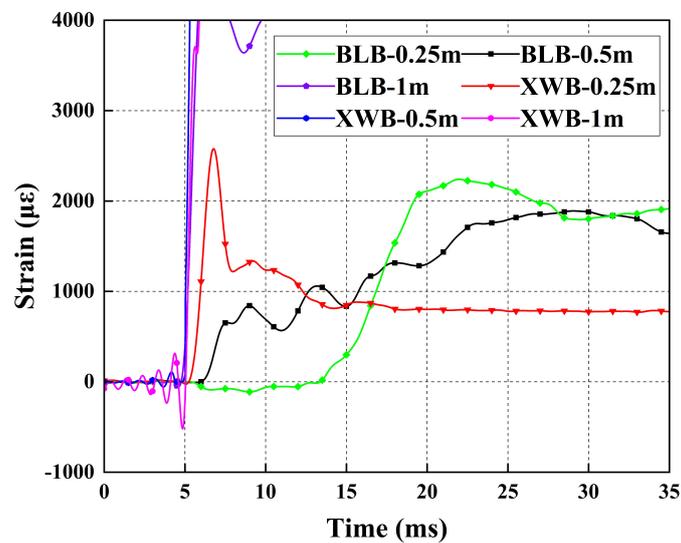
(b) Plate side strain time history curve

Figure 14b demonstrates a rapid rise in plate side strain of the fiber-reinforced one-way plate after 5 ms, followed by a decrease and stabilization. Despite some variations, the overall curve trends are similar. The one-way plate exhibits brittle failure under impact, with strain gauges on the side failing concurrently with concrete matrix cracking. Effective strain values within the initial 35 ms of contact with the drop hammer indicate positive values, signifying tension on the plate side. Increasing the drop height results in higher peak impact force and side plate strain values.

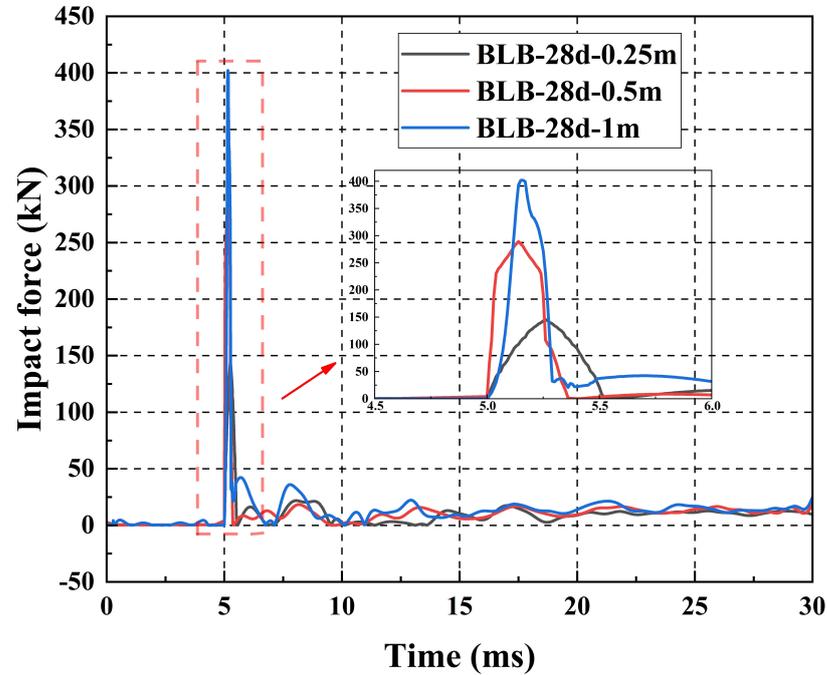
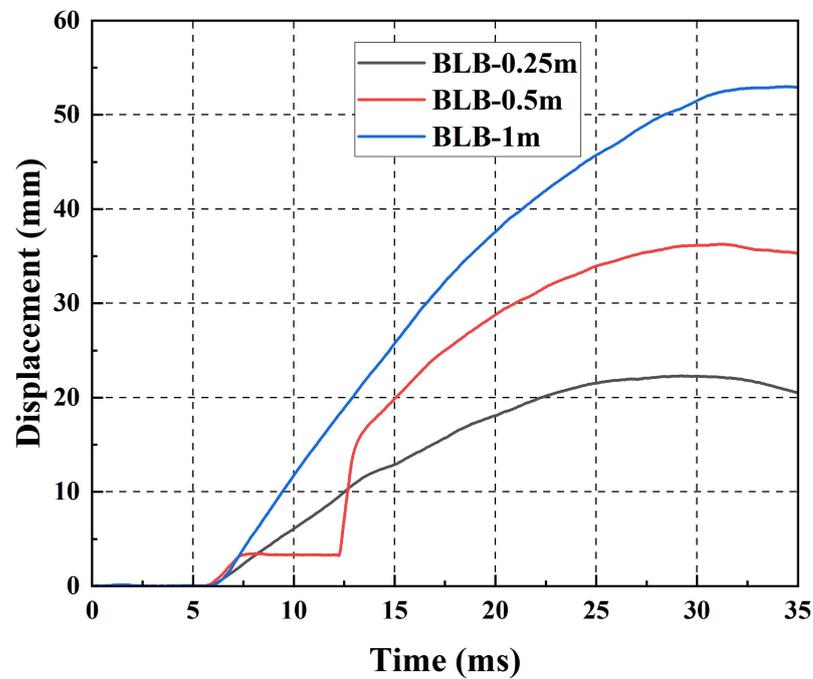
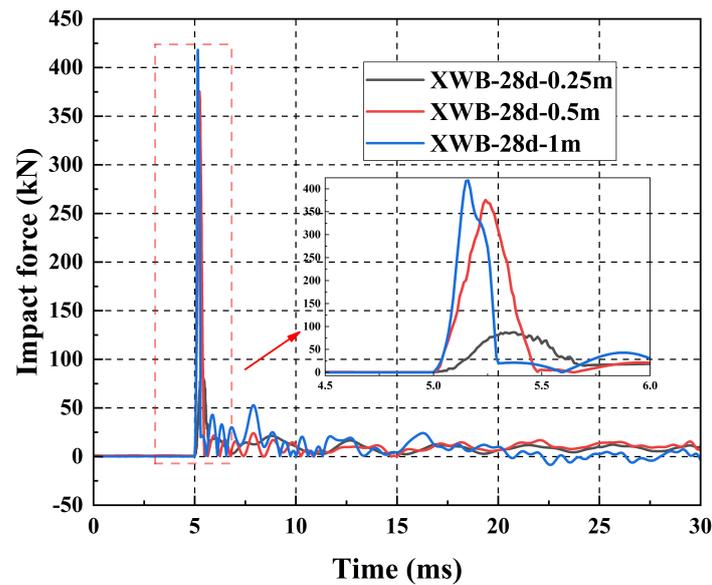
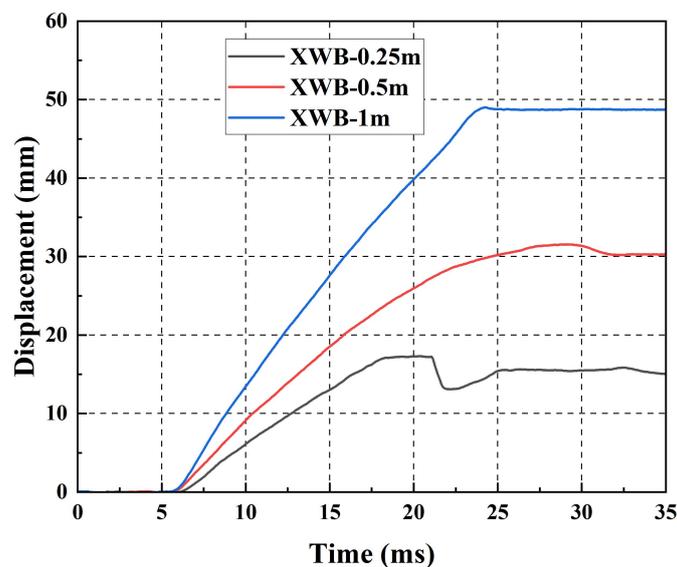
**Figure 15.** Comparison of impact force and mid-span deflection time history of different fiber reinforcement materials. (a) Impact force time history curve for glass fiber reinforcement material, (b) Mid-span deflection time history curve for glass fiber reinforcement material, (c) Impact force time history curve for basalt fiber reinforcement material, (d) Mid-span deflection time history curve for basalt fiber reinforcement material.

Figure 15 illustrates the impact force time history curve and mid-span deflection time history curve of six one-way fiber-reinforced concrete plates fabricated with distinct fiber materials.

It is evident from the graph that as the impact height on the two types of fiber-reinforced concrete plates increases, there is a linear escalation in peak impact force and the peak deflection at mid-span also increases accordingly. Comparing the results, it is noteworthy that across three drop weight impact heights, the glass fiber-reinforced concrete one-way slab exhibits slightly higher mid-span deflection peaks than its basalt fiber-reinforced counterpart. Glass fiber-reinforced concrete displays enhanced resilience to impact deformation and superior impact toughness. This superiority can be attributed to two primary factors: firstly, the superior deformation capabilities of glass fibers compared to basalt fibers; secondly, the special manufacturing process involving blending highly elastic fiber materials with resin and shaping them into composite materials, resulting in
