# Innovative Approaches and Challenges in the Demolition of Large-Span Post-Tensioned Beams: Insights from a Case Study

**Citation:** Jonaidi, M.; Kaplan, A.; Keyvanfar, A. Innovative Approaches and Challenges in the Demolition of Large-Span Post-Tensioned Beams: Insights from a Case Study. *Buildings* **2024**, *14*, 1380. <https://doi.org/10.3390/buildings14051380>

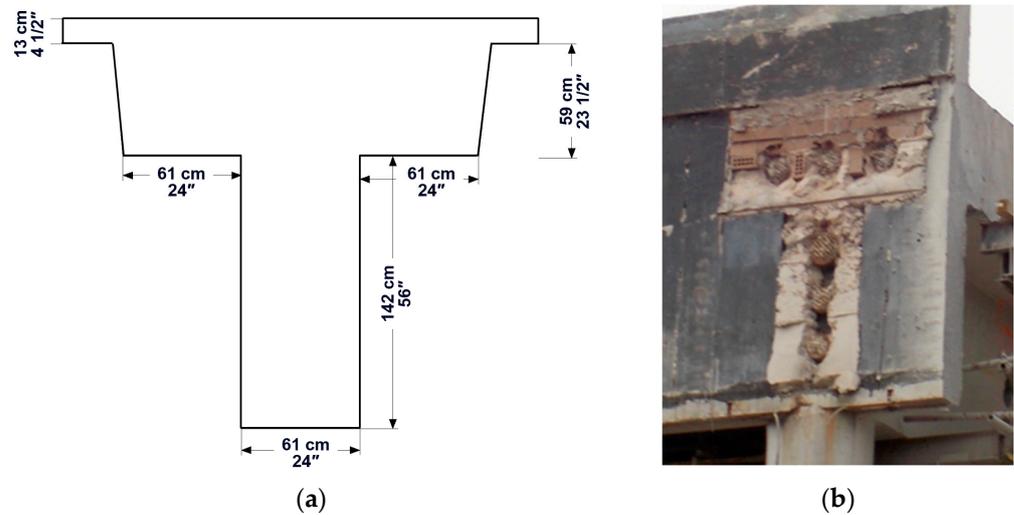
**Figure 1.** (a) The cross section of the beam. (b) The end view of the beam showing the PT anchors.

A total of 160 tendons were used, and these were distributed among six ducts with a diameter of 10 cm. Figure 1b depicts the end view of the beam. The number of tendons per duct varied to ensure that the center of gravity of the tendons aligned with the centroid of the T-section. To analyze the beam's condition at different loading stages, a computer model was created using the Ram Concept software V8i Release 5.0.1 from Bentley Systems, Inc. [8]. The primary focus was to determine the stress levels at the top and bottom of the T-beam when the dead load of the topsoil was removed. Additionally, the 61 cm (24-inch)-diameter columns were included in the modeling. It should be noted that the demolition had been conducted nearly 30 years after construction, during which all prestress losses had occurred.

During the saw cutting of the roof slab, initial cuts were made through the 1.8 m (6 ft)-wide top section of the girder. This pre-cut, with a depth of 71 cm (28 inches), facilitated the efficient use of a cable/wire saw once the adjoining sections of the roof were removed. Subsequently, a wire saw was employed from the top of the girder, which was wrapped around the 61 cm (24 inches)  $\times$  142 cm (56 inches) bottom section of the beam (Figure 1a), to complete the cutting of the entire beam section.

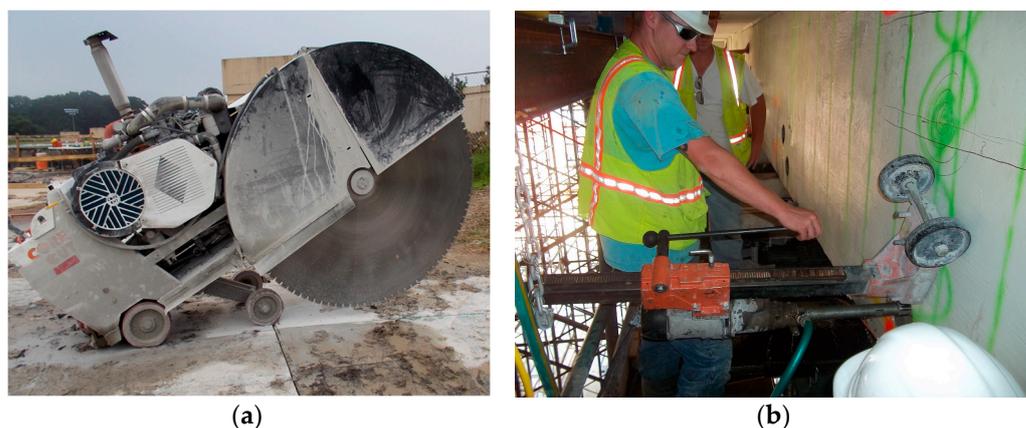
**Figure 2.** (a) A diesel-operated slab saw. (b) The drilling operation conducted on the side of the beam.

The demolition was carried out using a modern and well-maintained fleet of equipment, which were operated by skilled personnel. Large hydraulic and diesel-operated slab saws and cable, or wire saws, were employed to cut through the 71 cm-deep (28 in) joists of the waffle slab and the 2.1 m-deep (7 ft) concrete PT beams. Figure 2a depicts the placement of the large saw atop the slab to penetrate the thick concrete. The drilling operation conducted on the side of the beam, using a 15.2 cm-diameter (6 in) hydraulic drill, is depicted in Figure 2b. The materials slated for demolition were initially reduced in height and dimensions as was necessary to ensure safe removal. Subsequently, they were further reduced in size to facilitate efficient transport from the site.

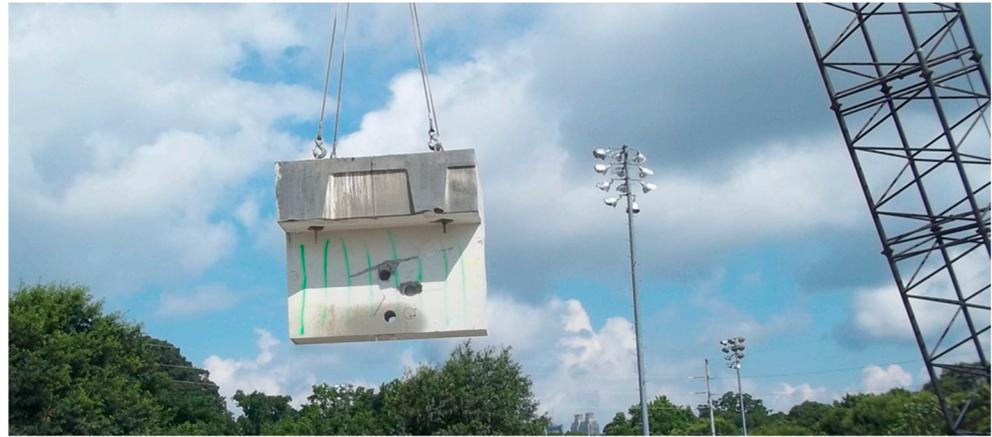
**Figure 3.** Lifting of a cut segment of the PT beam.

The length of the segments of the beam being cut was determined by the capacity of the crane and the distance of each piece relative to the crane's location, which was on one side of the building. Segments were removed from front to back, with each segment decreasing in size and weight to accommodate the reach and lift capacity of the truck crane. Depending on the weight of each segment, four anchors were carefully designed with attention being paid to the impact effect, and this was then drilled on the top to be connected to the crane hook. Figure 3 illustrates the lifting of a cut segment.

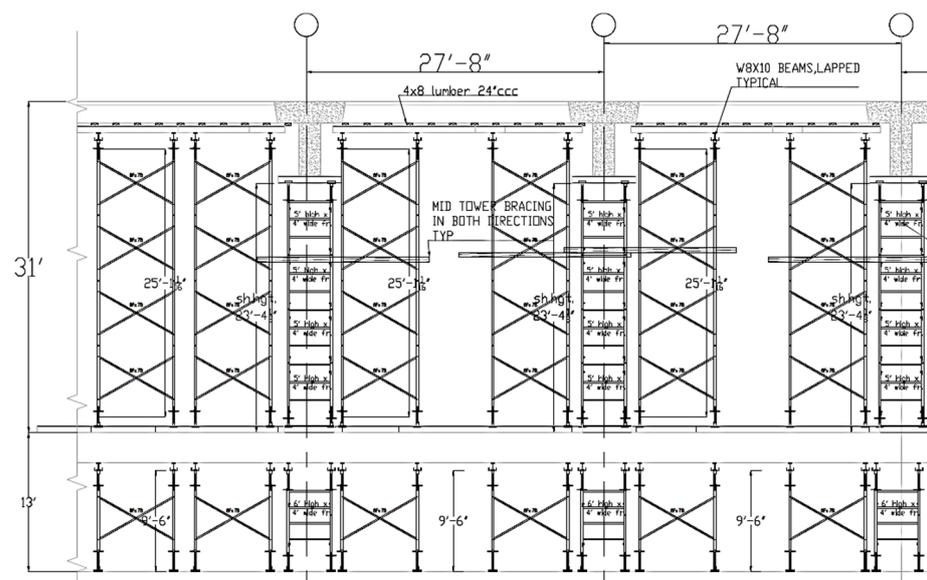
**Figure 4.** A section of a portion of the shoring system ( $27'-8'' = 8.4$  m;  $31' = 9.5$  m; and  $13' = 4$  m).

steel beams commonly used in shoring systems. Local loads applied from either a structural element above the beam or the shoring post below the beam can cause a localized buckling of the web. This effect is sometimes overlooked in shoring design, so it is recommended that engineers take it seriously and evaluate it thoroughly. A section of a portion of the shoring system is presented in Figure 4.

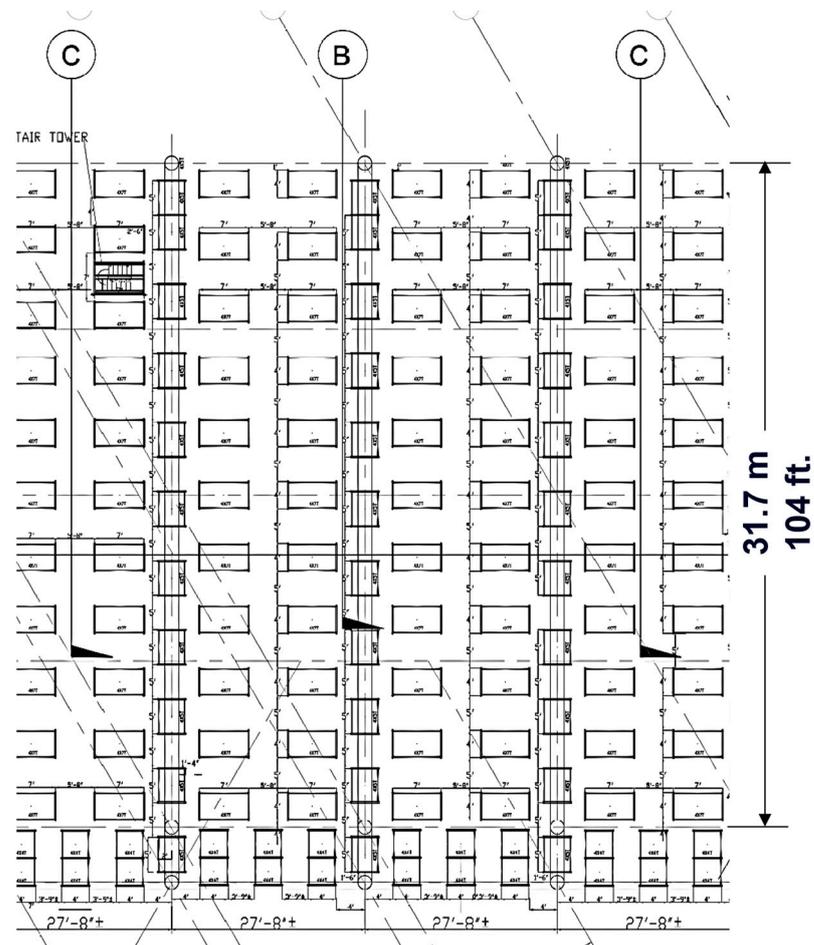
**Figure 5.** A portion of the shoring plan (27'-8" = 8.4 m).

A portion of the shoring plan is presented in Figure 5. This figure also serves to depict a portion of the building plan. As shown, the distance between the beams was 8.4 m (27.67 feet) and the length of the beam was 31.7 m (104 feet), measured from the center to center of columns at each end.

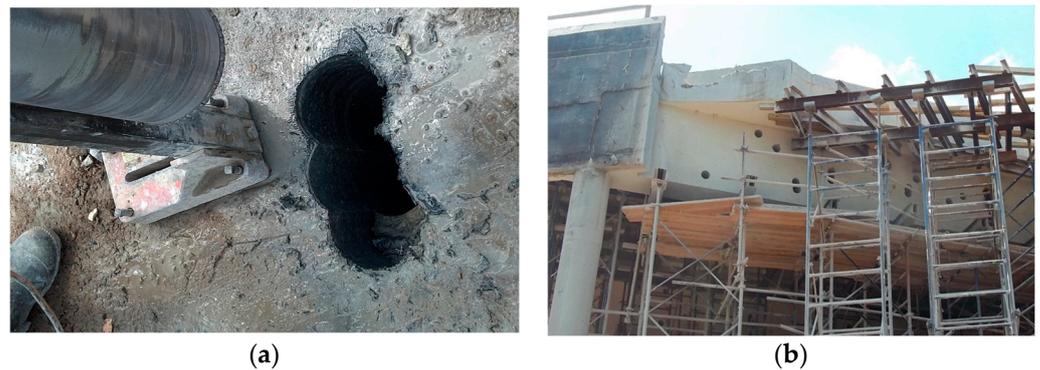
**Figure 6.** (a) The drill and holes on top. (b) Side view of one of the beams showing the considerable number of drillings required to locate and cut the PT ducts.

To address both abovementioned scenarios, an innovative approach was adopted: cutting each duct individually, one by one, using a powerful drill. A specialized 15 cm (6-inch)-diameter drill was employed for the drilling process. This drill, being heavy, required mounting to the concrete using anchor bolts. Based on the tendon profile provided in the structural drawings, it was determined that the first drilling should be performed at the top of the beam near the end. This decision was made because three ducts were expected to be closer to the top of the beam, as depicted in Figure 1b, which shows the three anchors on the beam flange. Drilling near the end would also mitigate the risk of anchors popping out, especially if the grouting was not performed adequately. Figure 6a depicts the drill and the holes on the top of one of the beams. It is evident from this image that three holes were drilled to locate one duct. The challenge of locating the PT ducts became more pronounced, especially when drilling on the side of the beam, as seen in Figure 6b, which shows many holes that were drilled to locate tendon ducts. This is also evident in Figure 3 which shows several holes in a cut segment. Although Ground Penetrating Radar (GPR) scanning of concrete was employed to locate the rebar and tendon ducts, many ducts were not positioned close enough to the surface to be accurately located. This issue arose due to the discrepancies between the design drawings and the as-built conditions. Such discrepancies need to be carefully considered when undertaking demolition projects of this nature.

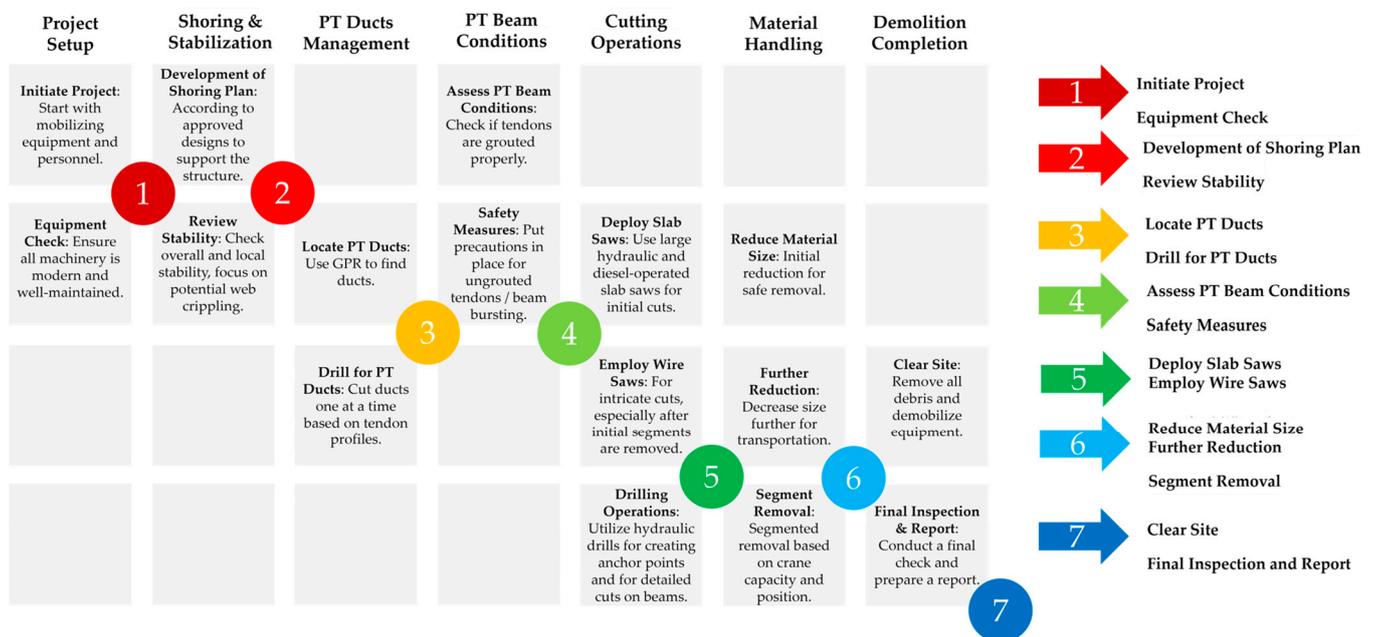
**Figure 7.** Overview of the demolition process: sequential stages and key activities.

Figure 7 outlines a systematic demolition approach across seven key stages, starting with “Project Setup,” where equipment and personnel were mobilized, and where the machinery was checked for maintenance. This was followed by “Shoring and Stabilization,” which involves developing and reviewing support structures for stability. The “PT Ducts Management” stage includes locating and drilling PT ducts based on specific tendon profiles. In “PT Beam Conditions,” the integrity of PT beams is assessed, and necessary safety measures are implemented. The “Cutting Operations” stage involves using various saws and drills for precise cutting and for creating anchor points. “Material Handling” focuses on reducing and removing materials safely according to the crane’s capacity. Finally, “Demolition Completion” involves clearing the site, demobilizing equipment, and conducting a final inspection and report to ensure all standards are met. Each stage is crucial to ensure the demolition is conducted safely and efficiently.

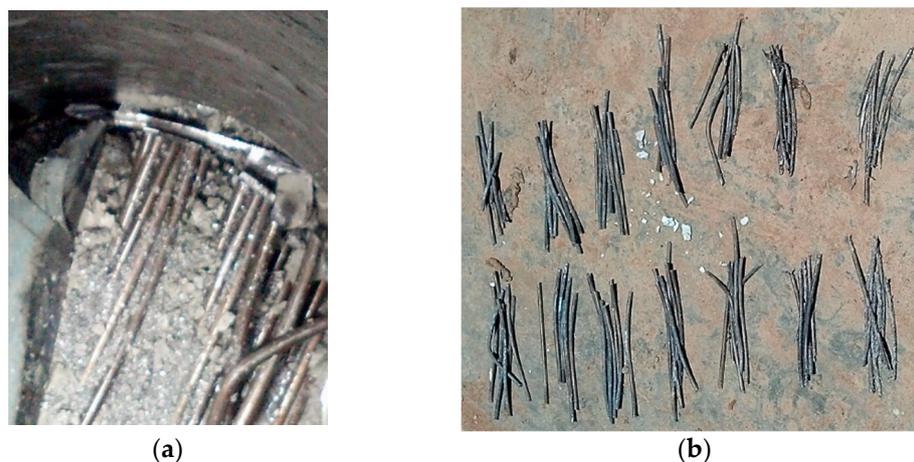
**Figure 8.** (a) Strands inside the duct. (b) The loose pieces of strands after cutting through the duct.

been hindered by several factors, including difficulties in locating ducts, thus leading to guesswork and inefficiencies. The actual number of cores required were two to three times higher than initially estimated; for example, in the case where three cores were needed to locate just one duct, which were each up to 66 cm (26 inches) deep. Moreover, the presence of four to six 2.54 cm (1-inch)-diameter steel rebars on top necessitated careful drilling. Extensive cord lengths, reaching several meters to the power box, also posed logistical challenges, including placing strain on the drills. Additionally, when reaching the duct and starting to cut strands, the loose pieces, 7 cm to 10 cm (3 to 4 inches) long, rotated, thereby resulting in drilling through the same strand multiple times (Figure 8a). When this occurred, the drill had to be pulled out, the hole cleaned, and the loose strands (Figure 8b) removed before starting again. This necessitated frequent drill removal, hole cleaning, and strand removal, adding to operational complexities.

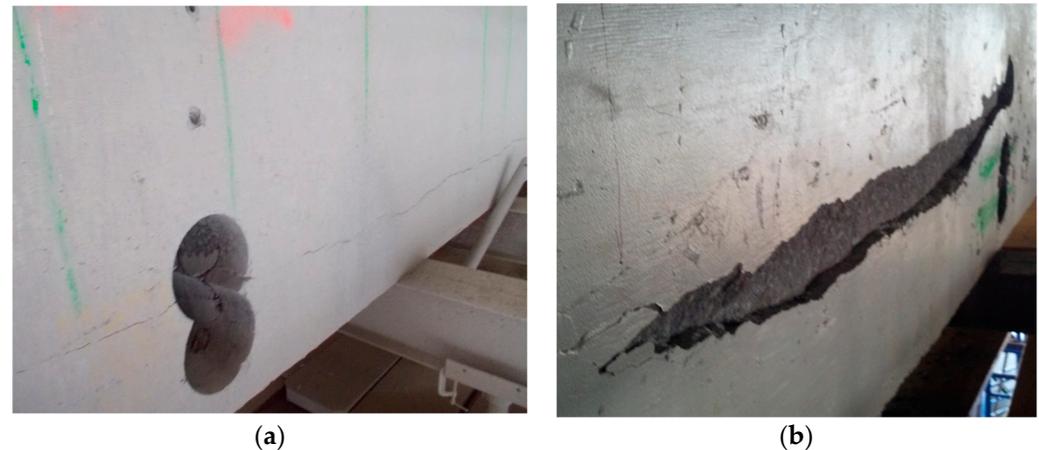
**Figure 9.** Horizontal cracking (a) and spalling of concrete (b) on the side of the beams as the result of drilling and cutting tendons.

The horizontal cracking observed on the side of the beam after cutting the tendons in a duct is depicted in Figure 9a. Additionally, Figure 9b illustrates the spalling of concrete in another beam. The presence of #4 (12 mm, 0.5”) stirrups at 30 cm (12 inches) on the center

along the beam had proven effective in preventing the catastrophic bursting of concrete, and it had also limited the width of the cracking.

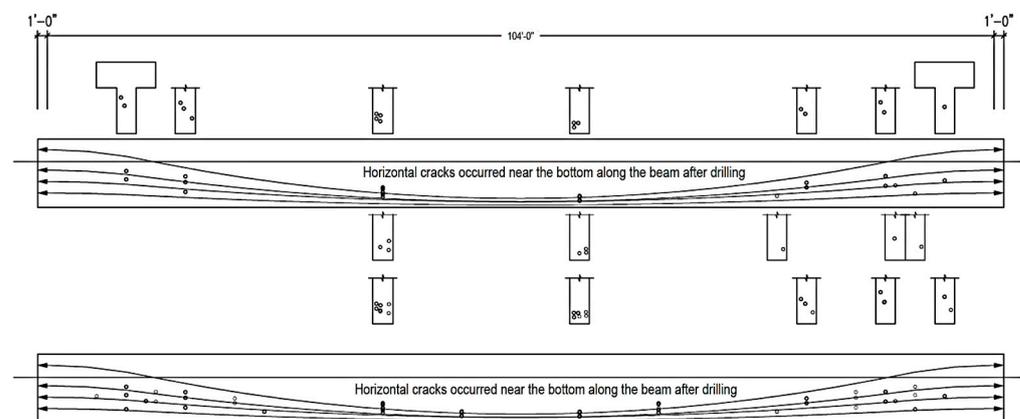
**Figure 10.** A sketch of the side view of two beams (104 feet = 31.7 m; 1 foot = 0.305 m).

The sketch of the side view of two beams is presented in Figure 10. The figure illustrates the elevation (profile) of the ducts that were intended to be installed according to the construction documents. However, the actual profile differed, as evidenced by the location of numerous holes drilled to cut a duct. This discrepancy highlights the challenges encountered in this project, and it offers insights to the construction industry, thereby emphasizing the importance of inspections prior to concrete casting to ensure that the as-built members conform to the construction documents. Additionally, there is a possibility that the ducts were not securely supported, which would lead to movement during the pouring of concrete.

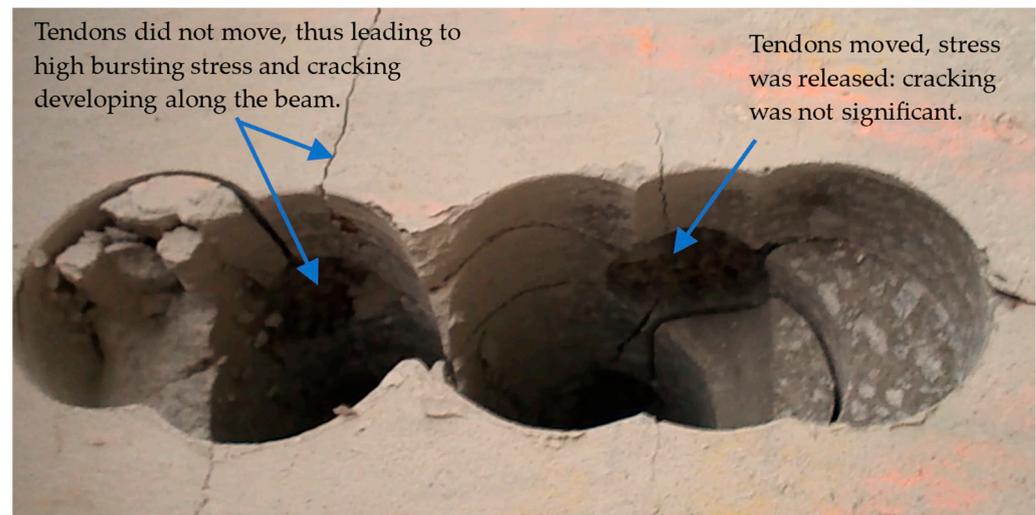
**Figure 11.** Cracking due to the bursting effect that occurred, which depended on the tendons' movement.

Depending on the effectiveness of the grouting, the tendons inside the duct moved approximately up to 12.7 mm (0.5 inches) in some cases, while, in others, there was no movement, as illustrated in Figure 11.

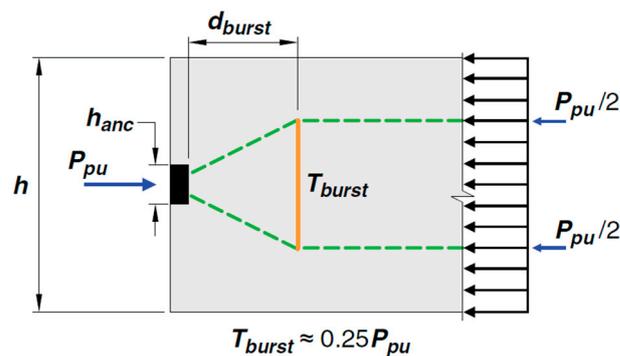
**Figure 12.** Tensile stress (bursting) zone in the PT beam after ACI 318-19 [12].

The significance of the tension stresses (bursting) behind the anchorage zone is a function of the ratio of the size of the anchor and the depth of the beam ( $h_{anc}/h$ ), as specified in ACI 318-19 [12]. In the case of cutting one duct, this ratio is the duct diameter (10 cm) to the beam depth (213 cm (84 inches)), which is negligible. Hence,  $T_{burst}$  can be considered as 25% of the released force of tendons in one duct, as illustrated in Figure 12 (provided by ACI 318-19). Assuming there are 25 tendons in one duct, and when utilizing the typical force of 120 kN (27 kips) per tendon (which is commonly used in PT design), the calculated bursting force would amount to  $0.25 \times 25 \times 120 \text{ kN (27 kips)} = 750 \text{ kN (169 kips)}$ . This

It is crucial to note that the scenario of cutting one duct, as encountered in this demolition project, differs slightly from the depiction in Figure 12. When a duct is cut, the released force is transferred to the concrete over a certain length of the duct, albeit suddenly and with impact. Therefore, the concept of bursting force behind an anchor (Figure 12) is used solely to explain the phenomenon of bursting that results in horizontal cracking in the beam during demolition.
