Article

# Novel Approaches for Fracture Detection in Steel Girder Bridges

Department of Civil and Environmental Engineering, Florida International University, Miami, FL 33174, USA

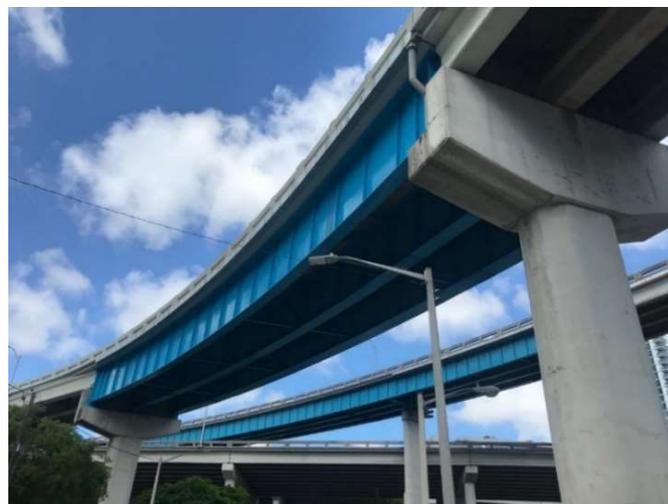
**Figure 1.** Side view of the I-95 NB to SE 1st Ave. highway bridge in downtown Miami, FL.

The I-95 NB to SE 1st Ave. highway bridge in downtown Miami, FL (Figure 1), was selected based on the accessibility for testing to study the characteristics of traffic-induced vibration. This bridge is a simple span multiple steel-girder bridge with the span length of 36.5 m (120 ft) carrying one traffic lane with the average daily traffic of 14,250 veh/day that was built in 1968. The last bridge inspection report on July 2016 shows the superstructure is in a satisfactory condition. A laser vibrometer as shown in Figure 2 was simply stationed under the bridge on a walkway with no interruption to traffic on and under the bridge and no need for direct access to the bridge. The bridge vibration at mid-span and quarter-span was captured under moving normal traffic loading for all three girders. The velocity time history of girders was recorded by the laser vibrometer at several time intervals of 60 s during very low traffic volume passing the bridge. The velocity time histories of the interior girder at mid-span and quarter-span (Figure 3a,b) were integrated to obtain the time histories of displacement (Figure 3c,d). Frequency spectra were also obtained using Fast Fourier Transform (FFT) and are shown in Figure 3e, f. Vehicle classes passing the bridge were recorded during the test and corresponded with the field test results. The vibration levels shown in Figure 3 are the results of passing vehicles in the class of Midsize Sport Utility Vehicle (SUV) with the average weight of 18.6 kN and lighter vehicles.

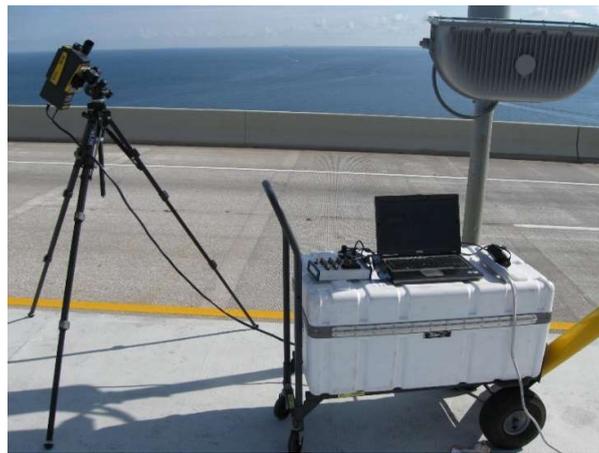
Figure 2. The Laser vibrometer used in the field measurement.

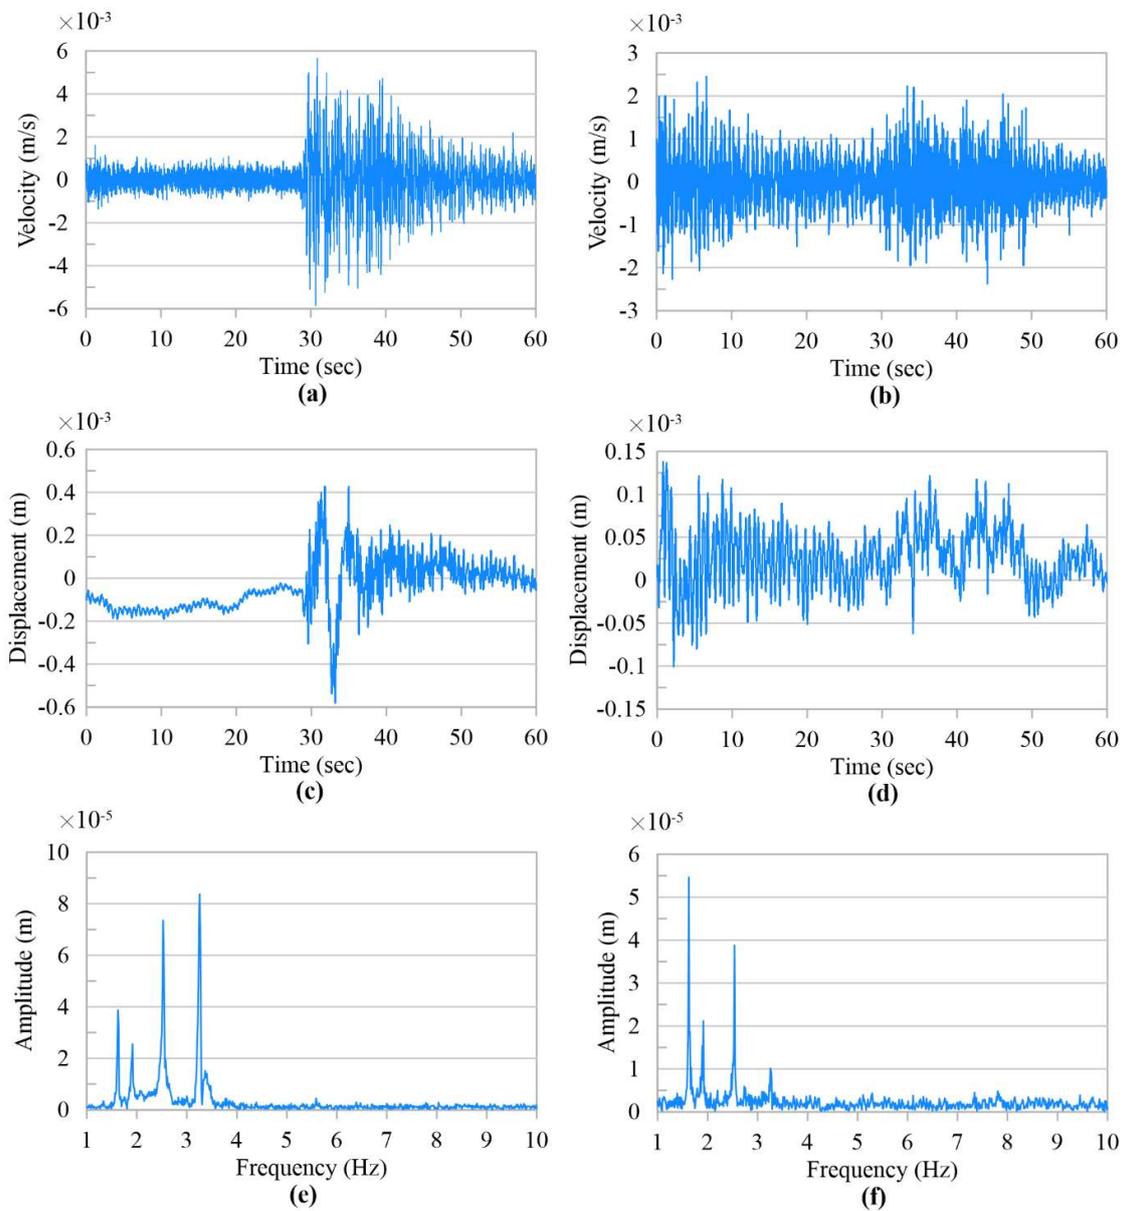
Figure 3. Time series and frequency spectrum of girder displacement and velocity. (a,c,e) Interior girder at mid-span. (b,d,f) Interior girder at quarter span.

Several key observations can be made from this experiment. First, because of the integral composite bridge superstructure accommodating only one lane, vibration amplitudes of the interior and exterior girders are similar to each other. Second, vibration levels at supports are minimal and reach the maximum at the middle of the span. Third, the amplitude of displacement at mid-span and quarter span under light weight traffic (Midsize SUV with the average weight of 18.6 kN) reaches up to 0.6 mm and 0.15 mm, respectively. Fourth, and most importantly, the experiment demonstrated the capability of laser vibrometer for remote measurement of vibration and calculation of natural frequencies with minimal efforts. As it will be discussed later, a comparison between vibration characteristics of the intact and fractured bridge can lead to detection of fracture and other problems that occur in the interval between two measurements. Hence, the laser vibrometer provides an effective, economic, non-interruptive, and safe alternative technique for verification of the integrity of the bridge. Although, field test results can provide precious information regarding the bridge vibration under actual traffic for the intact bridge, however, finite element method is needed for comparing the vibration level of an intact and fractured bridge.

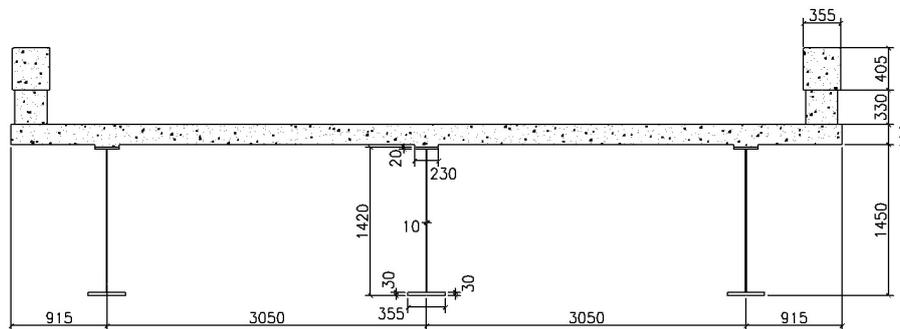
**Figure 4.** Cross section of the University of Nebraska-Lincoln Multiple Plate Girder Bridge. (All dimensions are in mm).

This bridge was a full-scale simple span bridge with a span length of 21.3 m (70 ft) and is 7.9 m (26 ft) wide accommodating two traffic lanes. The superstructure consists of three welded steel plate girders made composite with a 0.2 m ( $7\frac{1}{2}$  in.) reinforced concrete deck as shown in Figure 4. The girders are spaced 3 m (10 ft) on center and the reinforced concrete deck has a 0.9 m (3 ft) overhang, and the railing system is a typical Nebraska Department of Road (NDOR) open concrete bridge rail with  $0.3 \times 0.3$  m ( $11 \times 11$  in.) posts spaced 2.4 m (8 ft) on center. Several tests were conducted on this bridge to evaluate the effect of diaphragms, elastic behavior and ultimate load carrying capacity of the bridge. The ultimate test which consisted of loading the bridge (point loads in terms of simulating HS20 truck load) to collapse, was selected for validating the capability of FE modeling adopted in this study for predicting the elastic behavior and ultimate capacity and failure modes. The bridge

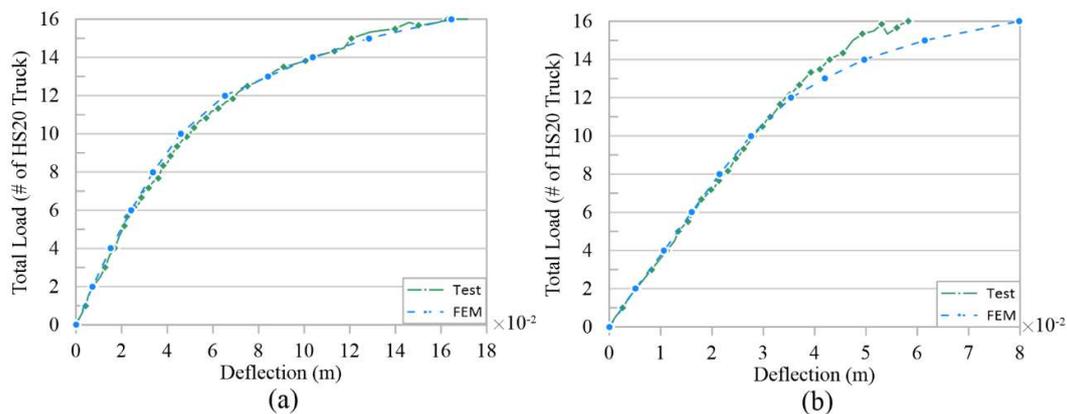
**Figure 5.** Comparison of load-deflection curves obtained from experiment and finite element (FE) model. (a) Interior Girder and (b) Exterior Girder.

Figure 5 shows the comparison of load- deflection curves between experimental and FE results for the exterior and interior girders in the ultimate test which consisted of loading the bridge to collapse. Deflection refers to vertical displacement of the bottom flange of each (exterior or interior) girder at the mid-span and was measured using displacement transducers in the laboratory tests and calculated through analysis using finite element method (FEM) for the analytical simulation, and total load refers to point loads in terms of simulating HS20 truck load. As shown in these graphs, the FE model can predict the global behavior of the bridge during the elastic and plastic states. It was also able to simulate the local failure due to punching shear in the deck and cracking in the railing.

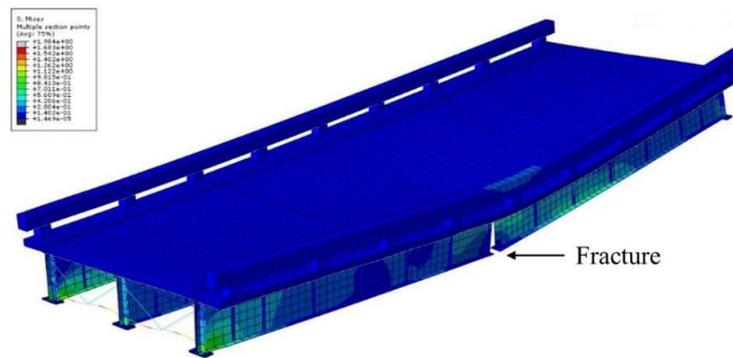
Figure 6. Simulation of damage (fracture of exterior girder) in the finite element model.

Moving traffic load in the model was simulated by defining multiple tire contact area along the bridge only for the lane over the fractured girder (eccentric loading) and assigning amplitude intensity pattern to them based on the WIM data for a period of 60 s. Figure 7 shows the amplitude curve assigned to a one tire contact area during this 60-s time period based on the WIM data to simulate the actual traffic consisting of trucks and cars. Amplitude of one (1) on the vertical axis in this figure is equal to the average weight of heavier truck wheel over a month with the average truck weight of 205 kN (46 kips) and other amplitudes, proportioned with respect to the latter, are a representative of loading for a variety of cars and light trucks. It is worth noting that the amplitude of 0.1 in this figure is equal to the weight of Midsize SUV recorded in the field test.

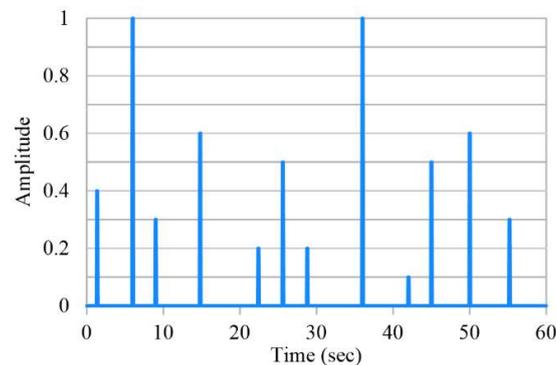
Figure 7. Load amplitude curve of the moving traffic load.

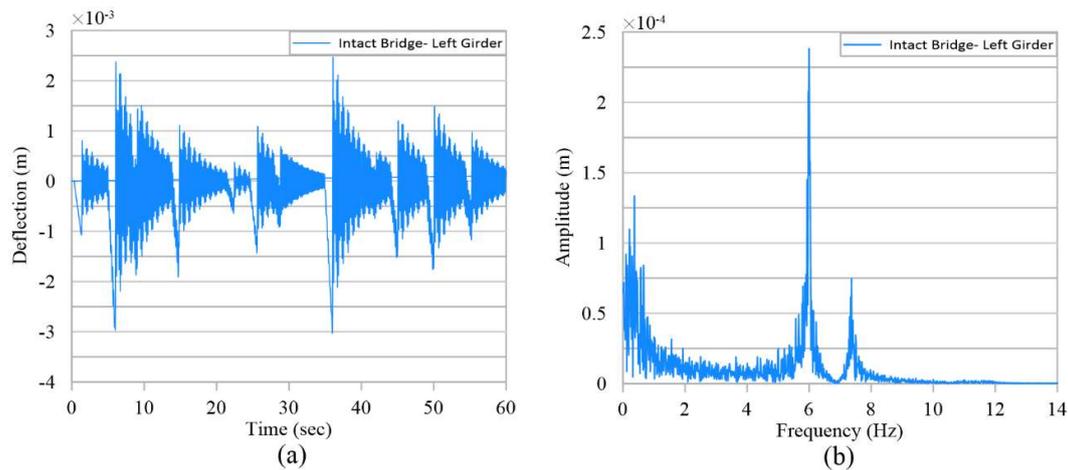
**Figure 8.** Intact Bridge. (a) Time histories and (b) frequency spectrum of girder deflection at the middle of exterior girder.

Figures 8 and 9 show the time histories and frequency spectrum of girder deflection obtained from the FE model for intact and fractured scenarios at the middle of the exterior girder (fractured), respectively, under the moving traffic of 60 s duration. The simulation necessitated discretization for movement of the loads along the span. Moving a load from one point to the next is modeled by removing the load at one point and adding to the next, as it occurs in actual case with some continuity. Response of the bridge span to this moving load (one of several situated on the bridge) generates oscillations as it has also been measured in the similar bridge for actual traffic reported in this paper. It should be pointed out that, in practice, time history curves shown in these figures can be generated by instrumenting the intact bridge using several types of contacting sensors among which are strain gages, displacement transducers, and accelerometers, as well as non-contacting transducers including vision based equipment and laser vibrometers. However, bridge vibration for the fractured bridge needs to be generated using a finite element model.

Using FE analysis, the deflection at the mid-span of the exterior girder extracted from Figure 8a for the load amplitude of 0.1 (equivalent to a Midsize SUV at time 42 s in Figure 7) is determined to be a maximum of 0.56 mm and deflection of the mid-span of the exterior girder of the bridge subjected to field testing was determined under similar loading to be 0.6 mm (Figure 3c). The comparison of these two results, FE analysis and field testing, that are in the same order of magnitude validates two important inferences. First, the FE model has the ability to simulate the bridge dynamic responses with acceptable accuracy, and secondly, the results obtained in this study provides the order of magnitude for vibration of the bridge under service load. The latter will be used in this paper to verify the sufficiency of the vibration amplitudes in providing the required energy for self-powered sensors.

Comparing these results with those obtained from FE analysis (Figures 8 and 9) and field test conducted in this study show that the vibration amplitude in the intact and fractured girders in this study is comparable and similar range to the results reported by Sazonov et al. [37]. Therefore, the results indicate the feasibility of designing electromagnetic generators (or a similar energy harvesting system) that could feed the monitoring sensors for detection of fracture in steel girders.

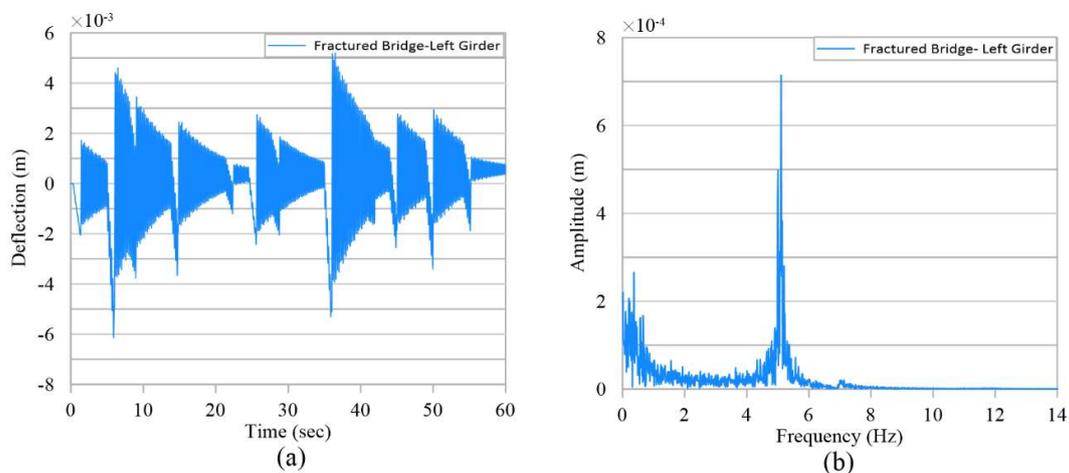
**Figure 9.** Bridge with Fractured Girder. (a) Time histories and (b) frequency spectrum of girder deflection at the middle of exterior girder (fractured).

The time history results show that the vibration amplitude of the girder at the middle of the span has almost doubled and at quarter points increased in average about 60% under normal traffic load because of the fracture. Therefore, a threshold can be predefined for the girder bridge deflection amplitude, crossing which would be an indication of fracture in the girder. Furthermore, the results in frequency domain indicate two major changes after the fracture has occurred. One is a major shift in the fundamental/dominant mode vibration frequency of the bridge, and the other is a significant increase in the amplitude of the vibration. The major peak in the frequency spectra can be used to determine the frequency and its amplitude. For the intact condition, the frequency stands at 6 Hz with amplitude of  $2.35 \times 10^{-4}$  m. For the fractured condition, this frequency has shifted lower

to 5 Hz with an increased amplitude of  $7.15 \times 10^{-4}$  m. This shift in dominant frequency and increase in amplitude can be exploited for signaling occurrence of a major event, in this case, fracture of the girder. In a continuous monitoring system, a safe buffer zone can be established and specified for the dominant modal frequency and amplitude based on expected minor variation in the frequency due to ambient effects. If the monitoring system indicates that the dominant frequency has fallen outside this buffer zone and/or amplitude of vibration has increased beyond the threshold, it will be indicative of a significant event, i.e., girder fracture.

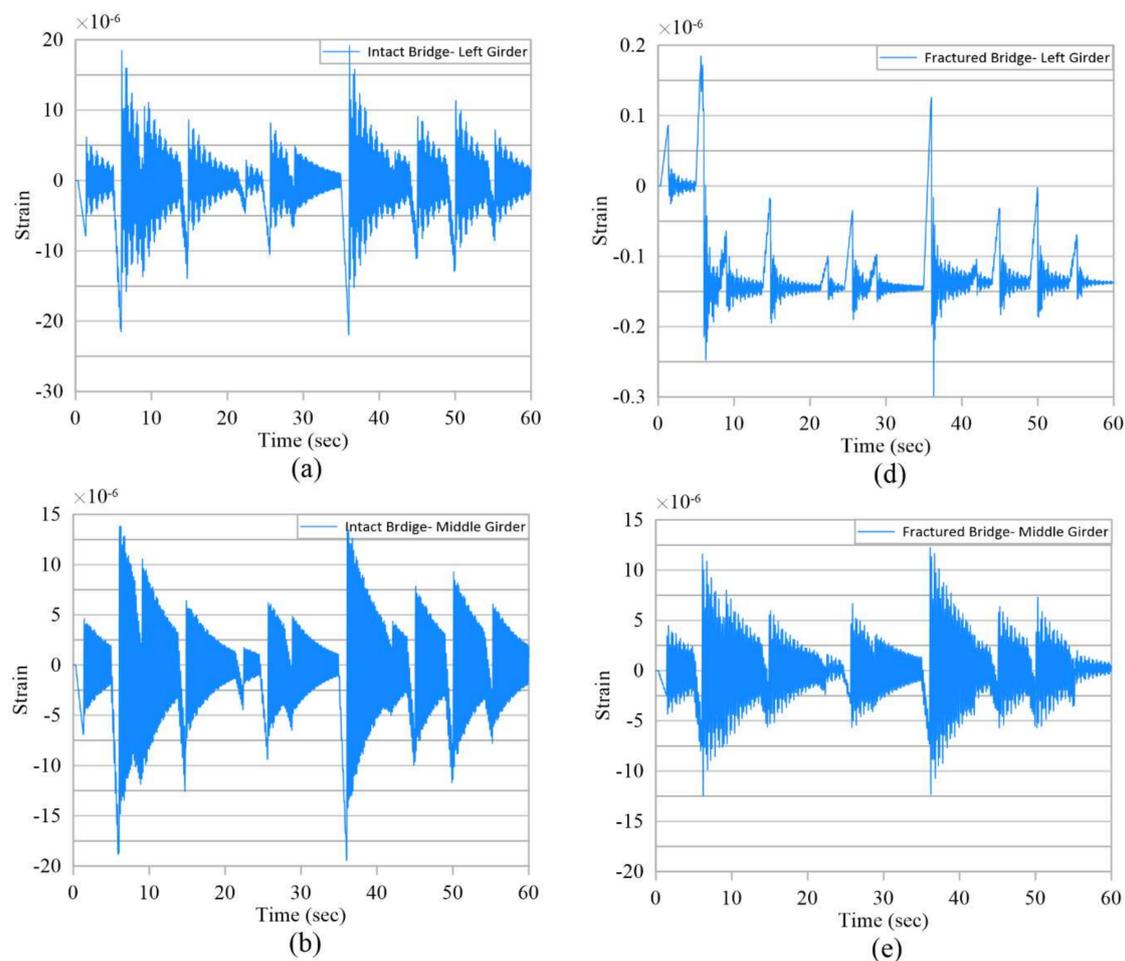
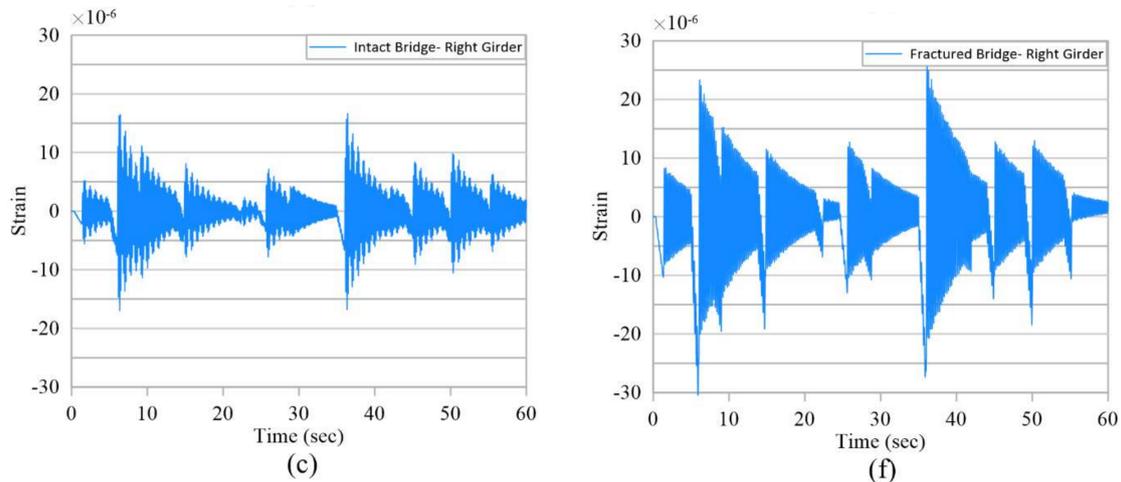
Figure 10. Cont.

Figure 10. Time histories of girders strain. (a–c) Intact Bridge and (d–f) Fractured Bridge.

To investigate the strain variation of the steel plate girders resulted from fracture of a girder, time histories of girders' longitudinal strain were calculated through analysis using finite element method (FEM) for mid-and quarter-span along the bridge for the bottom flange. The strain record corresponding to the middle of the span for all three girders are presented in Figure 10. The strain results clearly show highly noticeable changes in the response of all girders for fractured scenario. The strains in the left girder (fractured) show the highest drop in the fractured scenario. This is indicative of presence of fracture in this girder where the strain near the fracture would relax because of significant reduction in stiffness and load distribution to other girders. As expected, the middle girder shows increase in the strain indicating absorbing some of the load from the fractured girder. The right girder shows the least of variation in strain. This pattern is indicative of firstly the occurrence of the fracture and secondly the girder and the location where the fracture is.

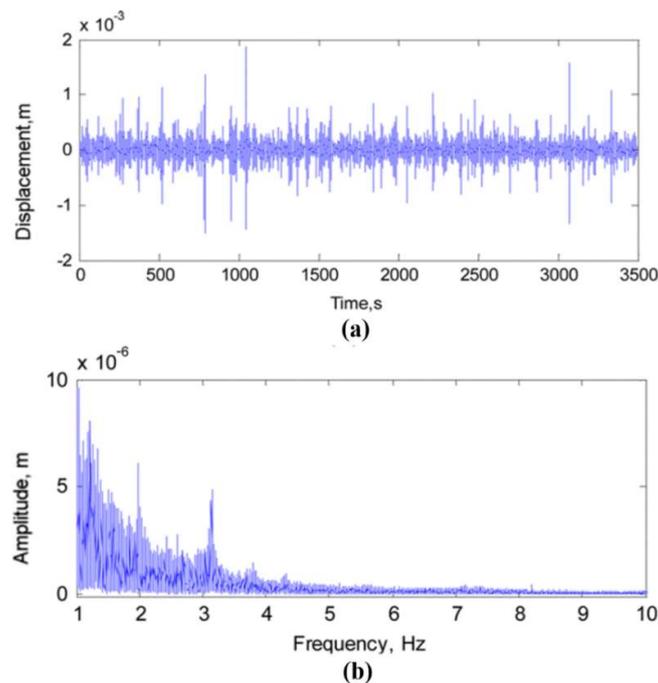
**Figure 11.** (a) Time history and (b) frequency spectrum of girder displacement obtained from the study by Sazonov et al. [37].

These sensors were installed on one of the girders of a simple three span steel plate girder bridge and a linear electromagnetic generator was used to harvest vibration energy created by the passing traffic. The sensors were able to transmit between 25 and 480 measurements per day, average of 1 to 20 per hour, depending on the volume of daily traffic, which indicates the feasibility of self-powered operation for long-term monitoring of a rural highway bridge with low traffic volume. Better results are expected from roads with heavier traffic.
