# Seasonal Change in Techno-Economic Properties of Waterfront Structural Pinewood

**Citation:** Yılmaz, I.C.; Tekin, H.; Palanci, M.; Atabay, Ş. Seasonal Change in Techno-Economic Properties of Waterfront Structural Pinewood. *Buildings* **2024**, *14*, 945. <https://doi.org/10.3390/buildings14040945>

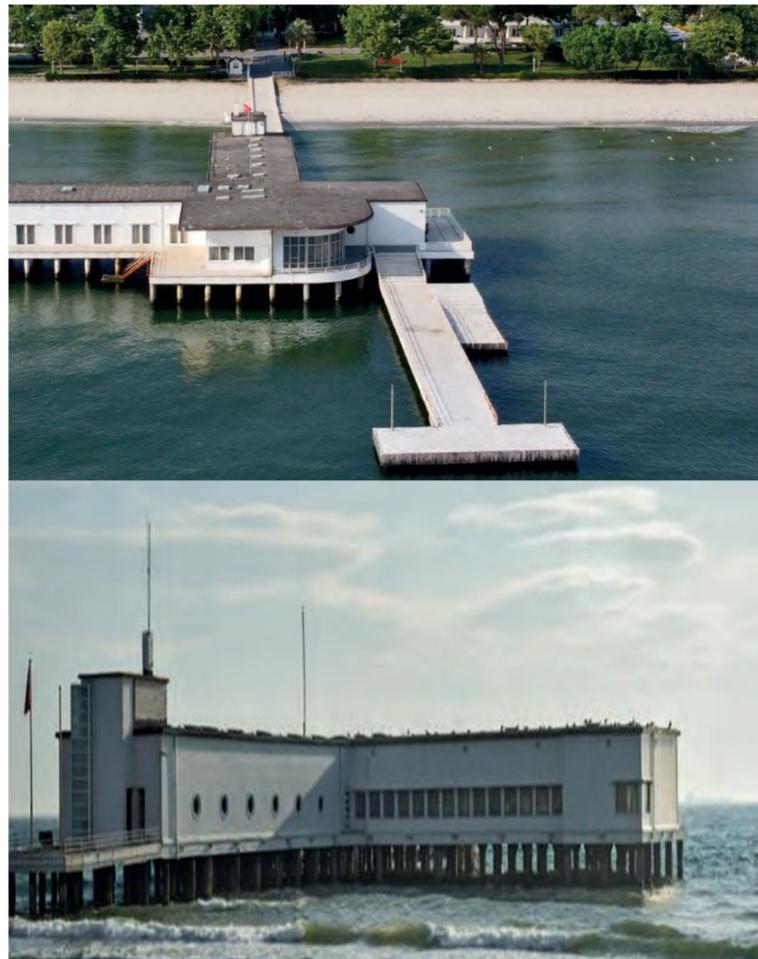
**Figure 1.** Different views of the studied building and placement of specimens [78].

Today, the mansion, which serves as a museum with its single-story L-shaped wooden structure made of specially designed materials and fittings, consisting of a large living room, library, relaxation area, bedrooms, and a bathroom, has undergone significant renovations, replacing part of the structure with reinforced concrete and, despite being a wooden structure, it is built on reinforced concrete legs supported by the sea [77]. However, the mansion has suffered damage from various factors such as seawater, marine environment, climatic conditions, and other events. To protect the mansion, precautions have been taken to maintain its structural integrity. Different views of the studied building and the placement of specimens are shown in Figure 1.

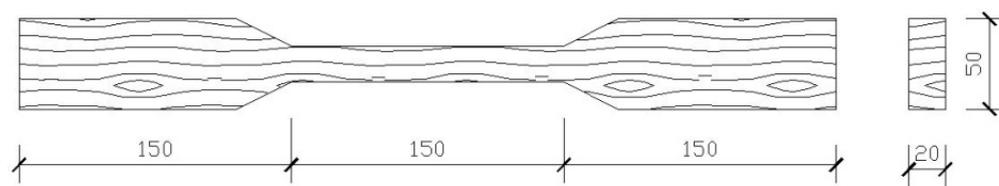
**Figure 2.** Tensile test specimen front and section view.

**Figure 3.** Bending test specimen front and section view.

Within the scope of this study, pinewood specimens (*Pinus sylvestris*) were prepared in the dimensions of  $20 \times 50 \times 400$  mm according to the TS 2475 [79] standard for the tensile test and in the dimensions of  $20 \times 20 \times 360$  mm according to the TS 2474 [80] standard for the bending test (see Figures 2 and 3).

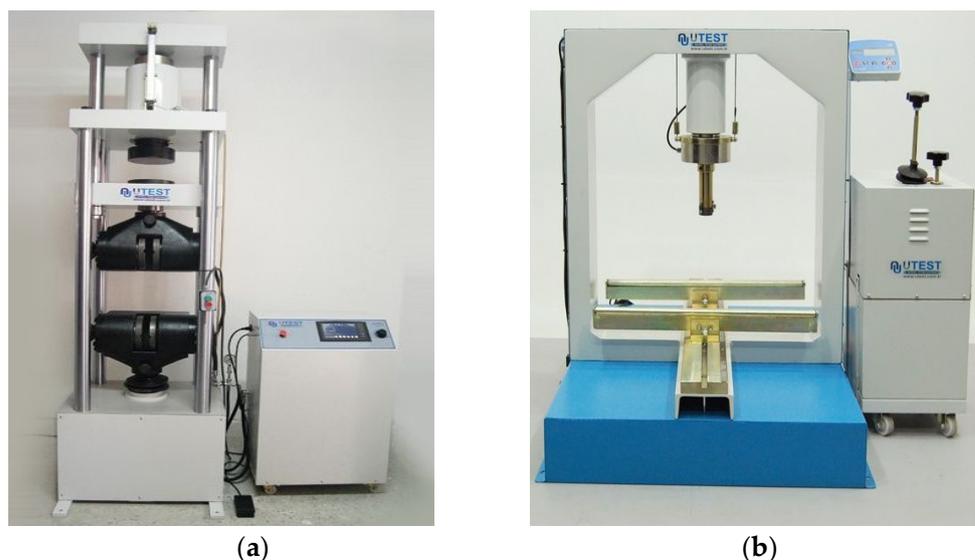
**Figure 4.** The applied laboratory test for the specimens: (a) universal tensile test machine; (b) bending test machine.

In this research, both prepared and naturally aged samples underwent a tensile test with the hydraulic universal testing machine marked as UTM-4000 and a bending test with the electromechanical universal test device labeled as UTM-8050, as illustrated in Figure 4. The tensile test involved pulling the samples at a steady speed of 2 m/s while monitoring their strength and elongation up until the point of fracture. Similarly, the specimens were subjected to a 3-point bending test at a constant speed of 2 m/s, and the strength and deflection at the center of the samples were recorded. These tests were conducted at the university’s laboratories.

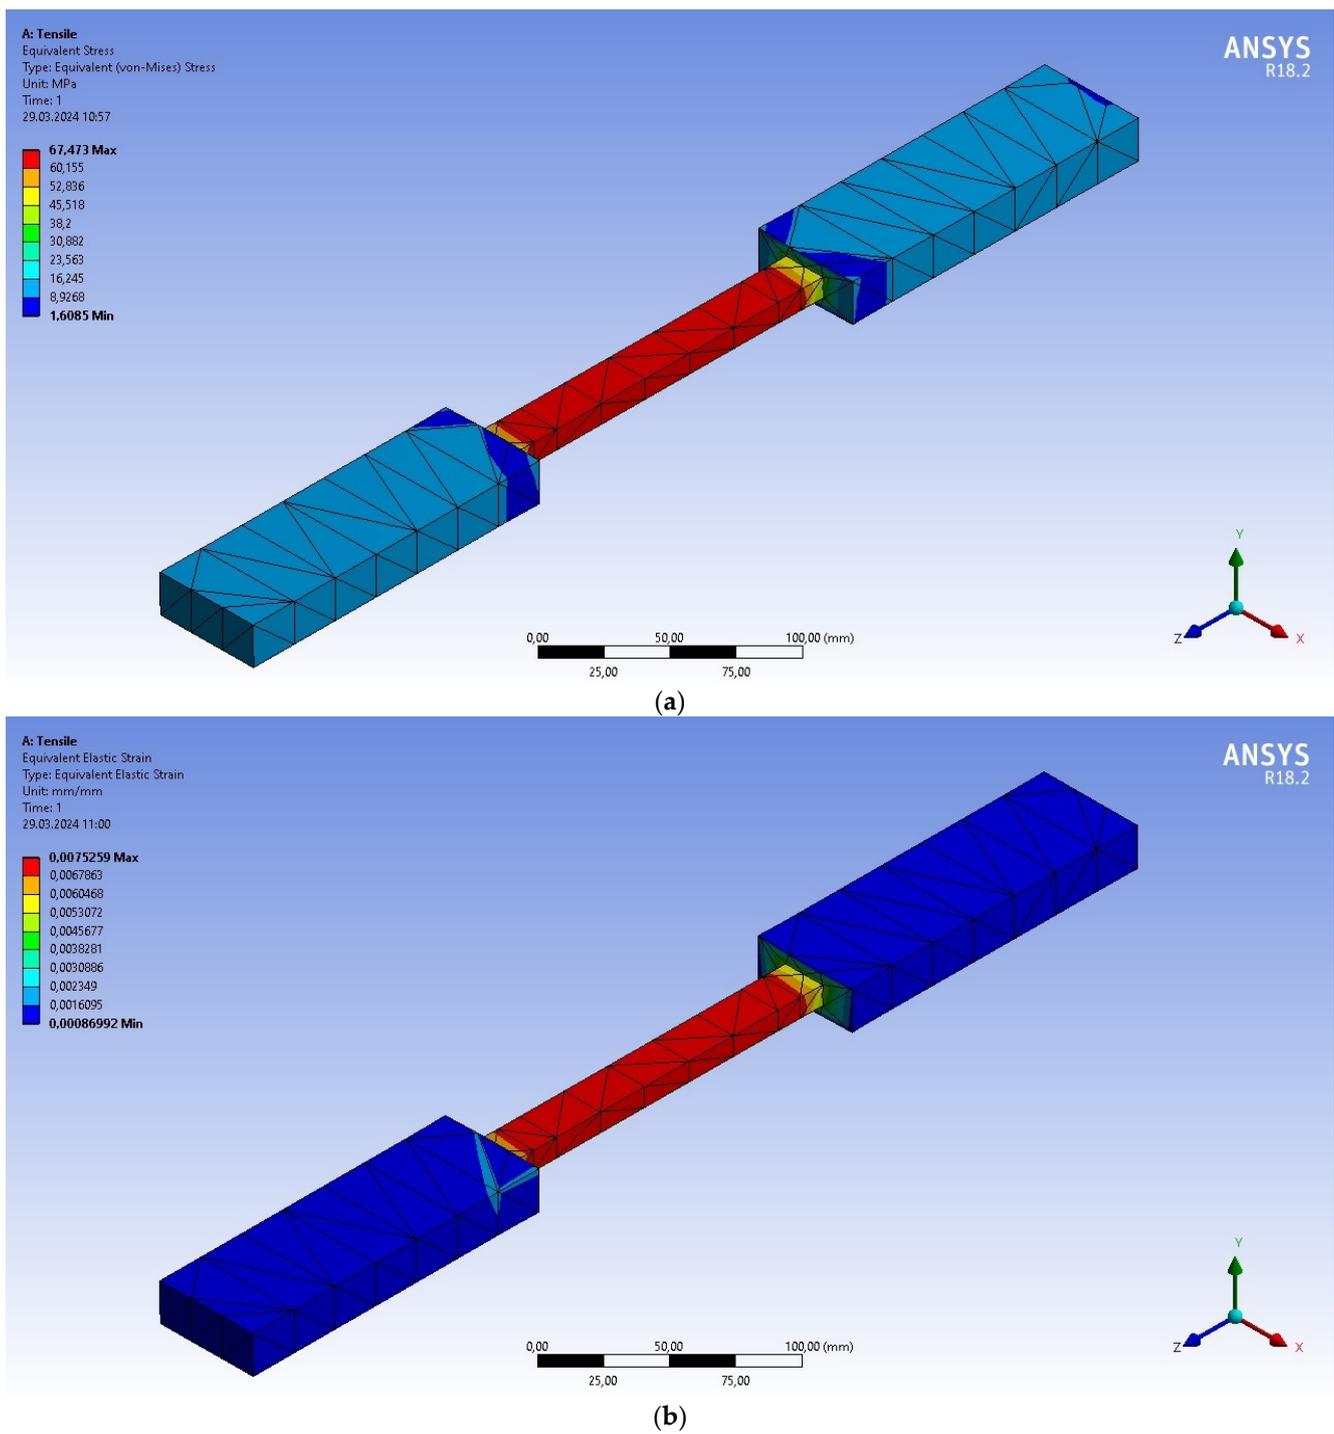
**Figure 5.** Stress and strain analysis of specimens for the tensile test: (a) tensile stress; (b) tensile strain modeling.

The samples were carefully prepared and left to age naturally in a predetermined seashore area. During the first phase of each period, the original three samples underwent both tensile and bending tests in the lab. At the end of the period, new samples were taken from the same location and every third sample was subjected to the same tests. This process was repeated over the course of several seasons, with each period lasting three months to reflect the changing seasons in Türkiye. The maximum tensile and bending strength values were recorded from the tests. Due to cultural heritage restrictions, the test specimens were monitored for three years and underwent the same procedure annually. The maximum tensile strength (MTS) and maximum bending strength (MBS) results were obtained for each sample, and the average results for all three years were presented in Section 3 for evaluation purposes. These experimental values were then used as input for numerical analysis in ANSYS Workbench v.18.2 software. Figures 5 and 6 illustrate the simulation results for the April–May–June period, and similar results were computed for each period and provided between Tables 2–5. The simulations yielded equivalent (von Misses) tensile stress (Figure 5a), equivalent (von Misses) bending stress (Figure 6a), equivalent tensile strain (Figure 5b), and bending deformation (Figure 6b) values.

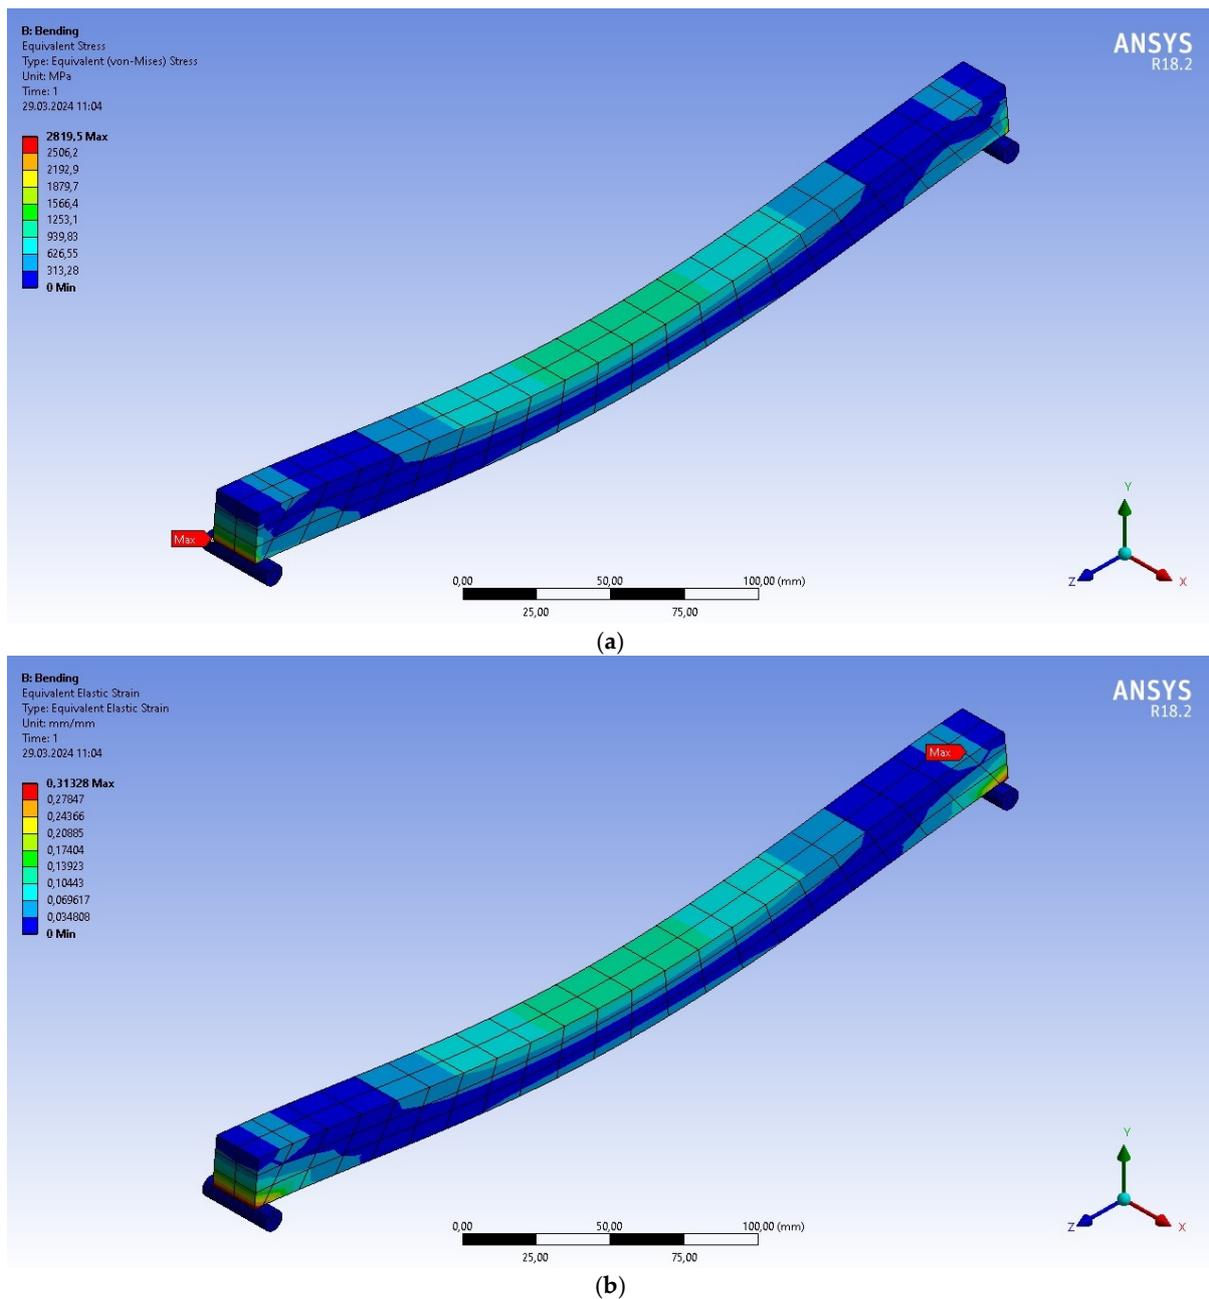
**Figure 6.** Stress and deformation analysis of specimens for the bending test: (a) bending stress; (b) bending deformation.

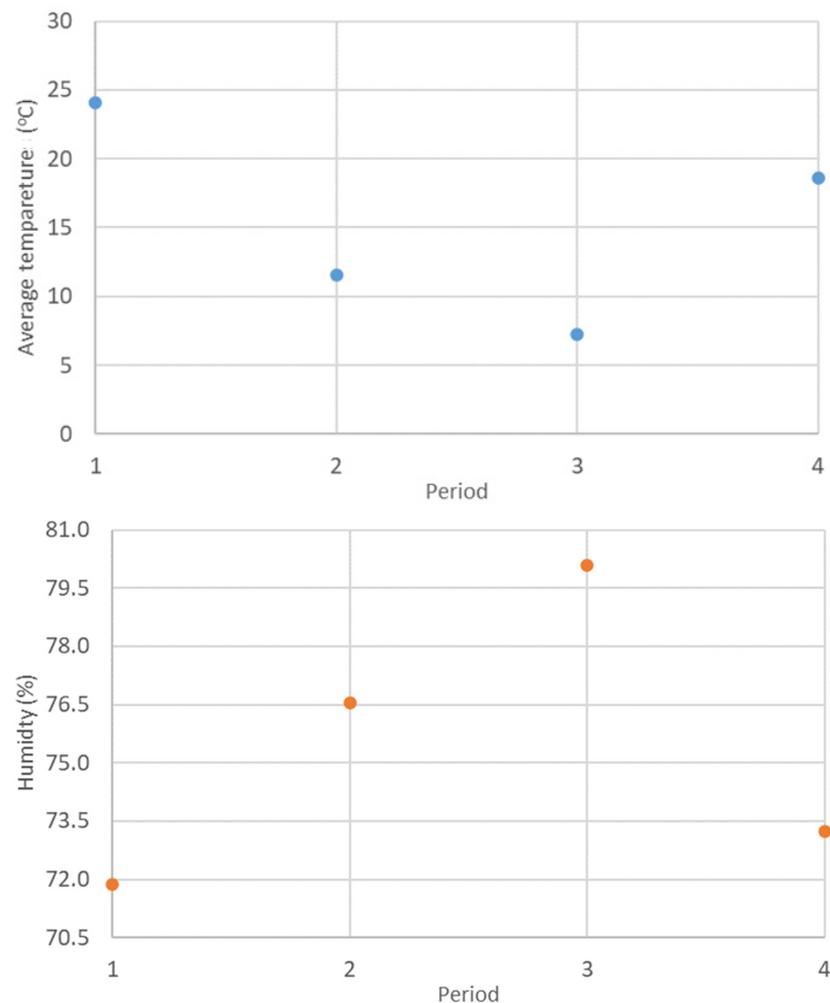
**Figure 7.** The variation in average temperature and humidity depending on the pursuing periods.

To assess the impact of seasonal and environmental factors on our study, we also gathered data on temperature and humidity from a nearby meteorological station, located 500 m away from the Atatürk Marine Mansion where our research was conducted. Table 2 displays the average values for each season, and we note a decline in temperatures from the first to the third season, followed by a rise in the fourth season. Conversely, humidity levels increase from the first to the third season and continue to rise in the fourth season. In the next section, we compare and evaluate the tensile stress values of our specimens for each season, analyzing their strength and deformation. To provide a visual representation of our findings, we have included Figure 7, which illustrates the relationship between temperature and humidity across the seasons. There is a negative correlation between temperature and humidity, resulting in a decrease in humidity as temperatures rise. Additionally, the warmest temperatures tend to occur in the 1st and 4th periods due to seasonal conditions.

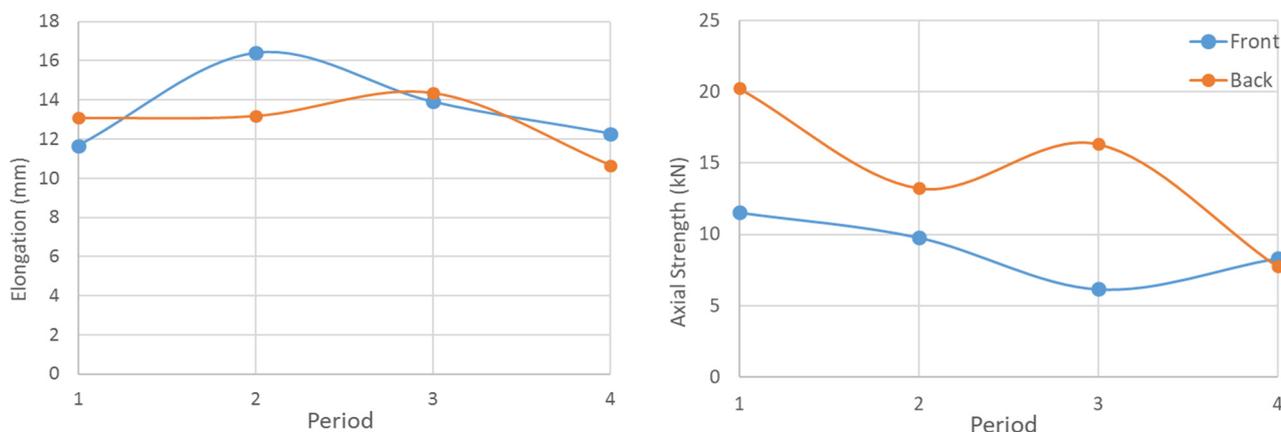
**Figure 8.** The variation in axial strength (left) and elongation (right) of specimens versus pursuing periods determined from tensile test.

Based on Figure 8, it appears that the temperature distribution over time aligns with the axial strength variation in pinewood material, particularly for samples taken from the front-facing side of the building. This suggests that direct sunlight and a more saline environment can affect the strength of pinewood material in building materials. On the other hand, back-facing samples are more susceptible to dry air conditions compared to front-facing ones, and this discrepancy has a nearly twofold impact on the material's axial strength [83]. When investigating the axial deformation of materials, it seems that humidity also has a greater influence on the elongation, or axial strain, of the material compared to temperature [84]. To address this, in addition to scheduling maintenance during optimal times, thermal modification can be a viable solution for improving the mechanical properties of wooden structures, including strength, dimensional stability, and durability while reducing heterogeneity [85,86]. A study by Zhang et al. [87] on bamboo samples revealed that vacuum thermal modification enhanced dimensional and moisture stability, axial compressive strength, and hardness. In general, elongation, or ductility, of the material increased, but air conditions affected front- and back-facing specimens differently. While both sides experienced an increase in elongation with humidity, front-facing specimens in the second period showed a greater increase compared to back-facing ones. However, front-facing samples responded differently to sunlight and a saline environment, and when humidity levels peaked in the third period, the elongation of back-facing specimens continued to rise while that of front-facing ones plateaued.

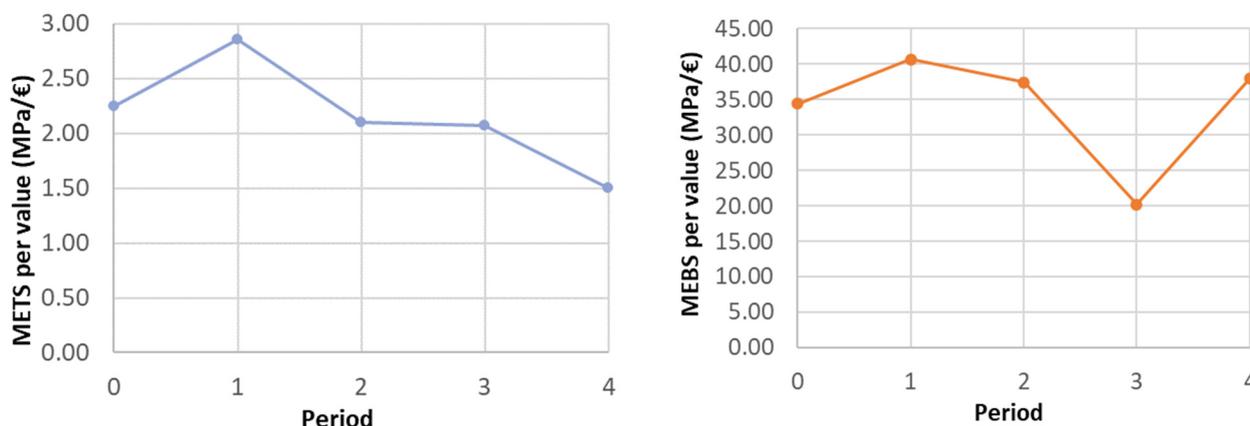
**Figure 9.** The change in per unit values of material over the pursuing periods determined from the tensile test (left) and bending test (right).

The economic changes in per unit values, as calculated in Tables 4 and 5, are visually represented in Figure 9. It is clear that the curves in both figures increase at first and then dramatically decrease in the third period of the year. The results show that the Maximum Equivalent Tensile Strength (METS) per unit value reaches its lowest point in the fourth period, but the decrement is relatively smaller than in the third period. Additionally, the Maximum Equivalent Bending Stress (MEBS) per unit value reaches its minimum value in the third period, resulting in a very low economic value. However, it does receive a relatively lower increment in the fourth period compared to the previous one. Therefore, it can be concluded that the loss of economic value due to changes in the physical properties of the wooden material mainly occurs in the third and fourth periods, which are exposed to marine weather conditions. Due to concerns surrounding the sustainable sourcing of wood as a raw material and procurement issues [89], the monetary values of timber structures are increasingly crucial compared to other construction methods.
