## Evaluation of Mechanical Tomato Harvesting Using Wireless Sensors

Silvia Arazuri \*, Ignacio Arana and Carmen Jaren

**Abstract:** The harvesting of processing tomatoes is fully mechanised and it is well known that during harvest, fruits are subjected to mechanical stress causing physical injuries, including skin punctures, pulp and cell rupture. Some wireless sensors have been used for research during recent years with the main purpose of reducing the quality loss of tomato fruits by diminishing the number and intensity of impacts. In this study the IRD (impact recorder device) sensor was used to evaluate several tomato harvesters. The specific objectives were to evaluate the impacts during mechanical harvest using a wireless sensor, to determine the critical points at which damage occurs, and to assess the damage levels. Samples were taken to determine the influence of mechanical harvest on texture, or on other quality characteristics including percentage of damages. From the obtained data it has been possible to identify the critical points where the damages were produced for each one of the five harvester models examined. The highest risk of damage was in zone 1 of the comb

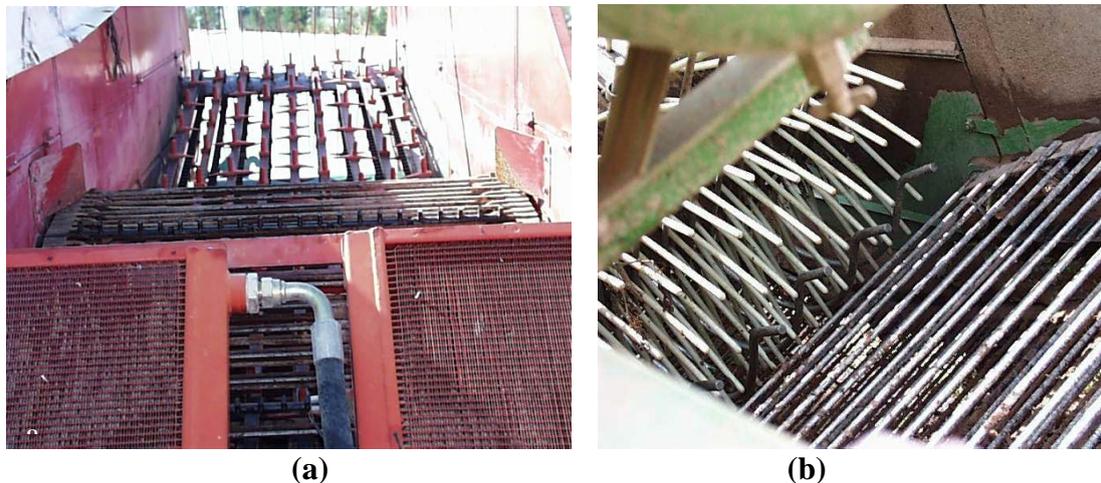
**Figure 1.** Harvester shaker systems: (a) belt shaker and (b) rotary shaker.

There are two types of shakers (Figure 1): those using belts or rotary shakers. Nowadays, there is a tendency to prefer rotary shakers instead of belt shakers, since they have a reduced size, require less energy in tomato selection and are more silent.

The belt shaker consists of several belts which produce horizontal and vertical vibrations in plants, allowing separation of the tomatoes. The gap between belts allows the fruits to fall to another belt to continue the selection process while the plant is expelled at the rear of the harvester.

The rotary shaker consists of a cylindrical rotor with gum rings located above. These rings contain a number of flexible equidistant sticks. During rotation, which is very slow, an engine moves two eccentric masses located at either side of the unit. They swing around two different and parallel axes, equidistant to the main rotation axis to which they are joined by a holder. The effect of these movements is to vibrate the plant.

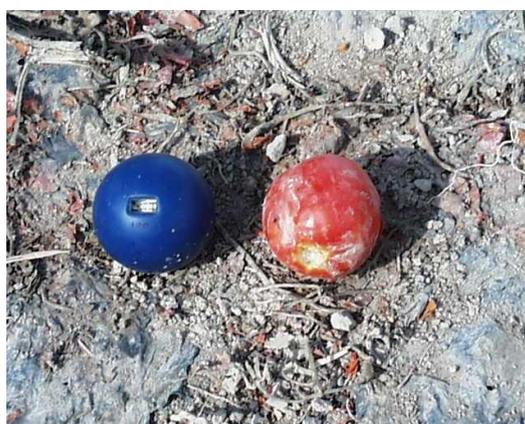
**Figure 2.** IRD sensor near a tomato fruit.

Impact measurement on tomatoes was done using the IRD-400 wireless sensor (Figure 2). It was developed at the Michigan Agricultural Experiment Station and the USDA's Agricultural Research Service (United States). It is mainly used in fruit packing lines and consists of a tri-axial accelerometer as sensor, a microprocessor device designed for data collection, an internal real-time clock, and a rechargeable Ni-Cd battery [8].

The IRD-400 is a new version of the IS-100 and is manufactured by Techmark, Inc. It has a 3,906 Hz sample rate, a sensitivity of 6-300 g and an accuracy of 3%. A 64 mm diameter IRD was used because this size is the nearest to the size of commercial processing tomato fruits. The IRD-400 is controlled by the user using the PCIRD© software version 3.03, provided by Techmark, Inc. Using this software, the user defines the impact sensitivity and other data collection parameters, begins and stops impact recording, and uploads and interprets impact data [19]. The acceleration chosen to be considered zero impact was 50 g [20] because peaches and apples were not damaged by impacts under

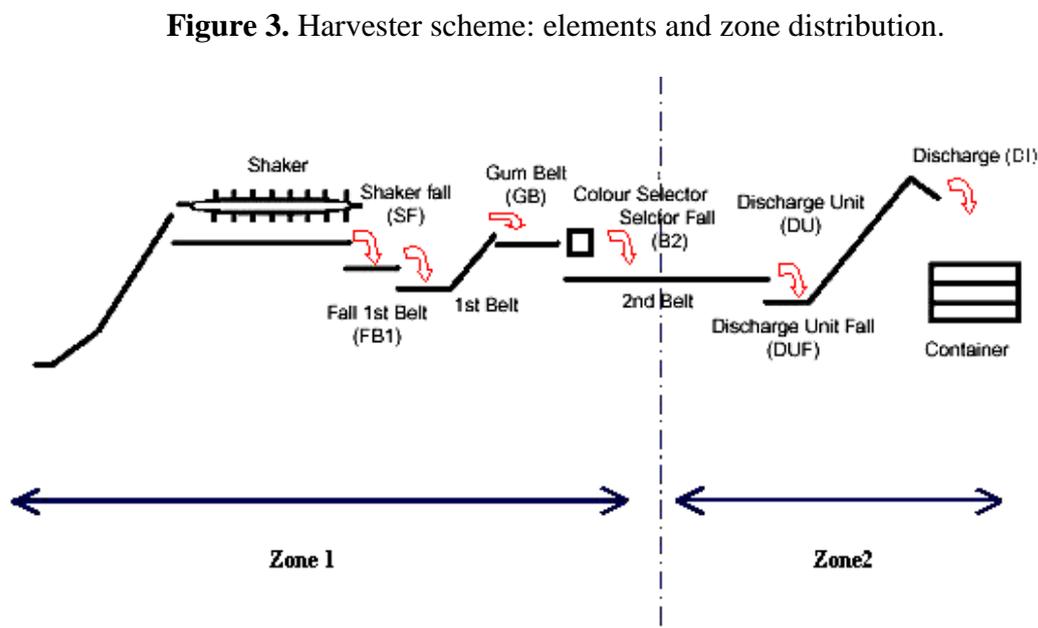
The elements of the harvesters were divided in two general zones to evaluate the damages (Figure 3):

Zone 1: from the cutting system to the second belt.

Zone 2: from the second belt to loading onto the trailer.

Although all elements or transfer points were tested (Figure 3) some of the main elements focused on were:

- (1) shaker: the tomatoes are separated from the plant by vibrations;
- (2) out of shaker: step between shaker and sorting belts;
- (3) sorting belts: rest of plants, stones, *etc.* were eliminated by hand;
- (4) drop to unloading unit: this unit received tomatoes from sorting and discharged them onto a trailer; and,
- (5) loading onto the trailer or discharge to transport.

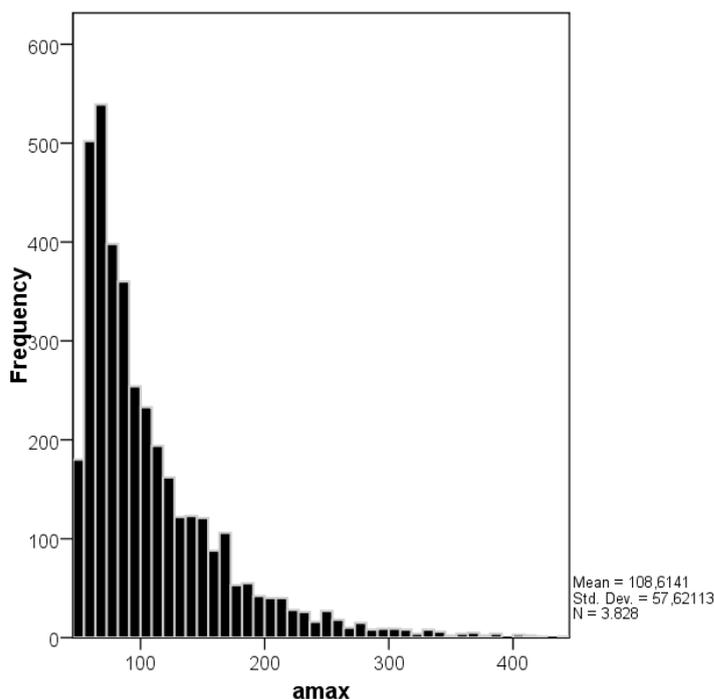
**Figure 4.** Distribution of the impacts according to the impact acceleration  $a_{\max}$ .

The majority of the registered impacts (Figure 4) had maximum accelerations values ( $a_{\max}$ ) between 60 and 180. There were few impacts with  $a_{\max}$  above 300, but there were some impacts that reached an  $a_{\max}$  value of 440.

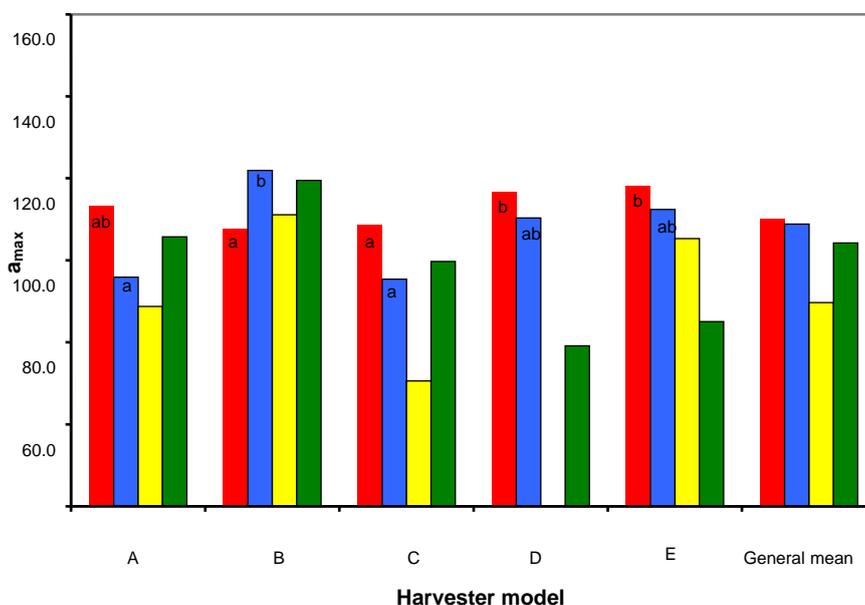
**Figure 5.** Impact acceleration ( $a_{\max}$ ) for the harvester elements: ■ shaker; ■ discharge unit fall; ■ discharge unit; ■ discharge unit's exit. Different letters in each column are significantly different ( $p < 0.05$ ).

The differences in  $a_{\max}$  between machines are shown in Figure 5:

- (1) Shaker: the average rates on this element could be classified as level 3 impacts, medium-high acceleration. Two groups were distinguished, E, D machines with  $a_{\max}$  rates higher than 110 and, on the other hand, B and C with lower rates. The  $\Delta v$  variable (data not shown) also divided the machines into two groups. In the first one, were B and E (1.34 m s<sup>-1</sup> and 1.38 m s<sup>-1</sup>, respectively), models in which the impacts happened on a less absorbing surface, –compared to greater than 1.6 m s<sup>-1</sup> for the rest of the harvesters.

- (2) Discharge unit fall (DUF): in this transfer, although generally tomatoes fall on the harvested tomatoes, several  $a_{\max}$  rates in B harvester exceeded 120. At this point, the highest risk of damage was found in the D harvester with an  $a_{\max}$  value of 110.34 and a  $\Delta v$  value of 1.53 m s<sup>-1</sup>.

- (4) The discharge unit's exit (DUE): harvester models A and B showed the highest medium values for  $a_{\max}$ , 105.7 and 119.5, respectively, while the rest of combines showed lower medium values for this variable, 79.2 for D, 85.0 for E and 99.7 for C. On the other hand, A, C and D showed the lowest  $\Delta v$  values: 1.48 m s<sup>-1</sup>, 1.11 m s<sup>-1</sup> and 1.38 m s<sup>-1</sup>, respectively. Therefore this element is a critical point for A combine because of the  $a_{\max}$  high value and the low  $\Delta v$  value and also for the C combine because of the really low  $\Delta v$  value and the high  $a_{\max}$  value.

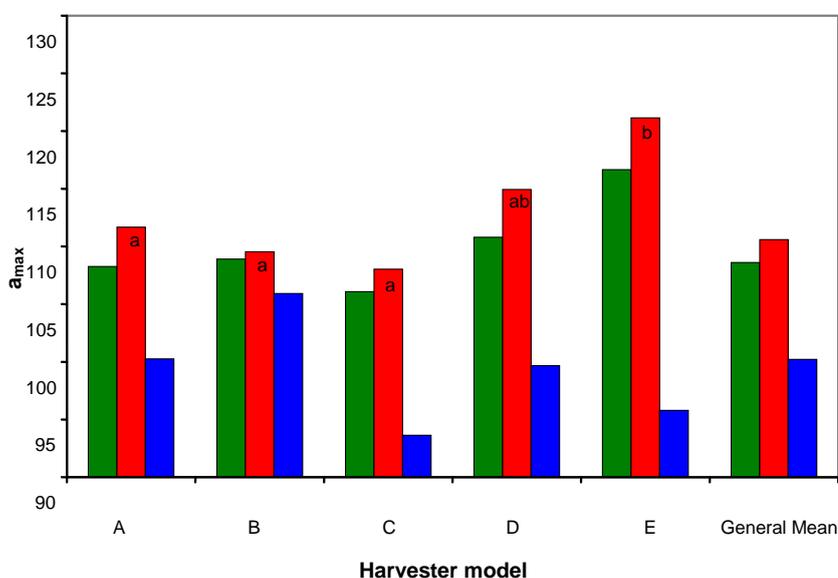
**Figure 6.** Impact acceleration ( $a_{\max}$ ) for each harvester and each zone: ■ harvester mean value; ■ zone 1; ■ zone 2. Zone 1: combine elements from cutting device to second belt. Zone 2: combine elements from second belt to loading onto the trailer. Different letters in each column are significantly different ( $p < 0.05$ ).

The highest intensity impacts and the lowest velocity changes took place in zone 1, thus the risk of tomato damage was higher in this zone of the machines (Figure 6 and Figure 7). The colour selector in zone 1 was not used in these field assays because it eliminated the IRD as another strange element. That is why this step was done by hand, but in all cases the height and the conveyor belt material was the same. In order to solve this problem the selector was characterised in empty machine assays which revealed the colour selector as one of the most critical zones, causing an increase of differences between zones 1 and 2.

Figure 6 shows the impact intensity registered on each combine harvester and zone. Data distinguishes two groups in zone 1, with E having higher impact intensity compared to all other machines except D which is intermediate. In zone 2, there are no statistically significant differences between the five combine harvester models. There were no significant differences between the different combine models for harvester mean  $a_{\max}$  variable.

Finally, Figure 6 shows the  $a_{\max}$  data registered by the IRDs during the harvesting tests. The average impact acceleration values were between 106 and 116 for all the machines and the difference between models lies on the  $\Delta v$  variable (Figure 7). The harvester B, with a significantly lower value of  $\Delta v$  showed the greatest risk to damage tomatoes, because for the same intensity value, the impacting surface absorbed less energy.

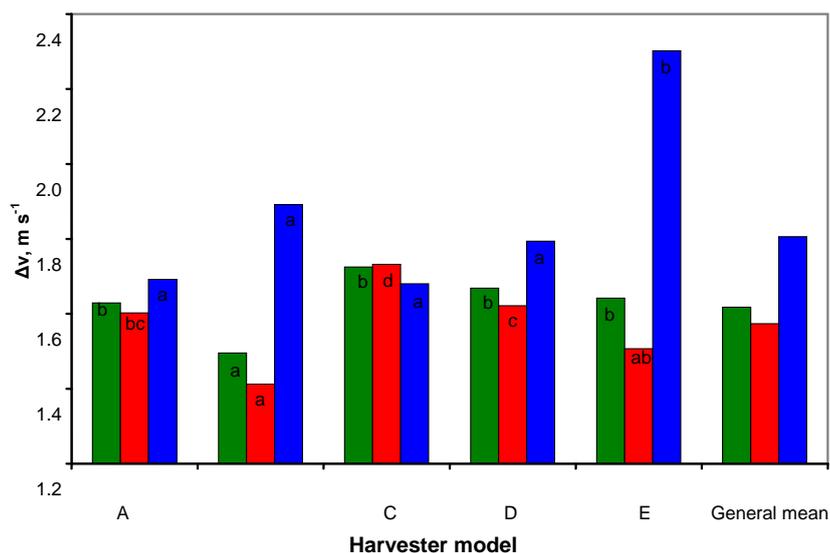
**Figure 7.** Velocity change ( $\Delta v$ , in  $\text{m s}^{-1}$ ) for each harvester and each zone: ■ harvester mean value; ■ zone 1; ■ zone 2. Zone 1: combine elements from cutting device to second belt. Zone 2: combine elements from second belt to loading onto the trailer. Different letters in each column are significantly different ( $p < 0.05$ ).

The velocity change  $-\Delta v-$  showed more variation (Figure 7). In zone 1, the lower values for  $\Delta v$  were registered in B and E. Therefore, the impacts on less absorbing surfaces occurred in these harvesters. D and A showed medium values for this variable and C reached the highest values. In zone 2, E showed significantly higher  $\Delta v$  impacts.

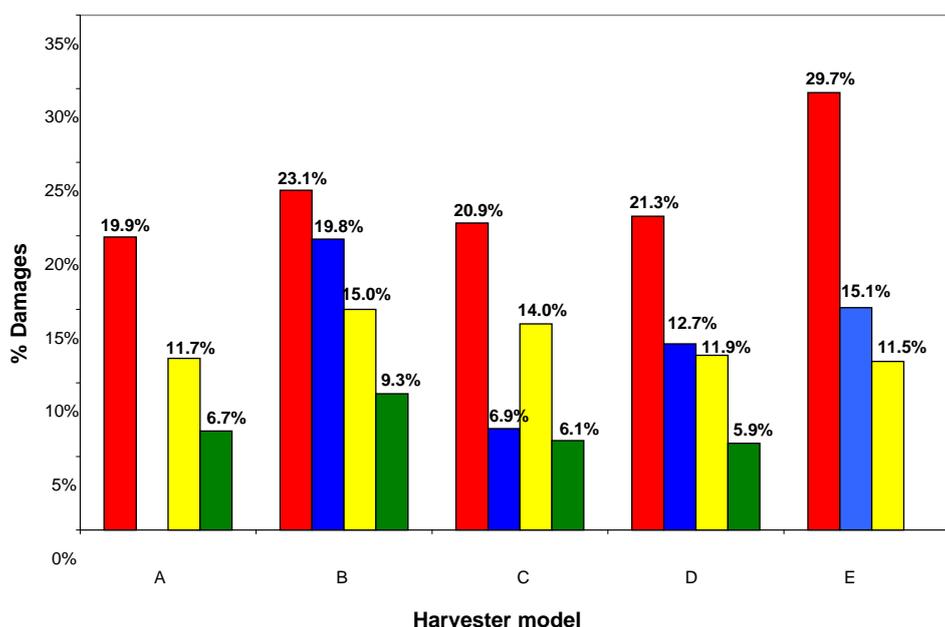
**Figure 8.** Total damages (%) recorded for each harvester and each year: ■ year 1; ■ year 2; ■ year 3; ■ year 4.

The total percentage of damages/year produced in each harvester did not exceed 30% (Figure 8). With the exception of C, that produced very low damage in the second year, the tendency was for damage to decrease year by year. In the second year, damages data were not recorded for harvester A.

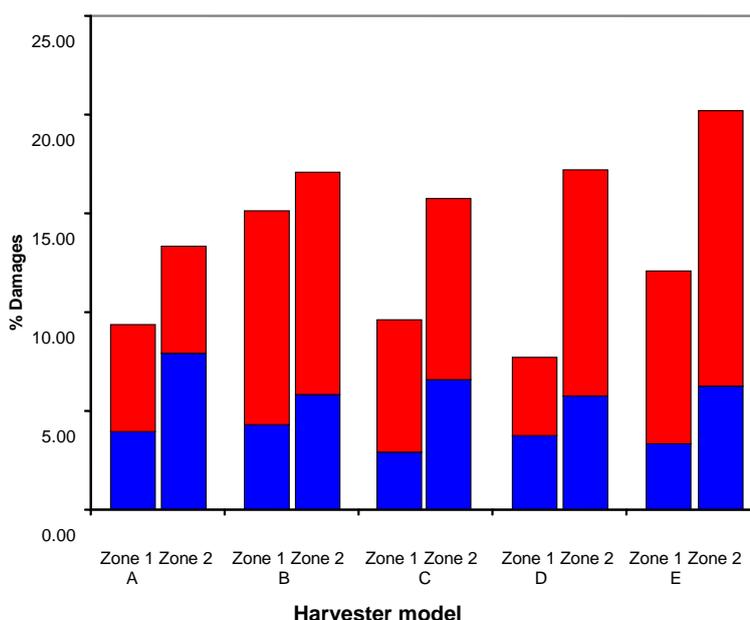
**Figure 9.** Total damages registered per harvester and zone: ■ % broken; ■ % cracked. Zone 1: combine elements from cutting device to second belt. Zone 2: combine elements from second belt to loading onto the trailer. Cracked tomatoes with only skin damages. Broken tomatoes with deep damages.

Figure 9 shows the percentages of cracked and broken tomatoes in each harvester during the discharge (zone 2). These data do not include the cracked and broken tomatoes from zone 1, which were previously eliminated (the total number of tomatoes damaged in zone 2 were corrected using the percentage of tomatoes damaged in zone 1). Thus, it is assured that the damages observed in the trailer were produced in zone 2 of the harvester. The lowest percentage of cracked tomatoes was found in D and the highest in A. With regard to broken tomatoes the highest rate was in E and the lowest in A. However, the data didn't show significant differences among harvesters.
