## Fabrication Quality Analysis of a Fiber Optic Refractive Index Sensor Created by CO<sub>2</sub> Laser Machining

**Keywords:** CO<sub>2</sub> laser machining; optical fiber sensor; refractive index sensing

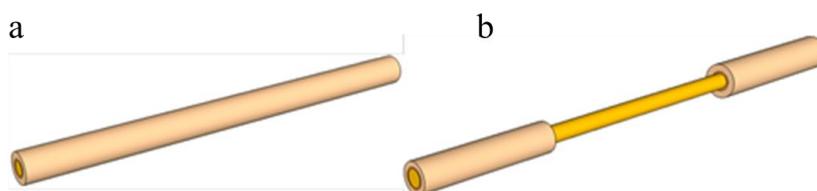
**Figure 1.** Schematic of the fiber sensor: (a) crude fiber; and (b) fiber sensors (window type).

Based on the above discussion, and to further understand the basic characteristics of window-type optical fiber sensors, we used CO<sub>2</sub> laser processing as the fiber optic sensor processing method in this study because the laser-processing parameters are convenient to configure and provide a wider range of basic characteristics. Studies of common optical fiber sensors typically investigate only fiber optic sensor fabrication methods or the resolution and sensitivity of back-end sensing applications; the processing quality of the sensing area is rarely examined [13–15]. Poor-quality processing, such as over-processing resulting in excessive removal or modification of material, can reduce the sensor resolution and sensitivity, cause light scattering in the sensing area, insufficient sensing power, or functional surface coverage during subsequent surface plasmon resonance (SPR) or particle plasmon resonance (PPR) detection [16,17]. Therefore, the purpose of this study was to eliminate defects or residue from the sensing area of window-type optical fiber sensors. We examined the CO<sub>2</sub> laser processing results for the sensing area and established a CO<sub>2</sub> laser processing quality inspection method. Finally, a window-type optical fiber sensor was developed according to the optimal processing conditions identified in this study, and the sensor performance was subsequently verified.

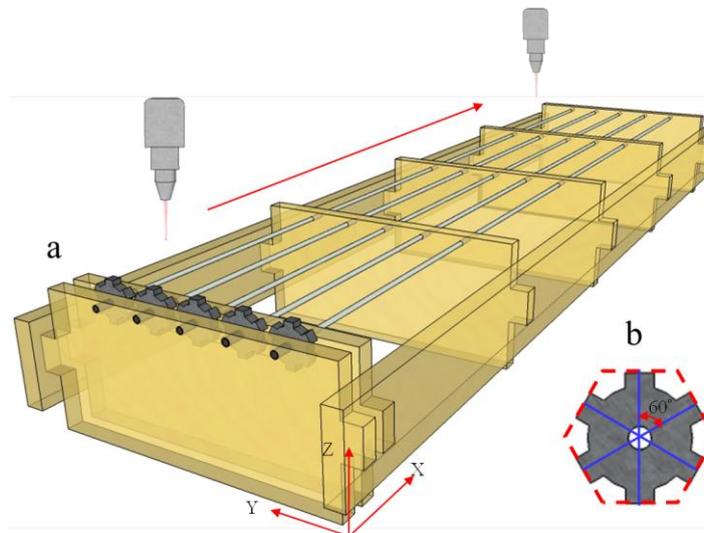
**Figure 2.** Schematic of the laser machining fixtures: (a) the processing fixture; and (b) the rotating and fixed optical fiber fixture.

The adjustable parameters of the CO<sub>2</sub> laser machine (Model Mercury-II M-12, LaserPro Inc., New Taipei, Taiwan) employed in this study included the processing power (1 W to 10 W), processing speed (0.63 cm/s to 63 cm/s), laser-sourced cooling nozzle pressure (0.1 MPa at less than 60 psi), and focusing position (adjusted by altering the Z-axis in the machine's three-axis displacement platform). The non-adjustable parameters were the laser pulse width ( $\pm 0.2 \mu\text{s}$ ) and pulse frequency (5 KHz). This study primarily analyzed the sensing area quality of laser-processed optical fiber sensors. To conduct various quality analyses more accurately, we set the fixed length of the sensing region to 1 cm, the focusing position on the fiber core to 0.1 mm, the laser pulse width to  $1 \pm 0.2 \mu\text{s}$ , the laser pulse frequency to 5 KHz, and the air nozzle gauge pressure to 0.3 MPa for air processing. In this study, we considered the laser processing power and speed, in addition to self-developed fixtures, to explore the laser processing path. Figure 2(a) shows the processing fixture used to attach the processed optical fibers; this fixture is capable of attaching five optical fibers simultaneously. Figure 2(b) shows

a rotating fixture with a central hole packed tightly with optical fibers ready for processing in lockstep rotation. Using the preset structure highlighted at every  $60^\circ$ , the operator can process optical fibers every  $60^\circ$  a total of six times.

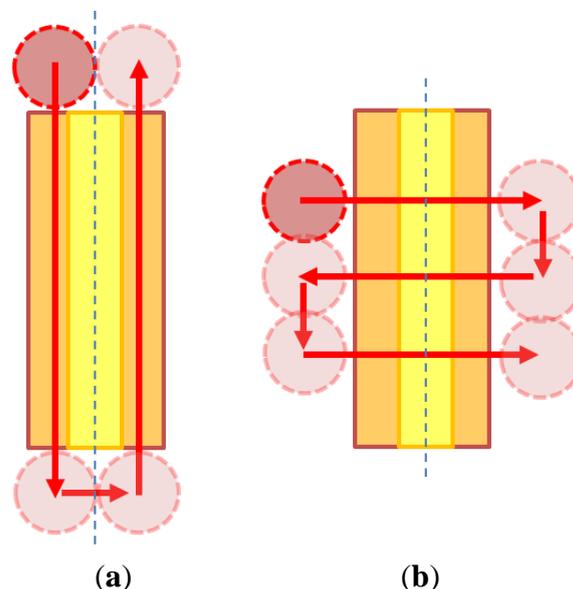
**Figure 3.** Schematic of the laser processing path: (a) parallel machining; and (b) vertical machining.

The yellow portion of the structure shown in Figure 3 is the optical fiber to be processed, the blue dotted line denotes the established processing direction of the optical fiber, and the red arrows and circular patterns represent the moving path and processing area of the laser source. When the laser source and the blue dotted reference line move horizontally during processing, the structure adopts the parallel machining condition; otherwise, the vertical machining condition is employed.

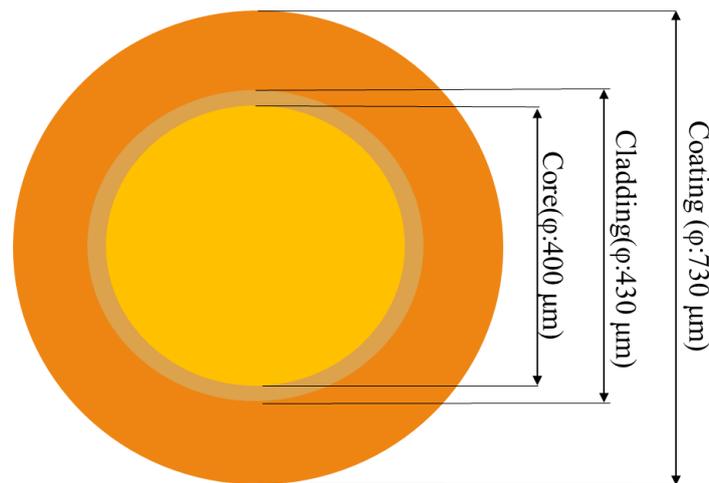
**Figure 4.** Schematic of the optical fiber.

The research goals of this study were to propose a comprehensive method for assessing the quality of window-type optical fibers processed by lasers, the convenience of light coupling in subsequent sensing measurements, and the mechanical strength of manufactured window optical fibers. Therefore, we employed a multi-mode glass optical fiber with a 400- $\mu\text{m}$  fiber core, manufactured by Newport<sup>®</sup> under the model number F-MBC, as the optical fiber. Regarding the size and structure, the optical fiber comprised a 400- $\mu\text{m}$  fiber core, 430- $\mu\text{m}$  cladding, and 730- $\mu\text{m}$  coating, as shown in Figure 4. The fiber core was made of silica material, the cladding was made of hard and brittle polymer, and the coating was made of Tefzel material. These materials were used to provide the optical fiber with superior mechanical protection.

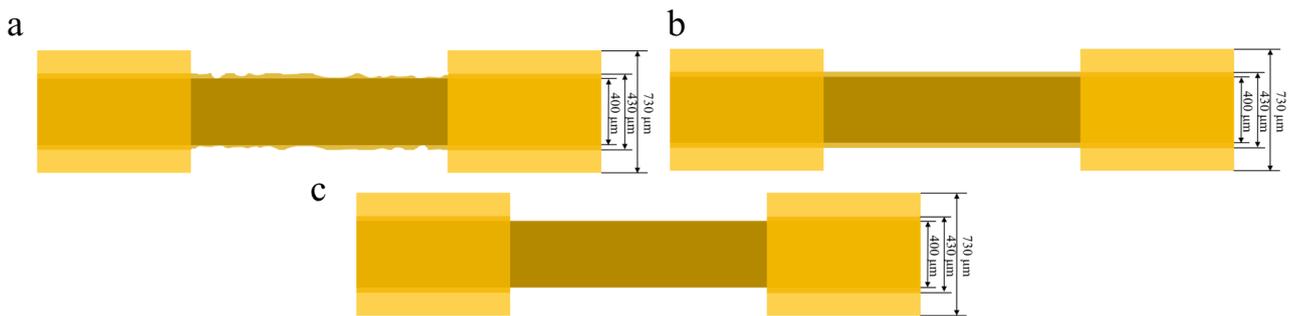
**Figure 5.** Schematic of an optical fiber cable: (a) partially removed; (b) insufficiently removed; and (c) completely removed.

1. The fiber core and coating material is either completely or partially removed, as shown in Figure 5.
  - (a) The fiber core and coating material are partially removed.
  - (b) The fiber core and coating material are insufficiently removed.
  - (c) The fiber core and coating material are completely (maybe even excessively) removed.
2. The surface of the fiber core is altered, as shown in Figure 6.
  - (a) The surface changes are not uniform.
  - (b) The surface changes are uniform.
3. The fiber core shape changes, as shown in Figure 7.
  - (a) Wavy pattern
  - (b) Excessive removal

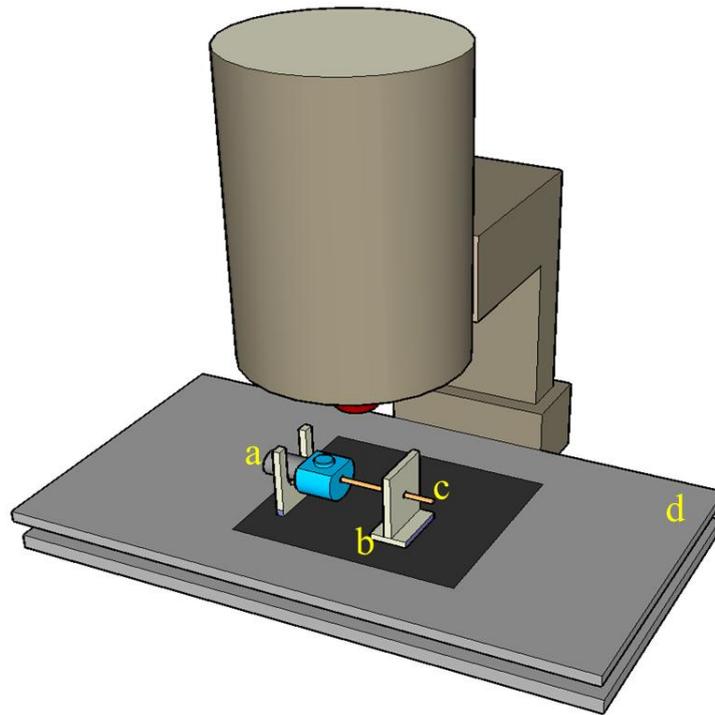
**Figure 8.** Schematic of the measuring instrument: (a) fiber connector; (b) measuring fixture; (c) processed fiber; and (d) micro-stage.

This element can identify lacking, incomplete, or excessive removals and distinguish between the two defect types, namely, wavy pattern and excessive removal, during fiber core modifications. The measuring instrument is shown in Figure 8. The optical fiber sensor location point measurements are shown in Figure 9. First, data from Points 1 and 6 were removed because the cumulative thermal effect at these two points was relatively lower than the processing level in other areas. To prevent the values measured at these two points from affecting the values measured at normal processing areas, we use them to verify the total processing length at the sensing area. Then, the additional diameter of the processing core was used as the average value of the four remaining data groups (the remainder of the core,  $D_c^R$ ).

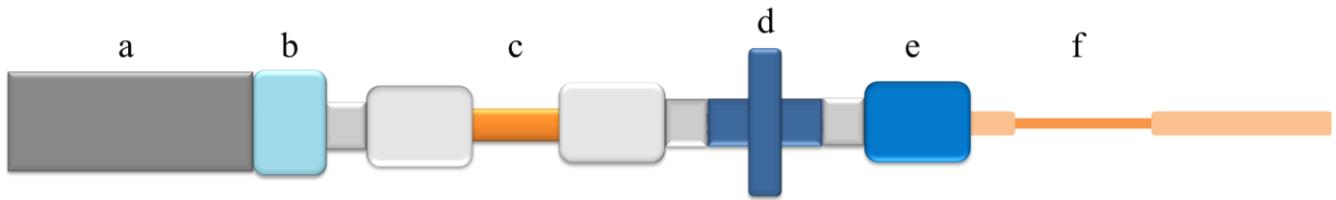
**Figure 10.** Diagram of the components of an optical light transmission defect: (a) laser source; (b) collimator; (c) fiber cable (NA = 0.27); (d) fiber adapter; (e) fiber connector; and (f) fiber sensor (NA = 0.37).

The light transmission defect detection method was primarily based on internal optical fiber core propagation by optically coupling the laser to the process. For this study, we used the structure shown in Figure 10 to guide the laser light inside the optical fiber sensor as it propagates. First, an optical collimator was used to focus the laser source (wavelength: 532 nm; power: 10 mW) inside the optical fiber transmission line (NA = 0.27) during light propagation. At this time, light from the source was transmitted to the end with an NA value of 0.27 and then guided through the optical fiber adapter as it propagated within the optical fiber core (NA = 0.37). The Optical fiber core was then examined to confirm that the confined light source was guided to the core of the optical fiber when propagating. A diagram of the measurement is shown in Figure 11. When the surface is irregular or contains debris from processing, according to the optical transmission principle, irregular surfaces in the path of light transmissions cause the light to diffuse. Observation of the light diffusion phenomenon facilitates the achievement of quality analysis objectives.

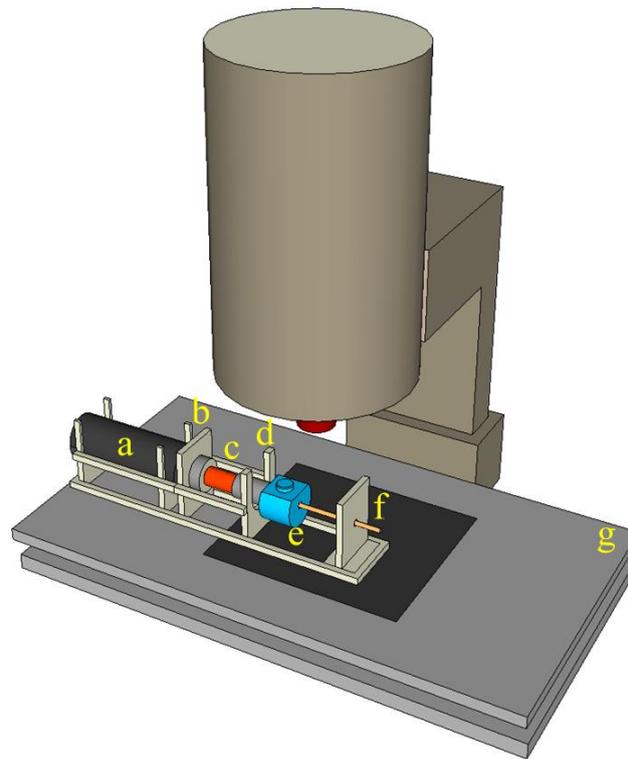
**Figure 11.** Schematic of the tool used for qualitative analysis of the optical transmission defects: (a) laser source; (b) collimator; (c) fiber cable; (d) fiber adapter; (e) fiber connector; (f) processed fiber; and (g) micro-stage.

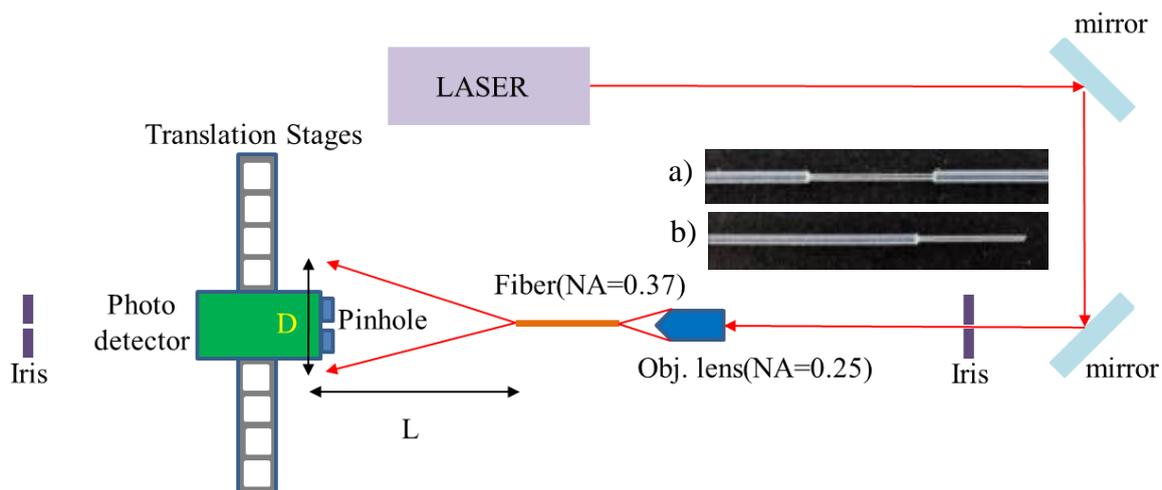
**Figure 12.** Schematic of the numerical aperture measurement instrument.

The two quality analysis methods previous mentioned were used to perform preliminary quality analysis of the laser-processed optical fiber sensors. However, to ensure that no defects remain undetected, additional in-depth investigations of the internal sensing area may be necessary. Therefore, we established a numerical aperture measurement platform to measure the post-processing numerical aperture of optical fiber sensors. The architecture in Figure 12 shows that parallel optical modulation was first conducted. Subsequently, the focusing lens and optical fiber coupler were used to focus and couple the beam onto the core inside the processed optical fiber sensor for light propagation. To measure the NA value of the optical fiber sensor area, we partially cut the processed optical fiber sensor, as shown in Figure 12(a) and 12(b), and employed the grinding method to smooth the sectioned surface for further measurement. After the light coupled to the core layer was propagated, it scattered

from the back-end of the truncated plane to the rear, forming a circular light spot with a diameter of  $D$ . This was then attached to the optical sensor using the moving platform to measure the size of the circular light spot with a diameter of  $D$  at various lengths  $L$ . According to Equation (1) [18], the  $L$  and  $D$  values measured can be employed to determine the numerical aperture value. If the sensing area of the processed optical fiber sensor shows homogeneous surface modification, the NA value of the sensing area decreases. This is because the width of the possible transmission light path is reduced by surface modifications. In this study, we used this method as a basis for identifying defects.

$$NA = \sin \theta = \frac{D}{\sqrt{D^2 + 4L^2}} \quad (1)$$

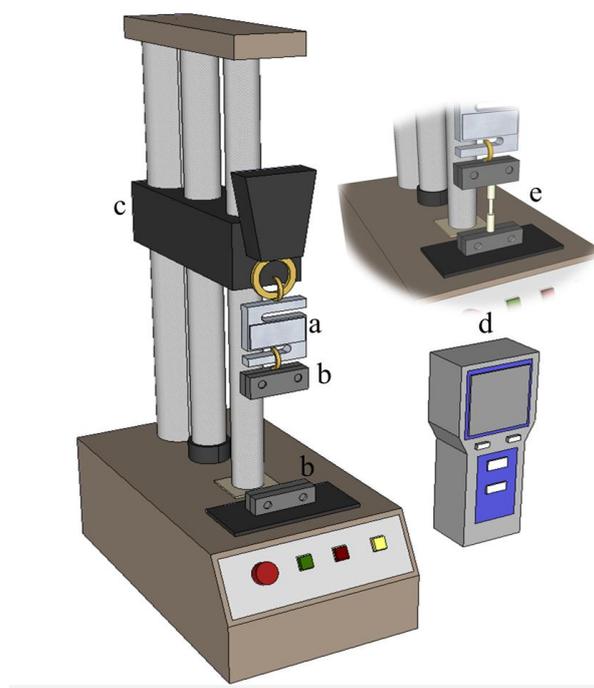
**Figure 13.** Schematic of the tensile test (Model FS-1002, Lutron Inc., New Taipei, Taiwan): (a) force gauge; (b) measuring fixture; (c) translation stage; (d) gauge value display; and (e) processed fiber.

The Weibull tensile test is suitable for analyzing the tensile properties of hard and brittle materials. The partial exposure of the optical fiber's core silica material during the laser-stripping procedure either alters the material properties or results in internally generated processing defects. If window-type optical fiber sensors contain defects not detected by the previously described quality analysis method, a Weibull tensile test can be employed to exploit the changing trends in tensile failure characteristics. Figure 13 shows a tensile test diagram. Data obtained from the tensile test are analyzed using the Weibull distribution. The mathematical formula for the Weibull distribution is shown as Equation (2), where  $P$  is the cumulative probability of failure,  $\sigma$  is the applied tension force (kgf),  $\eta$  is the scale parameter,  $\sigma_0$  is the minimum breaking tension force (kgf), and  $\omega$  is the Weibull modulus:

$$P = 1 - \exp\left[-\left(\frac{\sigma - \sigma_0}{\eta}\right)^\omega\right] \quad (2)$$

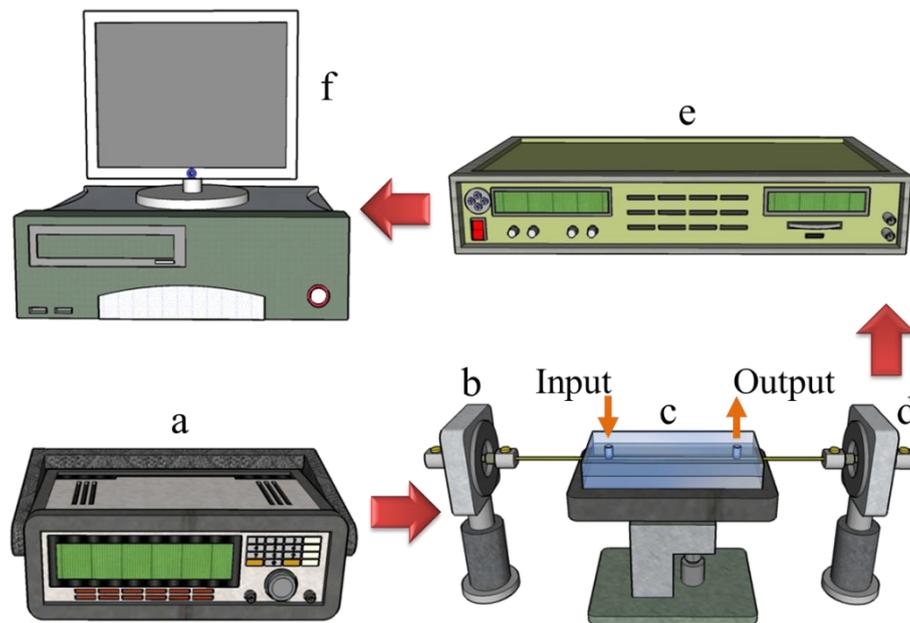
**Figure 14.** Schematic of the experimental setup for creating sensing measurements: (a) function generator (Agilent Inc. Model: 33220A); (b) LED light source (Model: EHP-AX08LS-HA/SUG01-P01, Everlight Inc.); (c) sensing chip; (d) photo diode (Model PD-ET2040, EOT Inc., Traverse, MI, USA); (e) lock-in amplifier (Model 7225, Signal Recovery Inc., Oak Ridge, TN, USA); and (f) computer.

This study investigated whether the processing parameters selected based on the quality analysis results offer sensing capabilities. The setup of the sensing experiment employed for this study is shown in Figure 14. First, a function generator (Model 33220A, Agilent Inc., Santa Clara, CA, USA) was used to generate a direct current pulse with square waves of a 1-KHz frequency and 1-V voltage to drive the green light-emitting diode (LED) light source (Model EHP-AX08LS-HA/SUG01-P01, Everlight Inc., New Taipei, Taiwan). Next, the total reflection characteristic of optical fiber was used to direct the light into the sensing area for ATR sensing. Subsequently, the optical signal was further directed through the optical fiber to the back-end signal capture device for photoelectric signal conversion and processing. The microfluidic chip was made of poly(methyl methacrylate): PMMA (chip size:  $50 \times 20 \times 8$  mm; micro-channel size:  $50 \times 1 \times 0.9$  mm) and fabricated using a computer numerical control engraving machine by our group [21]. The sensing fiber was packaged inside the microfluidic chip. The input and output ports of the microfluidic chip were used to infuse the solution flowing through the sensing fiber. The sensing environment involved the injection of various sucrose solution concentrations into a sensing microfluidic chip using a syringe for further sensing testing. For the experiment, we first prepared deionized (DI) water. The relationship between the sucrose concentration and refractive index of 1.333 to 1.383 RIU is shown in Table 1 [7]. After the sensing experiment, to compare our results with those reported in previous literature [13], we calculated the resolution of the sensor. Then, we modified the gold nanoparticles in the sensing area to conduct PPR-sensed environmental refractive index measurements [13]. The gold nanoparticles modified in the optical fiber sensing area were prepared by the study researchers [7].

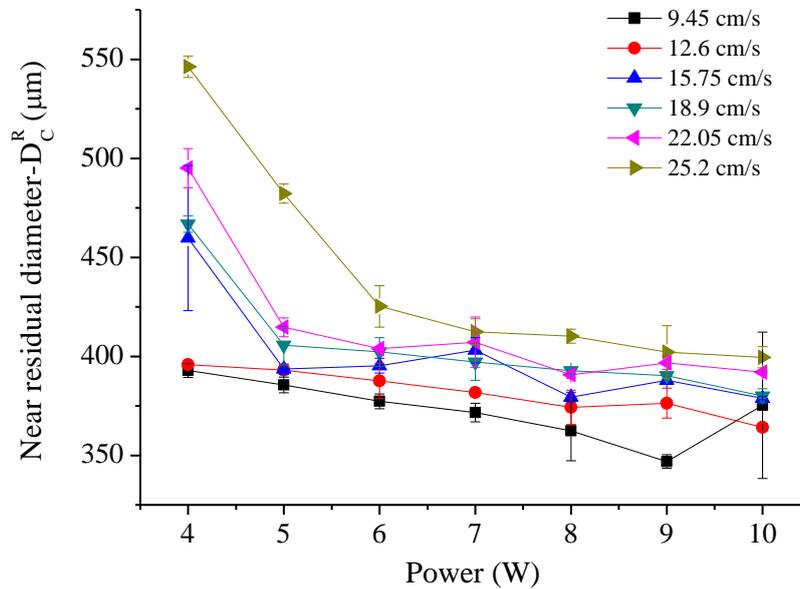
**Figure 15.** Schematic of the size analysis results (Scanning path: parallel).

This study used the parameter scanning method to identify superior parameters. First, the result of a large-range parameter measurement was employed to obtain a near residual diameter ( $D_c^R$ ) of 400  $\mu\text{m}$  at a processing speed of 9.45 to 25.2 cm/s and to arrange a parameter scanning experiment in this processing speed range. Figure 15 is a diagram showing the relationship between the power of various parallel spindle paths and  $D_c^R$ ; the results indicate that as the processing power increases, the residual diameter gradually decreases under various processing speeds. From the same perspective of processing energy, as the processing speed increases, the total energy loss per unit area per unit of time causes  $D_c^R$  to gradually increase. Figure 16 is a diagram of the vertical spindle processing relationship, which exhibits the same conditions. The line graph results in Figures 15 and 16 show that the sloping trend of parallel spindle processing exceeds that of vertical spindle processing. This suggests that the

material removal processing change rate under horizontal conditions is comparatively greater. In addition, the standard deviations of the data points from the two processing paths show that parallel spindle path processing is greater than vertical spindle path processing. The cause of this phenomenon may be the greater horizontal processing path displacement, because cumulative structure errors can lead to inconsistent processing quality.

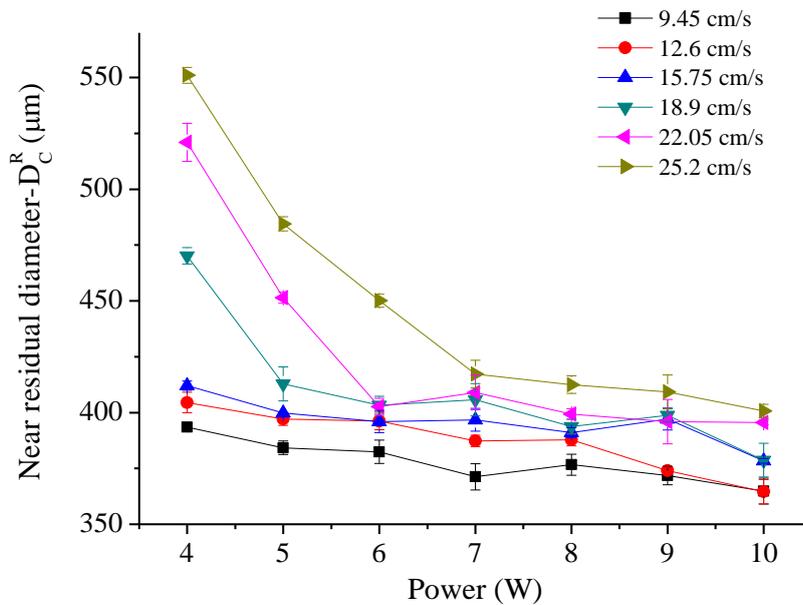
**Figure 16.** Schematic of the size analysis results (Scanning path: vertical).

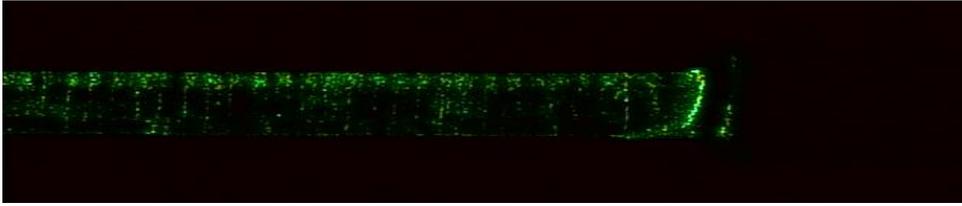
**Figure 17.** Schematic of the wavy pattern defect.

The nine sets of data obtained through size measurements satisfy the criteria for superior parameters (within the expected range). The optical defect transmission method was used to qualitatively analyze the quality of the processing area. The results in Table 3 show that under parallel processing machining conditions, with a laser processing power of 4 W and a processing speed of 9.45 cm/s, excessively low processing speeds result in exorbitant removal of material, generating wavy patterns on the surface of the processing area, as shown in Figure 17. Additionally, regarding the vertical processing machining condition, for optical fiber sensors processed with a power of 5 to 10 W and a speed of 12.6 to 22.05 cm/s, some of the material could not be removed correctly, resulting in the optical leakage phenomenon, as shown in Figure 18. Figure 19 is a diagram of the schematic without defects.

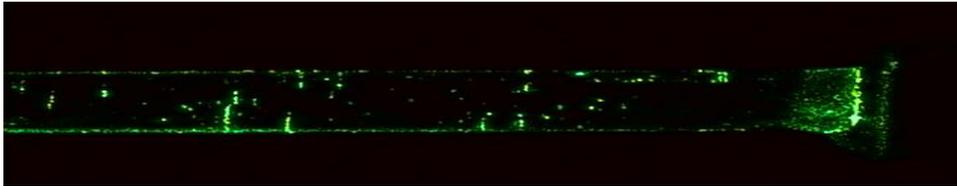
**Figure 18.** Schematic of the incomplete removal defect.

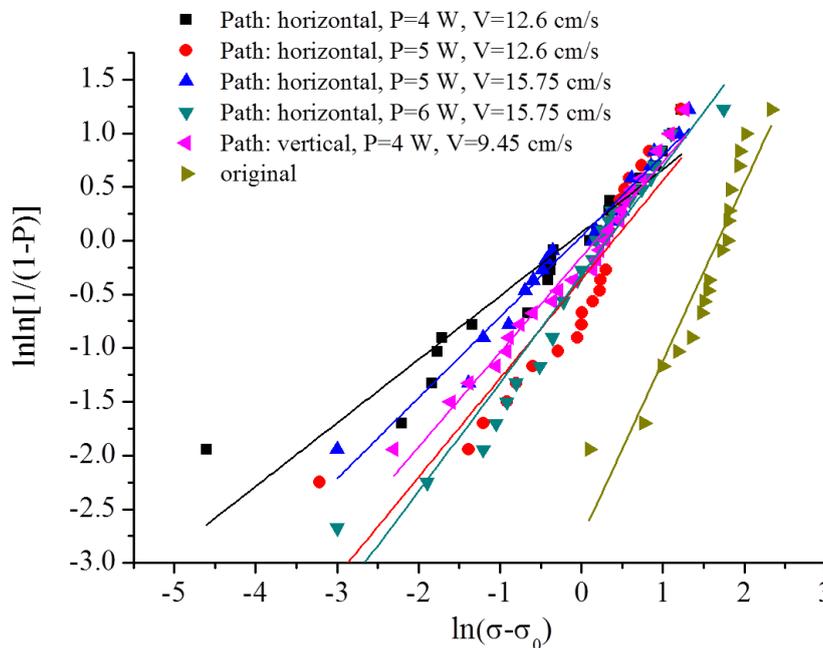
**Figure 20.** Weibull distribution.

By converting the diagram of stress and cumulative damage probability created using the Weibull tensile test, we can plot a Weibull graph. Figure 20 shows that the information in Table 5 can be obtained after linearly fitting the five parameter groups. The larger the Weibull modulus equation  $\omega$  in the Weibull distribution, the greater the reliability. Another important parameter is  $\eta$ , which belongs to the scale parameter. The larger this value, the greater the damage to the material. Additionally, the wider the fracture stress distribution, the less homogeneous the material. By contrast, the smaller the value, the more homogeneous the material. Therefore, the resulting table shows that Group 4 has a superior Weibull modulus. However, regarding the results of NA measurements, this group had the smallest value. Thus, to prevent defects, Group 4 was ignored. Statistical analysis of the NA measurement results indicated that Groups 1, 2, and 3 had no significant differences. However, the Weibull tensile analysis results showed that various parameters changed excessively. To avoid the occurrence of non-detected defects, these groups were also eliminated. Therefore, the parameters of Group 5 were selected as the optimum processing parameters for this study.

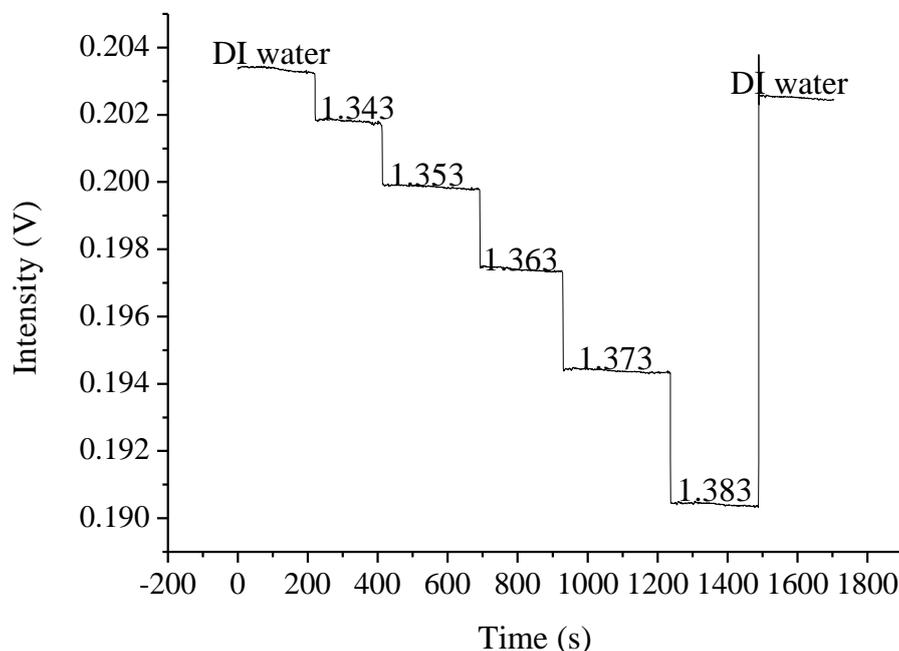
**Figure 21.** Plot of the ATR fiber sensors' temporal responses to injections of increasing sucrose solution concentrations and refractive indices.

The quality inspection method previously described was used to select processing parameters for the vertical spindle processing path. A superior set of parameters, including a processing power of 4 W and a processing speed of 9.45 cm/s, was used to create optical fiber sensors for the refractive index sensing experiments. In Figure 21, the X-axis represents the time and the Y-axis represents the signal. Figure 21 shows that the experimental intensity decreased as the injection concentration increased (refractive index increment). When the signal measurement was complete, the sensor resolution was calculated. In Figure 22, the X-axis represents the refractive index value and the Y-axis represents the signal level of each concentration after the average signal was normalized. The relationship diagram in Table 6 shows the sensor slope ( $m$ ) used to calculate the sensor resolution. After repeating the experiment three times, we obtained an average sensor resolution value of  $1.8 \times 10^{-4}$  RIU.

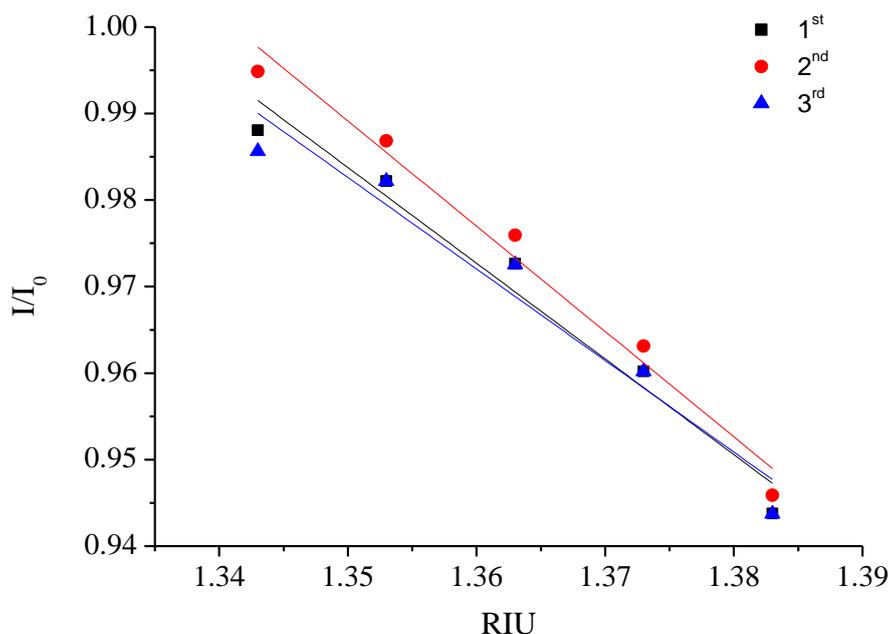
**Figure 22.** Plot of the ATR fiber sensor response *versus* the refractive index of the sucrose solution.

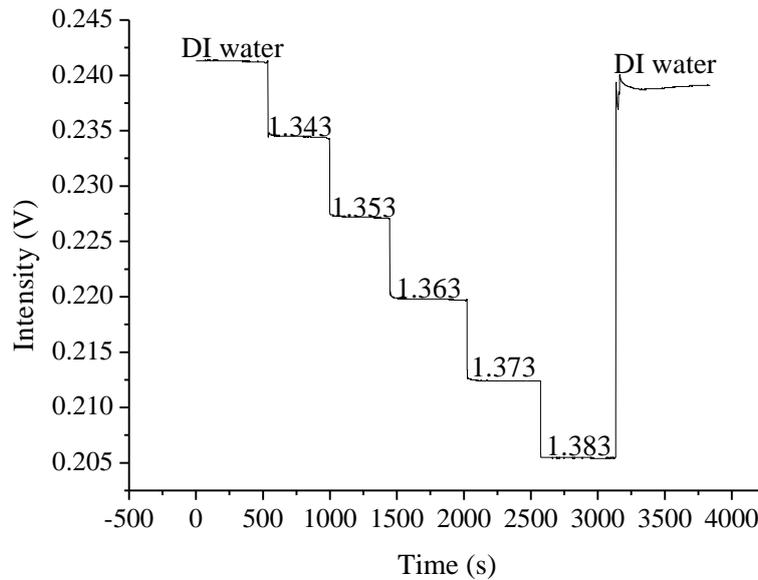
**Figure 23.** Plot of the PPR fiber sensors’ temporal response to injections of increasing sucrose solution concentrations and refractive indices.

This study also used the superior processing parameters obtained through quality analysis to create window-type optical fiber sensors by modifying gold nanoparticles [13]. The PPR sensing method was used to conduct three iterations of the refractive index sensing experiment. A diagram of the relationship between the experiment time and signal is shown in Figure 23. The relationship between the average intensity of the refractive index of a measured signal and the refractive index is shown in Figure 24. The results of the sensing resolution after linear regression are shown in Table 7. The average sensor resolution was approximately  $5.73 \times 10^{-5}$  RIU. Compared to unmodified ATR sensors, the resolution of the sensor was an order of magnitude smaller as that reported in previous literature, although the sensor length was similar [13]. The results of the linearity comparison modified sensing method are shown in Figure 25. The quality analyzed optical fiber sensors have a superior degree of linearity compared to the non-quality analyzed optical fiber sensors reported in previous studies. This may be because the removal of optical fiber material could not be confirmed in related literature. Thus, quality-analyzed window-type optical fiber sensors possess basic ATR sensing abilities, with the sensor resolution reaching a  $10^{-4}$  RIU level. Once the modified gold nanoparticles sensed using the PPR method were excited, they created a regional plasma resonance response that effectively increased the sensor resolution and linearity.

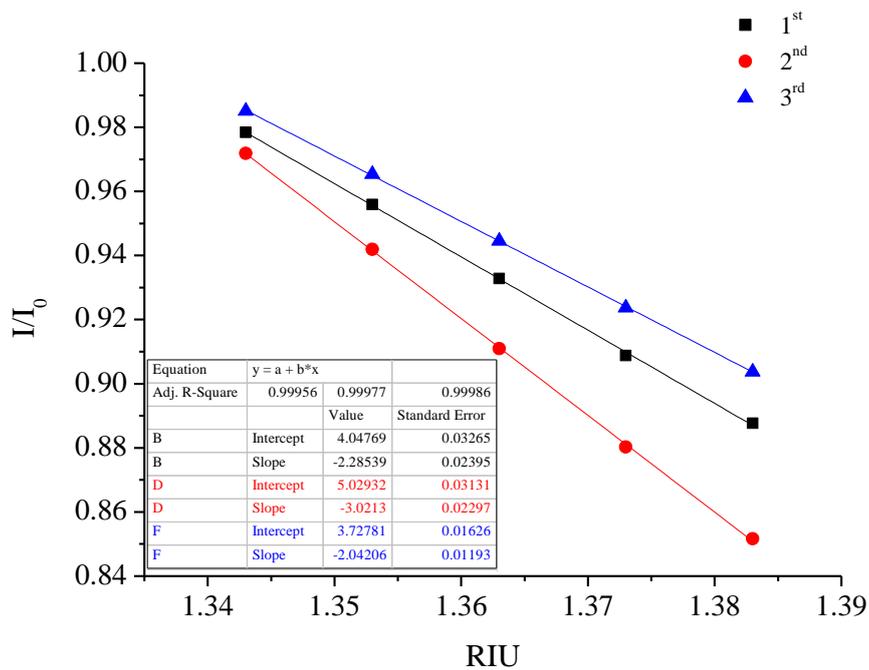
**Figure 24.** Plot of the PPR fiber sensor response *versus* the refractive index of the sucrose solution.

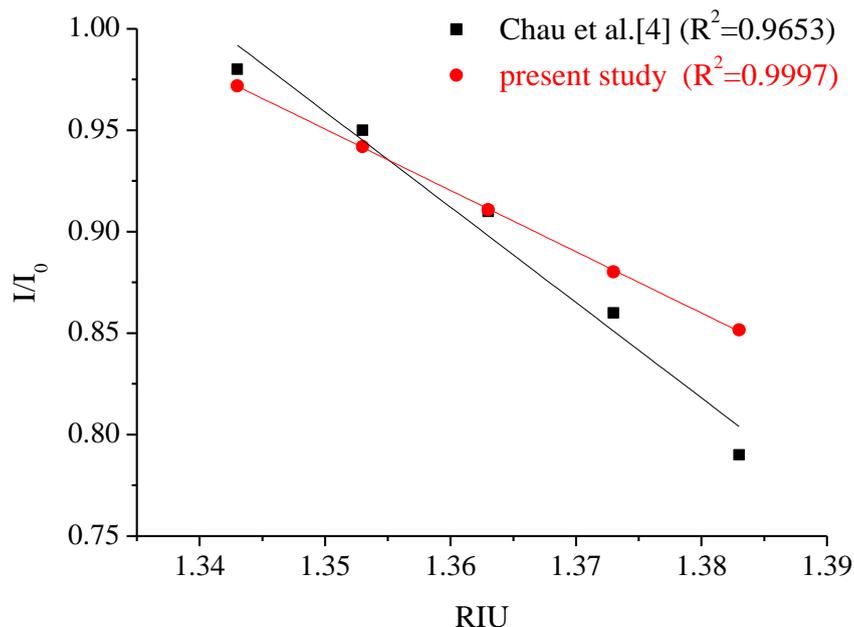
**Figure 25.** Plot of the sensor response *versus* the refractive index of the sucrose solution.
