*Article*

# Combined Use of Terrestrial Laser Scanning and IR Thermography Applied to a Historical Building

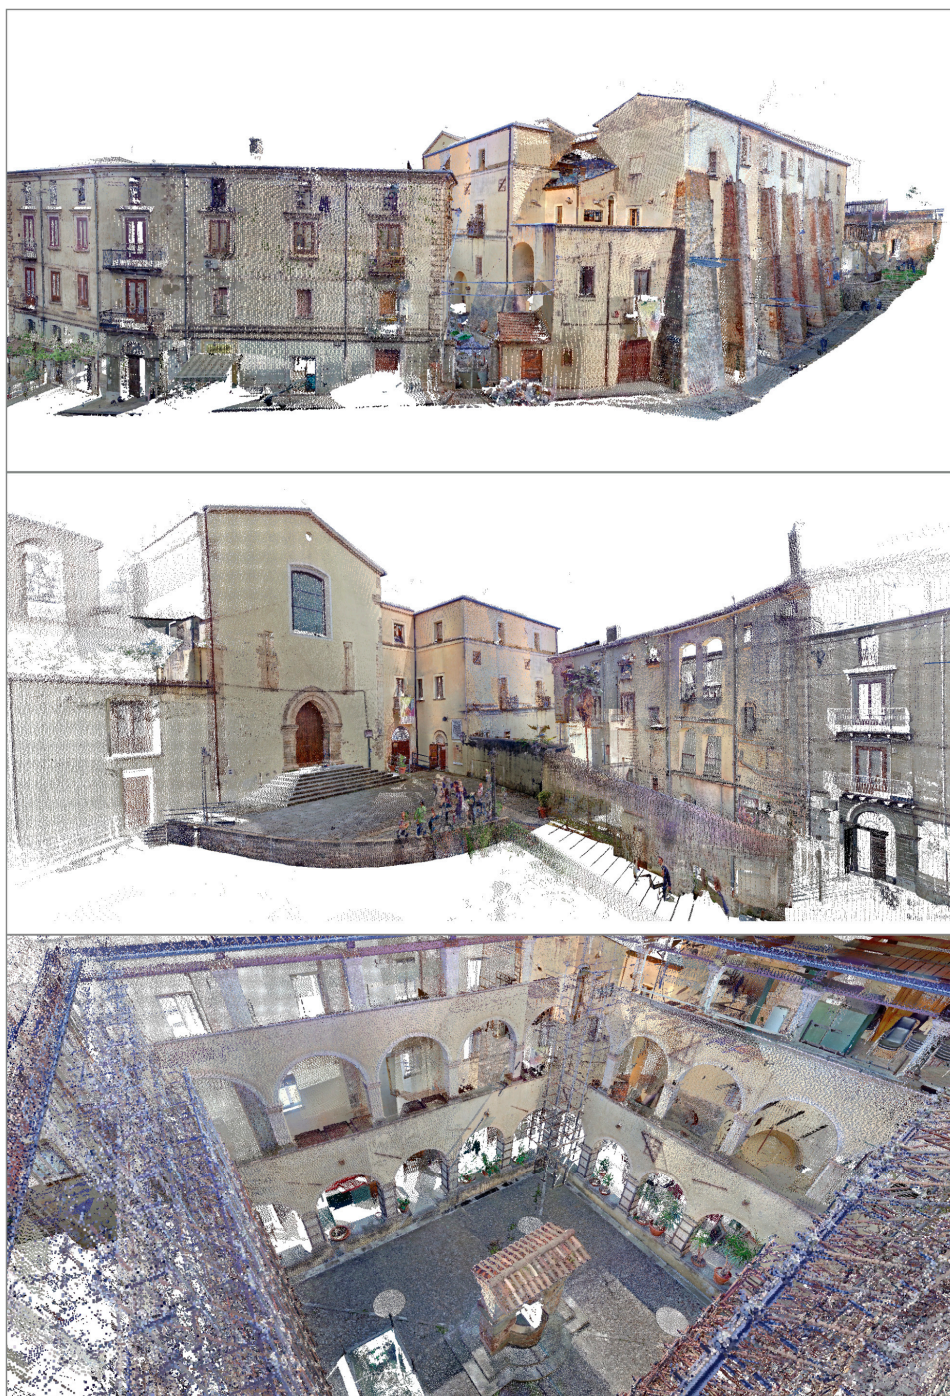
**Figure 3.** Views of the tridimensional model of the St. Augustine monumental compound obtained by alignment of the scans.

- the TLS survey permitted a complete 3D reconstruction of the building, in order to make a more accurate structural modeling and to provide the reference for the monitoring activities over time (cf. Figure 3);

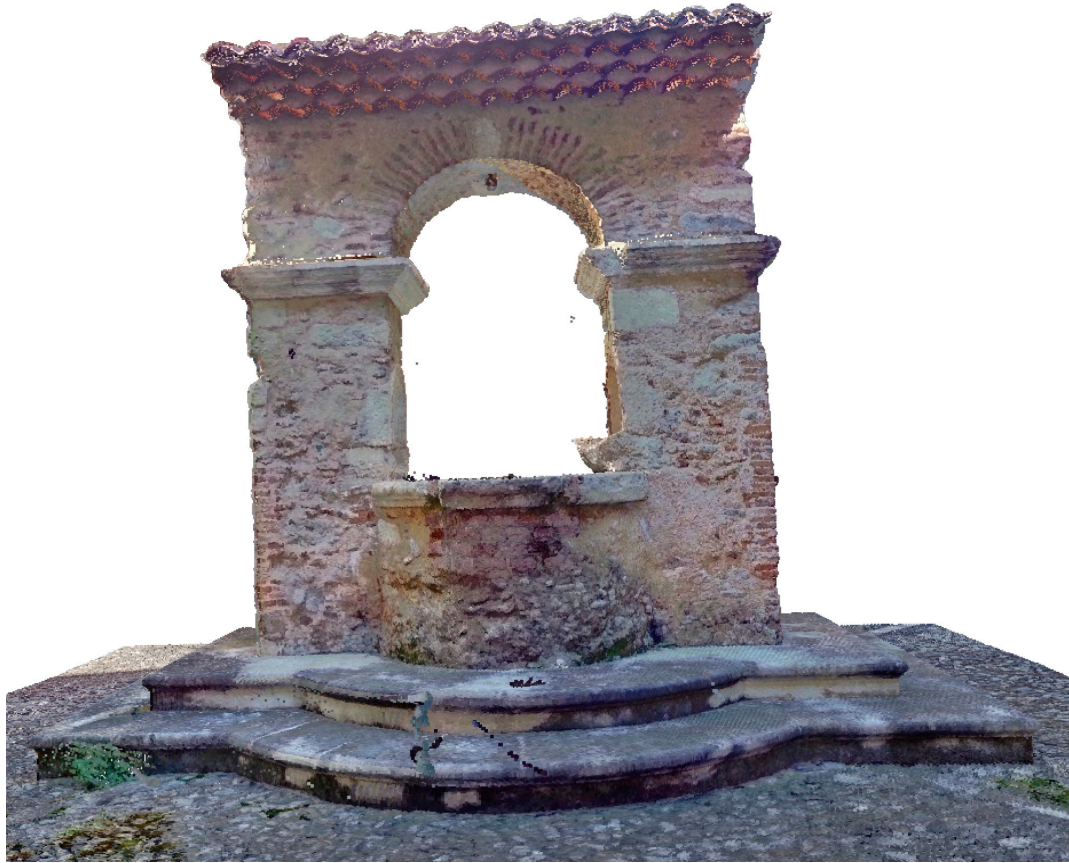
Figure 4 reproduces this functional element from the monastic life built of chaotic masonry, composed by coarse aggregates and brick-faced; all materials were reconstructed in 3D modeling with good approximation. The well, 3.15 m high and 2.81 m wide, is adorned by a rounded arch supported through two columns with square base of side about 0.70 m and decorated with capitals, making it an appreciable architectural element.

**Figure 4.** Tridimensional mesh of the well inside the cloister of the compound.

- the combination of the data provided by both TLS and IR thermography allowed us to identify the anomalies on the masonry (cracks, detachments of plaster, moisture zones) and the different construction materials used during the initial construction and in the further phases of rebuilding and restoration (cf. Figures 4 and 5);

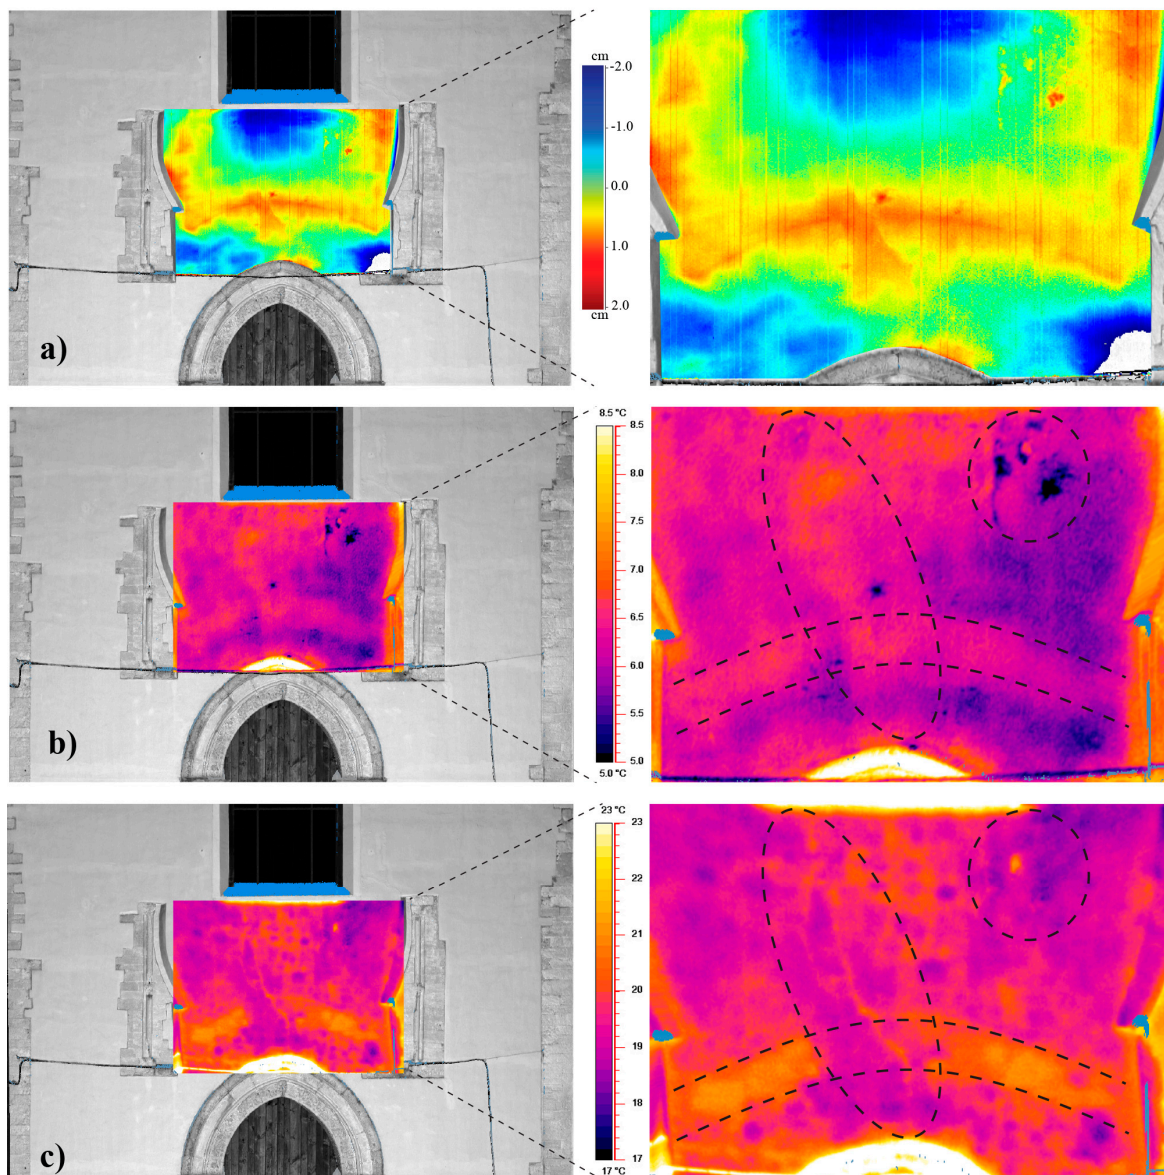
**Figure 6.** Particular of the façade of the church: (a) mesh by point cloud and map of the residuals with respect to a fitting plane; (b) image obtained in the evening of 4 December 2013 and (c) in the morning of 13 April 2014.

The map of the residuals of the façade, obtained as the distance between the point cloud acquired with a single scan and a best fitting plane, shows large irregularities in correspondence to the window (Figure 5c), where originally a rosette had been realized as reported by the historical survey. The same figure also shows deviations of the point on the façade localized immediately above the lancet arch, assuming the shape of a segmental arc linking the two columns (see area bounded by a dashed line in Figure 5c and in particular in Figure 6a).

A counterproof of the same anomaly can be detected by the thermal images, which, to permit the correlation between the two survey techniques, were projected over the mesh obtained by the point cloud (Figure 6b,c). In fact, the thermograms also allow one to observe an arch shape, similar to the one identified by laser scanning, showing a temperature of about 2 °C higher than the surrounding area. Different hypotheses can be made on the presence of the “hidden arch”: possibly another original element of the first building in the transition zone between the large portal and the now absent rosette, similar to those still exposed to the view, or a specific material used to protect the portal during the rebuilding work of the upper part of the façade.

- Moreover, the results on the church façade allowed us to also detect an anomaly immediately above the lancet arch of the portal, with a particular segmental arch shape, linked to a hidden element (cf. Figure 6).

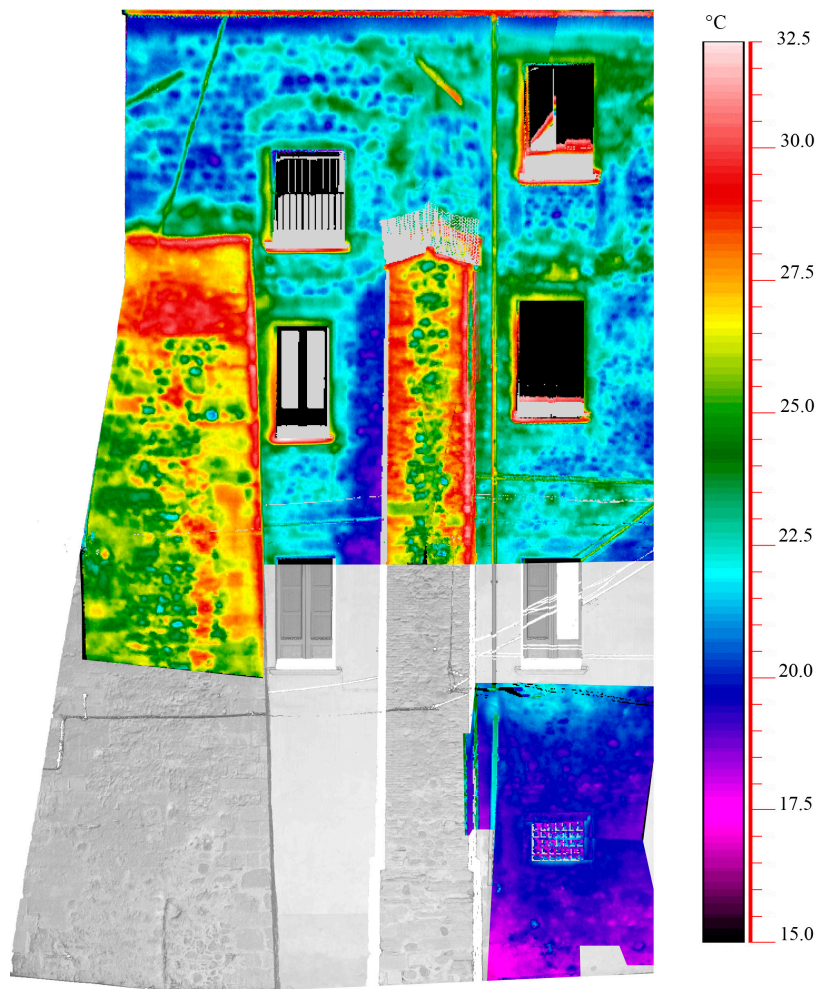
The thermographic survey obtained on the wall and the buttresses allowed us to detect high thermal differences. In Figure 8 some thermograms were projected on the point clouds of the wall. The temperature analysis demonstrates high local differences in the masonry. In fact, the wall was constructed by stones and covered by plastering, while the buttresses were made of composite material containing both stones and bricks, which can be identified by the different detected temperatures, so probably these elements have been built in a subsequent period respect to the wall. This condition plays an important role in the evaluation of the mechanical strength to be assigned to the masonry. Moreover, a particular behavior can be found in correspondence with the openings, which have probably been changed over time. In the lower part of the wall the presence of moisture due to the capillary rise of water from the subsoil is detectable; indeed, the thermogram indicates the lowest temperatures.

**Figure 8.** Thermograms projected on the point cloud relating to the external wall (represented up to Section II with reference to the Figure 7) of the St. Augustine Monumental Compound.

- the overlap of the thermal images on the point clouds and the comparison with the analysis of the residuals showed on the façade of the church, a large irregularity in correspondence to the window above the portal, where the historical survey suggests the existence of an ancient rosette (cf. Figure 5); in addition, on the wall reinforced by buttresses the deformed shape and the high heterogeneity of the construction materials was detected (cf. Figures 7 and 8);
