Article

High Resolution Trichromatic Road Surface Scanning with a Line Scan Camera and Light Emitting Diode Lighting for Road-Kill Detection

Keywords: road scanning; computer vision; pavement inspection; line scan camera

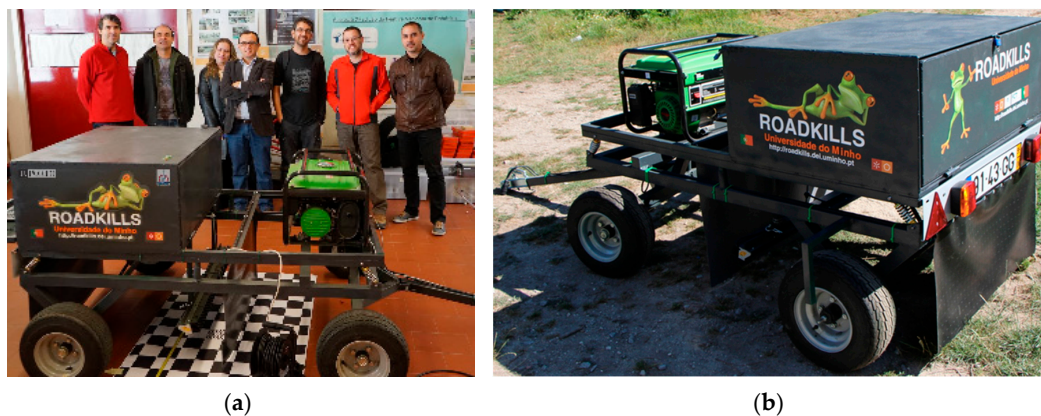
Figure 1. Developed road scanning trailer: (a) Prototype and project team; (b) Prototype outdoors.

Under the Roadkills project—“Intelligent systems for survey of mortality in amphibians Portuguese roads”, a joint venture of the University of Minho, University of Porto and University Institute of Maia, a mobile system was developed that is capable of acquiring images of Portuguese road surfaces in a continuous manner and over a pre-determined path defined by biologists. After several discussions on what type of vehicle would be suitable for this purpose, it was opted for the development of a mobile two-axle trailer as shown in Figure 1.

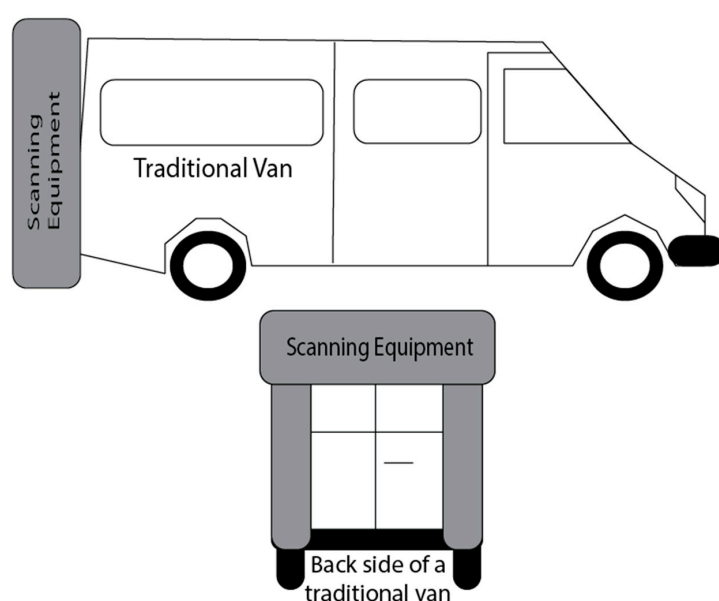
Figure 2. Example of the adaptation found in the existing road scanning systems.

Figure 2 shows an example of how typically vehicles are adapted on the described systems. They are essentially based in adapted commercial vans. The cost of the vehicle itself plus the adaptation can go up to around several hundred thousand euros [5]. The process is considered accurate, but too expensive for many road maintenance agencies and therefore it is performed only once every two years or so [5]. This budgetary level is too high for the purposes of this project and therefore, it was necessary to search for valid solutions that could be carried out at much lower cost.

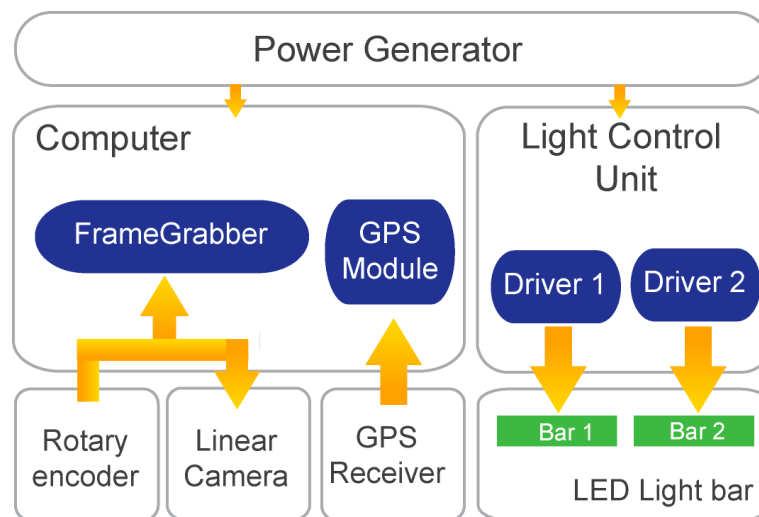
Figure 3. System architecture of the developed solution.

On top of the diagram of Figure 3 is the electrical power generator running on petrol and supplying 2.2 kW of alternating current (AC) 230 V at 50 Hz, allowing the system its independence from any external power supply. As long as petrol is provided to the generator, the system runs uninterruptedly. A 12 V battery (190 Ah) attached to a 2 kW pure sine wave inverter was also tested, instead of the petrol generator, providing enough power for a 5 km run at an average trailer capturing speed of 30 km/h. Since the whole system is paced by motion due to the use of an encoder, when the trailer is stopped the image acquisition is also stopped. This allows the user to refill the tank of the power generator, allowing some more hours of image acquisition. From the power generator two leads with switches enable both systems (computer and LED lights) to be turned on separately. If the trailer is stopped and the trailer's computer is being accessed, the LED lights can be switched off.

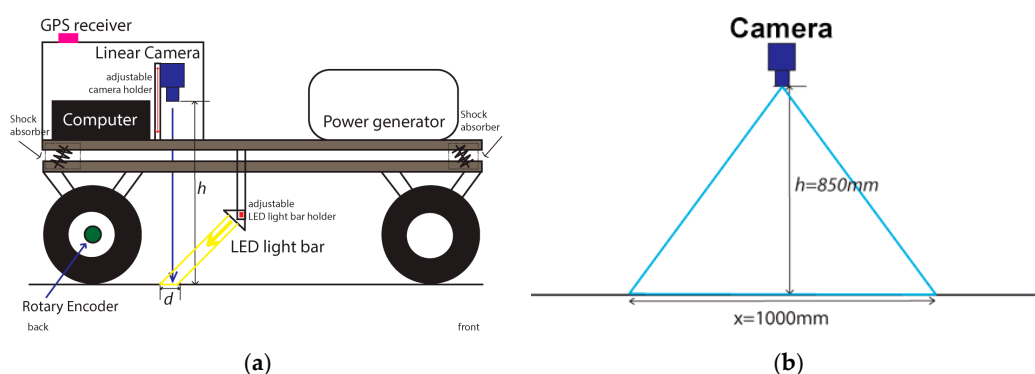
Figure 4. Diagrams of the developed scanner: (a) Complete device set with the blocks that makes the system; (b) Camera height and captured line width.

Due to the application and integration of different subsystems, individual calibration of each one was necessary in order to make the whole system fully operational. The trailer was designed and built with a dual axle, to allow a controlled and consistent distance from the camera position and its perpendicular point to the road surface. It is a very important requirement because in this way, there is no horizontal rotational movement (tilting) that occurs on one axle trailers. When attached to different height towing vehicles or during travelling on irregular bumpy roads, this tilting effect is constantly felt. Perpendicularity is then strongly enforced between the camera and the road surface. Figure 4a shows how the camera and the LED light bar unit were positioned, along with the other equipment described earlier. Both devices (camera and light) have adjustable fixtures allowing some fine tuning in different axes. For the camera, the main adjustment is its distance to the road surface whereas with the LED light, distance to the road and tilting are essential for a good alignment and positioning as shown in Figure 4a. This means that the line scanned by the camera should be illuminated evenly throughout the 4096 pixels, to avoid changes in brightness and possible occlusions. Figure 4b shows the distances utilized for the camera positioning.

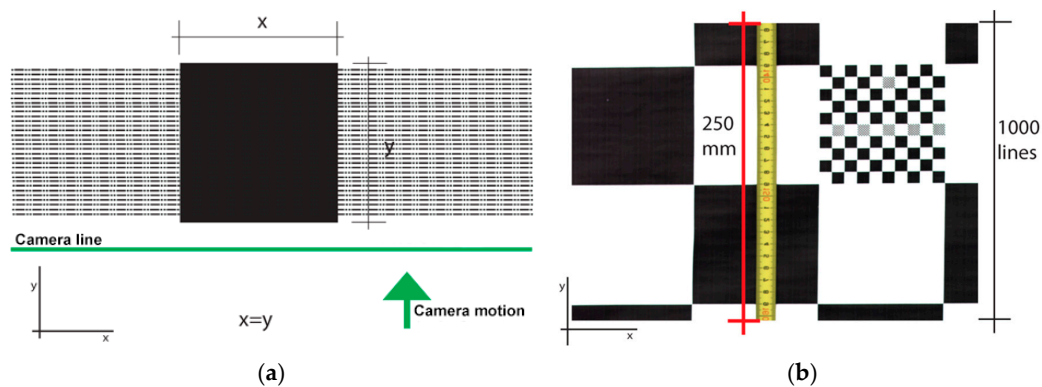
Figure 5. Scanning procedure using the line scan camera: (a) Checkerboard black square and respective scanning lines; (b) Captured lines and respective length in millimeters.

Another important subsystem calibration, is what defines the ratio between width and height of a scanned square on the road. In other words, as the trailer moves, the scanned lines must guarantee proportionality between the width (scanned line) and the length travelled (height of a scanned image) to avoid ratio distortion. This involves finding the relation between the incremental encoder pulses

generated as the trailer moves and the trailer wheel perimeter. Thus, a calibration procedure was adopted that attempts to minimize the maximum possible errors in the proportionality of a scanned image. For such task, a checkerboard printed paper was laid down on the floor and scanned over, ensuring that it was aligned with the camera acquisition line. The scanned checkerboard was then analyzed and a single black square was isolated for the measurements, as shown in Figure 5a. As it can be seen, each scanned line defines one-pixel height of an image. Counting the obtained x pixels of the square (fixed by the camera line pixel distance), the same amount of y pixels should be attained (depending on the incremental encoder pulses). Dividing both values, a ratio is obtained and passed to the software setup, in order to define the pulses to use from the incremental encoder in the frame grabber. After the ratio is set, the hardware automatically accepts only the valid pulses from the encoder rejecting all the others.

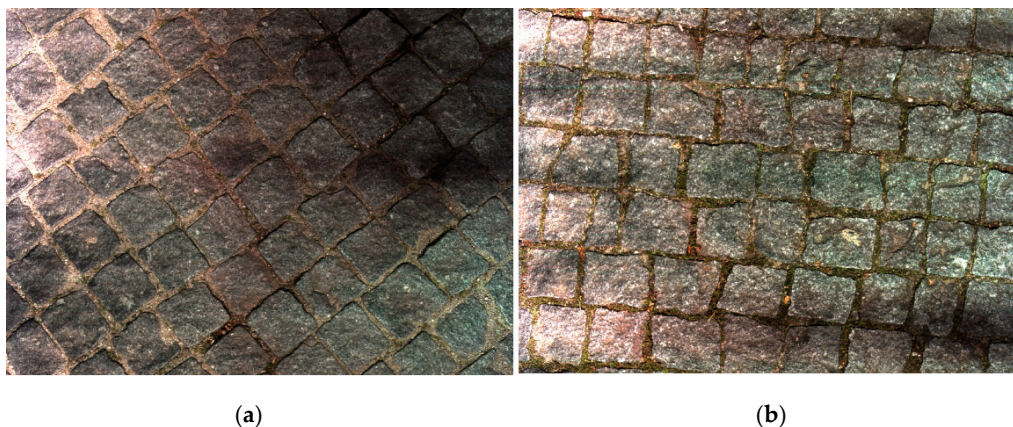
Figure 6. Scanning results in different situations: (a) Sunny daylight time; (b) At night.

The first set of tests was conducted for stress and robustness analyses, alongside the system failure finding. It has passed all performed day and night tests, on heavily bumpy cobbled roads. Images were acquired during these tests and it showed that at any travel speed, images were acquired with good quality (no tremor). No difference was found between the images acquired during the day and at night (Figure 6). It was then concluded that the lighting unit was performing well enough and it was sufficient for the purpose. From the other performed tests, the prototype revealed to be sufficiently robust to travel at the desired speeds on severely damaged roads. It also demonstrated accuracy on the obtained values, both from the GPS and the acquired images.

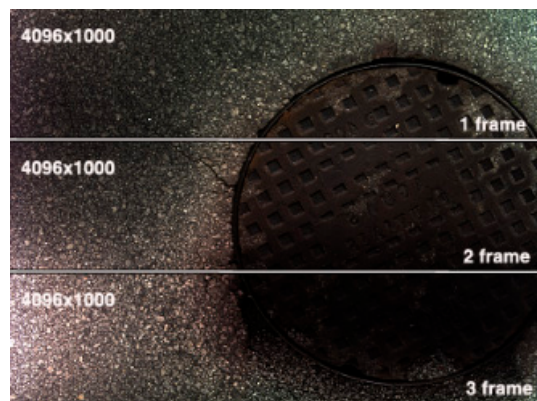
Figure 7. Three consecutive frames with a resolution of 4096×1000 pixels on each frame obtained at a travel speed of 20 km/h.

Several tests were carried out with different configuration parameters of the camera. Frame buffer (number of lines per frame) was changed between 1000 and 4096 lines to test for possible differences in the output data. The images obtained from the tests revealed good results with the tested values. At the same time, no line gaps were obtained at any tested travel speed. Figure 7 shows an example of three consecutive acquired frames with 1000 lines per frame at 20 km/h travel speed. The three frames of the figure were deliberately slightly detached to show their boundaries. When put together there is a perfect match and no gap or lost line is found.

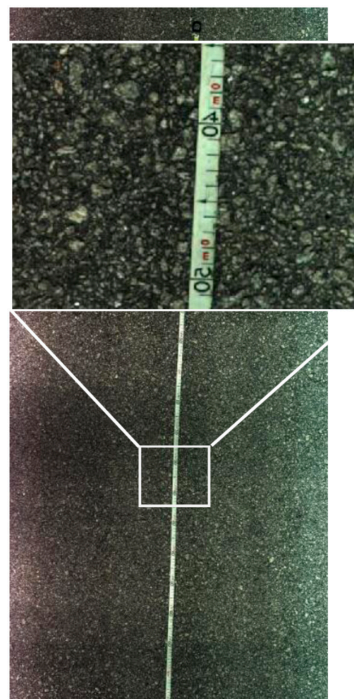
Figure 8. Set of stitched images with a scanned tape measure on the road and a particular zoomed area showing sub-millimeter resolution.

Figure 8 shows an extract from a sequence of images of the scanned road surface at 20 km/h, allowing the quality analysis of the image and its resolution. As it can be seen in the zoomed area of Figure 8, features smaller than one millimeter can be easily recognized. On this test, a tape measure was placed on the road and scanned at different travel speeds. The zoomed area was chosen in between two consecutive frames and a good stitching is made without any visible gaps or repetitions.

After performing various tests, the results have shown some points that needed to be addressed. An important phenomenon was found and it is visible in Figure 8. Some slight gradient changes in the pixel light intensity are clearly visible in the images. Darker areas followed by lighter areas like cast shadows are visible throughout the sequences. It is important to observe at this point since it is easier to notice this feature on a long image sequence as in Figure 8.

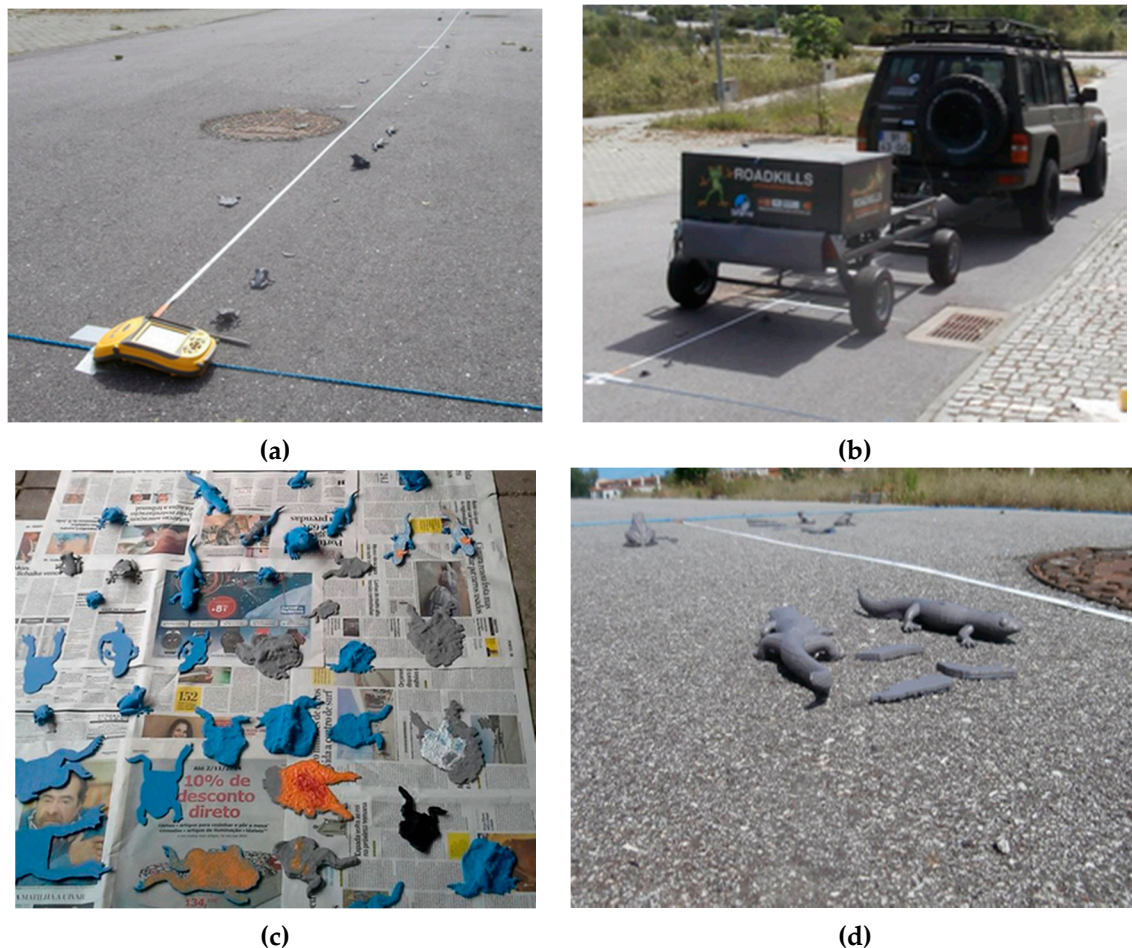
Figure 9. Images from the 3D models scanning tests: (a) Setup on asphalt with tape measure and precision GPS positioning of the specimens; (b) Scanning in progress; (c) Developed 50 specimens in 3D printed plastic; (d) Perspective view of the specimens on the road and their respective differences in height.

Tests were also performed by scanning 50 tridimensional (3D) specimens of printed models of amphibian casualties. They were positioned on 20 m of road as shown in Figure 9. The tests consisted on 10 scans over this setup at a constant speed of 20 km/h, in three different arrangements of the specimens. On the first trial the specimens were georeferenced with an accuracy of 1 cm. On the second trial they were grouped together on different groups. On the third trial they were positioned randomly over the cobblestone road.

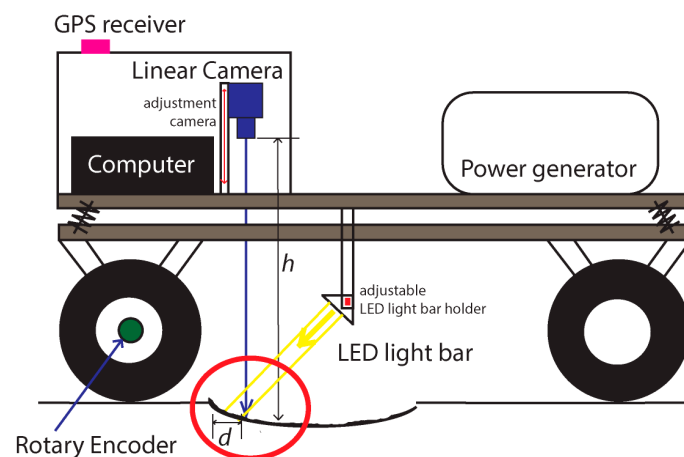
Two problems can be observed: (a) the distance h of the camera to the ground increases during the road depression making the acquired pixels in that area subject to be in a different focal plane; (b) the lighting that should be centered in the focal point is shifted originating therefore light intensity variations.

Figure 11. Road irregularities producing misalignments between the light line and the camera scanned line.

The same feature can be observed in Figure 10 with a darker area on the left side and a lighter area on the right side of the image. This phenomenon was related to irregularities in the road surface. Any bump or pothole in the road will interfere with the perfect alignment of the light and the calibrated point for the line scanning. Figure 11 shows a diagram demonstrating this possible cause.

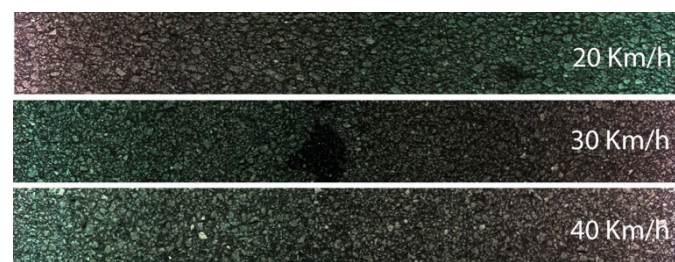
Figure 12. Image acquired at various travel speeds showing no loss or deterioration of the image quality.

Another important result is related with the data throughput bottleneck as mentioned earlier. Over speeding results in a disruption of the continuous sequence of image acquisition. At speeds above 30 km/h some errors were detected, however the results were considered valid for the frames considered correct and in sequence. Figure 12 shows the results of three tests performed at speeds of 20, 30 and 40 km/h. Although at the highest speed the system could not cope with a continuous recording, the non-repetitive captured images are valid and still show good quality.

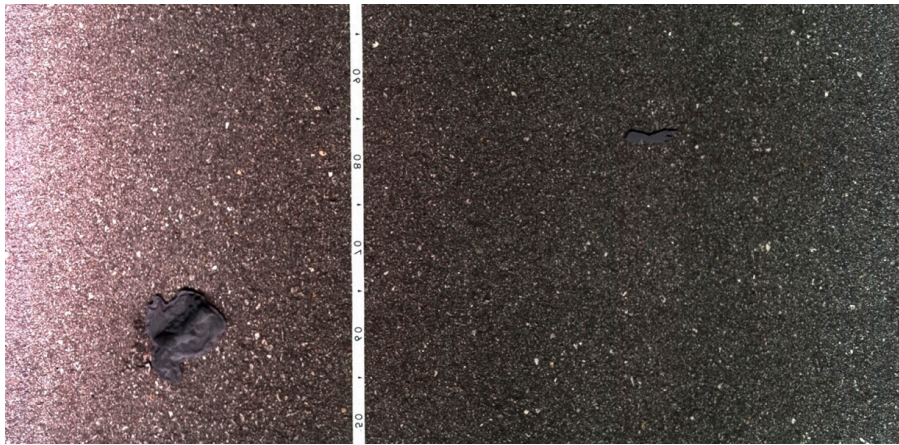
Figure 13. Scanned 3D model of amphibian casualties on asphalt, body part on the left and leg on the right.

From the 3D amphibian model tests, the data was analyzed and it was supplied to train the detection algorithms with specimens used as positive search material to the database. The results using the Haar classifier method of computer vision were promising, showing more than 65% of successful findings when the files were post-processed by the computer vision algorithms. Figure 13 shows a sampled image from this trial on the asphalt and Figure 14 from the cobblestone road. On the asphalt, the left specimen is clearly seen by the human eye but on the right side of the same image the small leg model is very difficult to differentiate from the floor color. The algorithm was not able to detect it and thus it still needs to be improved, possibly by more training with better images. On the cobblestone the specimen was also not detected but many false positives were generated. Cobblestone roads are a challenge for computer vision algorithms due to their natural source of shapes in between the stones, resembling smashed animals.

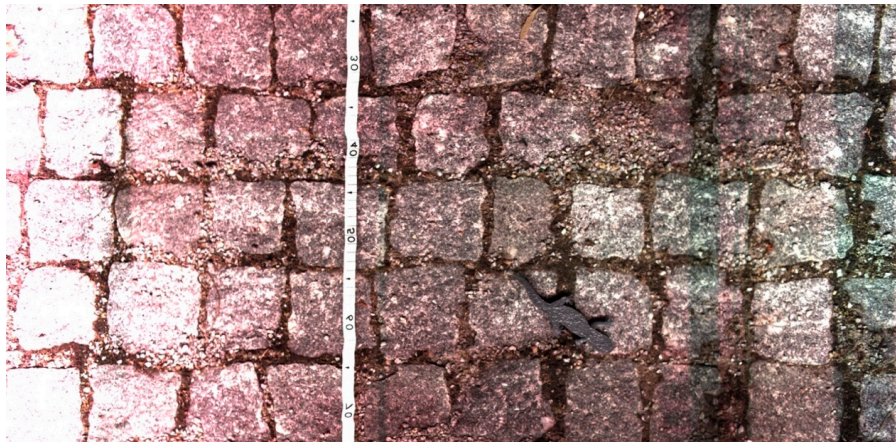
Figure 14. Scanned 3D model of an amphibian on a cobblestone road.

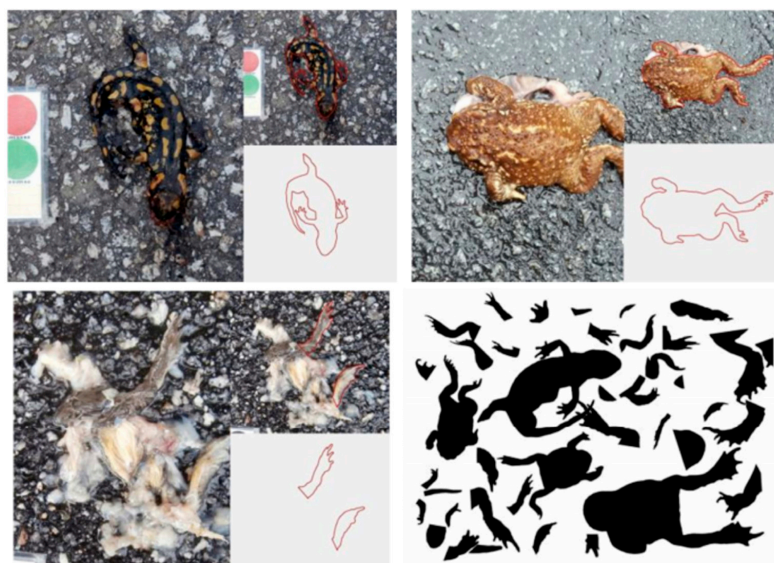
Figure 15. Pictures of amphibian casualties and the extracted contours of the visible detectable parts.

The algorithms are being trained with a database that was built based on casualty pictures as positive search material. Also, from each casualty, the animal contours were extracted and added to the database as shown in Figure 15. When in a casualty picture only the limbs are detectable, this contour is isolated and added to the database. This provides a more robust detection since in many situations, only the small hind limbs are visible from a smashed amphibian as it is visible in Figure 15.

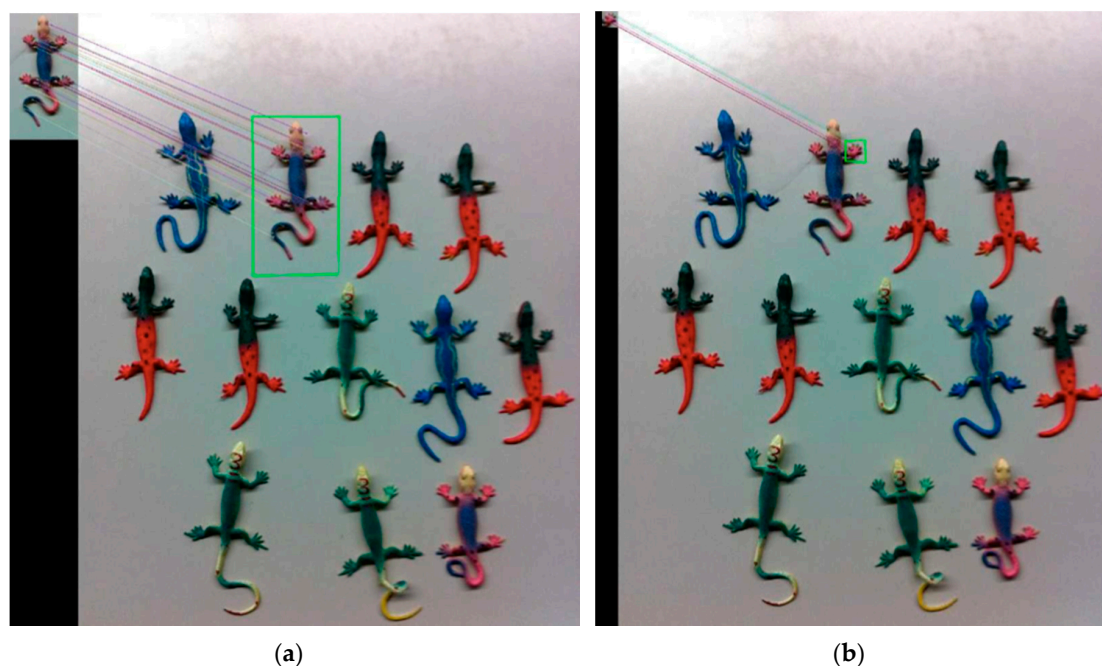
Figure 16. Template search using the SIFT algorithm: (a) Full body template of a specimen; (b) Right front claw of the specimen.

Other computer vision approaches are being developed by the use of known feature detection algorithms such as the Scale Invariant Feature Transform (SIFT) [22] and its successors. Figure 16 shows some tests performed on laboratory samples and the obtained results. This figure shows two instances of the searched part of one of the specimens used. In Figure 16a a complete specimen was searched and its template is located on the top left corner of the image. It was detected in the main image where other specimens were also present. In Figure 16b, the same search was performed but this time to the right claw of the specimen. This template was also found in the main image. The algorithm has shown to be efficient on feature detection although in both cases, it took around three seconds for a single frame search.
