Damage Detection Based on Power Dissipation Measured with PZT Sensors through the Combination of Electro-Mechanical Impedances and Guided Waves

Enrique Sevillano ^{*,†}, Rui Sun [†] and Ricardo Perera [†]

Department of Structural Mechanics, Technical University of Madrid, C/ José Gutiérrez Abascal, 2, Madrid 28006, Spain; rui.sun@alumnos.upm.es (R.S.); ricardo.perera@upm.es (R.P.)

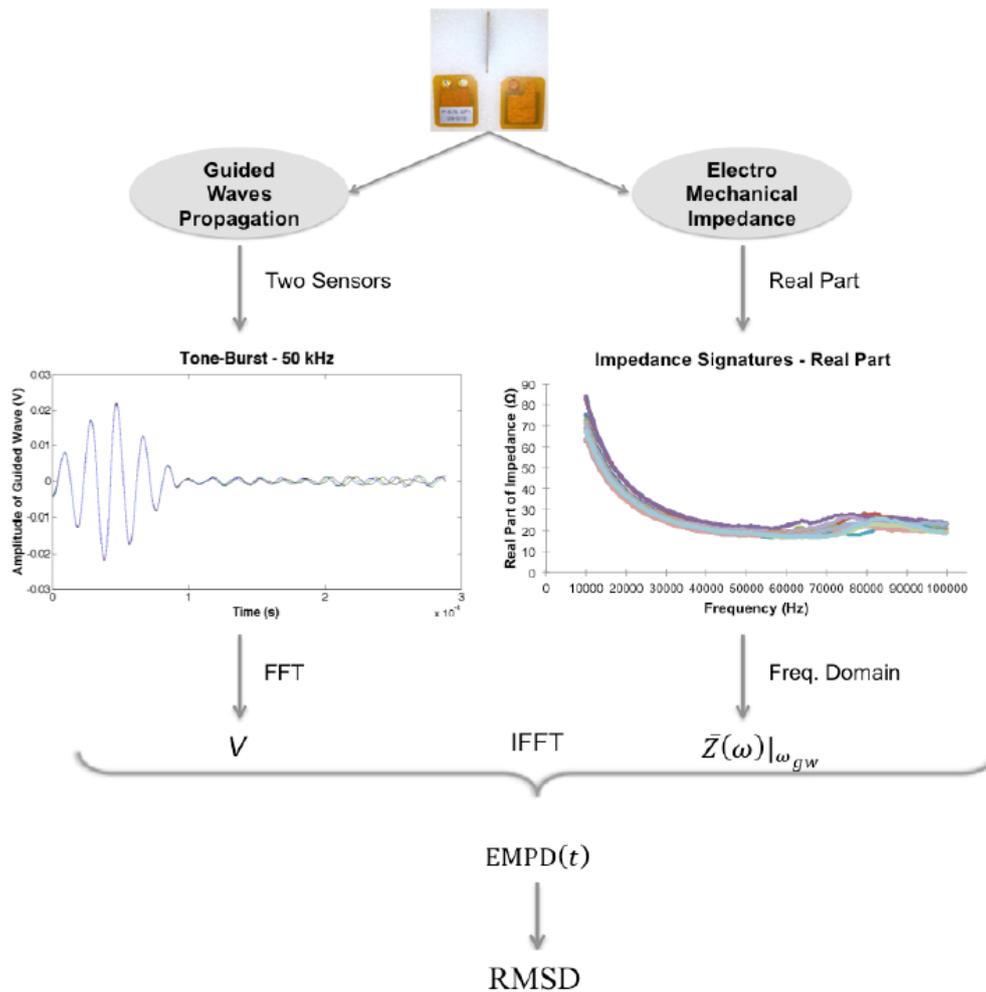
Figure 1. Overall procedure to extract the Damage Indicator based on Electro-Mechanical Power Dissipation.

The overall procedure of the proposed integrated damage detection technique is illustrated in Figure 1. This process starts by measuring, separately, the impedance signatures and the guided waves for a baseline stage of the structure, if possible, in a healthy state. Thanks to the combination of both signals at a particular frequency, it is then possible to obtain EMPD in the time domain for different damage conditions or stages. All possible deviations in the EMPD signal, when compared with the

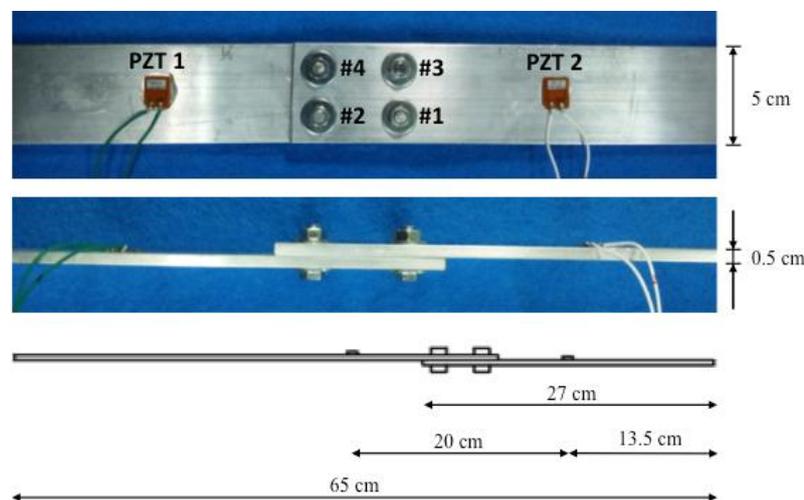
Figure 2. Bolt-jointed aluminium beam with two PZT transducers.

The first test was carried out on a lab-scale bolt jointed aluminium specimen consisting of two beams, the first one with dimensions of $45 \times 5 \times 0.5\text{ cm}^3$ and the second one with dimensions of $27 \times 5 \times 0.5\text{ cm}^3$, connected by four bolts with a diameter of 10 mm (Figure 2). Two identical P-876 DuraAct Patch Transducers [35] were bonded to both sides of the lap joint at a distance of 20 cm between them by using an epoxy adhesive. The purpose of this test was to evaluate the ability of the proposed approach to detect the damage due to loose bolts by inducing the following four stages or damage scenarios in the analyzed specimen: (a) No damage (D0), for which five different and independent measures were taken and used as raw data (D1 to D5); (b) Damage 1 (D1): Loose bolt #3 by one half-cycle; (c) Damage 2 (D2): Loose bolt #3 by another half-cycle; (d) Damage 3 (D3): Loose bolt #2 by one-half-cycle. It is important to remark here that all the necessary measurements were taken one after another for each subsequent damage condition. In this way, for the D0 condition, both impedances and guided waves were initially measured. Once these measurements were collected, damage D1 was induced and the new stage was measured and so on.

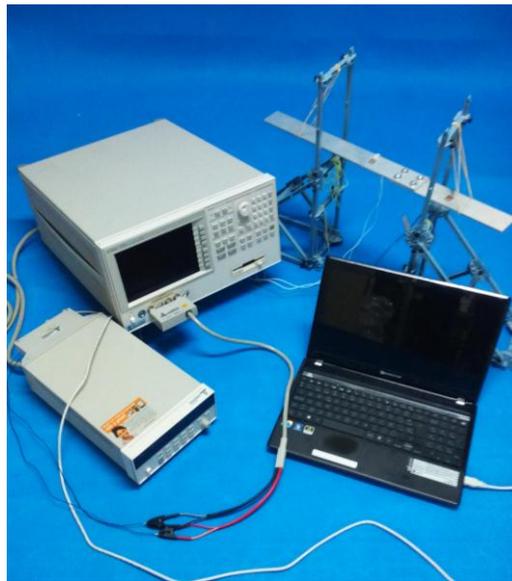
Figure 3. Experimental setup for impedance measurements on the bolt-jointed aluminium beam.

The two PZT sensors were individually connected to two different channels of the 3499B multiplexor, which was used to make a multiple connection between the HP 4192A Impedance Analyzer and the PZT sensors. Both, the multiplexor and the impedance analyzer were from Agilent Technologies. To measure the impedances at each sensor, a sinusoidal sweep voltage with a 1 volt amplitude was applied to the PZT sensors over a frequency range of between 10 kHz and 100 kHz. Five impedance signatures were measured for each damage case, so the raw data were obtained by averaging the responses of five measurements. Figure 3 shows the overall experimental setup for the impedance measurements.

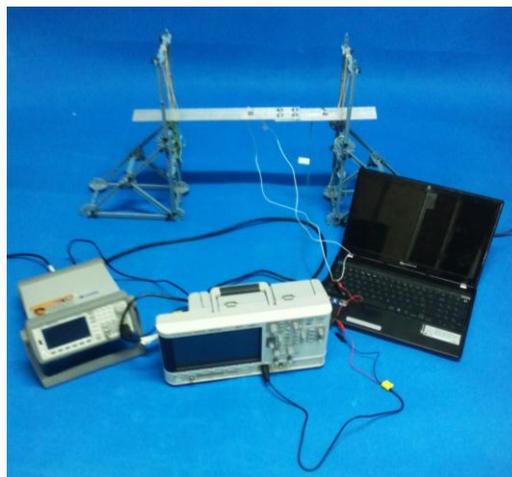
Figure 4. Experimental setup for guided waves measurements on the bolt-jointed aluminium beam.

Once all the impedance data were collected at each damage step, each sensor was afterwards and alternatively connected to the guided waves system, which consists on the following components: a waveform generator that sends the selected waveform to the structure in the form of an input excitation on the first sensor, an oscilloscope to register the response of the structure on the second sensor, and a conventional laptop controlling both of them (Figure 4). Both the waveform generator and the oscilloscope were acquired from Agilent Technologies. In this test, the same 10-cycle tone-burst was sent in all cases at 50 kHz with a peak amplitude of 10 volts, and five time signals were measured and averaged. Finally, a bandpass filter with 1 kHz and 500 kHz low and high cutoff frequencies was used to improve the quality of the guided signals.

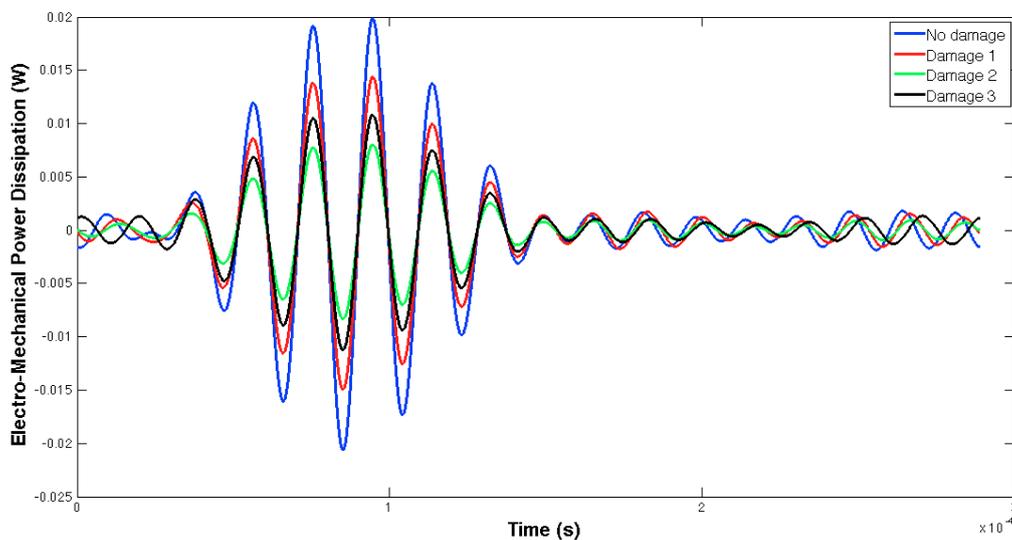
Figure 5. EMPD at 50 kHz. Tone-burst sent from sensor 1 to sensor 2.

Figures 5 and 6 show, respectively, the EMPD obtained when the guided tone-burst is sent from sensor 1 to sensor 2, and vice versa. As can be immediately verified from these figures, there is a visible variation in the EMPD every time new damage is induced in the bolt-jointed aluminium beam, which indicates that the EMPD is sensitive to the presence of, at least, this kind of damage in this sort of lab-scale structures. Furthermore, this variation in the EMPD, which appears to be affecting the amplitude of the measured signal, is not exactly the same in both figures, since it slightly depends on the wave direction. This conclusion might not be too obvious to extract from these figures, but it is quite easy to check by a simple comparison between the corresponding arrays of output data at each damage level. An example of this is shown in Figure 7 for damage D0 and the wave travelling in both directions. Nevertheless, further information might be extracted if Equation (4) is used to translate these data into a damage indicator.

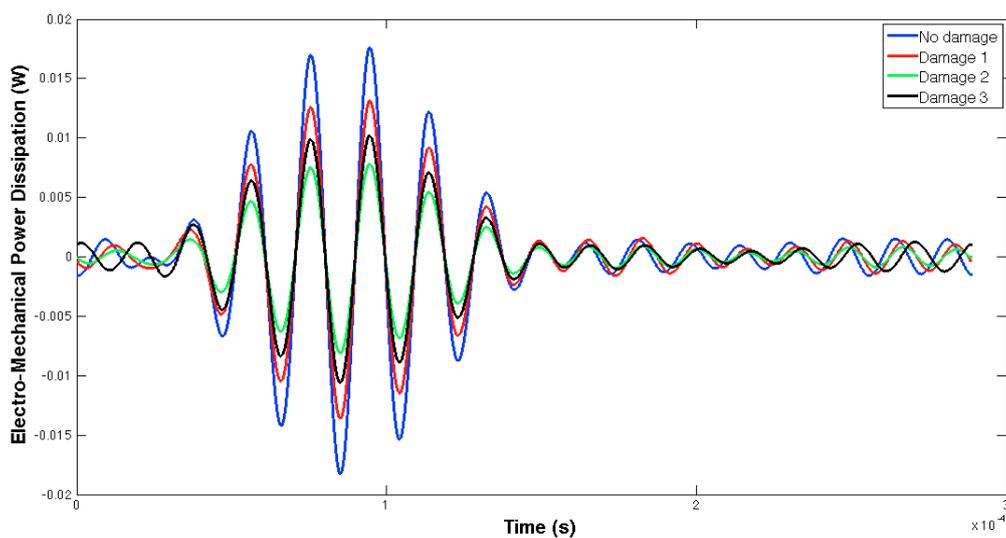
Figure 6. EMPD at 50 kHz. Tone-burst sent from sensor 2 to sensor 1.

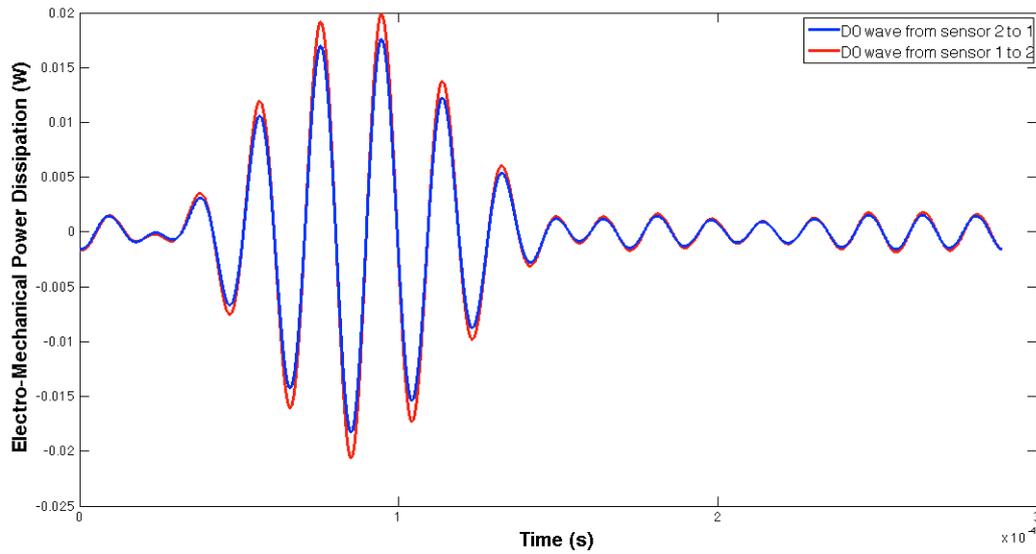
Figure 7. Differences in the EMPD in the aluminium lap-joint for damage D0 when the wave travels opposite directions.

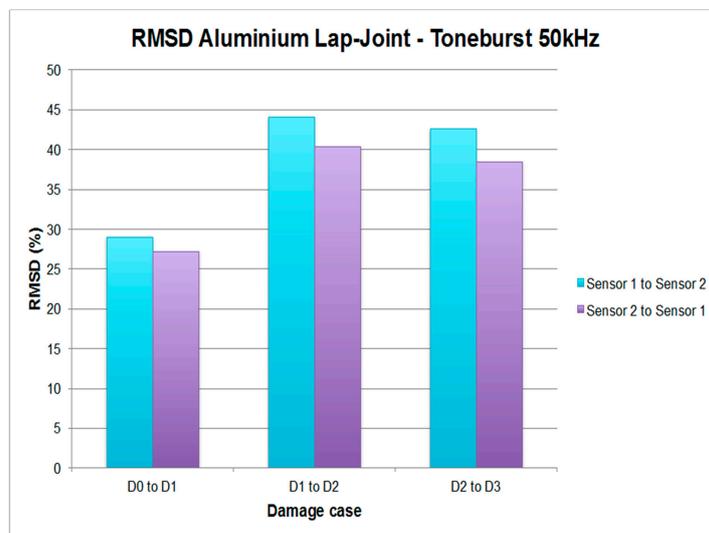
Figure 8. RMSD values for the bolt-jointed aluminium beam.

Figure 8 shows the computed values of the RMSD corresponding to the two previous figures, one value per damage stage and wave direction. As commented above, this figure shows a clear sensitivity to the appearance of damage in all cases. Nevertheless, a clear difference cannot be found between single and multiple damage scenarios. In the two single damage scenarios, D1 and D2, the RMSD is higher when the tone-burst travels towards sensor 2 (1.78% higher for D1 and 3.7% higher for D2, where damage is more severe), and this sensor turns out to be the one closer to the induced damage (bolt #3). From this statement it is tempting to extract the general conclusion that the variation in the EMPD will be higher when the damage is closer to the sensor in which the tone-burst is received, and this might work in that way for all single damage scenarios, but it is certainly not true when addressing the case of a multiple damage scenario (D3). In this case, even though there is new damage induced close to sensor 1 (bolt #2), the RMSD calculated in the other direction is still higher, which clearly contradicts the conclusions from the single damage scenario. However, this might make sense given that the damage severity at bolt #3 is higher than the new damage at bolt #2. Also, considering the proximity between the two bolts makes the process more difficult.

By means of this comparison, it can be stated that the EMPD is more sensitive to the appearance of new damages (D2 and D3) than the traditional EMI, given that the RMSD values are significantly lower after the first damage scenario when using the EMI method instead of the EMPD, even though additional damage was induced in the specimen. Therefore, it is possible to obtain a better estimation of the severity of the total damage in the specimen by using the EMPD signatures, making them more sensitive to the presence of damage. However, attending to the results after damages D1 and D2, it has to be pointed out that the estimation of damage localization is not really improved with respect to the EMI method, particularly in the case of damage D2, since the differences in the RMSD values between sensors are larger for the EMI method. On the other hand, both methods give an incorrect localization for damage D3, which is the most severe and complex in the specimen.

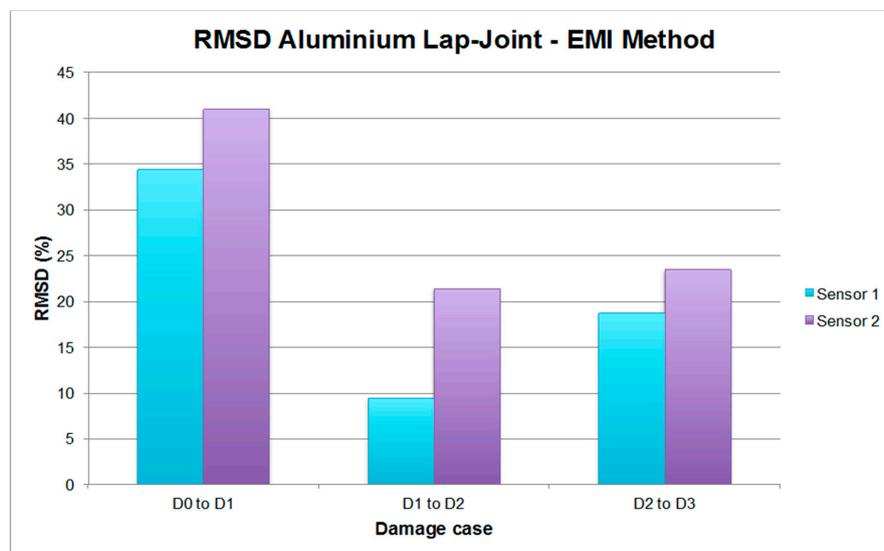
Figure 9. RMSD values for the bolt-jointed aluminium beam corresponding to the EMI method.

These damage predictions can be now compared to the ones obtained from the traditional EMI method, which are shown in Figure 9.

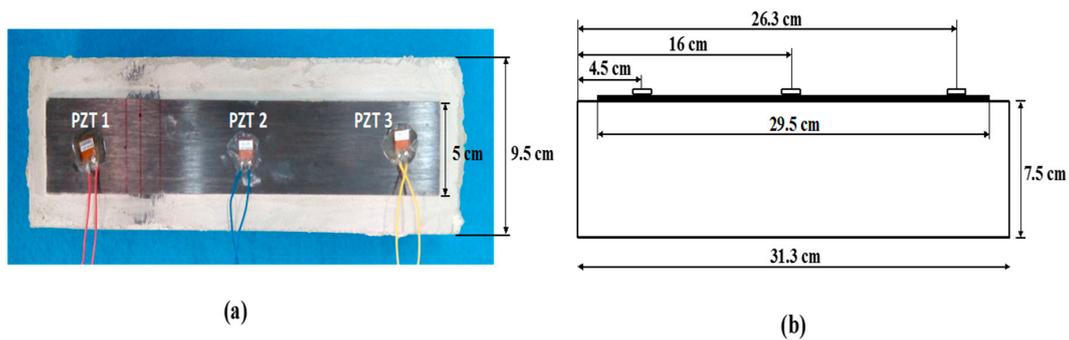
Figure 10. FRP-strengthened concrete specimen with three PZT transducers.

The second test was carried out over a concrete specimen with dimensions $31.3 \times 9.5 \times 7.5 \text{ cm}^3$ which was strengthened with an external FRP strip, with dimensions $29.5 \times 5 \times 0.18 \text{ cm}^3$, bonded by using an epoxy resin adhesive. Three identical P-876 DuraAct Patch Transducers from Piceramics [35] with the thickness of 0.5 mm were symmetrically bonded along the length of the specimen using the same epoxy adhesive as before (Figure 10). The overall experimental setups for the measurements are the same as the ones shown in Figures 3 and 4 and the same measurement conditions were imposed on both the impedance signatures and the guided waves.

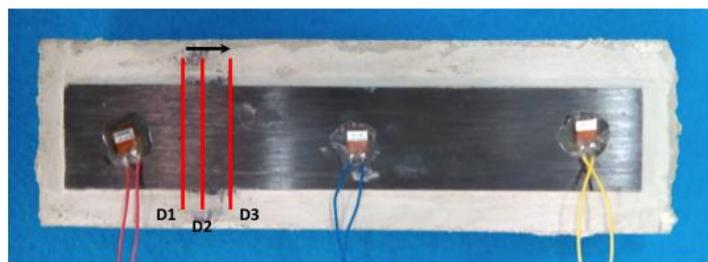
Figure 11. Damage scenario for an FRP-strengthened concrete specimen (I).

The purpose of this final test was to simulate, over a lab-scale concrete specimen, the debonding failure mode that usually comes up in real structures strengthened with FRP strips. In order to detect that failure through the application of the proposed method, the following four stages or damage scenarios were induced (all by means of holes drilled in the resin adhesive) in the analyzed specimen: (a) No damage (D0); (b) Damage 1 (D1): a 5 mm debonding located 7.25 cm away from the left end of the specimen; (c) Damage 2 (D2): amplification of the debonding practised in the previous stage towards the PZT number 2, up to a total debonding length of 1 cm; (d) Damage 3 (D3): repetition of the previous step up to a total debonding length of 2.5 cm (Figures 11 and 12).

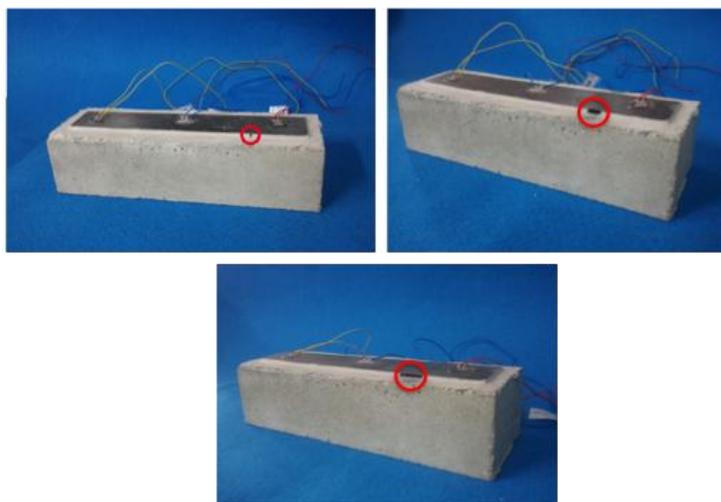
Figure 12. Damage scenario for an FRP-strengthened concrete specimen (II).

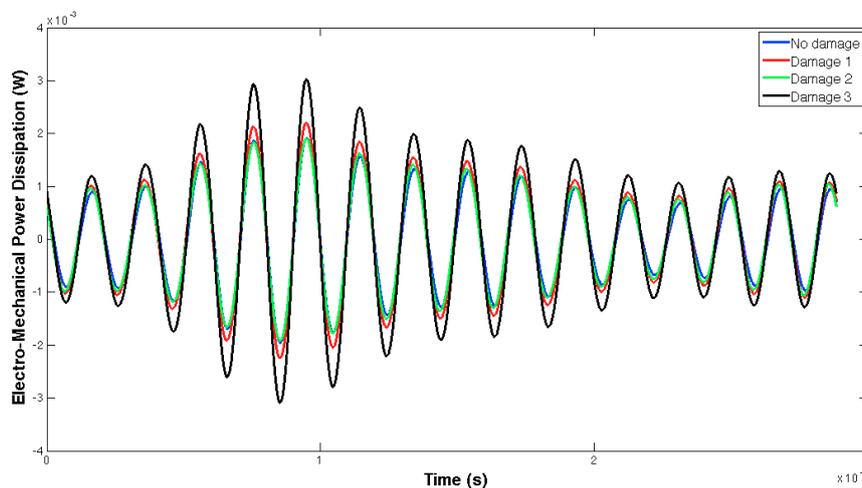
Figure 13. EMPD at 50 kHz. Tone-burst sent from sensor 1 to sensor 2.

In this case, both the structural properties and boundaries, as well as the nature of the damage, are totally different from those used in the previous example, so different EMPD results are expected. These differences can actually be found in Figures 13 and 14 where not only the shape of the EMPD

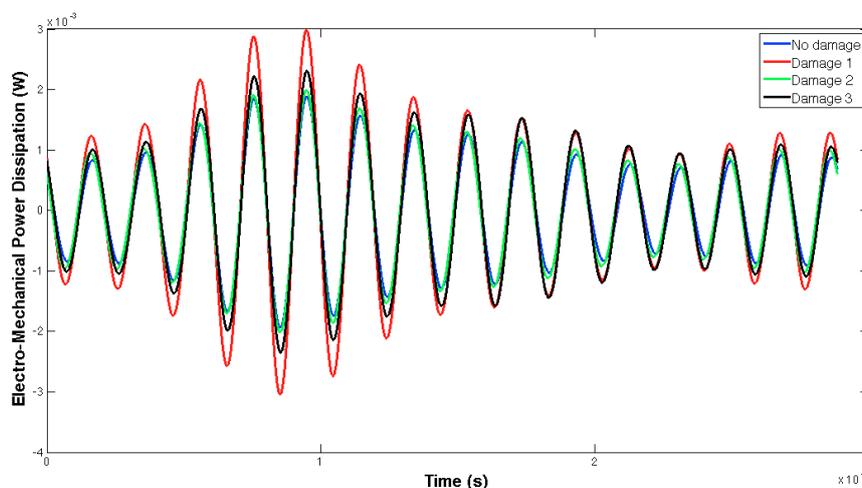
Figure 14. EMPD at 50 kHz. Tone-burst sent from sensor 2 to sensor 1.

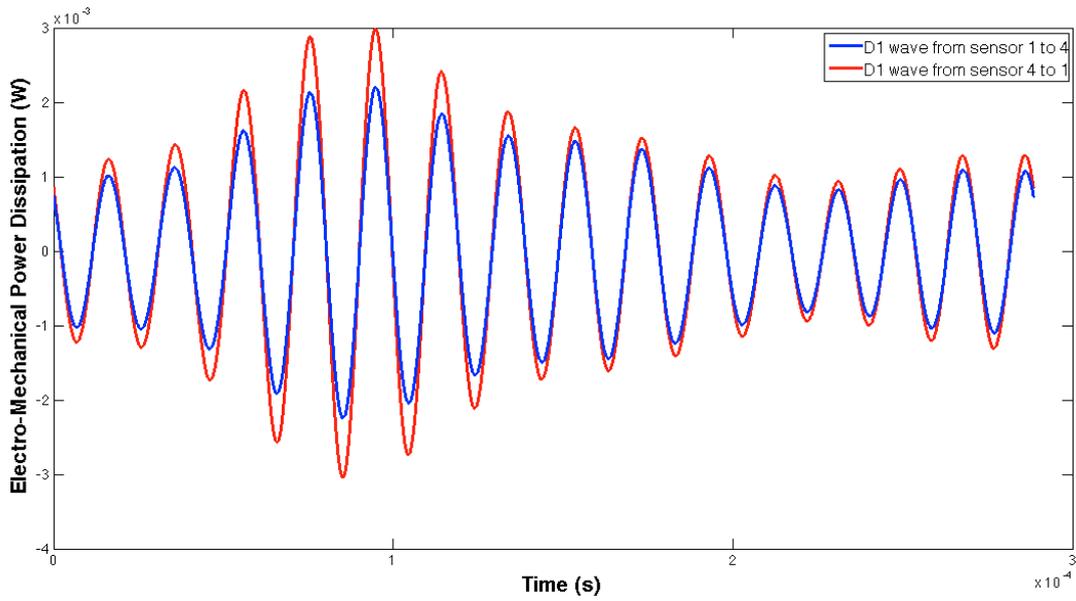
Figure 15. Differences in the EMPD in the concrete specimen for damage D1 when the wave travels opposite directions.

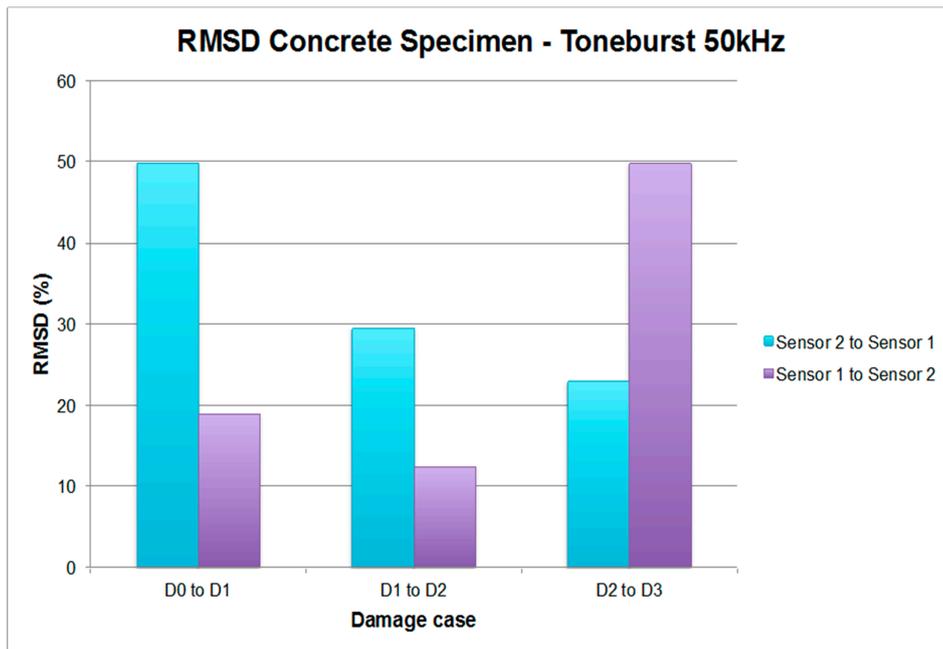
Figure 16. RMSD values for the concrete specimen.

As in the previous example, these differences encountered in the EMPD can be evaluated through the RMSD index in order to obtain conclusions about damage presence in the concrete specimen. These values are, again, calculated once per damage stage and wave direction, as shown in Figure 16.

For the D2 damage case, whose severity is higher than in the D1 scenario, again the RMSD is higher when the guided wave travels towards sensor 1, with a difference of 17.08% this time. According to this, it is again concluded that the damage is located closer to sensor 1. However, the RMSD value is quite smaller than that corresponding to D1, when a similar value might be expected. This reduction, from the experience of the authors, is quite normal given that the first hole made in the adhesive implies bigger alterations of the mechanical properties of the specimen than those induced by the second one. In a real-scale specimen, a hole of those characteristics would be more than sufficient to initiate the failure mechanism due to debonding propagation. Furthermore, it should not be forgotten

that the RMSD values are computed between two consecutive stages. Therefore, this parameter should only reflect any change between one stage and the consecutive one, so consistently higher RMSD values cannot be expected for the same sensor at different damage stages, since damage is being extended along the specimen in the opposite direction (from sensor 1 to sensor 2 in this case).

Finally, in the D3 damage case, the RMSD values are much higher when the EMPD is calculated from the measurements at sensor 2, which, according to the reasoning proposed in this paper, would erroneously mean that this damage is much closer to sensor 2 this time, given that the maximum extent of this hole reached the midpoint between the two sensors. Nevertheless, considering just the RMSD values calculated when the guided wave travels towards sensor 1, it is quite clear that the value corresponding to each of the damage cases is lower each time, which suggests that the new debonding between the concrete and the FRP is further each time from this sensor, as can be verified from Figure 12. Taking into account again the expression defined in Equation (4) for the RMSD indicator, the values computed between D2 and D3 stages should only capture the new debonding practiced at the interface from the D2 stage.

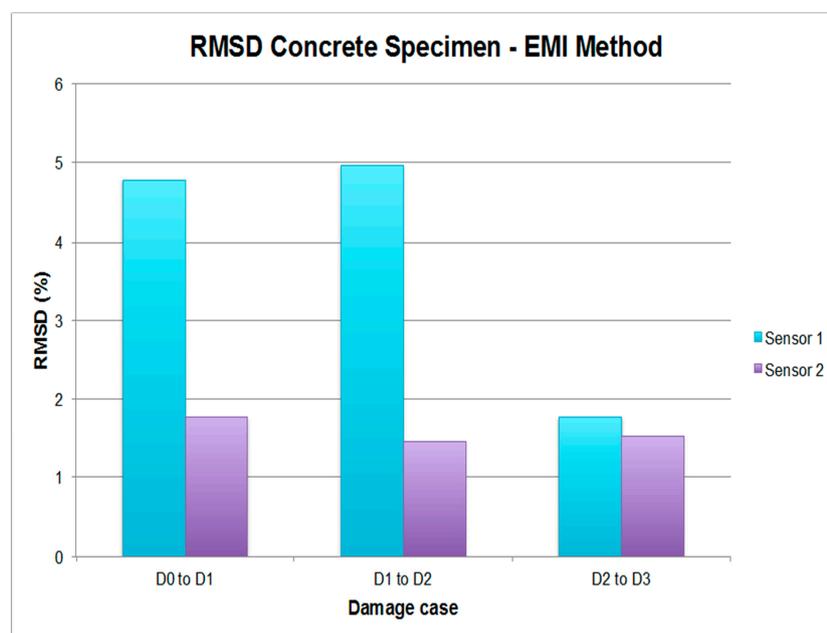
Figure 17. RMSD values for the concrete specimen corresponding to the EMI method.

By making a comparison, as in the previous example, with the RMSD obtained by applying the traditional EMI method, shown in Figure 17, it is even clearer in this case that the proposed methodology is quite more sensitive to damage than the traditional EMI method. Furthermore, it might be true that the proposed methodology fails in the localization of damage D3, but the values of the RMSD shown in Figure 16 are more representative of the real damage present in the concrete specimen after inducing D3, which is actually the biggest damage induced in this example (see Figure 12). In comparison to the damage found by the EMPD, the values obtained with the traditional EMI can be considered negligible, so even the conclusions about damage location cannot be taken into account. In terms of RMSD differences between sensors 1 and 2 at each damage stage, it is clear as well that damage conclusions are much more evident by using the EMPD.

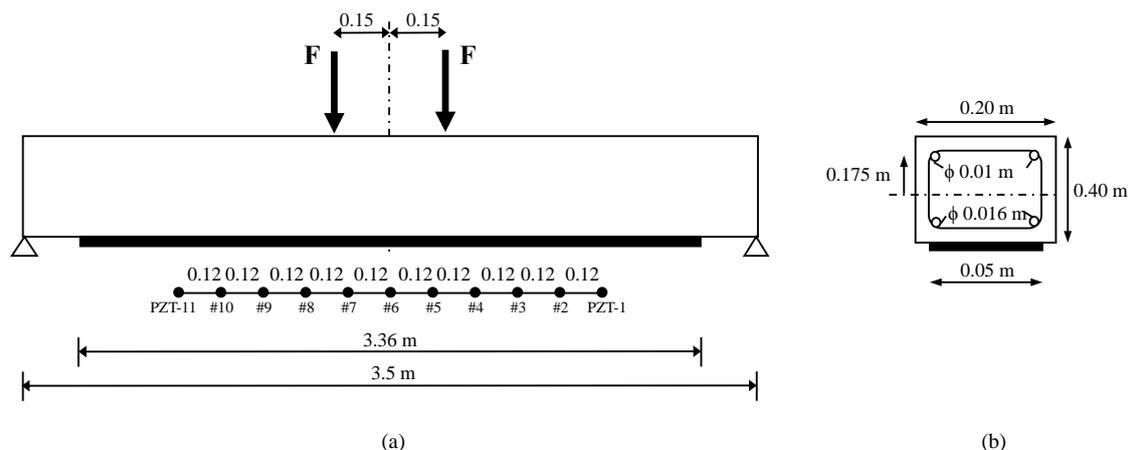
Figure 18. (a) Geometry, loading scheme, and sensor location map for the RC beam; (b) Cross-section of the beam.

The geometric dimensions and the reinforcement layout in the sections are illustrated in Figure 18. The identified material properties are: (a) for concrete, the elastic moduli, compressive strength, mass density, and Poisson coefficient were taken to be $E = 24,858$ MPa, $f_c = 24.64$ MPa, $\rho = 2350$ kg/m³, and $\nu = 0.2$, respectively; (b) for steel reinforcement, the elastic moduli, elastic limit, mass density, and Poisson coefficient were taken to be $E = 210,000$ MPa, $f_y = 510$ MPa, $\rho = 7850$ kg/m³ and $\nu = 0.3$, respectively; (c) for FRP external reinforcement, the elastic moduli and Poisson coefficient were taken to be $E = 150,000$ MPa and $\nu = 0.35$, respectively, with a thickness of $e_{FRP} = 1.4$ mm; (d) for adhesive, the shear moduli was assumed to be $G = 4300$ MPa and the thickness $e_{ad} = 3.45$ mm.

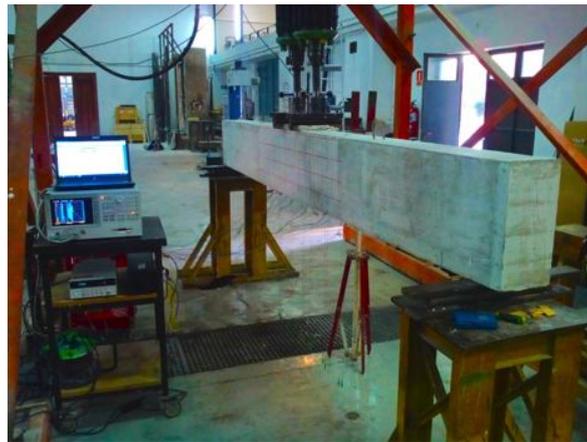
Figure 19. Experimental setup for the reinforced concrete beam externally strengthened with an FRP strip.

In the test programme performed, the strengthened beam was subjected to a series of four-point increasing static load tests with the purpose of gradually introducing the cracks into the specimen. After each static test, the impedance was measured by using 11 identical P-876 DuraAct Patch Transducers [35] of 0.5 mm thickness which were externally bonded with an epoxy adhesive along the FRP strip with a constant spacing of 12 cm (Figure 18). For this, both the impedance signatures and the guided waves were measured under the same conditions explained for the two previous examples. After that, four different loading stages were considered by applying the static loads of 26 (stage D1), 40 (stage D2), 65 (stage D3), and 100 kN (stage D4). Before measuring both the impedances and guided waves, the beam was previously unloaded after each loading stage. The experimental set-up is shown in Figure 19.

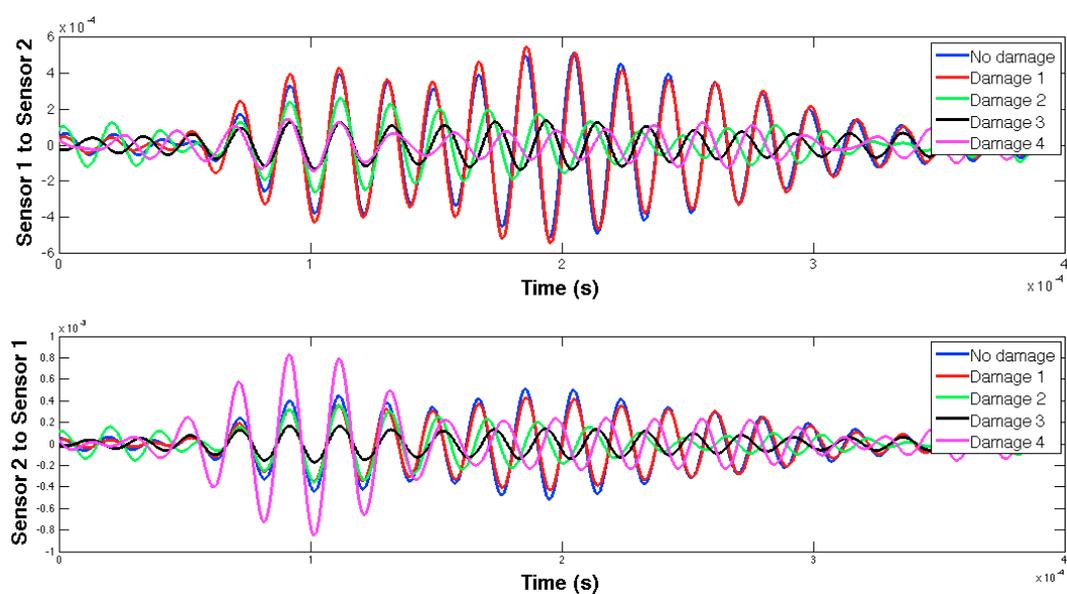
Figure 20. EMPD at 50 kHz. Tone-burst sent and measured between sensors 1 and 2.

The selected guided wave was sent between every two consecutive working sensors, and the EMPD values obtained from all those measurements are shown in Figures 20–27. As can be easily verified, the EMPD presents different shapes depending on the sensing region, on the damage scenario, as well as on the direction of motion of the guided waves, as in the two previous examples, which comes to confirm the high sensitivity of this new indicator to the presence of damage, even when dealing with structural systems of such complexity as the one addressed in this section. Furthermore, the differences in the EMPD depending on the direction of the tone-burst is clearer in this case than in the previous two examples, for almost all damage cases.

Each of the graphics shown in Figure 20 demonstrates the presence of the series of damage stages generated in the RC strengthened beam, and it is even possible to discriminate which one could have a higher impact on each sensing region. However, this is just a qualitative analysis of a really complex damage scenario, as shown in Figure 28. Thus, a better understanding will be achieved through the analysis of the RMSD values, as in the previous examples. These values are presented in Figure 29.

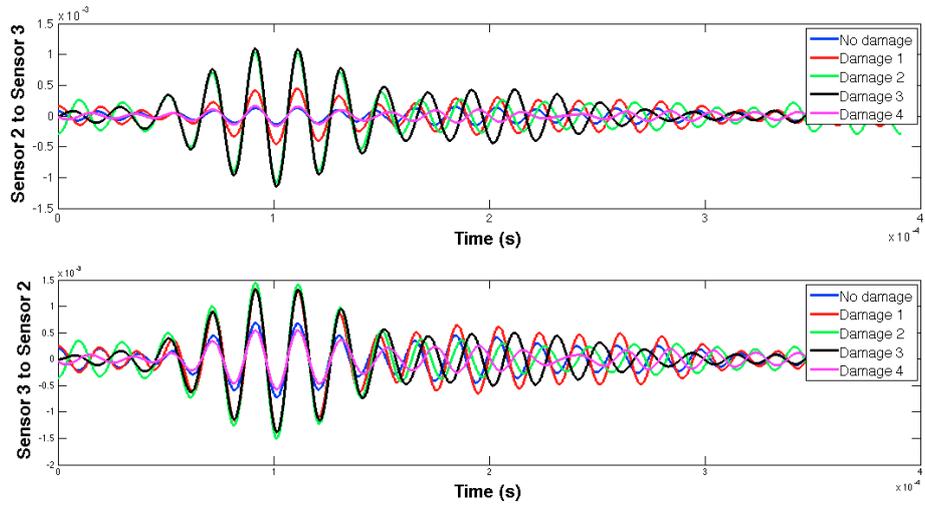
Figure 21. EMPD at 50 kHz. Tone-burst sent and measured between sensors 2 and 3.

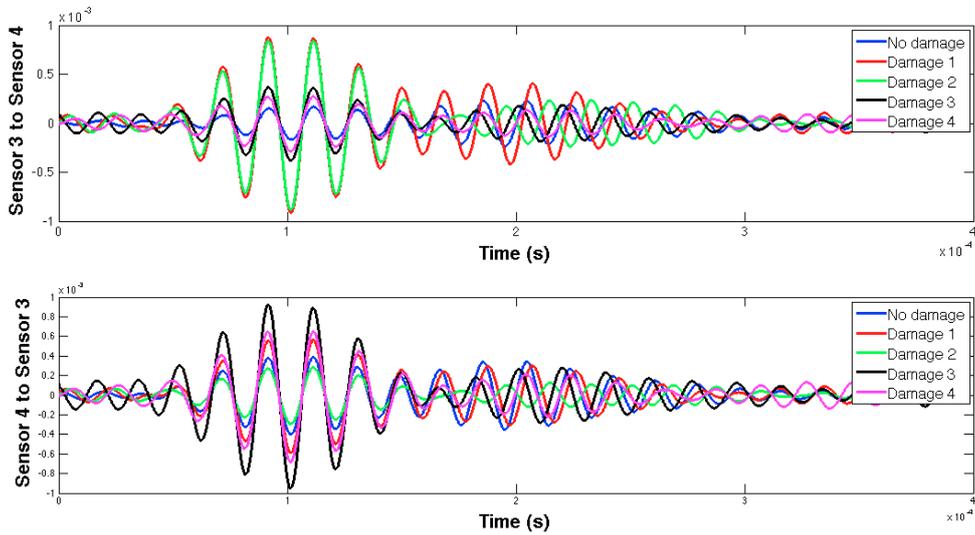
Figure 22. EMPD at 50 kHz. Tone-burst sent and measured between sensors 3 and 4.

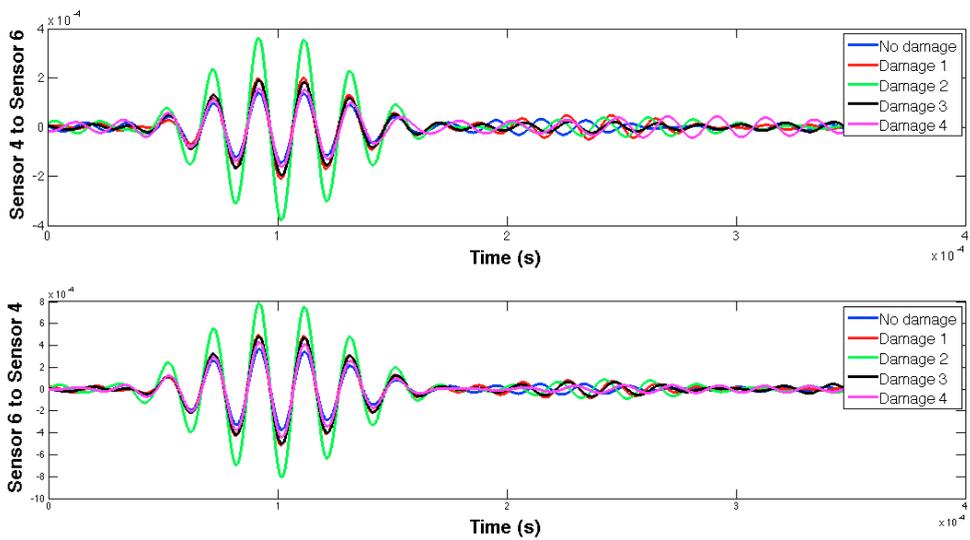
Figure 23. EMPD at 50 kHz. Tone-burst sent and measured between sensors 4 and 6.

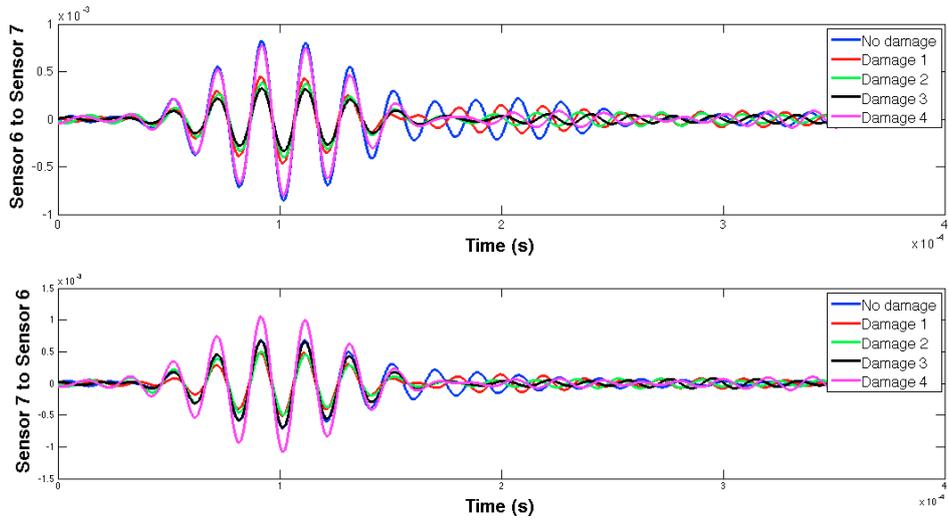
Figure 24. EMPD at 50 kHz. Tone-burst sent and measured between sensors 6 and 7.

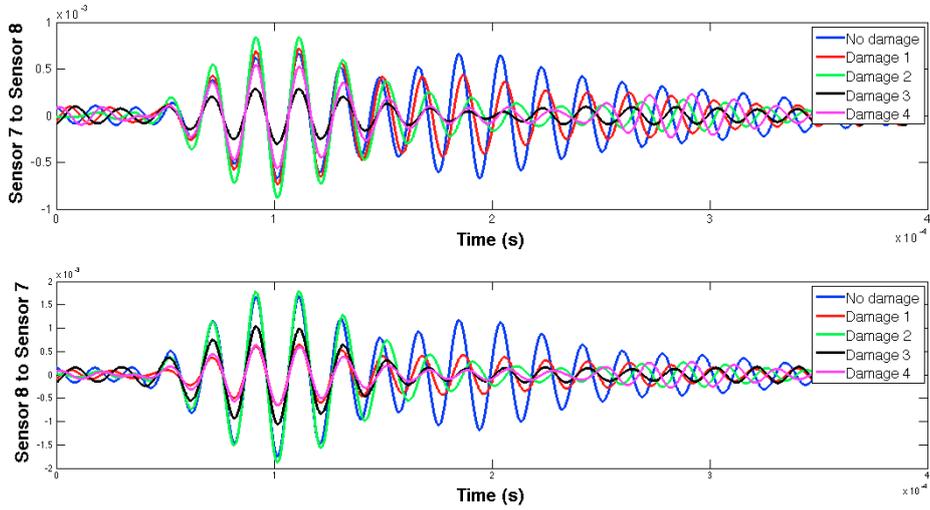
Figure 25. EMPD at 50 kHz. Tone-burst sent and measured between sensors 7 and 8.

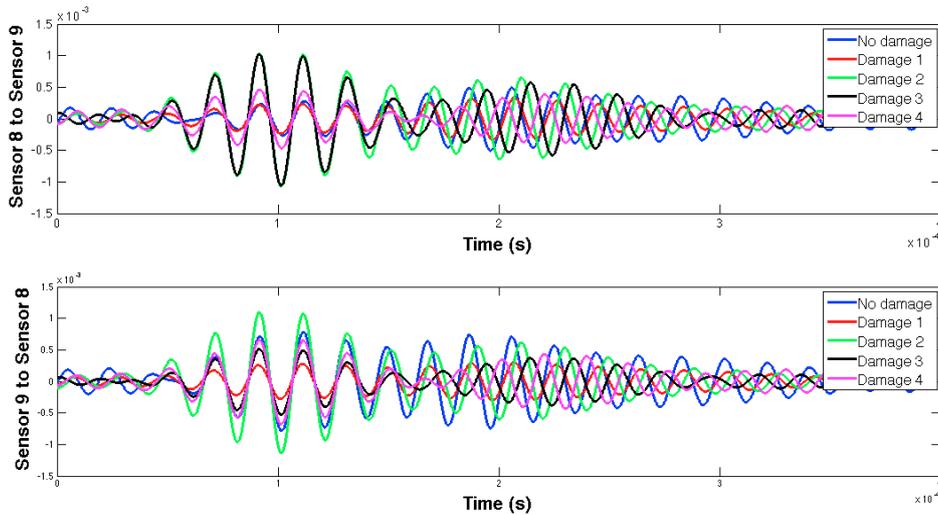
Figure 26. EMPD at 50 kHz. Tone-burst sent and measured between sensors 8 and 9.

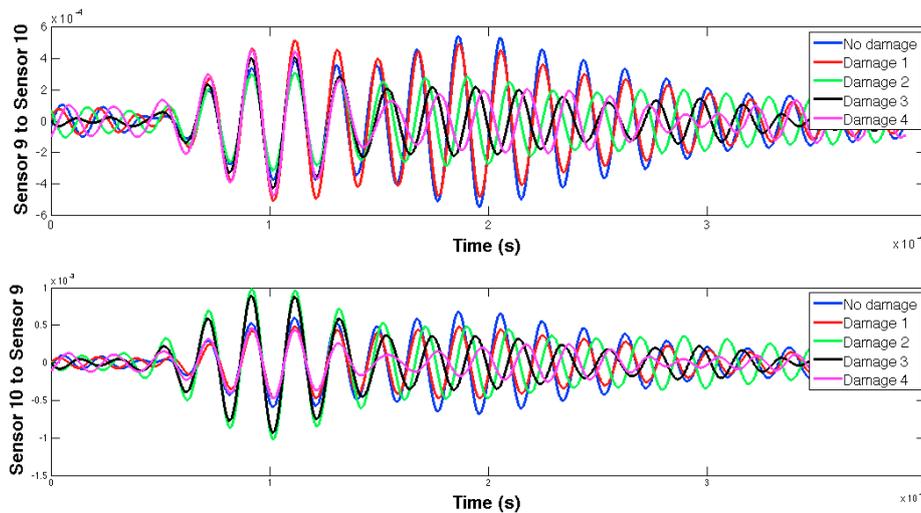
Figure 27. EMPD at 50 kHz. Tone-burst sent and measured between sensors 9 and 10.

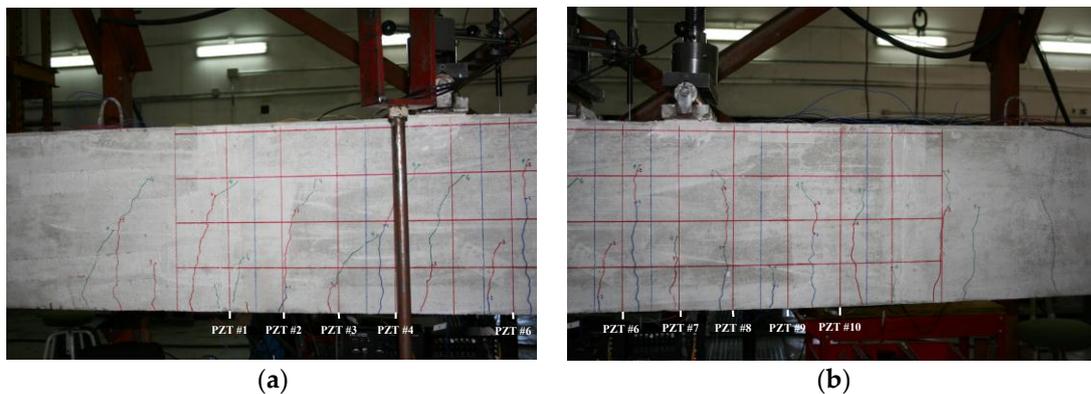
Figure 28. Cracking map of the beam after the last loading stage. (a) Left side of the beam; (b) right side of the beam.

Finally, there is an indication higher than 250%, from sensor 2 to sensor 1 for damage stage D4, which is not related to any debonding either. In this case, as can be seen in Figure 28, a new flexural crack bigger than 10 cm appeared right in the position of sensor 1, which is probably the reason for this unusual RMSD value almost at the end of the loading procedure. Once again, the methodology proposed in this paper enhances the performance of the traditional EMI method, given that this damage is not even noticeable in Figure 30, although there is certainly an important crack generated right in the position of sensor 1, as indicated above.

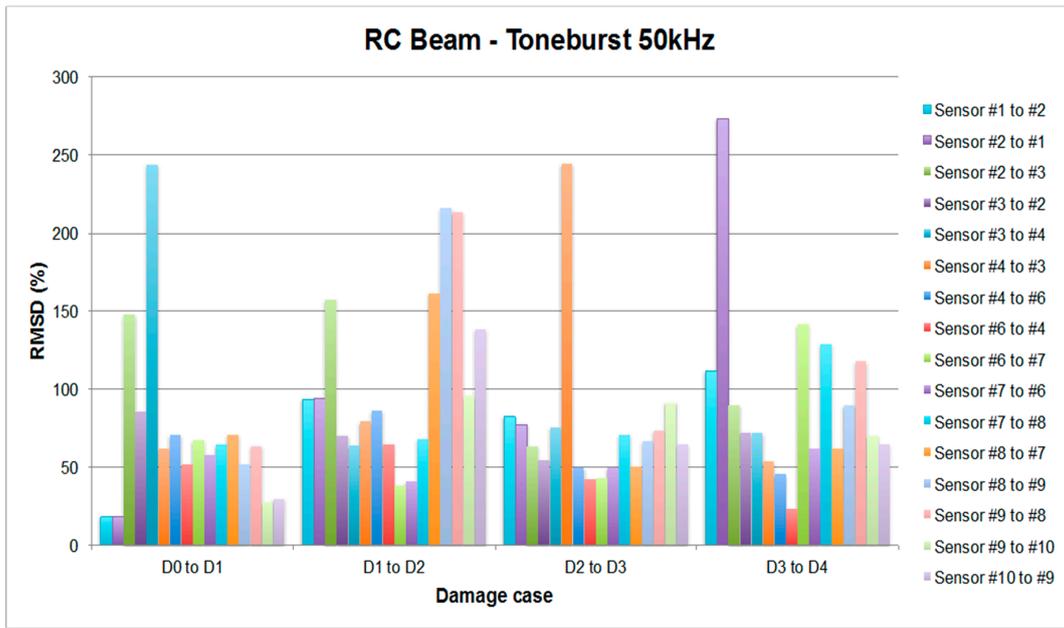
Figure 29. RMSD values for the RC beam.

From Figure 29, it is quite obvious that every loading step generates a set of damages that influence the calculated value of the EMPD. In this case, just by looking at the RMSD obtained values, the first conclusion is that the EMPD is quite sensitive to all damage present in the structure, regardless of its nature (debonding or flexural cracks). This conclusion can be stated due the fact that for every damage stage, almost all measurements give RMSD values close to or higher than 50%. Furthermore, the most remarkable conclusion corresponds to the first loading step, after which no visible flexural cracks were appreciated on the concrete surface (Figure 28), at least apparently. However, for this damage stage, all measurements clearly detect damage with high RMSD values, which means that there were minor damages generated in the vicinity of the interface between the concrete and the FRP. Hence, thanks to the high sensitivity of this integrated damage detection procedure, it is possible to detect damages at a very early stage of the loading procedure, even in spite of the complexity of the structural system under study. This, however, was not possible to determine so clearly by means of the traditional EMI, whose corresponding RMSD values are shown in Figure 30. In this last figure, all damage indications are much lower than those shown in Figure 29 for all sensors and damage cases, so with this test on a real-scale structure, it is fully demonstrated that the EMPD shows higher potential than the traditional EMI on its own, at least in terms of sensitivity to damage, minor damage in particular. Thanks to this, even small and non-visible incipient flexural cracks can be detected on the structure.

On the other hand, in Figure 29 there are several RMSD values that reach values around 150% and above, clearly far from the rest of the results. This, in the opinion of the authors, could suggest the presence of two different types of damage: while smaller RMSD values would indicate the presence of flexural cracks, these last values would indicate physical damages in the vicinity of the interface between FRP and concrete, which means an origin for debonding appearance. Some of these high values are obtained around sensor 3 for damages D1, D2, and D3 (D1: 147% when the tone-burst is sent from sensor 2 to sensor 3 and 243% from sensor 3 to 4; D2: 156% from sensor 2 to 4; D3: 244% from sensor 4 to 3), suggesting thus the potential presence of debonding in this region of the beam, which comes to be true as can be verified from Figure 31, where the debonding damages after the last loading step until failure are shown. However, this conclusion is apparently not confirmed by any sensor

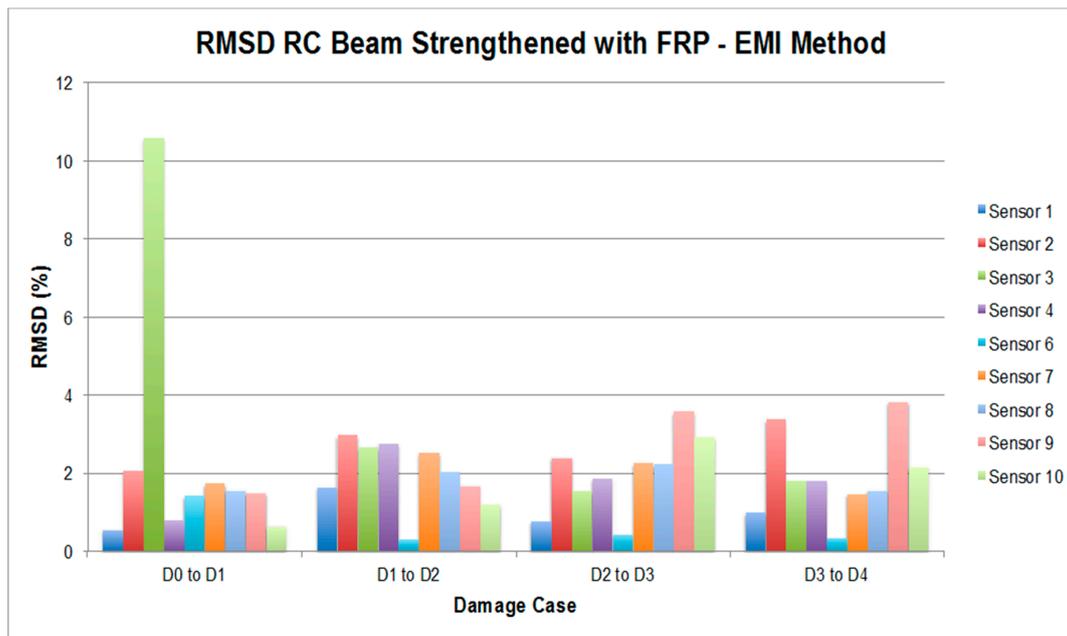
Figure 30. RMSD values for the RC beam corresponding to the EMI method.

debonding as well (Figure 32). Although it is true that this debonding is not so obvious as the one detected between sensors 2 and 3, with this methodology it is still possible to analyze each of the sensing regions with a higher level of detail and more accuracy than with the traditional EMI, which is not even capable of offering a clear distinction between stages of damage (Figure 30).

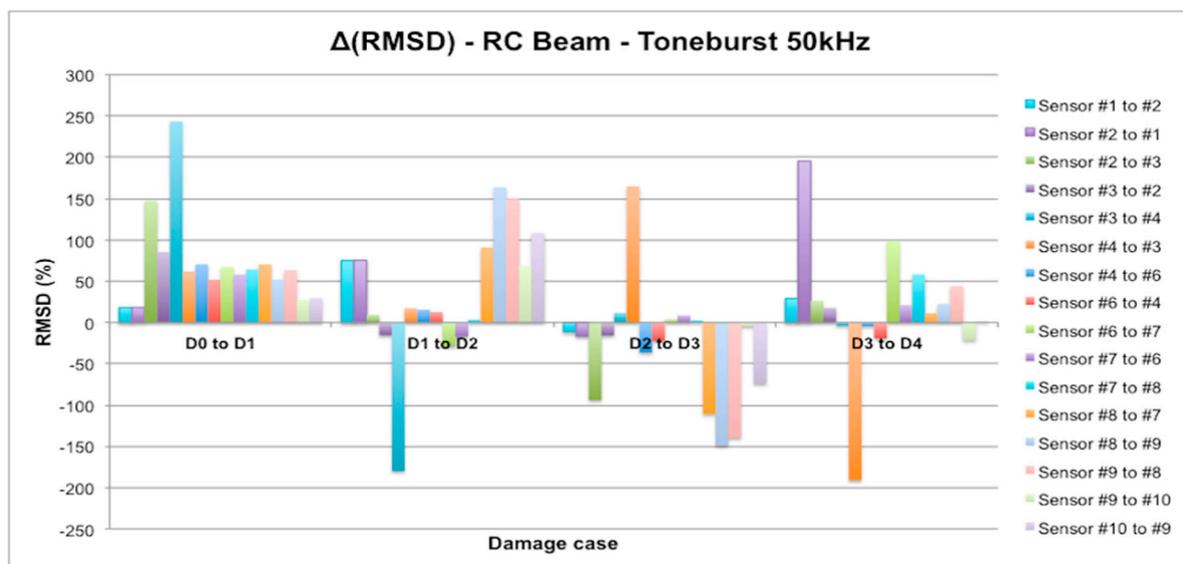
Figure 32. RMSD increments between loading steps for the RC beam corresponding to the EMPD method.

for the second debonding present in the sensing region between sensors 6 and 7. Therefore, further analysis is needed in this region, for which Figure 32 is proposed.
