Article

Automated Vision-Based Detection of Cracks on Concrete Surfaces Using a Deep Learning Technique

Department of Civil Engineering, University of Seoul, Seoul 02504, Korea; shdik2002@uos.ac.kr

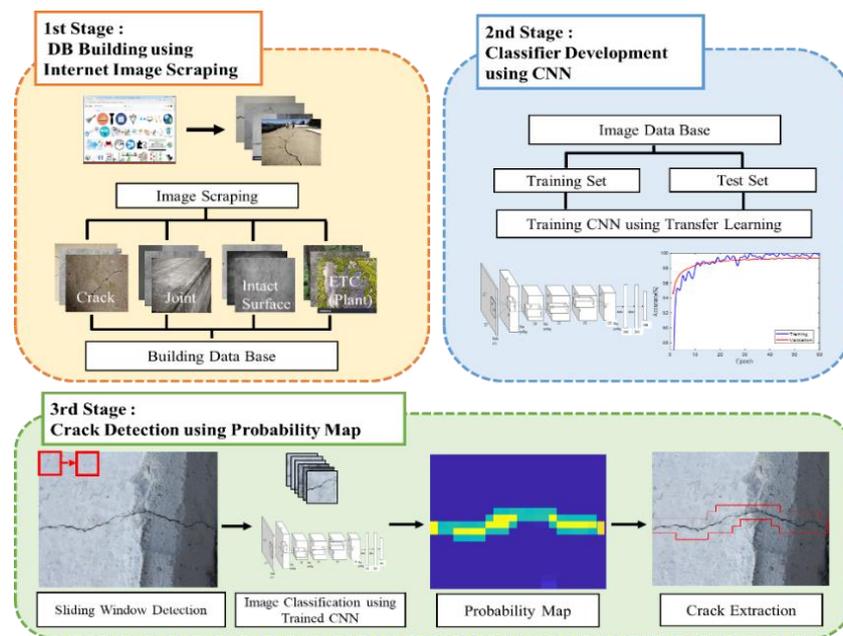
Figure 1. Overall framework of the proposed method.

Figure 1 illustrates the overall framework of the proposed crack detection method in this study. The framework is composed of three stages: (1) database (DB) building; (2) classifier development; and (3) crack detection. In the DB building stage, thousands of images are scraped from the Internet to create an image DB for deep learning model training. The images are scraped for various classes, such as cracks, intact concrete surfaces, and non-crack objects that can be easily misclassified as cracks. In the classifier development stage, a CNN classifier is developed to detect cracks against intact

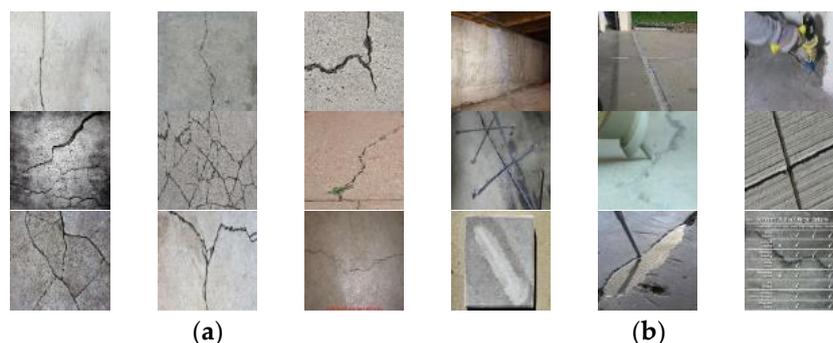
Figure 2. Examples of (a) valid and (b) invalid images scraped by the keyword “concrete crack”.

The image DB in this study was established using a commercial scraper, called ScrapeBox [31], which scrapes images from a search engine site (e.g., Google) for a keyword. The use of a scraper is beneficial in two aspects: (1) it can collect various types of images from a huge database on the Internet, and (2) it naturally provides images classified by the search keyword. Figure 2 shows examples of valid and invalid images scraped by the keyword “concrete crack”. The valid images contain single or multiple cracks on concrete or mortar surfaces, while the invalid images contain invisible, repaired, man-made cracks or irrelevant objects such as texts and company logos.

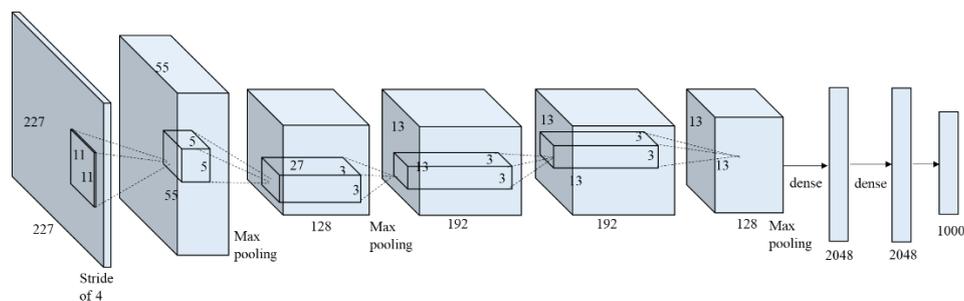
Figure 3. Overall architecture of AlexNet (redrawn from [30]).

Transfer learning reduces training time by fine-tuning a deep learning model that has been trained for a similar purpose. By starting the training on the pretrained model, and not on the randomly initialized model, the training process can be minimized. In this study, a CNN classifier for crack detection was developed using transfer learning of a CNN classifier developed for object detection, namely, AlexNet [30]. Since AlexNet [30] aims to classify objects in the images, it is a good model for transfer learning to classify cracks as objects in an image. AlexNet [30] consists of five convolutional layers followed by max-polling layers, and three fully-connected layers with a 1000-way softmax output as shown in Figure 3. AlexNet [30] implemented rectified nonlinear unit (ReLU) nonlinearity

The MATLAB Neural Network Toolbox provides easy implementation of AlexNet [30] for transfer learning to develop an image classifier. In this study, the final layer of AlexNet [30], was changed to have five outputs to detect five different classes, namely Crack, Joint/Edge (Multiple Lines, ML), Joint/Edge (Single Line, SL), Intact Surface, and Plant. Then, the pretrained AlexNet [30] model was retrained using the image DB categorized into five classes.

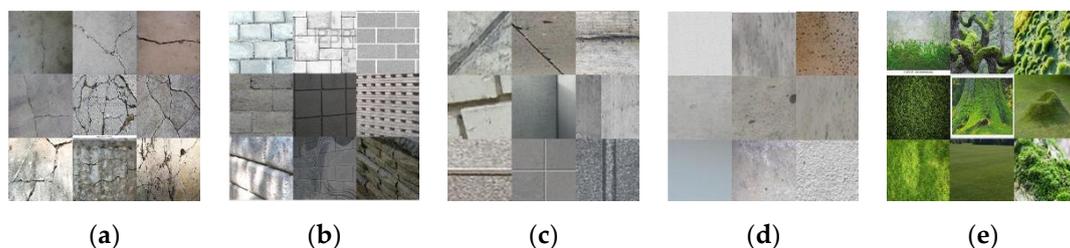
Figure 4. Examples of detailed categorization of images for crack detection: (a) Crack; (b) Joint/Edge (ML); (c) Joint/Edge (SL); (d) Intact Surface; and (e) Plant.

Image examples of the five classes are displayed in Figure 4. The images of various types of concrete cracks from macro to microcracks are categorized into Crack class (Figure 4a). The images containing multiple construction joints and joints between concrete tiles are categorized into Joint/Edge (ML) class (Figure 4b), and those that have one line or two lines at most into the Joint/Edge (SL) class (Figure 4c). To cover various types of real-world concrete surfaces, concrete surface images involving diverse texture and different colors are categorized into the Intact Surface class (Figure 4d). Finally, the images of moss-like plants which can be found on concrete surfaces are categorized into the Plant class (Figure 4e). This detailed categorization of images contributes to the high accuracy of the trained CNN model in detecting concrete cracks.

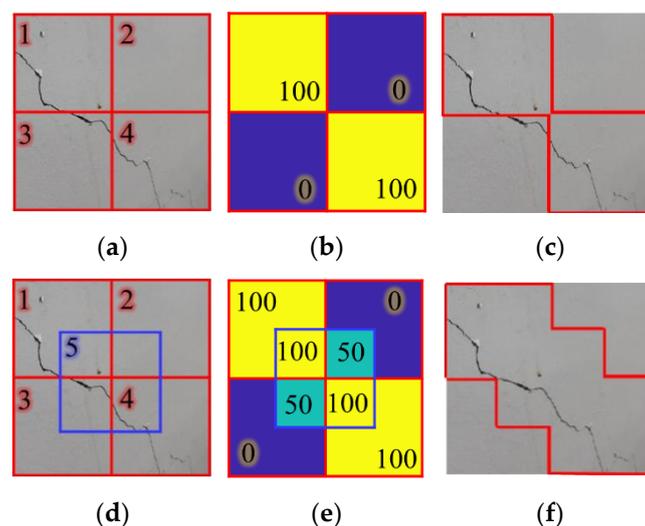
Figure 5. Performance enhancement using overlapped windows: (a) sliding windows without overlapping; (b) softmax output of the windows; (c) detection result from sliding windows without overlapping; (d) sliding windows with overlapping; (e) average softmax output of the windows; and (f) enhanced detection result with sliding windows with overlapping and probability map.

In this study, a probability map with an overlapped window sliding strategy is developed to overcome this issue. The test image is scanned using an overlapped window, and the probability map is obtained using the average softmax layer value of Crack class scanned by a sliding window with overlapping. Using this strategy, a crack object near the border of a window is located near the center of an overlapped window. Figure 5d shows an example of the addition of a 50% overlapped window to Figure 5a, and Figure 5e shows that the probability of the disregarded part of the crack in the detection result without overlapped windows was increased from 0% to 50%. By highlighting the pixels whose probability exceeds a predetermined threshold, 50% in this case, crack parts in the image can be extracted. The extracted crack parts in Figure 5f are more valid compared to the result of Figure 5c. The window sliding strategy may be changed according to the image size, allowable computing time, and target accuracy. Note that a window scans a test image twice with a quarter overlapping of the image as shown in Figure 5e in this study.

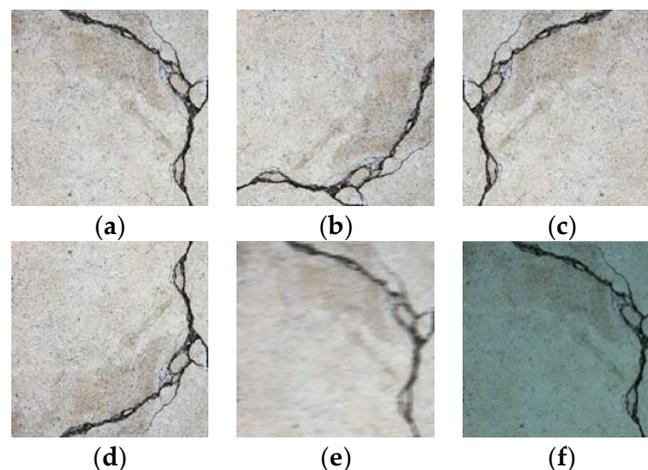
Figure 6. Example of image augmentation: (a) Original image; (b) rotation 90° to clockwise direction; (c) flip left to right; (d) flip up and down; (e) blur; and (f) color conversion.

The training images can be augmented in three ways: geometry transformation, blurring, and color conversion. Geometry transformation, which aliases translation, reflection, and rotation, considers the variation of direction and angle at which the images are taken. Blurring considers the possible instability of the imaging camera under insufficient light and unfocused shot. Color conversion, which aliases illumination of the color field (RGB), considers the variation of light and color characteristics of the imaging camera. Figure 6 shows examples of the image modification for data augmentation. Using data augmentation, the number of training data can increase up to at least ten times.

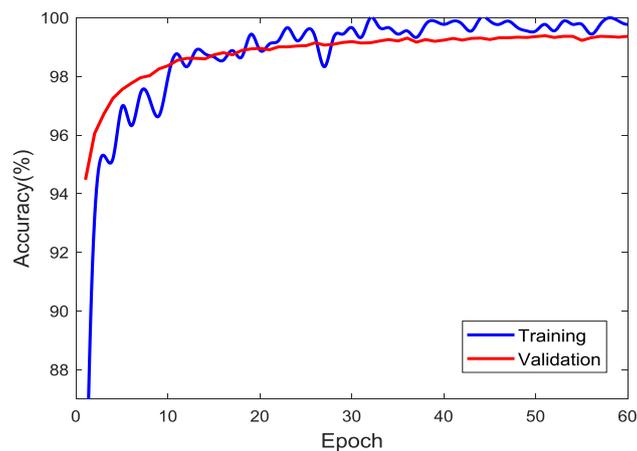
Figure 7. Accuracy of training and validation.

In this study, a personal computer (PC) with a single GPU (CPU: Intel(R) Core(TM) i3-6100, RAM: 8192 MB, GPU: NVIDIA Geforce 1060 3 GB) was used for the training with the help of transfer learning. The number of training images was increased to 10,000 for each class (i.e., a total of 50,000) by taking image augmentation techniques. Figure 7 shows the accuracy of training and validation as epochs proceed. To update the parameters using a stochastic gradient descent algorithm, the network takes a subset of the image data set, called a “mini-batch”, for each iteration. Once the network completes its pass through the full training set, it completes one epoch. The training accuracy is calculated based on 40,000 images, and validation based on 10,000 images not included in the training set. The highest accuracies in the training are 100.00% at several epochs and 99.39% at the 51st epoch in the validation. Despite the computer with relatively low computational power, the training during 60 epochs took 316 min since the training started from the parameters of the pretrained AlexNet. The result that the accuracy of validation reached 98% at 8th epoch shows the efficiency of transfer learning. For the sake of analysis, the CNN classifier was trained for 60 epochs even though the validation accuracy reached 99% at the 22nd epoch. This result confirmed that transfer learning is very effective in saving the training time, while the issue of overfitting does not arise.

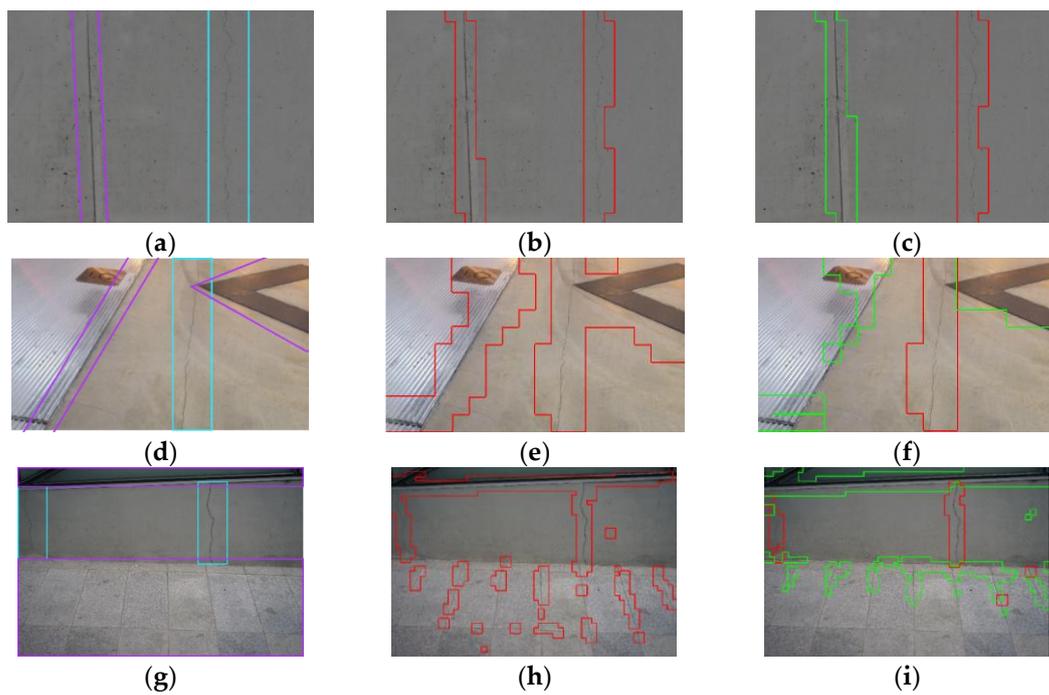
Figure 8. Examples to present enhancement by Joint/Edge Class: (a,d,g) original images, (b,e,h) classification results with two classes, Crack and Surface, and (c,f,i) enhanced classification results with introducing Joint/Edge(SL) class.

Figure 8 illustrates the enhancement obtained by introducing multiple classes to consider the confusing linear-shaped objects. Figure 8a,d,g shows three examples that contains both cracks and confusing objects, which are a joint in Figure 8a, objects with linear edges in Figure 8d, and linear concrete edges and rectangular tiles in Figure 8g. In the images, cracks are marked with cyan boxes and the confusing objects are marked with purple boxes. Figure 8b,e,h is the classification results of three images when two classes, Cracks and Surfaces, are considered. As presented in red boxes, the confusing objects are misclassified as cracks, since their shapes are closer to cracks than surfaces. Figure 8c,f,i is the enhanced results when multiple classes are used. The highlighted part with green boxes shows the confusing objects are classified as the Joint/Edge (SL) class, and they have high agreement with the misclassified parts as cracks in Figure 9b,e,h. The average precision of the three images increased from 32.72% to 97.93% while the average recall slightly decreased from 100% to 98.93%. Thus, by separating the confusing objects from real cracks, the false positives can be minimized in the practical environments.

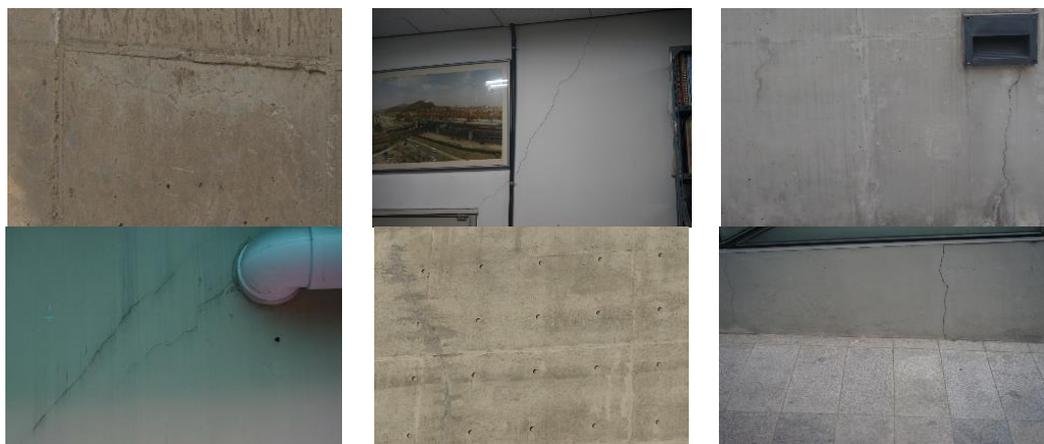
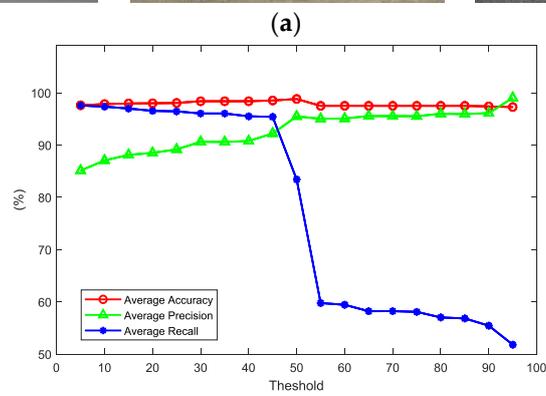
Figure 9. Parametric study of the probability threshold: (a) six crack images used for the parametric study; (b) performance measures of six images with increasing threshold.

where TP is the true positive, TN is the true negative, FP is the false positive, and FN is the false negative. Their averages of six images calculated from 5% threshold to 95% in an increasing unit of 5% are illustrated in Figure 9b. The average accuracy changed only slightly in relation to the threshold, while the other two measures changed significantly. The average precision slowly increases from 0% to 50% and remains relatively constant afterwards. However, the average recall decreases little from 0% to 50% and drops suddenly after 50%. The significant change of both precision and recall around 50% results from the sliding window that scans all the pixels of an image twice. This result seems reasonable considering the case where a crack is at the center of a sliding window and at the border of the overlapped window. At first scanning, the pixels containing cracks would get high probability near 100%, while the crack may be missed at the second overlapped scanning. Though the result suggests the use of 50% as the threshold, the threshold is determined in order to make both precision and recall exceed 90% and to minimize the possibility of missing cracks with a small possibility of false positives. In the further detection using the probability map, the threshold is determined as 35% where precision starts exceeding 90% as show in the Figure 9b. The threshold is set to 35% to maximize recall value but users might change the threshold according to their purpose of inspection.

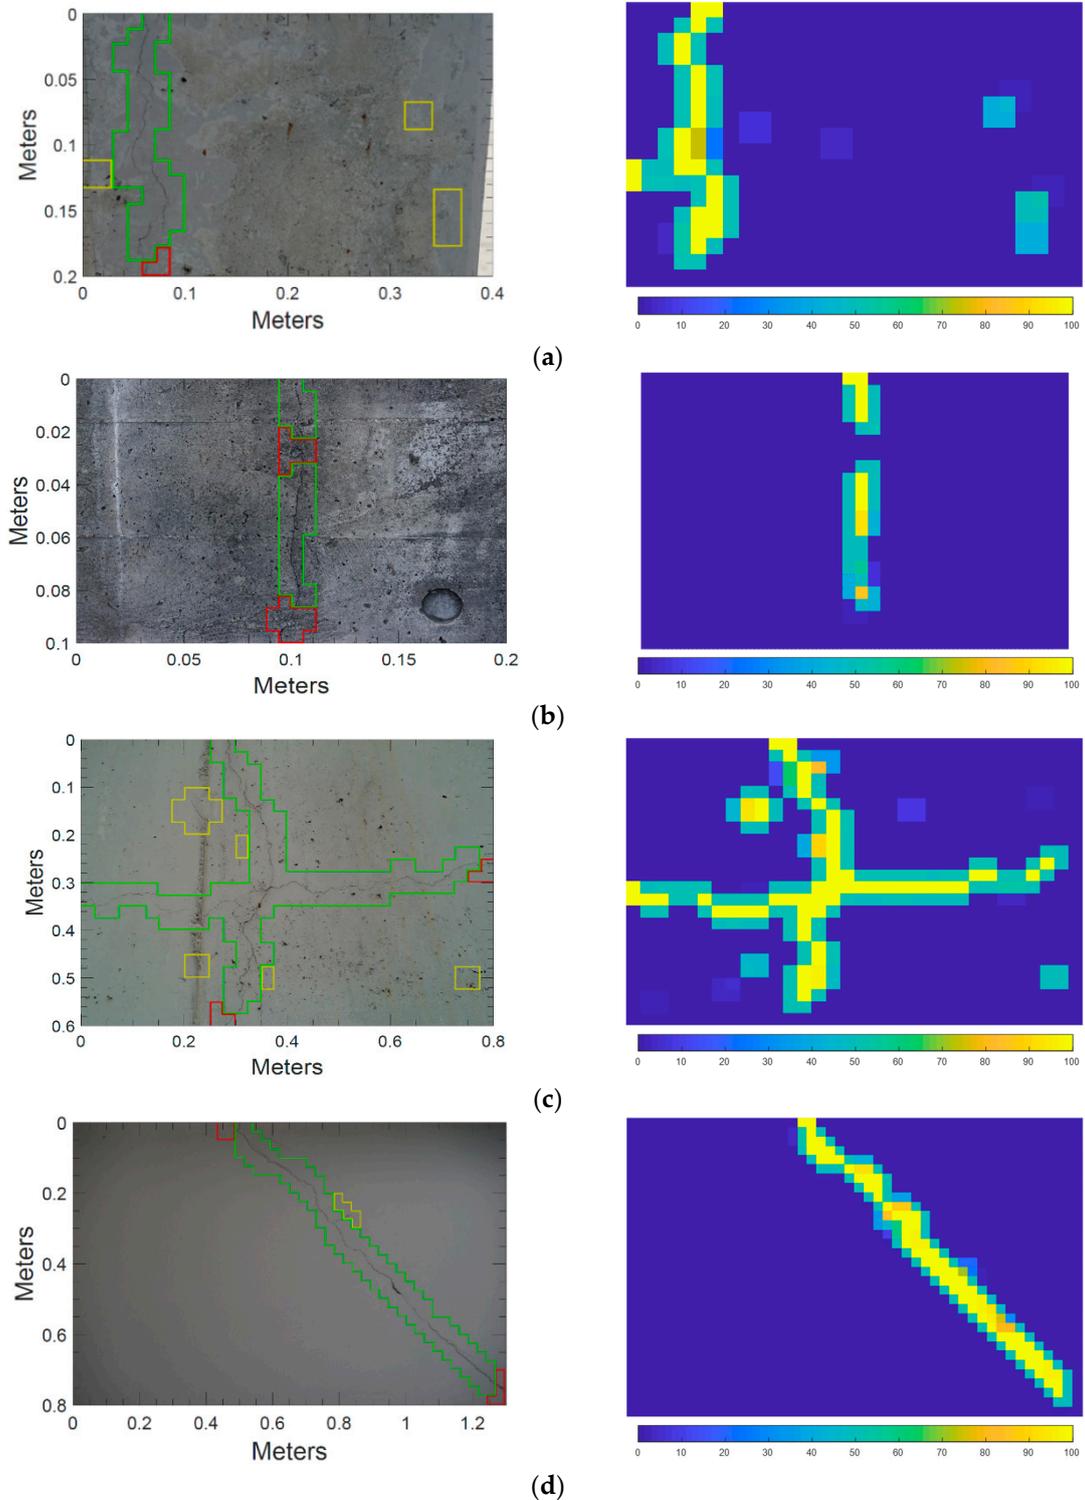
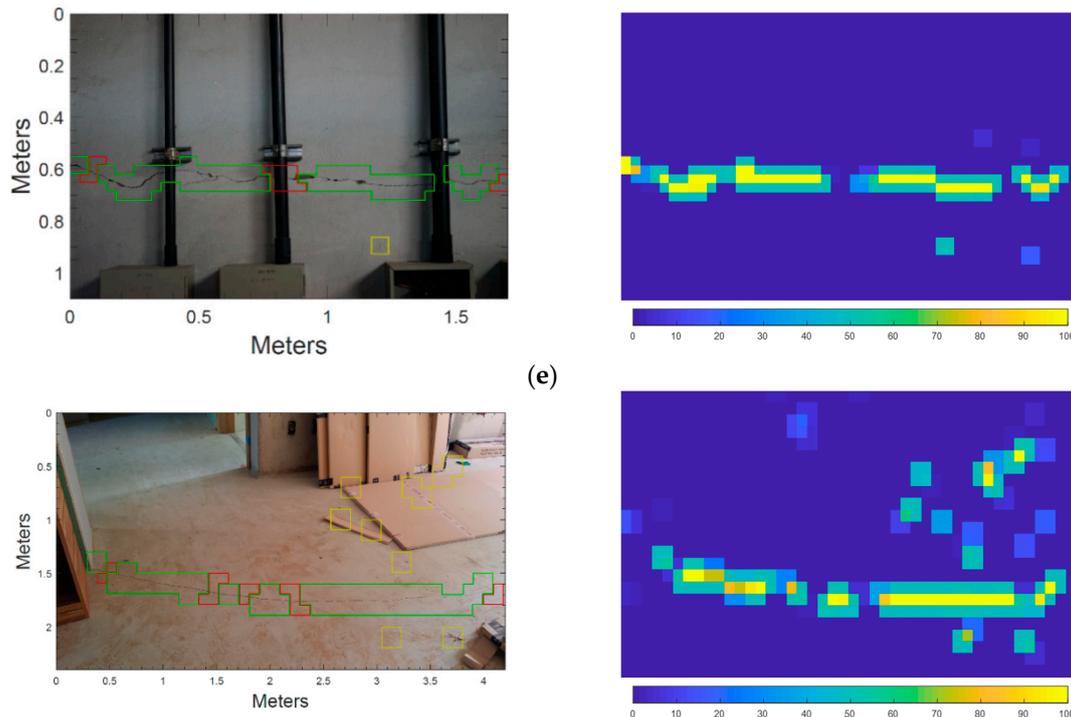
Figure 10. Crack detection result of each case by the proposed method (left column) and corresponding probability map (right column): (a) peeled concrete surface; (b) clean concrete surface; (c) concrete surface with many pores and construction joints; (d) dark concrete surface; (e) concrete surface with pipes and electric distribution boxes; and (f) floor with construction materials.

To validate the automated crack detection method, i.e., the applicability of the trained classifier to an on-site environment, tests were conducted with images taken from actual concrete structures with commercial DSLRs and smartphone cameras. The results of crack detection in Figure 10 show the performance of the proposed approach in extracting crack regions on concrete surfaces and the probability map corresponding to each image. In Figure 10, the distributions of true-positive (TP), false-negative (FN), and false-positive (FP) regions are highlighted as green, red, and yellow colored boxes, respectively. Remaining regions without highlight are true-negative (TN). The presence of cracks was detected successfully in all test images, though there were many obstacles. The obstacles in Figure 10a–d are stain, scratch, tie holes, and imprint of concrete mold that can be found on structure surfaces caused by poor handling and maintenance. Those in Figure 10e,f are pipes, electrical distribution boxes, and interior materials having a rectangular shape for the sake of convenience in construction. Despite the obstacles to crack detection varying according to each experimental environment, the proposed method successfully detected cracks as shown in Figure 10. Looking at the performance measures, the proposed method achieved more than 90% of accuracy for all the test images and attained an average precision of 86.73% and an average recall of 88.68% on the pixel-level,

Table 2. Crack detection result of six images in Figure 10.

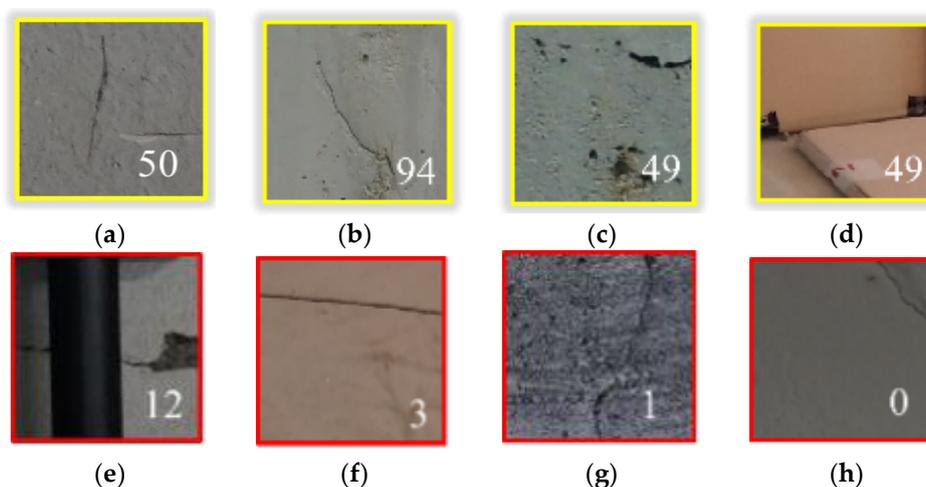
Figure 11. Example images of FP groups (a–d), FN groups (e–h) and their crack probabilities (a–d): (a) crack-shaped contaminants; (b) overlaid cement paste; (c) continuously distributed concrete pores; and (d) edge of linear-shaped construction material; (e) crack hidden behind object; (f) crack having straight line; (g) crack obscured by dark surface; and (h) crack on the corner of detecting window.

Despite of the excellent performance of the proposed method, it still has limitations in detecting cracks against objects that are indistinguishable in vision. Looking into the details, FPs were observed in various patterns that can be categorized into four groups. Figure 11a–d shows example images of four FP groups with their crack probabilities. The first group represents crack-shaped contaminants left on the surface as exemplified in Figure 11a; the second group is overlaid cement paste, as seen in Figure 11b; and the third group consists of continuously-distributed concrete pores, shown in Figure 11c. Due to their shapes, the possibilities of obtaining crack FPs for these three groups are estimated at over 35% (i.e., the threshold determined in Section 4.2). Under visual inspection, these FPs can be easily distinguished from cracks by checking for the existence of splits, which cannot be investigated in the monocular images. Instead, in order to reduce FPs in the proposed method, sufficient illumination may be used to unshadow these objects and contrast the split cracks; other techniques, such as stereovision [33] and infra-red, may also be implemented. The last group consists of a small number of discontinuous edges of linear-shaped construction material which are misclassified as cracks, Figure 11d. Though the proposed method suggested detailed categorization of surfaces to remove these patterns, a few which have relatively irregular shapes are classified as cracks. This FPs

may be removed out by considering the region areas, shapes, and continuities in the further study. FNs are also observed in various patterns that can be categorized into four groups. Figure 11e–h shows the example images of four FN groups with their crack probabilities estimated as being low. The first group are the cracks hidden behind other objects as exemplified in Figure 11e. In this case, the major object in the window (e.g., the pipe) reduced the crack possibility while increasing the possibility of other classes (e.g., Joint/Edge (ML) and (SL)). The second group are the cracks having a linear shape without irregular patterns, as seen in Figure 11f. The training image categorization of the proposed method is based on the assumption that cracks generally have an irregular linear shape, and thus the second group is mostly classified into Joint/Edge (SL). These FNs are the result of inevitable trade-off in the process removing crack-like objects, and may be removed out by considering the region areas, shapes, and continuities. The third group are the cracks obscured by dark surfaces, shown in Figure 11g. This may be overcome by implementing sufficient illumination. The last group are the cracks located on the corner and boundaries of the detecting window, as in Figure 11h. Since this FN is related to the FOV, it may be solved by taking another image with an altered FOV or by using a video stream.

Based on the investigations of FPs and FNs, the four types of solutions suggested for reducing FPs and FNs are summarized in Table 3. This table shows that the proposed method can perform excellently in practice if the solutions are combined in the further study.

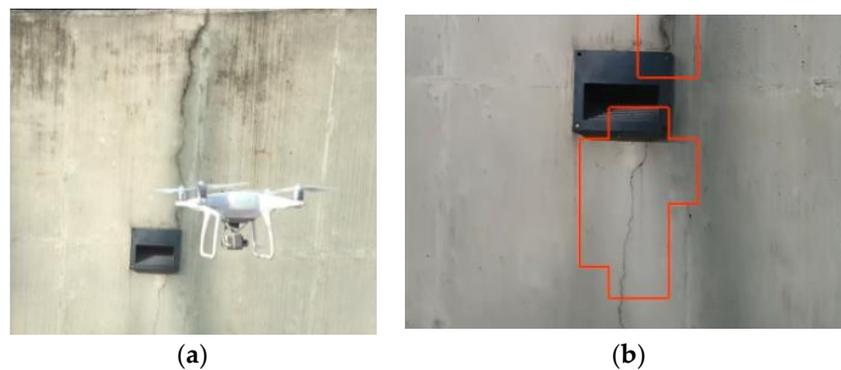
Figure 12. Automated crack detection using UAV: (a) Video shooting using UAV, (b) Example image of real-time crack detection.

The test video was taken at a concrete retaining wall located at the University of Seoul as shown in Figure 12. The wall has a varying height between 2 and 4 m, and a width of approximately 20 m. A region of 2×5 m was inspected using a drone, and 16 cracks were found visually with varying shapes and sizes. The wall is highly contaminated with sediments by leakage, and it attaches several pieces of rectangular sidewalk lighting equipment that initiate the cracks as in Figure 12.

The drone used in this study is Phantom 4 advanced (SZ DJI Baiwang Technology Co., Ltd., Shenzhen, China) equipped with a 1-inch 20-megapixel CMOS camera along a FOV 94° 20 mm lens. While shooting the video, the drone kept a distance from the concrete wall of about 2 m during the entire flight, and the approximate FOV was $0.75 \text{ m} \times 1.60 \text{ m}$ based on camera specifications. The working distance of 2 m was found to be sufficiently close for detecting major and minor cracks that formed on the concrete surface. The trained classifier was used to detect cracks from an image taken from the video every 0.5 s.

The real-time detection is demonstrated in the video [Link: <https://youtu.be/5sNbfEaRwkU>]. As shown in the video, the developed method successfully detected 15 out of 16 cracks, missing only a very small crack whose width was approximately 0.05 mm. For all images used in the detection, the precision and recall in the pixel level were calculated as 88% and 81%, respectively. Considering that the video frames taken by the moving UAV are quite blurred, the result shows that the proposed method is at the edge of practice for a UAV-based structure inspection.
