Article

Evaluating Post-Earthquake Building Safety Using Economical MEMS Seismometers

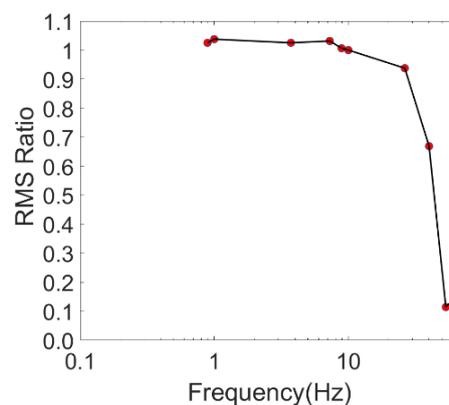
Figure 1. Low-Frequency Accelerometer Calibration System (LFACS) calibration results of a P-Alert sensor.

The P-Alert device is a triaxial MEMS accelerometer. It can record two horizontal and one vertical component of acceleration. Its signal resolution is 16 bits. It has a range of -2 g to $+2\text{ g}$, and a sampling rate of 100 samples per second. P-Alert also has networking capabilities, including the ability to stream real-time acceleration signals to the data collection server, to connect automatically to up to two servers, as well as clock synchronization thanks to the network time protocol (NTP). P-Alert offers 10 Hz and 20 Hz low-pass filters that must select one absolute filter. For EEWs, a 10 Hz low-pass filter is the standard choice. For the SHM cases in this study, we selected a 20 Hz low-pass filter to retain a stronger signal for the building response. The self-noise level of P-Alert is roughly 0.1 gal, which is higher than that of commercial accelerometers. We conducted an instrument calibration experiment using a Low-Frequency Accelerometer Calibration System (LFACS) in the calibration laboratory of the National Center for Research on Earthquake Engineering (NCREE), Taiwan. The certified frequency range of the LFACS in NCREE is 0.8–40 Hz. We compared the measured acceleration results obtained using P-Alert against the results we obtained with the reference accelerometer of the LFACS. The root mean square (RMS) value of the measured Sine waves with different frequencies at 0.8, 1, 2, 5, 8, 10, 15, 20, 30, and 40 Hz was calculated with the same timeframe. We determined the RMS ratio by using the RMS value of P-Alert divided by that of the LFACS. The results revealed that the RMS ratios were close to 1.0, in a range between 0.8 Hz and 10 Hz (Figure 1). The fundamental natural frequency of ordinary buildings lower than 10 stories typically falls within the range of 1–10 Hz. Because most buildings are less than 10 stories high, the quality of P-Alert may meet the requirement for the frequency range of interest, because the chief contributor of the interstory drift is the fundamental natural frequency.

Based on the results of the calibration tests, a single P-Alert device was verified as reliable for acceleration measurements at a frequency range between 0.8 Hz and 10 Hz. Moreover, in theory, the displacement caused by the lower frequencies is much greater than those resulting from higher frequencies, because the amplitude of the displacement signal is proportional to the inverse of the frequency squared. This implies that P-Alert is suitable for measuring displacement vibration signals contributed by the fundamental natural frequency of most ordinary buildings with fewer than 10 stories, the frequency range of which is between approximately 1 Hz and 5 Hz. The low correct rate for the damage level of stories for P-Alert is chiefly due to the time difference between each P-Alert sensor. Based on the substantial improvement to the correct rate, which was observed in the results after the pseudosynchronization of the P-Alert sensors, we recommend improving the synchronization of P-Alert sensors to achieve damage localization for stories.

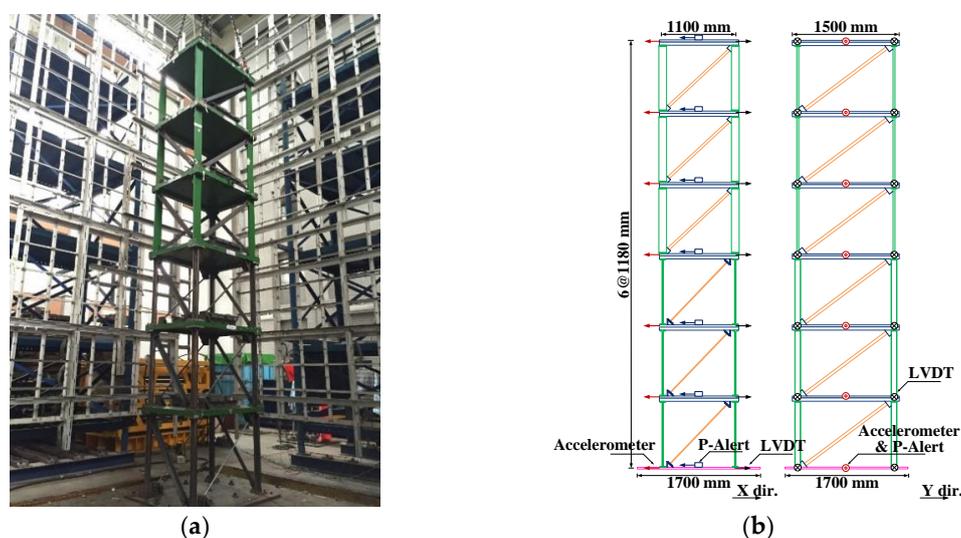
Figure 2. The 1/3-scale six-story steel structure. (a) Overview and (b) plane views with sensor arrangement.

A 1/3-scale six-story steel structure at the NCREC, Taiwan, was used to experimentally test the sensor and method. As shown in Figure 2, the structure consisted of a single bay comprising a 1.1 m × 1.5 m floor area, with a uniform height of 1.18 m per story. The cross-section of the beams was 50 mm × 100 mm × 6 mm (U-section). For scaled-down specimens of shaking table experiments, the same cross-sections of the elements in each story are typically used. Hence the damage occurs in the lower stories because the forces there are greater. However, due to budget limitations, the upper three stories of the steel building were loaned from another project. Although the story layouts are not typical, the aim to verify the ability to estimate structural safety is still valid without loss of generality. The overall stiffness and strength of these three upper stories were substantially higher compared to their 3 lower counterparts. The cross-section of the columns and bracings of these upper stories measured 150 mm × 25 mm (rectangular section) and 65 mm × 65 mm × 6 mm (L-section), respectively. To confirm that the steel building would sustain damage during the shaking table test, the structure was designed to have less seismic capacity in the lower three stories. The cross-section of the lower columns was 100 mm × 30 mm × 5 mm × 7 mm (H-section). In addition to the L-shaped bracings used in the upper stories, two differently sized tube bracings were used in the *x*-direction in the lower three stories. The outer diameter of these bracings measured 18 mm and 21.7 mm, respectively, with a thickness of 1.2 mm and 2 mm, respectively. For the entire steel building, the beam–floor connections were welded, whereas the beam–column connections and the base–column connections were bolted. The dead load was simulated with lead block units fixed to the steel plate of each floor. The total mass of each floor of the target structure was approximately 962.85 kg, except for the mass of the roof floor, which weighed 903.98 kg. The first natural frequency for the building was approximately 3.5 Hz.

For the wired measurement system of the shaking table facility, Setra141-A accelerometers with an acceleration range of ±4 g and a noise floor of 0.4 mg were used, as were a linear variable differential transformer (LVDT) and the Multiple Pacific Instrument Series PI660-6000 data acquisition chassis. The Setra of the NCREC measurement system was treated as the benchmark for the standard acceleration sensors. Figure 2b shows the location of all the installed sensors, including the P-Alert devices as well as the LVDT and Setra accelerometers. One P-Alert device was fixed to each floor, totaling seven P-Alert devices for each specimen. Figure 3 displays a photograph of an installed P-Alert device on the structure.

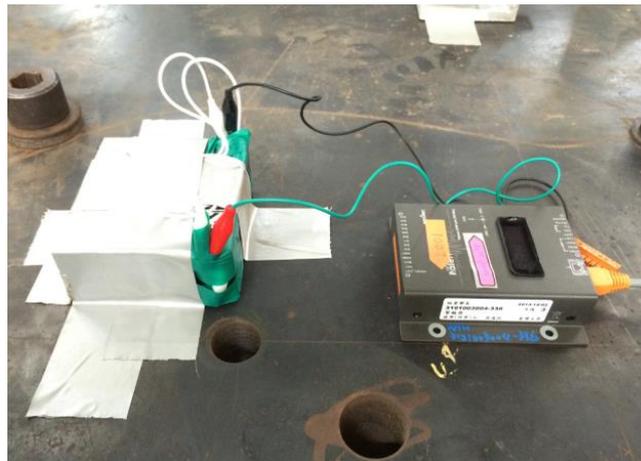
Figure 3. Photograph of installed P-Alert device.

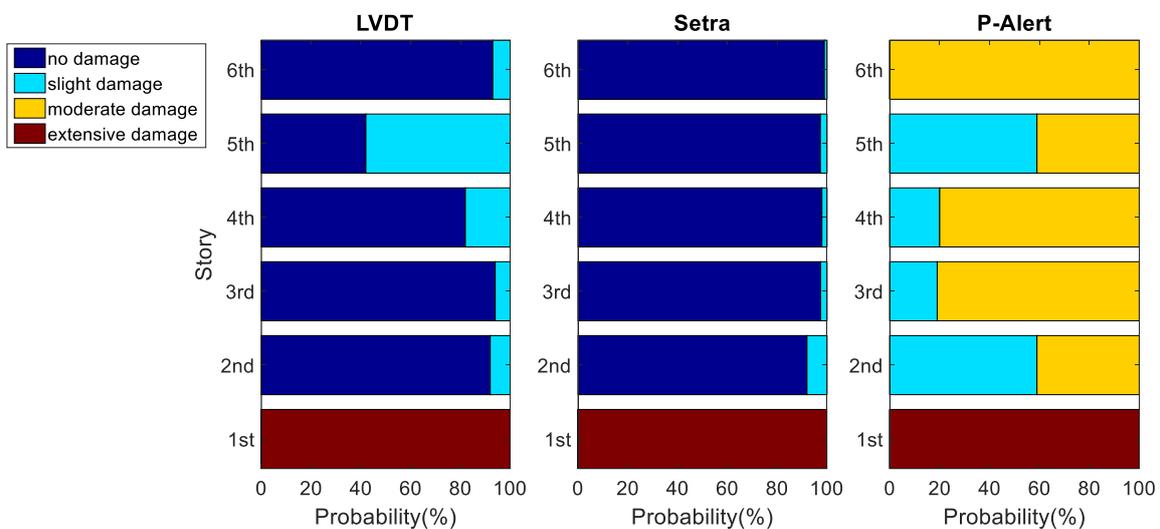
Figure 5. Typical result of Case 3 with peak ground acceleration (PGA) of 400 Gal.

Trapani et al. [27] suggested that the cutoff frequency, f_c , for the filter should be set within the range of $0.2 \text{ Hz} \leq f_c \leq 0.5 \text{ Hz} \times f$, where f is the fundamental natural frequency of the structure. The cutoff frequency, f_c , was selected as 0.5 Hz in our study. Afterward, we used the maximum absolute IDR of each story obtained using Setra, P-Alert, and LVDT to calculate the possibility of the damage levels of each story individually. Typical results of Case 3 with a PGA equal to 400 Gal are shown in Figure 5. The x -axis represents the probability of structural damage at different levels, and the y -axis represents the story. For each story, the damage level with the largest probability was selected to represent the estimated damage level of that story. In this typical result, Stories 1 and 5 were estimated to have sustained extensive damage and slight damage, respectively, and the remaining stories were gauged to have sustained no damage when using the LVDT. The LVDT results are relatively reasonable, because the bracings in Story 1 buckled, and residual displacement was easily noticeable, as is clearly observable in the photograph of Story 1 taken after the earthquake (Figure 6). No obvious signs of damage were noted in the other stories. A photograph of the entire structure after the earthquake is shown in Figure 7.

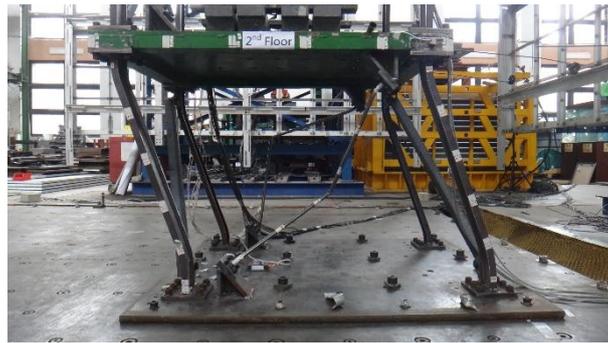
Figure 6. A close-up of Story 1 in Case 3 after the earthquake excitation with a PGA value of 400 Gal.

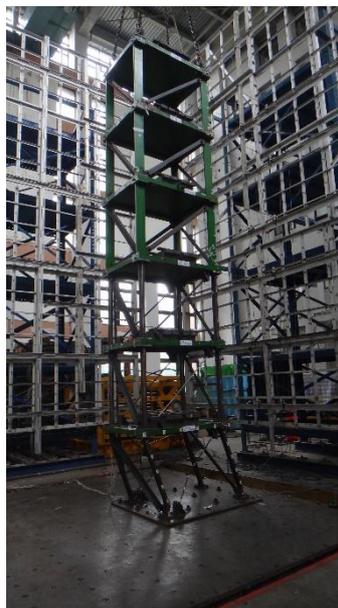
Figure 7. A general view of the entire structure in Case 3 after earthquake excitation with a PGA value of 400 Gal.

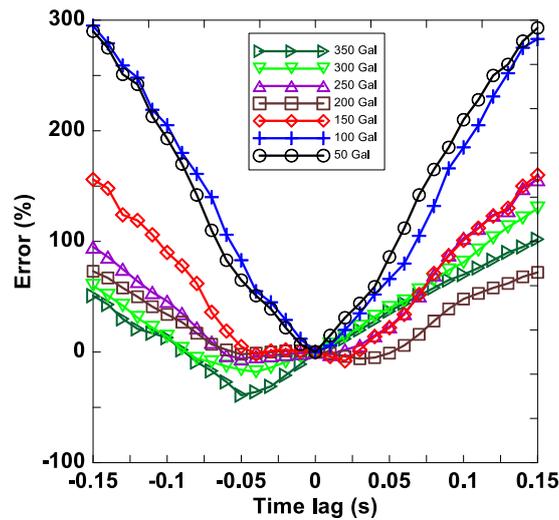
Figure 8. Time difference effects on interstory drift ratio (IDR) estimation.

We examined the effects of the time difference on the IDR at the first story for each excitation in Case 1; the results are shown in Figure 8. The vertical axis represents the error of the IDR, which was calculated using the following equation:

where IDR_0 represents the IDR without a time lag, whereas IDR_i represents the IDR with time lag i . The results indicated that the error of the IDR increased rapidly when the time lag increased. Both an overestimation and an underestimation could be obtained when the time lag was small, but overestimation was generally obtained when the time lag was large. The results show that the error caused by the time difference can be reduced substantially if the time difference is small.

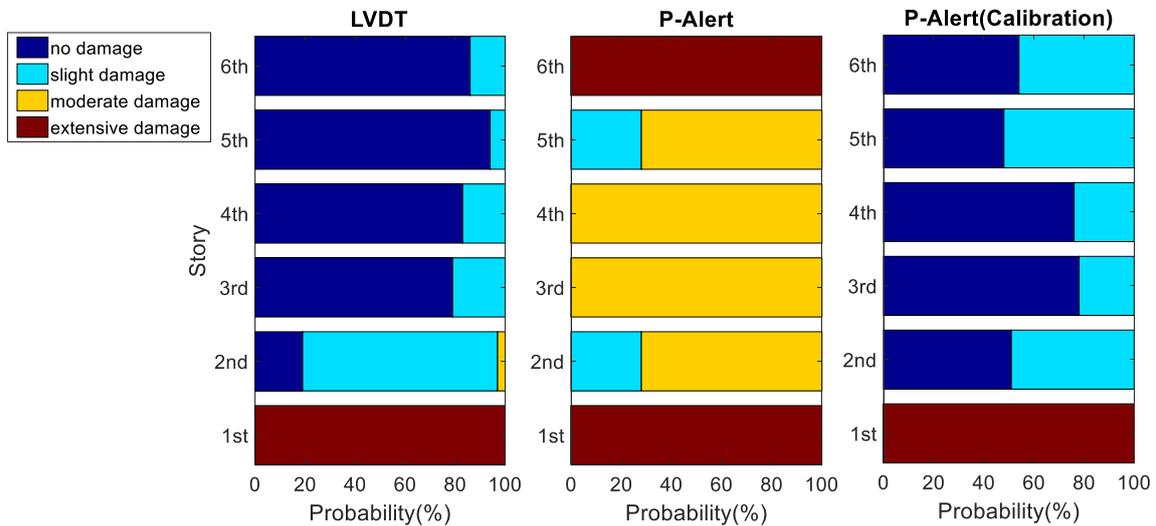
Figure 9. Results of Case 3 with PGA of 350 Gal, obtained with the LVDT, original P-Alert, and pseudosynchronized P-Alert.

Because time synchronization is a critical issue of P-Alert for IDR-reliant post-earthquake safety evaluations, we attempted to synchronize the P-Alert signals offline in order to understand the potential performance of P-Alert under conditions of minimal time difference. A cross-correlation was calculated to estimate the time difference between the P-Alert sensors in different stories, after which it was corrected to create pseudosynchronized acceleration signals. We treated the time lag of the maximum absolute value of the time history of the cross-correlation results as the time difference between the P-Alert sensors in different stories. We assumed that the time difference was a constant between each pair of sensors in the different stories; hence, the corrected IDR was calculated after the time shift of one sensor. One of the worst correct rates of damage level estimation for the stories was demonstrated with a potential pseudosynchronization improvement for P-Alert (i.e., Case 3 with a PGA of 350 Gal, as shown in Figure 9). Figure 9 displays the LVDT results, the original results of P-Alert, and the pseudosynchronized P-Alert results. The figure shows that the pseudosynchronized P-Alert results are much closer to those of the LVDT. The correct rate of the pseudosynchronized P-Alert for all the cases is also listed under Table 2. Despite a number of cases exhibiting little improvement in the correct rate, the overall correct rate increased substantially, to 70.8%. Synchronization was imperfect because we did not know the actual time difference between each P-Alert sensor, and hence, only cross-correlation was used to perform pseudosynchronization. We expect a higher correct rate to be achievable in case of perfect synchronization between the P-Alert sensors.
