Article

A UAV-Based Framework for Semi-Automated Thermographic Inspection of Belt Conveyors in the Mining Industry

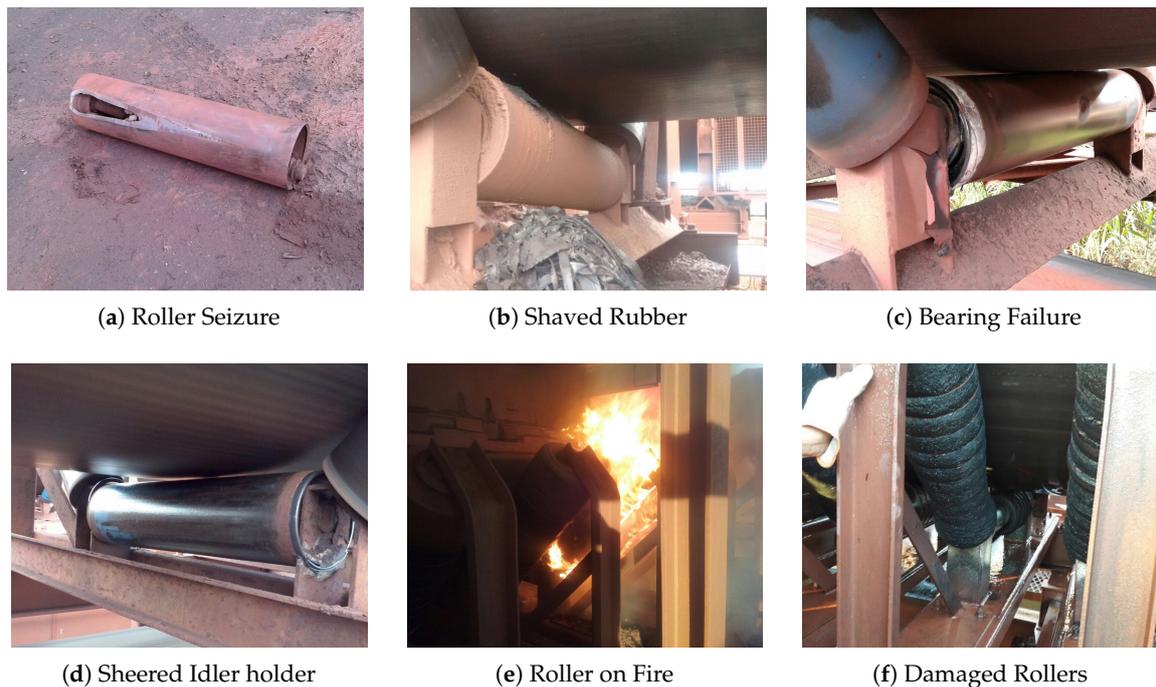
Figure 1. Rollers failures and its consequences: (a) Roller seizure that shaves the rubber of the BC, as demonstrated on (b). (c) A bearing failure affecting only the central roller. (d) Another bearing failure, this time, also affecting the idler holder. (e) An impact roller on fire and (f) rollers damaged by this event.

If the quality of the inspection is questionable, the consequences of an undetected defective roller are unpredictable. There may be no damage to the BC until the roller's eventual replacement, but it may also overheat and set the belt on fire. In extreme circumstances, the fire may spread to other equipment in the port, what is a dangerous situation entailing high financial losses. Figure 1 demonstrates examples of defective rollers with different consequences.

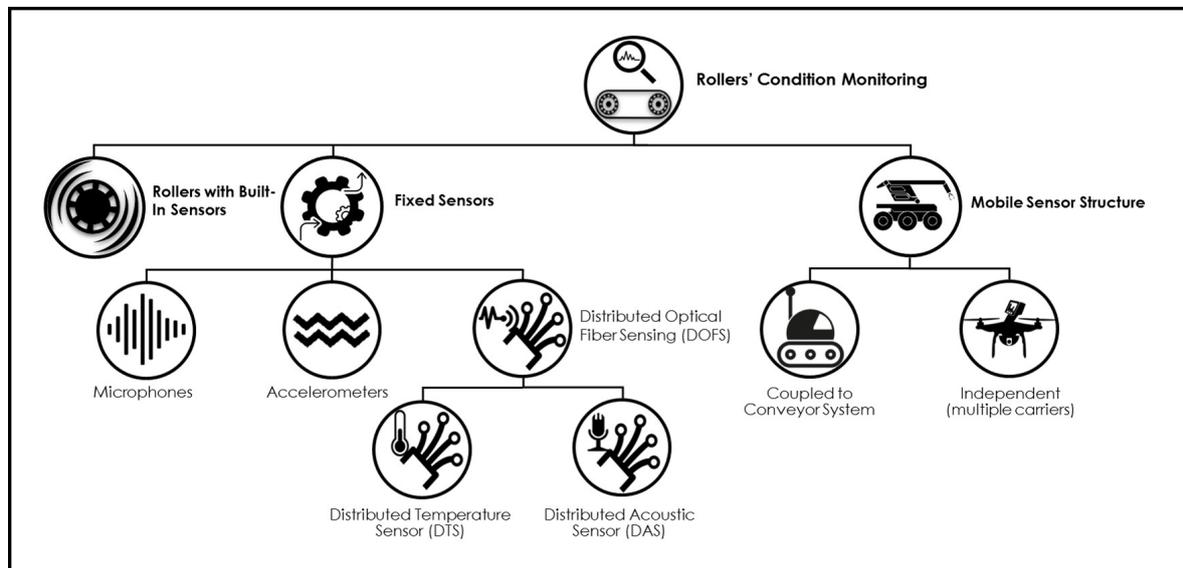
Figure 2. Sensor position and main techniques to monitor the condition of conveyor belt rollers.

Current techniques employ acoustic, thermal and vibration signals to assess the condition of the rollers. However, they differ on the type of the sensors used and how they are positioned (embedded in the roller, in the frame of the BCS or externally to the BCS). Figure 2 presents a diagram to classify the main solutions available.

The second group of solutions in Figure 2 is based on Fixed Sensors installed in the frame of the BCS. Li et al. [11] propose the installation of accelerometers to capture the vibration, Wavelet Packet Decomposition to isolate and identify the defective roller and Support Vector Machine to classify the failure. Similarly, Tan et al. [12] use neural networks and classifiers to recognize different failure types based on vibration signal. In turn, Jiang and Cao [2] capture acoustic signal with microphones and use Wavelet Transform to detect faulty behavior in rollers.

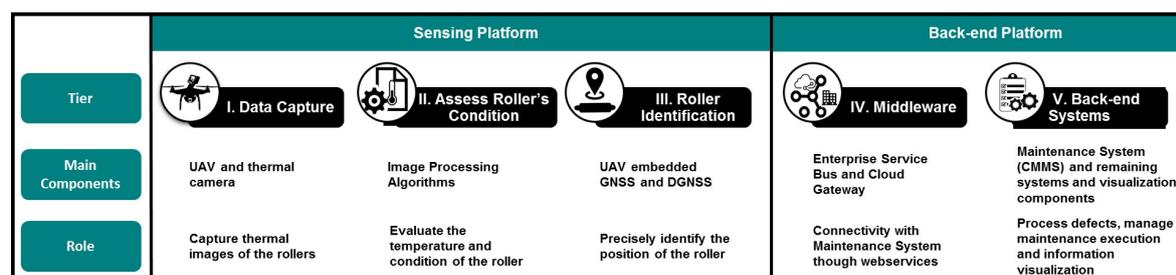
Figure 3. Main parts of the proposed solution to inspect conveyor belt rollers.

As demonstrated in the Figure 3, the solution is split into two layers: Sensing Platform and Back-end Platform. The former is composed of three tiers to capture the current state of the rollers and report defective conditions to Back-end Communication Platform. In turn, this layer enables the connectivity with systems in the organization and visualization tools (Figure 4), enabling the use of rollers' condition information, particularly by the Maintenance System. The following subsections describe the tiers of each layer.

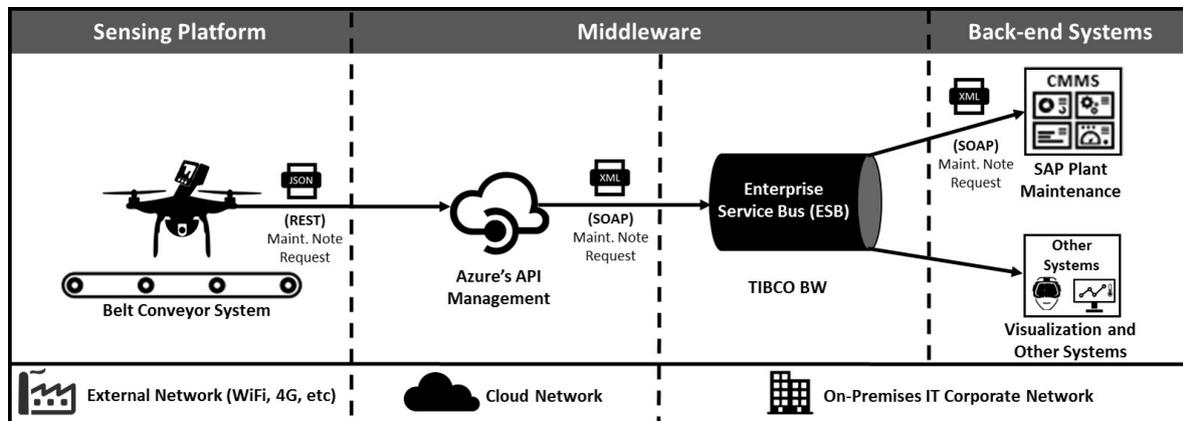
Figure 4. Middleware connectivity and protocol translation.

As demonstrated in Figure 4, the middleware tier has two main roles: connectivity and protocol conversion. In the first role, it is used as a secure gateway between the corporative and external

networks (4G, WiFi, etc.), where the Sensing Platform is connected to. We used Azure's API Management [39] to expose a REST [40] API available through the Internet (cloud), so any request to this API is forwarded to the ESB in the corporate network through a VPN link.

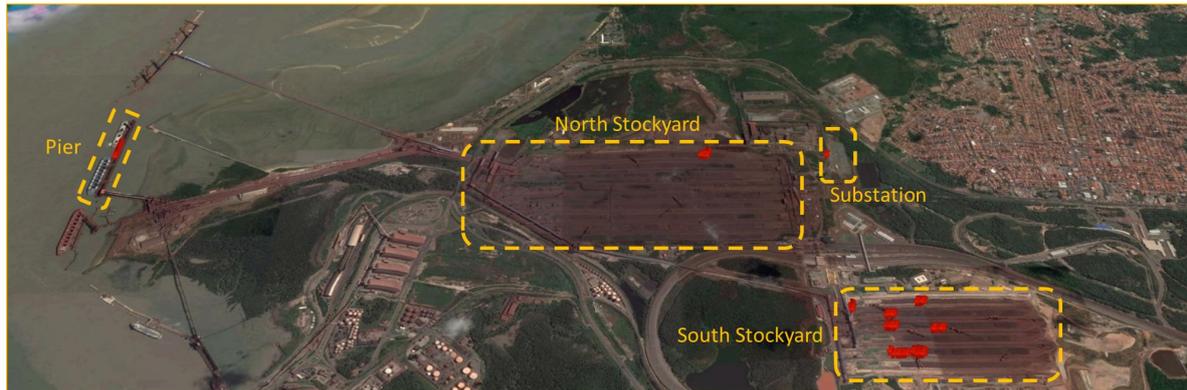
Figure 5. Overview of the test area with the Sensing Platform.

The field tests of our proposal were performed in a bulk port. We conducted tests at different times and on several BC to cover as many diverse situations as possible. The yellow dashed areas in Figure 5 represents the different locations where the tests were performed. Using the Sensing Platform, we captured 722 images represented as red dots in the image. After collecting this image database, we developed an algorithm in MATLAB to handle the computer vision tasks.

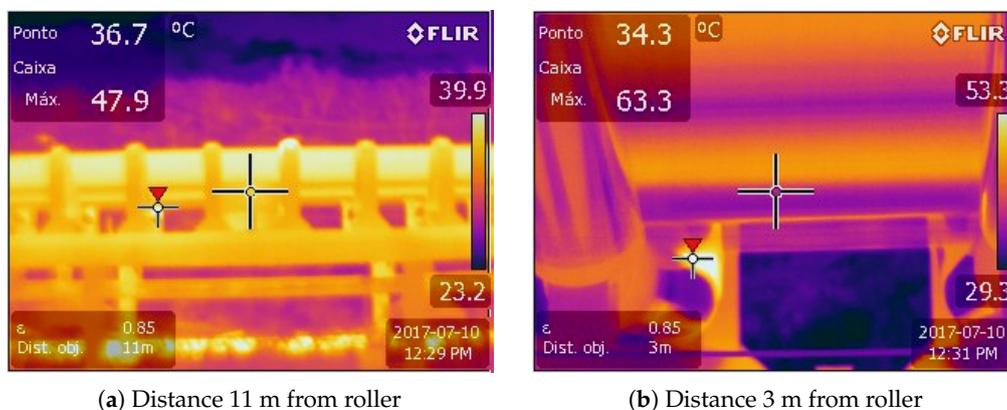
Figure 6. Distance influence in temperature measurement: (a) The photo was taken from 11 m, resulting in an image resolution of 1 pixels/cm². (b) Same roller with an image taken 3 m away and a 22 pixels/cm² image resolution. Both values for resolution are approximations.

The Figure 6 presents two images captured with the sensing platform at 11 m and 3 m. Both were captured in an interval inferior to 2 minutes, under the same operating conditions, emissivity of 0.85 and with the parameter of the camera distance to the object configured to match the actual distance. In the first image (Figure 6a) the maximum temperature value identified was 47.9 °C while the second image (Figure 6b) presents the maximum temperature of 63.3 °C. Despite the difference of 15.4 °C between the images, both detected the maximum temperature at the same point. The discrepancy can be explained by the image resolution, which is different at each distance. At 3 m, the camera resolution is approximately 22 pixels/cm², while at 11 m this value decreases to roughly 1 pixel/cm², meaning that the mean temperature of 22 pixels previously showed is now represented as a single pixel.

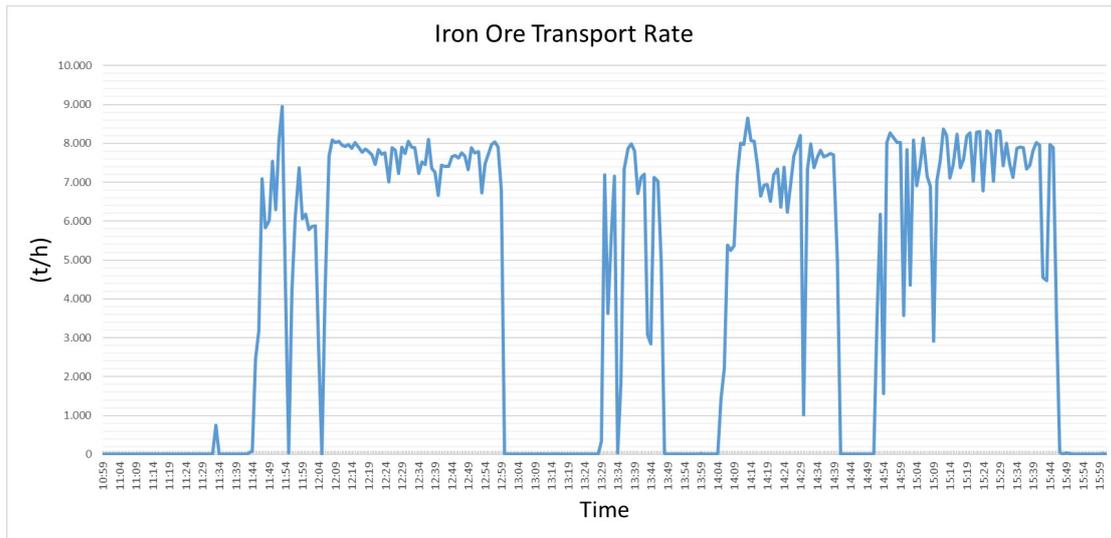
Figure 7. This chart shows how transport rate of one conveyor belt line can drop instantaneously and then recover the previous value of rate.

The Figure 7 presents the operation rate of one of the studied BC from 10:59 to 15:59 in the same day of Figure 6. During the assessed interval, the operation rate dropped significantly and immediately returned to the previous rate. In other time slots, as from 12:08 to 12:59, it operated at a rate with a standard deviation of 345.2 t/h, which is a small variation value to an iron ore operation. It also operated unloaded in different intervals, and 20 min was the maximum time it operated under this condition. Due to specific conditions on some BCs, like the slope of the belt conveyor and height, sometimes the inspector on the field does not know if the inspected equipment is operating with load or not. If the inspector collects the data while the BC is unloaded, as in one of the intervals demonstrated in Figure 7, the temperature values are unrealistic and real defects can be overlooked.

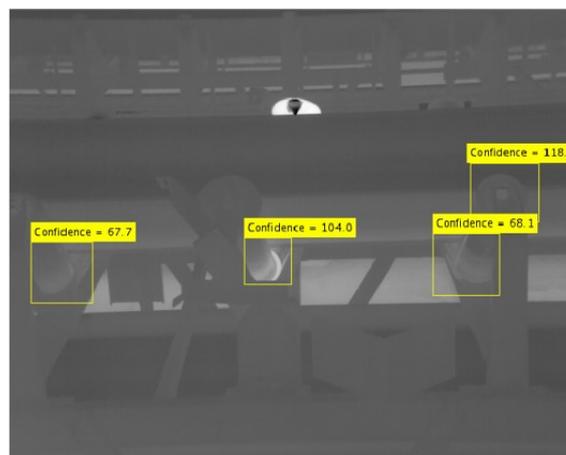
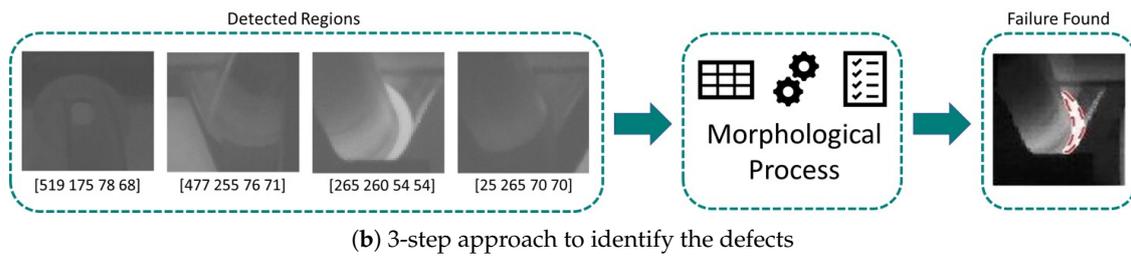
(a) Regions of interest identified in the image

Figure 8. Assessment of defects on rollers.

To achieve that, we propose an approach with three steps. First, the UAV collects the thermal images following the assumptions discussed earlier. On the second step, the algorithm identifies the bearings of the rollers (regions of interest) in the images. Finally, by applying morphological processing of the radiometric data on the images, it is possible to extract the temperature and identify the defective rollers. The Figure 8 illustrates the steps in this approach.

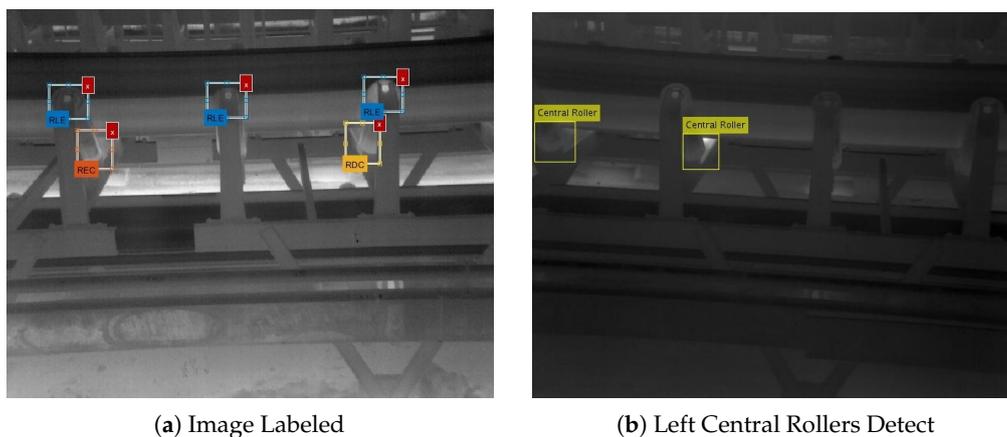
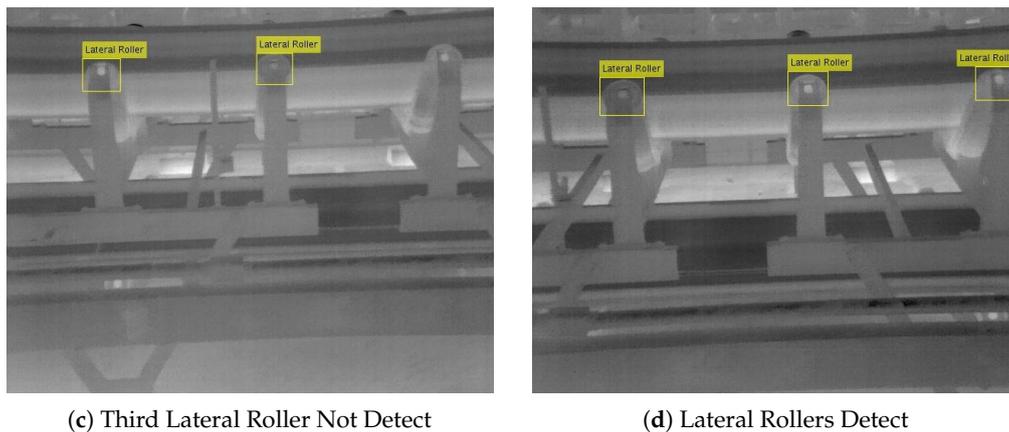
Figure 9. Training for Object Recognition: (a) Different regions of the rollers selected. (b) Left Central Rollers found using the trained detector. (c) Third Lateral Roller not found using the trained detector. (d) The Third Lateral Roller from Figure 9d, which is now the central lateral roller was found.

The ACF method proposed by Dollár and Appel uses several characteristic's channels and a decision tree to form a robust and fast classifier. As illustrated in the Figure 9a, we used a dataset with 644 labeled regions to train the algorithm, split in three different areas: the tip of the lateral roller (labeled as Rolo Lateral (Side Roller) (RLE) with 324 regions), the intersection of the lateral with the central roller in the left (Rolo Esquerdo Central (Left Central Rollers) (REC), with 167 regions), and the intersection of the central roller with the lateral roller in the right (Rolo Direito Central (Right Central Roller) (RDC), with 153 regions).

The differentiation between REC and RDC were necessary to mitigate image recognition errors due to different visualization angles. For example, in the Figure 9b, we used only the detector trained to detect REC regions, so the RDC regions were not classified. In Figure 9c we applied the detector for the RLE and the third roller was not detected, what has been corrected on the subsequent image (Figure 9d), where all the rollers were detected correctly.

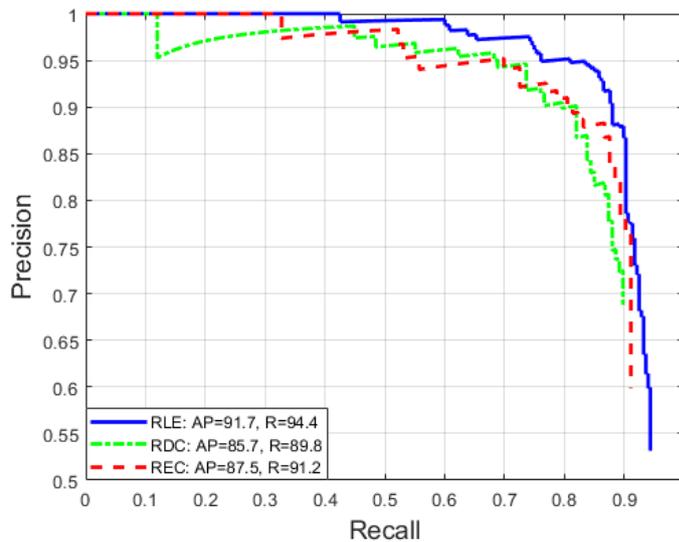
Figure 10. ACF algorithm evaluation.

Figure 10 shows the Precision x Recall curve, as well as the AP and R metrics, for each class of the database. The overall AP and AR metrics were 88.3% and 91.8% respectively, which gives our model an F_1 score of 90.0%. The *Overall False Negative Rate (OFNR)*, which can be calculated from the AR, was only 8.2%, strongly impacted by the RDC regions, which had a OFNR of 10.2%, while the regions RLE and REC had 5.6% and 8.8% respectively. Since we have a spatial redundancy of 3 images, as demonstrated in Figures 9c,d, the probability of not detecting a region of the roller is only 0.06% ($(8.2\%)^3 = 0.06\%$).

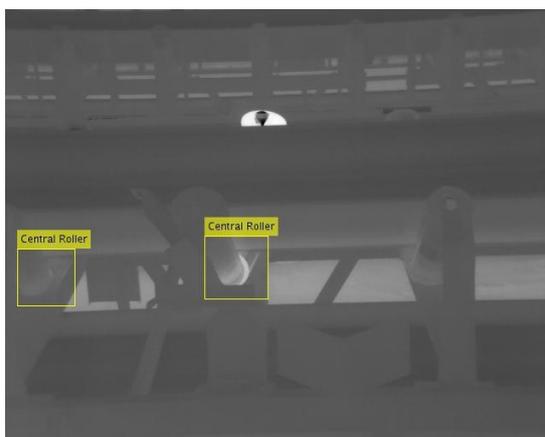
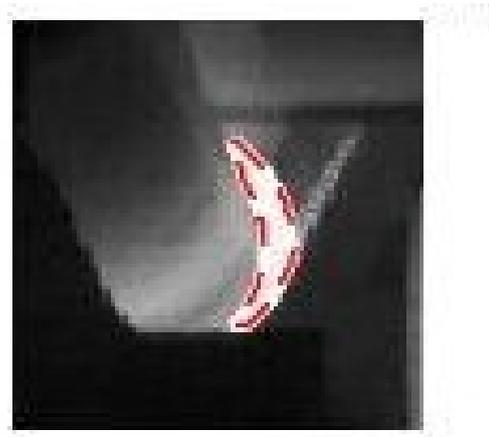
(a) Detector of REC regions applied

(b) Detail of Region of Interest (ROI) found

Figure 11. Defective roller found through the hybrid method: (a) ROIs selected. (b) Detail of the defective roller inside the selected region.

The Figure 11 illustrates how the method works. For this image we used only the detector for REC, therefore, central and lateral rollers were not identified, but two regions of interest were delimited (Figure 11a). Please note that there is a roller with a high temperature on the other side of the belt, but it is disregarded as we did not train it to detect opposite lateral rollers. In this context, it represents an example of an undesired interference, like the reflectance or a hot point, that was ignored as it is not part of the region of interest. Thus, only points inside the region selected are considered for temperature gathering by the morphological method, as demonstrated in the Figure 11b.

We created a mask that marks as 1 the values greater or equal to 45 °C and as 0 the remaining values. It is also important to eliminate small regions that do not represent failures in the rollers or means error readings in one of the camera's sensors. For this end, we used areas with size greater than 19 pixels, where each pixel is connected to 8 pixels that also have a temperature greater or equal to 45 °C. Finally, such regions can be plotted on the original image to highlight the defect to an inspector. The Figure 11b shows the result.

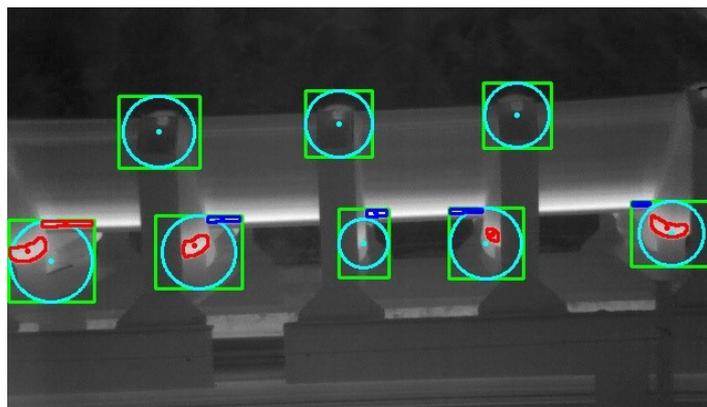
Figure 12. Defective regions found through the distance threshold approach.

We follow a two-step approach to apply this threshold. First, we calculate the distance between the centroid of the high-temperature region of interest (ROI) and the bounding box center. Then, we classify the ROI as a defect only if the distance is lower than the threshold. Figure 12 illustrates this procedure. The cyan point represents the bounding box center, and the cyan circle represents the area within the distance threshold. A high-temperature ROI is classified as a defect (red) if its centroid is within the circle. Otherwise, it is classified as a normal region (blue). Figure 12 also shows that this method reduces the number of false detections, but does not eliminate all of them. The roller on the far left of the figure has a region misclassified as a defect.
