## Supplementary

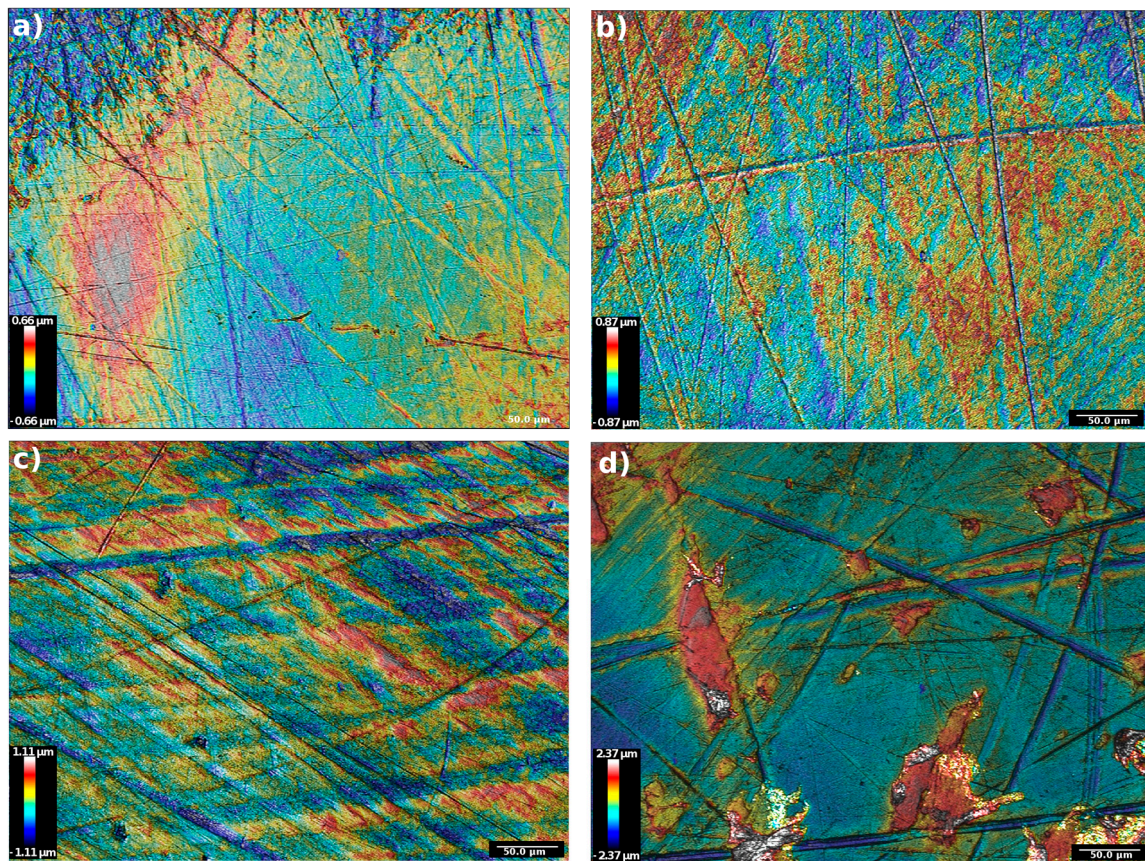
**Figure S1** – Supplementary figure with a second set of contour images of the topographies acquired on the worn inner surfaces of four loaded specimens: a VE; b STD; c XL-75; d XL-50. The observations are very similar to the ones described for Figure 4.
